### Year 2 Monitoring Report

### **Bohemian Mitigation Project**

DMS Project #: 100108 | Contract #: 7863 | DWR # 2019-1403 | RFP: 16-007703

Randolph & Guilford Counties, North Carolina Cape Fear River Basin Randleman Lake Watershed HUC 03030003

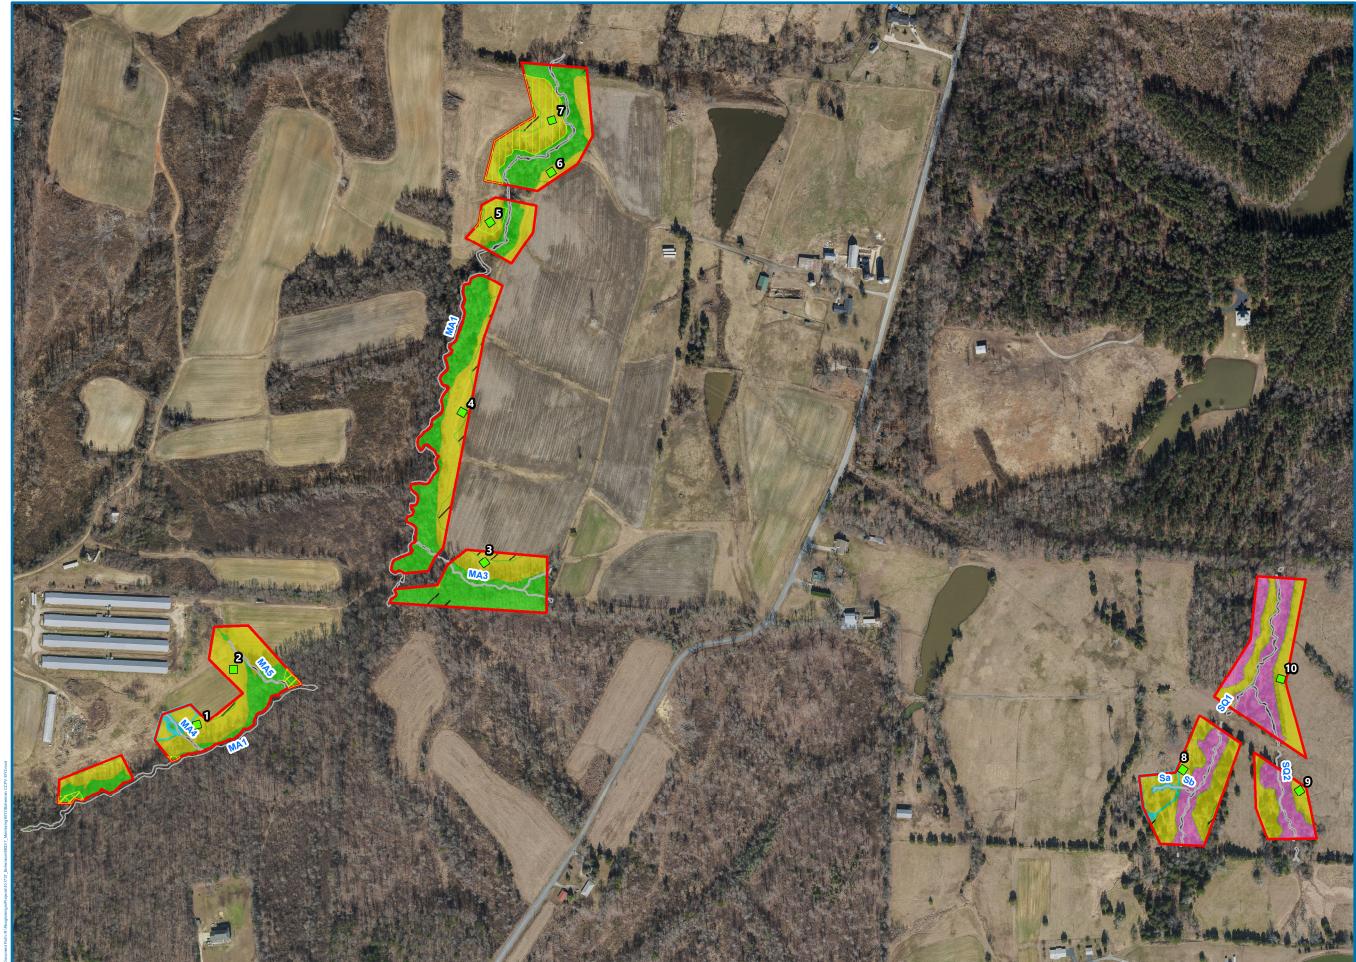
- Please show the area replanted in and around veg plots 5 and 7 on the CCPV (Figure 2) and submit the associated shapefile. The replanted area has been included on the CCPV (Figure 2) and the shapefile has been added to the support files.
- The CCPV does not clearly show the entirety of the invasive area when compared to the submitted Veg\_Problems\_Boho\_MY2 shapefile. Please review these differences and update either the CCPV or shapefile to reflect the current conditions. The shapefile has been updated to reflect the current areas of invasive species in need of treatment. The previous shapefile was sent in error, reflecting areas that had already been treated in 2021.
