**Bowl Basin Restoration Site
Monitoring Report MY08
DMS Project # 95721
DMS Contract # 005012**

**Onslow County, NC
CU# 03020106
DWR# 2013-0864
SAW# 2013-00393**

**Construction Completed: February 2015
Data Collection: 2022
Submitted: January 2023**

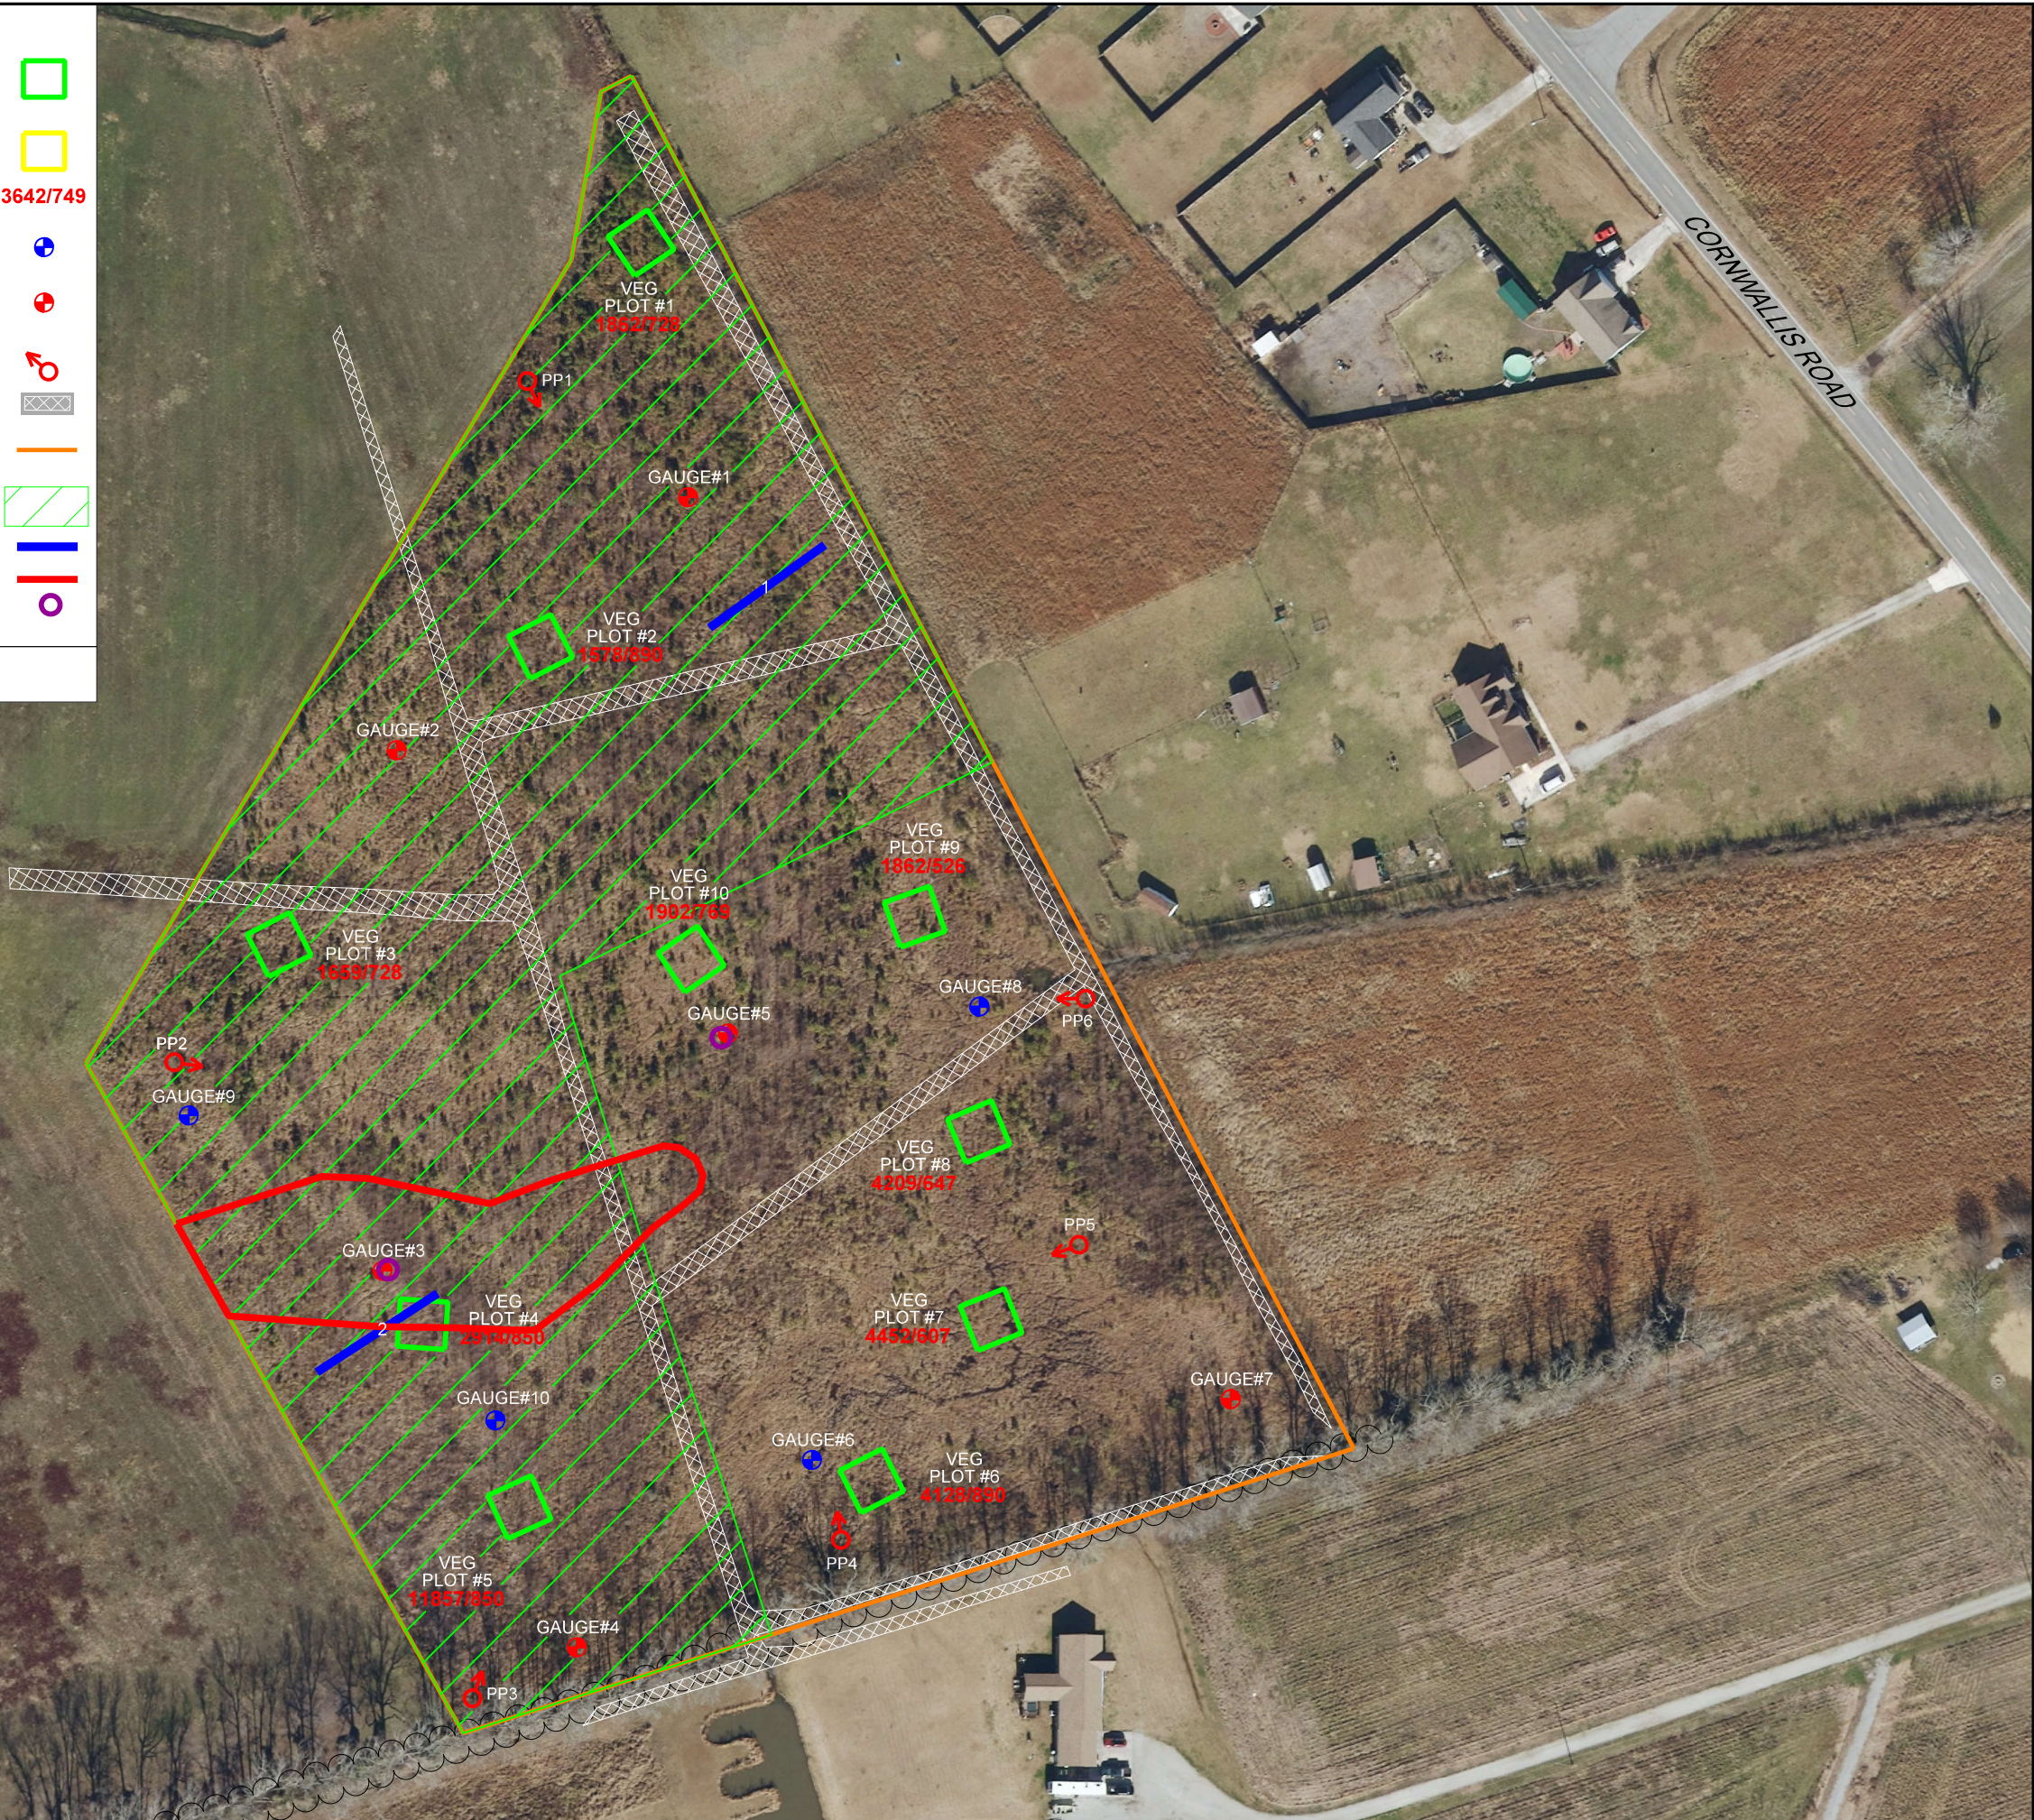
DATE: DEC 2022
 SCALE: GRAPHIC
 CURRENT
 CONDITION
 PLAN VIEW
 SHEET 1 OF 1
 FIGURE 3

between the “wet” and “dry” soils, a detailed delineation of the extent of each was completed in the area around Gauge 3. Based on this analysis, 0.668 acres have been designated as low performing hydrology area. KCI is proposing to remove the credits from this area.

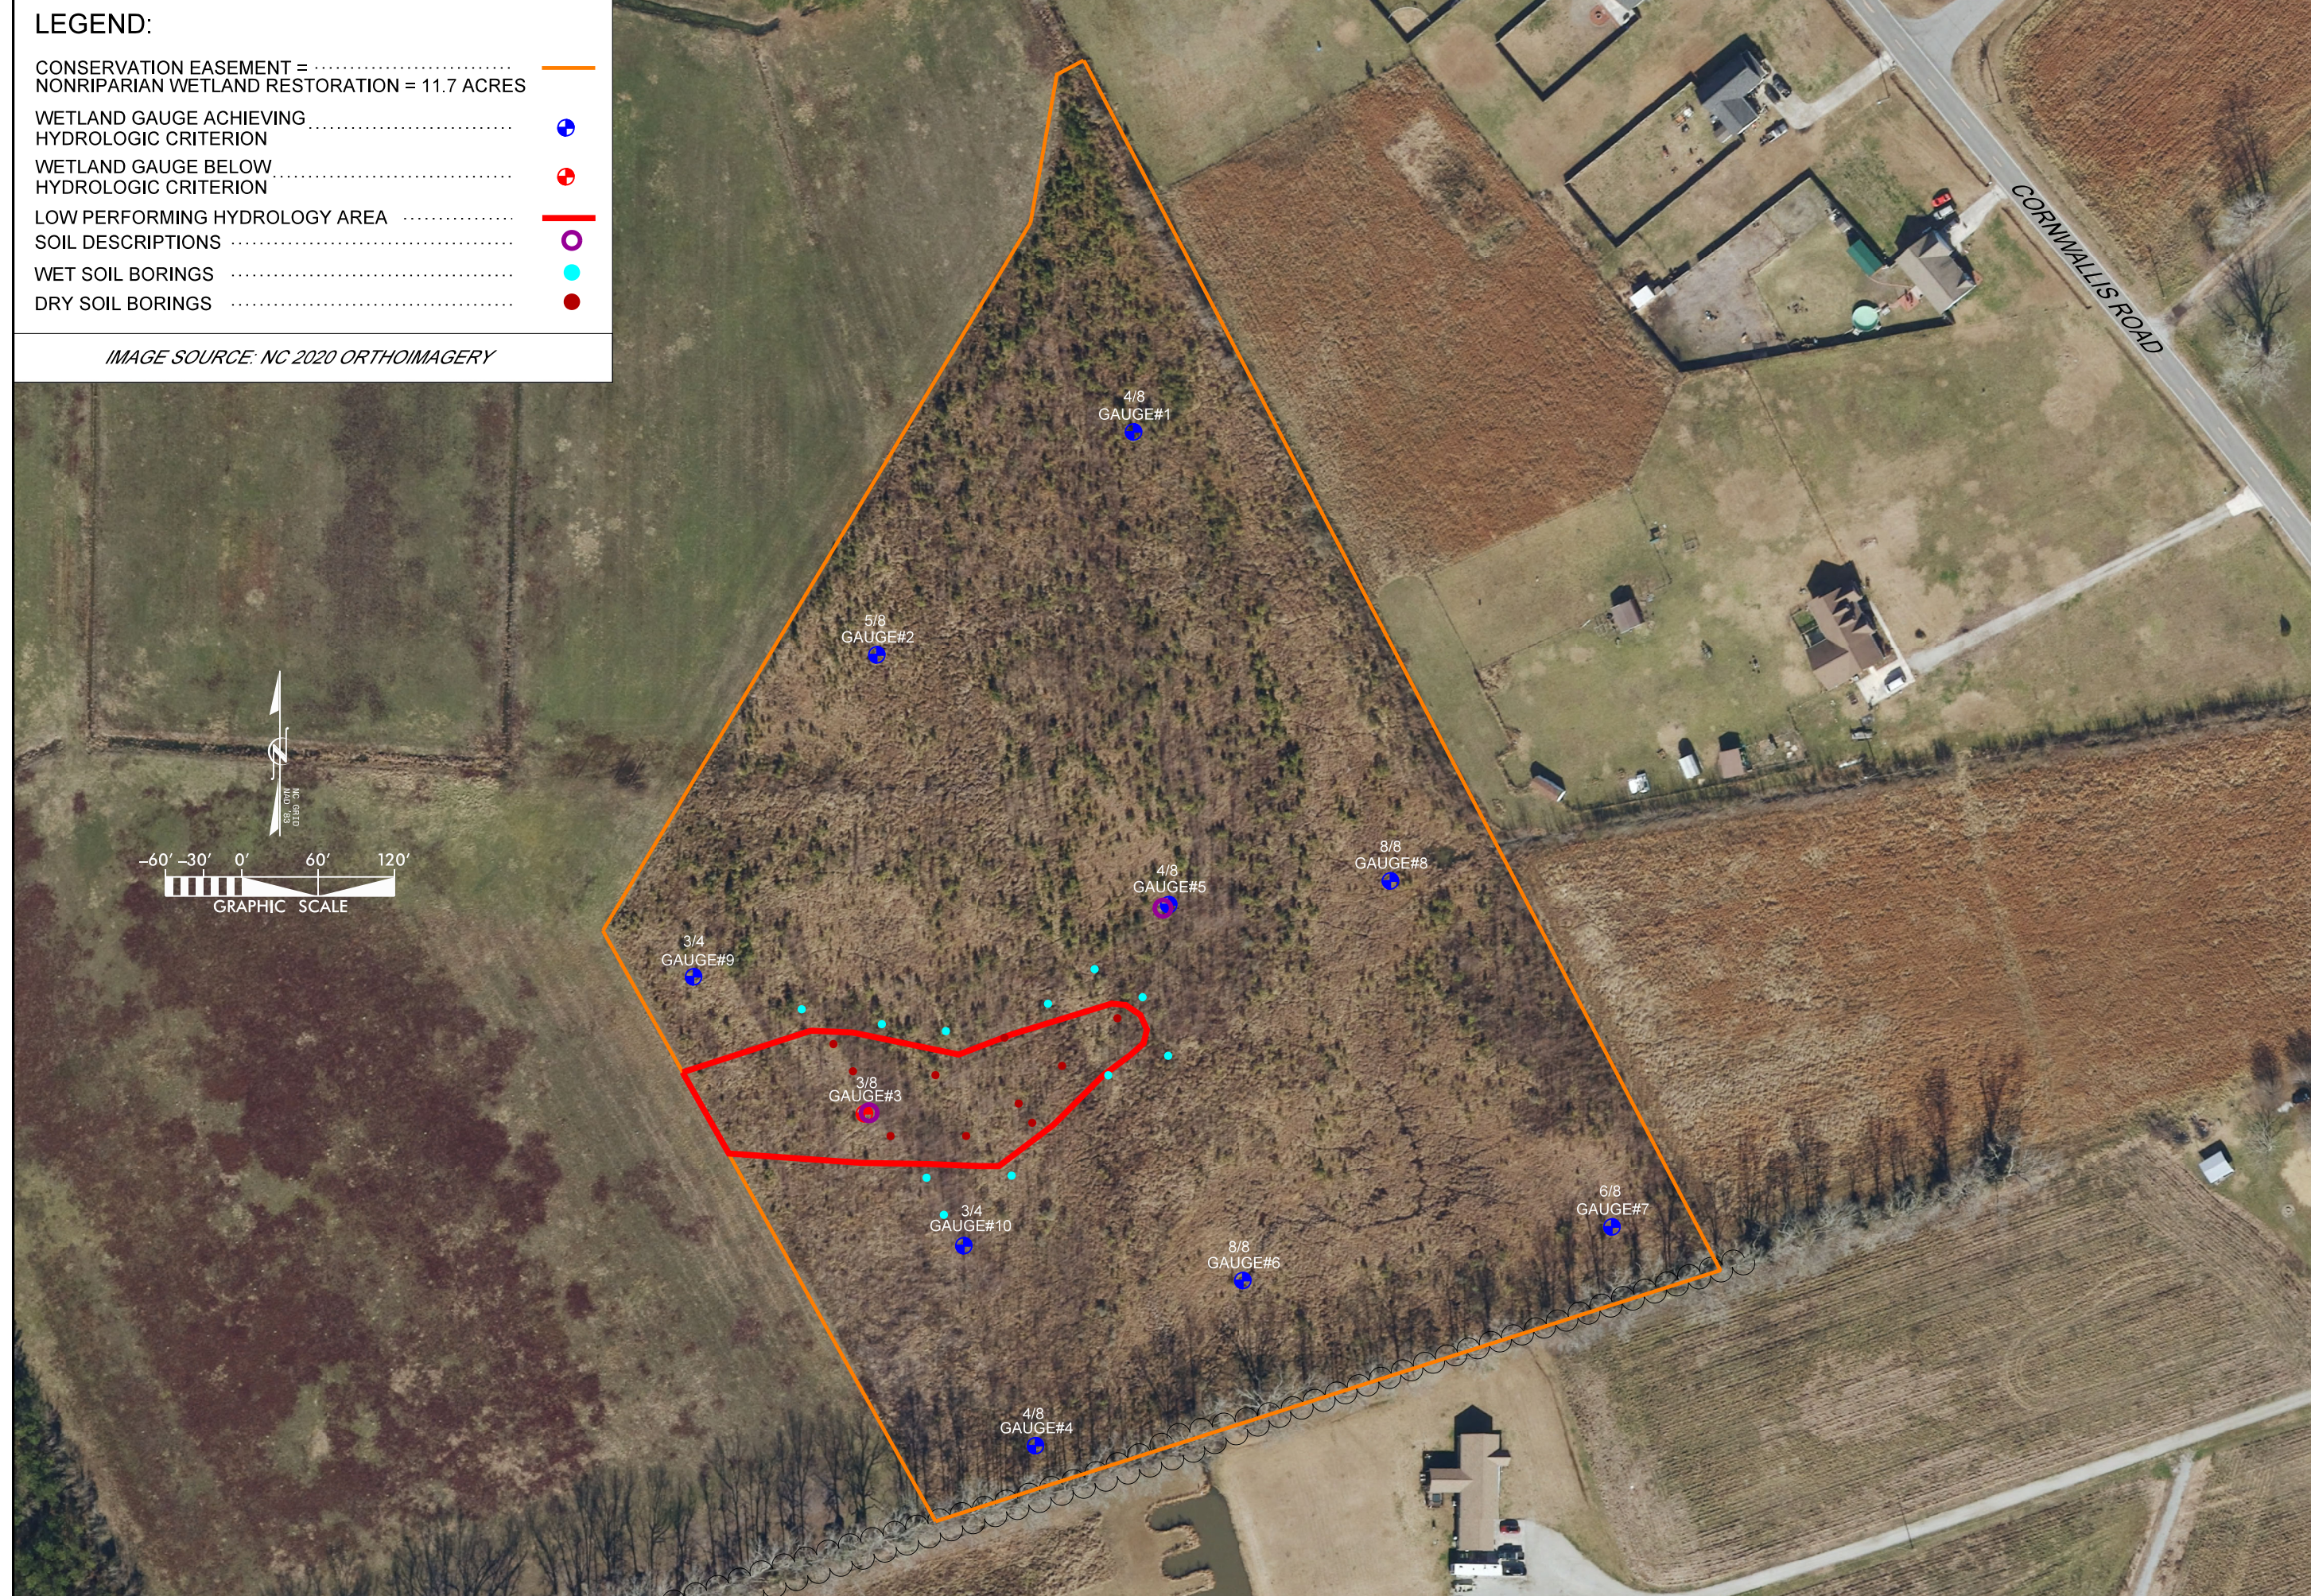
**SOIL
BORINGS
MAP**

Gauge 3 has only achieved the success criteria in 2 of the 8 years that it was installed. In 2020 Gauge 9 was installed approximately 170 feet northwest of Gauge 3, and Gauge 10 was installed approximately 130 feet southeast of Gauge 3, with the intention of better identifying the low performing hydrology area. These two gauges have met the success criteria in all three years since their installation. On December 1, 2022, KCI performed a detailed soil analysis of the area around Gauge 3 to further delineate the low performing hydrology area. This analysis identified the soils on site as having a thick, dark surface underlain by a lighter Bt horizon, consistent with the Pantego Series that was identified on-site during the initial phase of the project. In the area of low performing hydrology, this Bt horizon lacked redoximorphic features and was generally located at a deeper depth than in the wetter areas of the site. A11 – Depleted Below Dark Surface was the predominant hydric soil indicator used during this delineation. There were also some areas of A12 – Thick Dark Surface, but in general, areas with thick dark surfaces failed to meet the chroma or redox requirements for the underlying layer that this indicator requires. A representative description of both soil types is presented in Appendix A – Visual Assessment Data. After identifying the main difference
