Mayo Steam Electric Plant Ash Basin

Topographic Map and Discharge Assessment Plan

NPDES Permit NC0038377

December 30, 2014

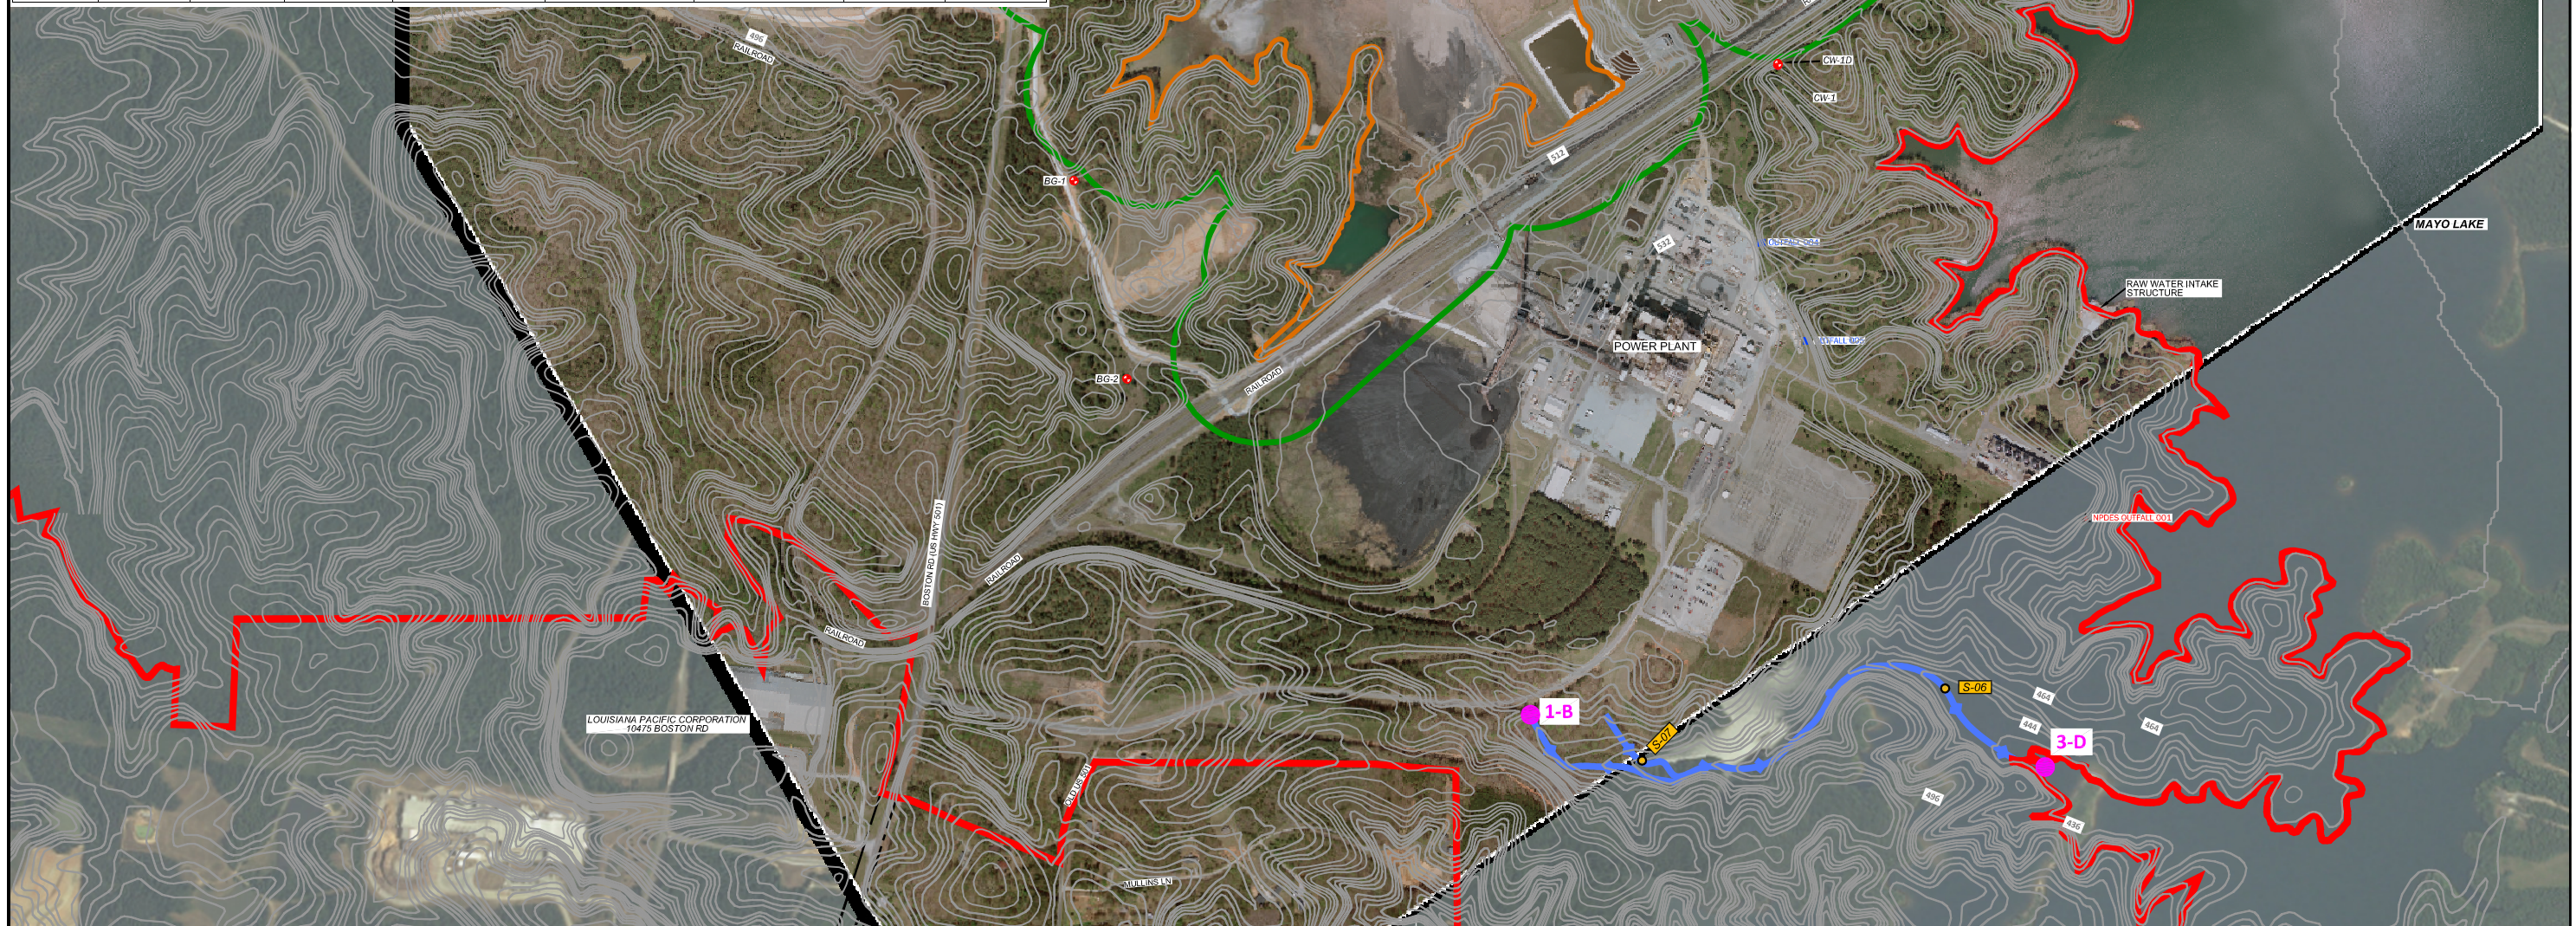
DATE
 DECEMBER, 2014
 FIGURE
 2

Locations of seepage at the ground surface adjacent to the ash basin have been identified and are shown in Figure 2. These areas include the earthen embankment which impound the ash basin as well as adjacent areas where water from the ash basin may have infiltrated into the underlying residual materials and expressed as seepage.

Topographic maps of the site were reviewed to identify regions of the site where there was a potential for ash basin related seepage to be present. These regions were determined by comparing ash basin full pond elevations to adjacent topography with ground surface elevations lower than the ash basin full pond elevation. Synterra staff performed site observations within these identified areas as part of NPDES inspections during the reapplication process during August and November 2014 and documented locations where seepage was apparent at the time of the site visit. These seeps are identified as required by GS 130A-309.210(a)(2)(ii) on Figure 2.
