# **Report on Slope Stability Related to the Jackson County Airport**

**North Carolina Geological Survey  
Division of Land Resources  
Department of Environment and Natural Resources**

**February 23, 2006**

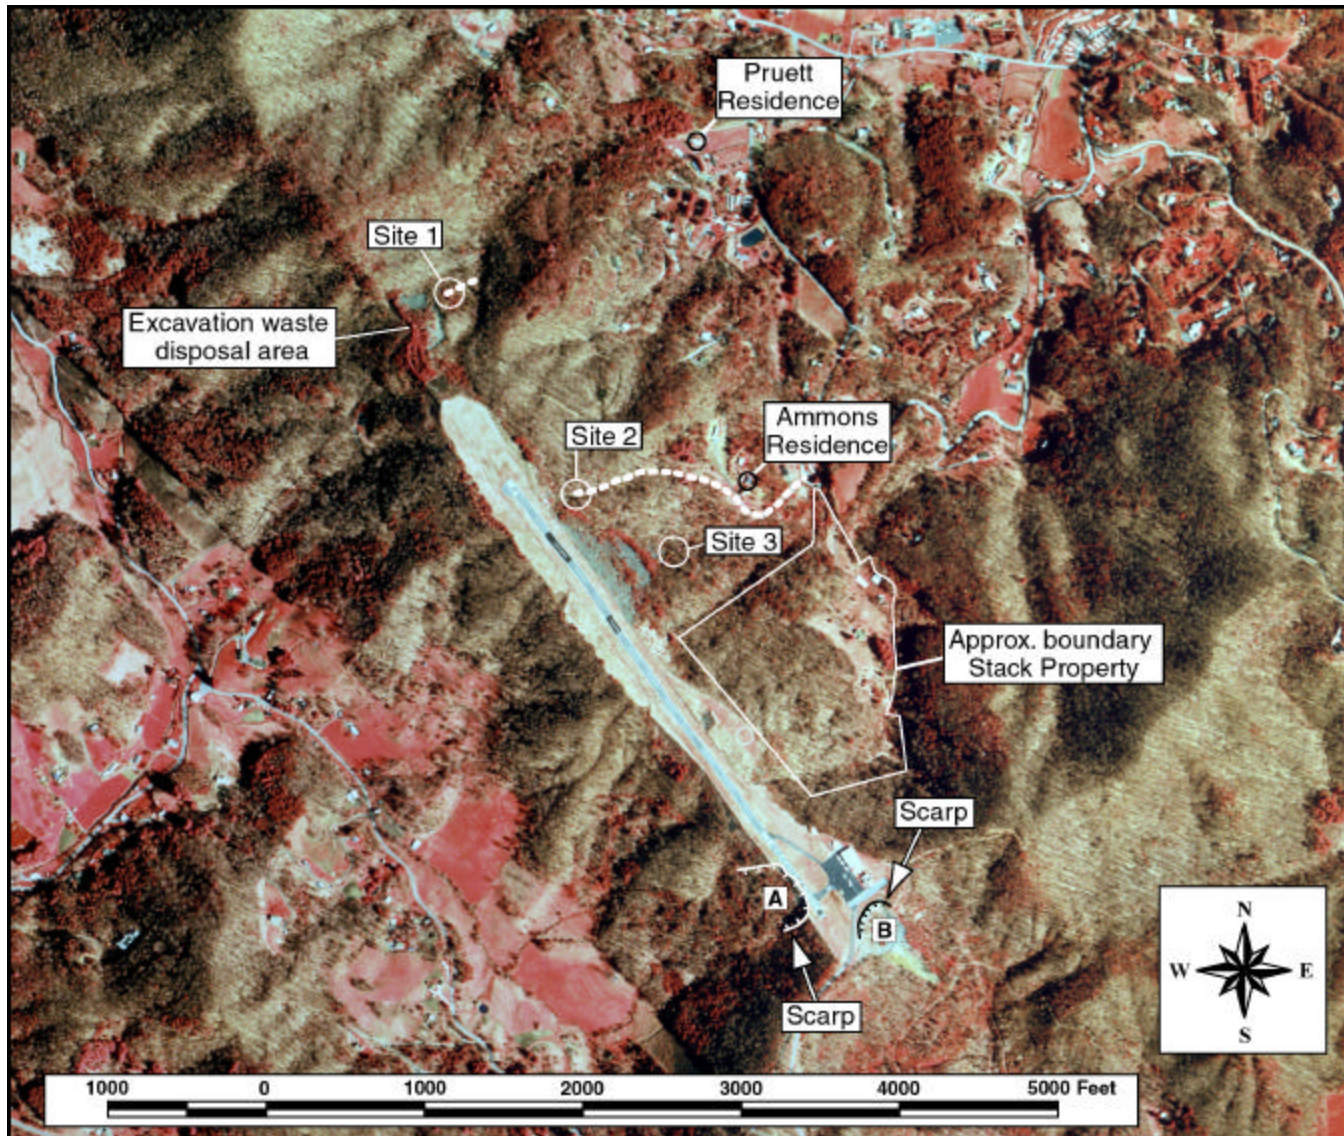
The past slope failures appear to be related to soil and rock material used to fill in drainages and low areas during airport construction. Figures 1 and 2 show two major scarps (A and B) that developed into embankment failures near the southeast end of the airport. Scarp A, southwest of the terminal, is about 400 ft wide at the top. Scarp B, south of the terminal, is about 300 ft wide. Scarp A began to develop approximately 8 months after airport construction was completed in 1976. It continued to progress upslope until it affected the runway pavement in 1987 shortening the runway by 500 feet and, in 1994, removed part of the taxiway (Talbert & Bright, Inc., 2004). According to the GeoTechnologies report (Appendix C, Talbert & Bright, 2004), the major failure at scarp A occurred in a soil fill that was originally designated as a rock fill. Because of the large volume of excavation waste material after site grading, concessions were made to allow the waste material with soil to be used as fill at this location. The time of initial slope movement related to scarp B is not known. A review of 1993 and 1998 aerial photographs indicates that approximately 50 feet of downslope movement occurred in the vicinity of scarp B between 1993 and 1998, as evidenced by displaced trees visible in the aerial photography.

Ground reconnaissance by NCGS staff on December 20, 2005 indicates the failed embankment material below scarps A and B shows signs of continued, slow movement as evidenced by numerous curved trees and saplings, and unvegetated intermediate scarps in both areas. An unvegetated, scoured channel originating in soil beneath rock boulders on the ground surface indicates recent erosion and slope movement below scarp B.

**Figure 1.** Excerpt from 1998 color-infrared digital orthophoto quarter-quadrangle (DOQQ) showing the locations of the Jackson County airport, sites visited on August 30, 2005, and other features. Dashed white lines show the approximate tracks of the August 22, 2005 slope failures. A white hachured line delineates scarp 'A,' and a black hachured line delineates scarp 'B,' showing the locations of known pre-existing embankment failures.

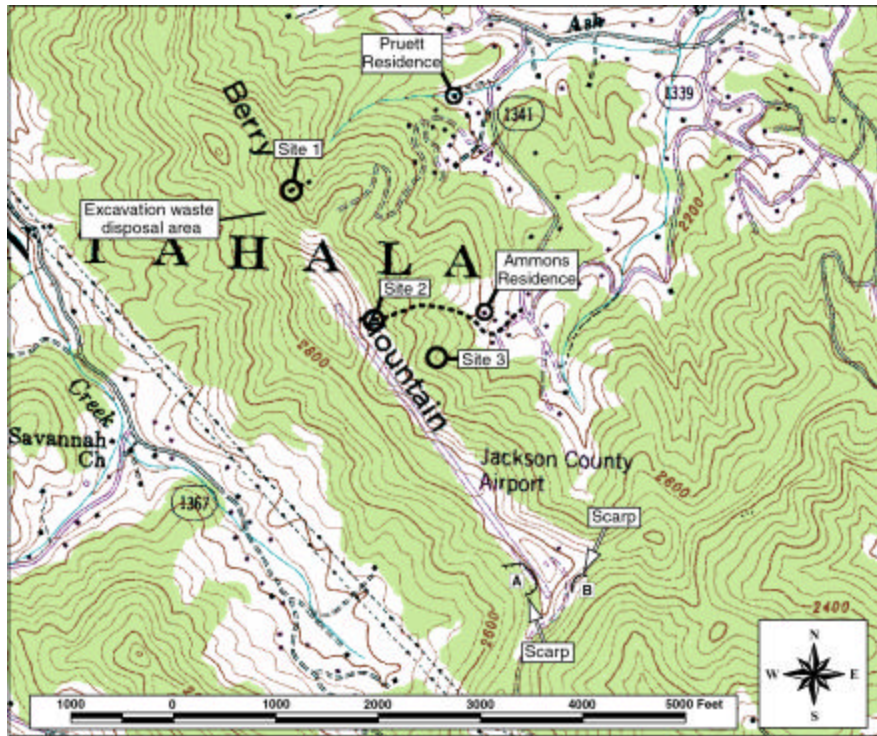
**Figure 2.** Excerpt from USGS 7.5-minute topographic map showing the locations of the Jackson County airport and sites visited on August 30, 2005. Dashed black lines show the approximate tracks of the August 22, 2005 slope failures originating at Sites 1 and 2 respectively. Black hachured lines delineate scarps labeled ‘A’ and ‘B’ located above pre-existing embankment failures.

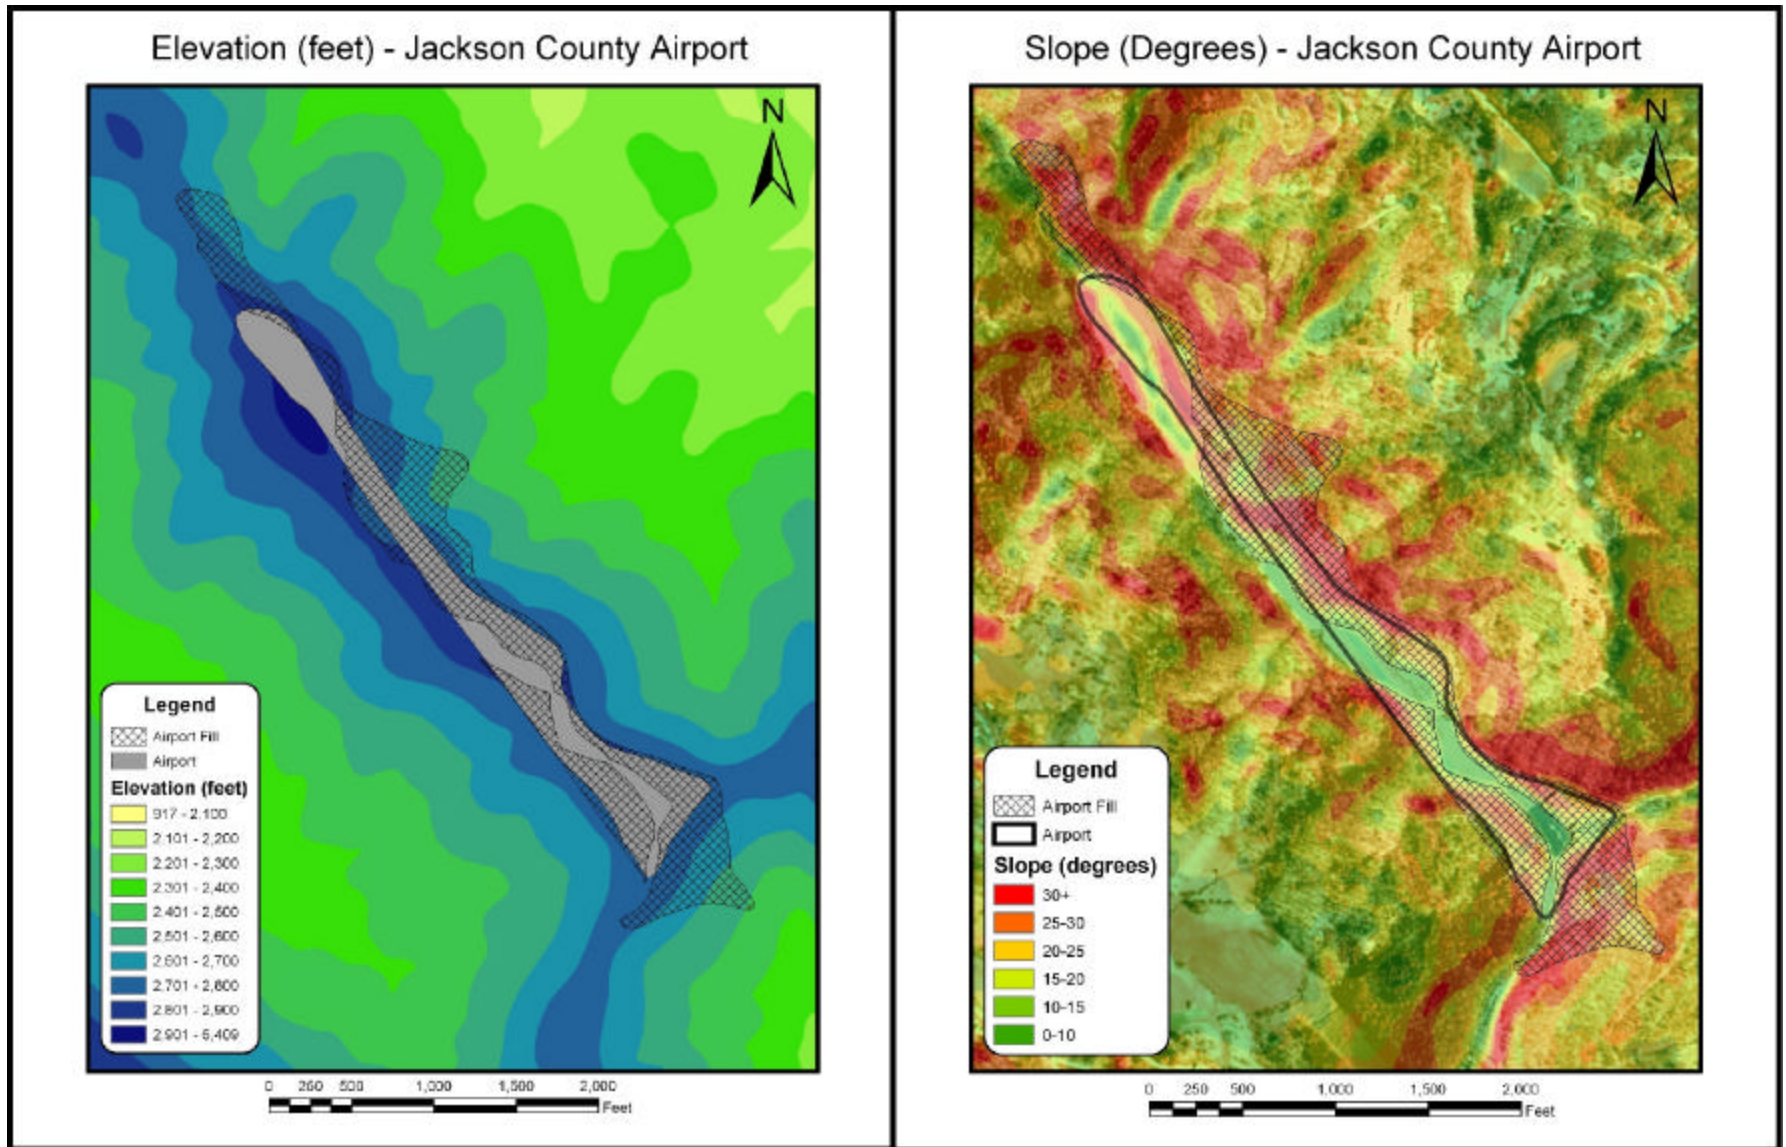
Construction of the airport required large volumes of fill material to obtain the current airport elevation (2857 ft). The NCGS's analysis of topographic maps and aerial photographs confirms that areas of thick soil and/or rock fills are present at several locations. Figure 4A is a geographic information system (GIS) map that shows the pre-airport topography overlain with the airport boundary and the approximate areas with fill. The approximate areas of extensive fill were estimated by identifying those areas in the airport vicinity that were below the current airport elevation as determined from topographic maps made prior to airport construction. Field observations and aerial photographs were also used to refine the estimates of the areal extent of fill.

Fills can be less stable than natural ground if they are not composed of suitable material that is properly placed on a stable foundation and compacted. Boring logs from the airport included in the GeoTechnologies report indicate that some fill contains woody and organic debris. This organic material eventually decomposes leaving void spaces in the fill that can channel water and destabilize the slope. The steepness of the slope also

affects its stability. Figure 4B is a GIS map showing general areas where slopes greater than 30 degrees (58%) occurred in the vicinity of the Jackson County Airport prior to airport construction. Unless adequately designed and constructed, fill placed on slopes steeper than 30 degrees can be less stable and more failure prone than unmodified slopes at the same slope angle. Figure 4B shows areas where fill appears to have been placed on slopes greater than 30 degrees.

**Figure 4.** GIS maps of the Jackson County Airport and vicinity. **A.** Elevation map of the Jackson County Airport. Grey area delineates airport. Hatched area shows assumed locations of constructed fills based on elevation. Some fills may be at least 75 ft thick based on differences in elevation. **B.** Slope map of the Jackson County Airport. Areas in red indicate slopes greater than 30 degrees (58%). Hatched area shows assumed locations of constructed fills. Slopes greater than 30 degrees (58%) can be marginally stable, particularly where overlain by fill.

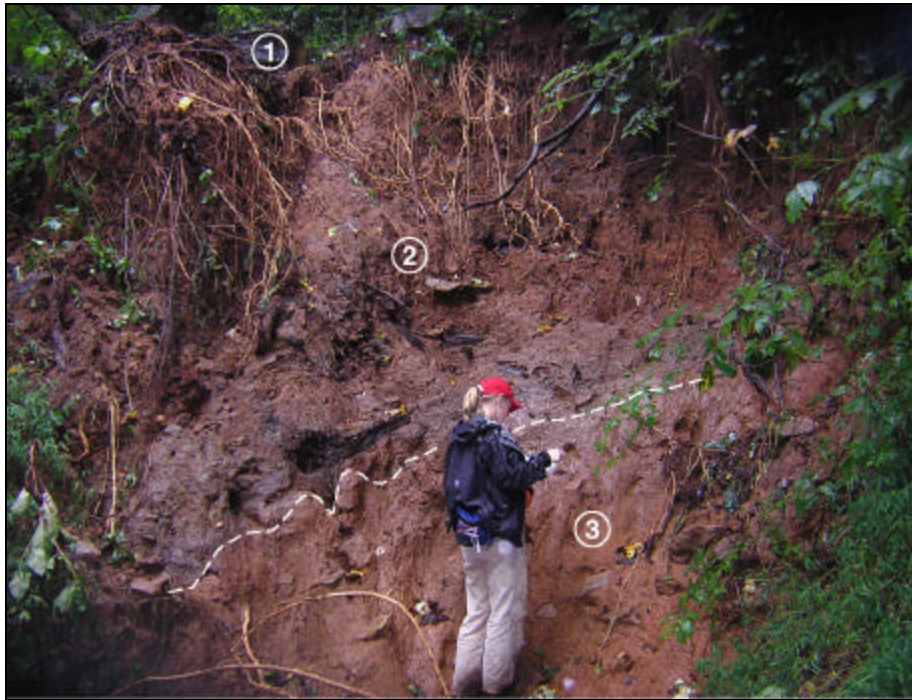
**SITE 1.** Site 1 is the head scarp area of the August 22, 2005 slope failure above Mr. Pruett's residence. The slope failure appears to have originated within material previously transported during a 1977 landslide that reportedly involved material from airport construction. The scarp exposed on August 22, 2005 (fig. 5) marks the location where material detached from the pre-existing slope either by water erosion and/or slope movement. Tension cracks were observed near the top edge of this oversteepened slope. Some gulying above the scarp indicated runoff was directed toward the slope that failed. The bulk of the slope failure material was transported by water onto the Pruett property for a distance of approximately 500 feet.

The steep scarp area exposed by the slope failure is shown in figure 5. The sequence of main deposits exposed in the scarp is described below, starting with the uppermost (youngest) deposit:

**Deposit 1.** Boulders on the ground surface from a rock slope placed during airport construction and possibly transported by a 1977 landslide. Numerous curved and tilted trees indicating soil creep are growing near the boulder deposit in the vicinity of the head scarp. The rock slope appears to thicken upslope toward airport property.

**Deposit 2.** Clay-silt-sand mixture with large fragments of decayed organic debris possibly transported during the 1977 landslide. Scattered gravel- and cobble-sized rock fragments are also in this horizon. The base of this unit may approximate the original ground surface prior to airport construction.

**Deposit 3.** Sandy, silty clay with subrounded gravel- and cobble-sized rock fragments. This deposit appears to be a colluvial hillslope deposit present well before airport construction.

The slopes exposed in the scarps at Sites 1 and 2 are oversteepened and are subject to further erosion and slope failure. Heavy rainfall triggered the slope failures that involved material that was emplaced or disturbed in connection with airport construction. Observations made during the site visit on the loose rock slopes above Sites 1 and 2 did not reveal any obvious signs of impending catastrophic failure. Exposures in the scarps at Sites 1 and 2 indicate that the sand-silt-clay deposits containing decayed organic debris may underlie the rock slopes at this and other locations below the airport.

**Figure 5.** Head scarp of slope failure at Site 1. **Deposit 1** – Rock boulders from airport construction on ground surface. **Deposit 2** – Sand-silt-clay mixture with large fragments of organic debris. **Deposit 3** – Colluvial hillslope deposit consisting of sandy, silty clay with gravel and cobbles. Portions of layers 1 and 2 may have been transported during the reported 1977 landslide.

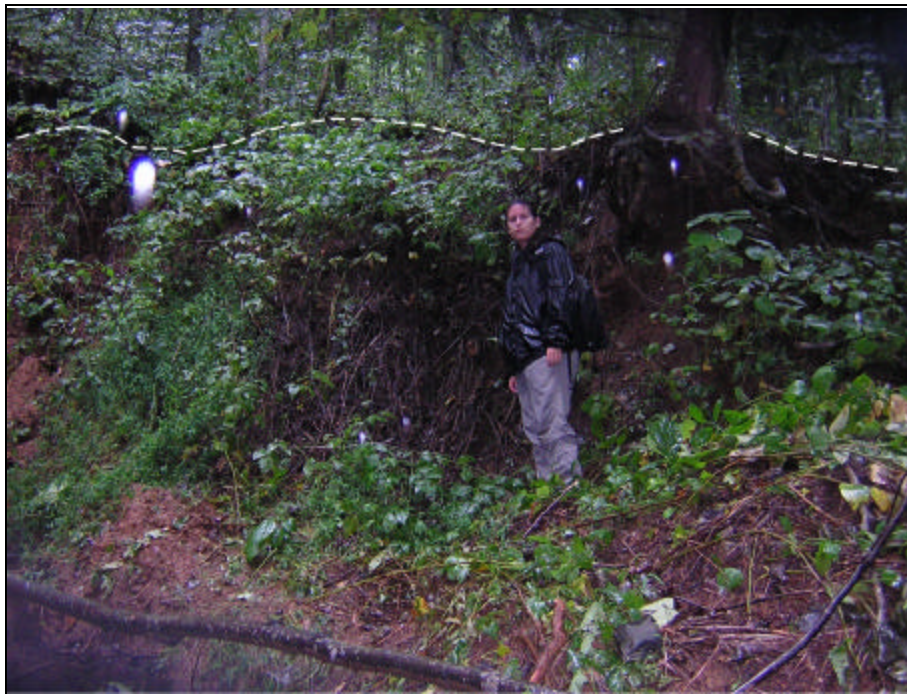
Also exposed at Site 1 are what appear to be remnants of an older scarp from a previous slope movement (fig. 6). This older scarp predates the August 22, 2005 slope failure, and may postdate the 1977 landslide event reported at this location.

**Figure 6.** Top of older scarp (white dashed line) exposed at Site 1. Geologist is standing on down-dropped surface. This partially vegetated older scarp predates the new scarp formed by the August 22, 2005 slope failure (just southeast of this location shown in figure 5). The older scarp may have developed in the reported 1977 landslide deposits.

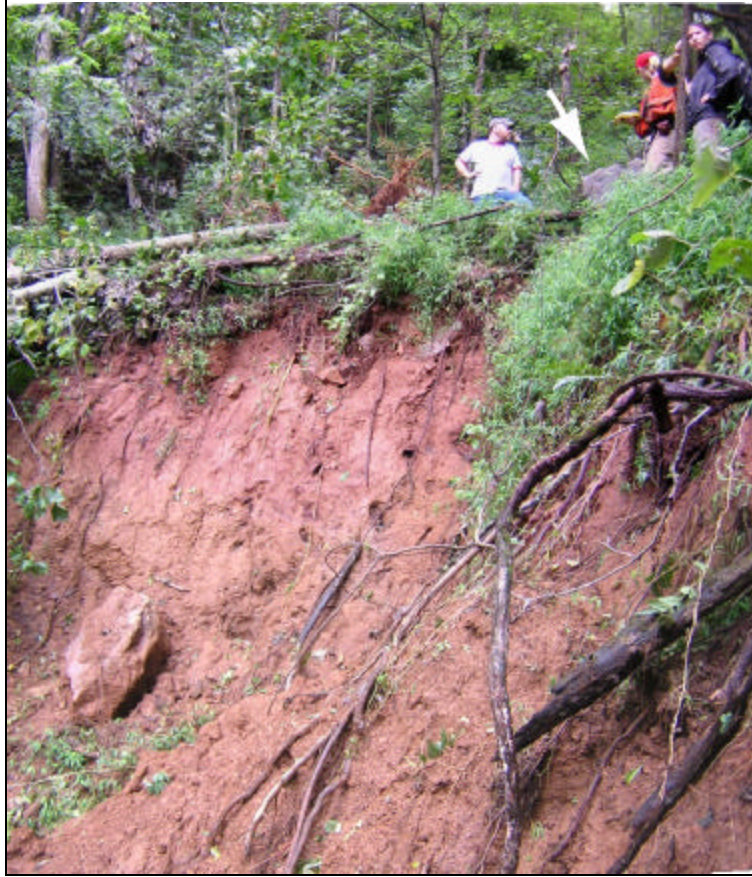
**SITE 2.** Site 2 is the head scarp of an August 22, 2005 debris flow that traveled about 1,500 feet downslope onto the Ammons property (figs. 1 and 2). Figure 7 shows a sequence of deposits at Site 2 similar to those exposed in the scarp at Site 1 (fig. 5). If present, any original colluvial deposit predating airport construction was not clearly exposed at this scarp location. Figure 8 shows decayed woody debris in the layer beneath the man-made rock slope most likely placed during airport construction. Gullying above the scarp indicates that some runoff was directed toward the slope that failed.

**Figure 7.** Debris flow head scarp exposed at Site 2. White arrow points to rock boulder from airport construction on ground surface.

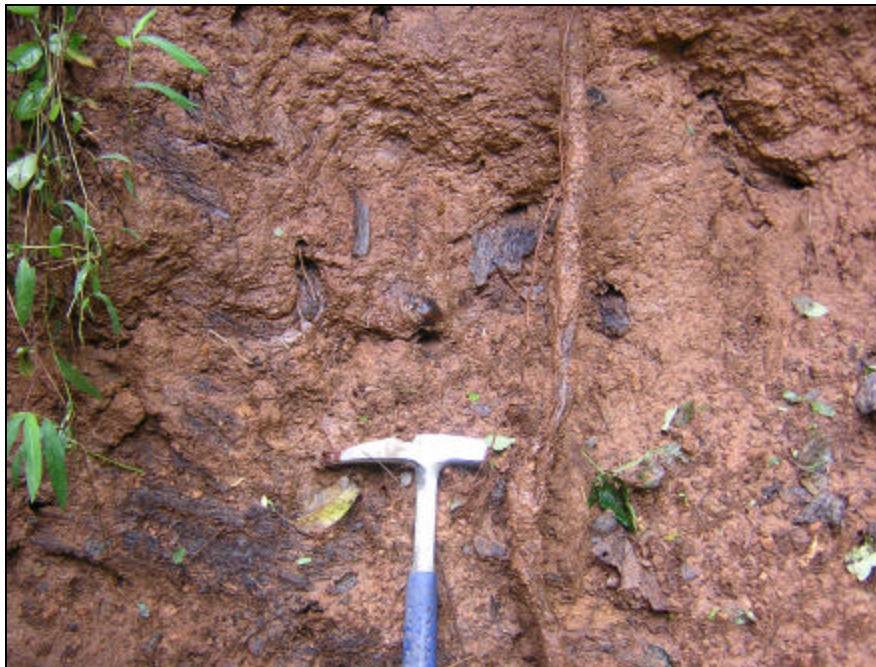
**Figure 8.** Close up view of decayed woody debris (dark areas) exposed in the August 22, 2005 debris flow head scarp at Site 2 (fig. 7). Hammer head is about 7 inches across.

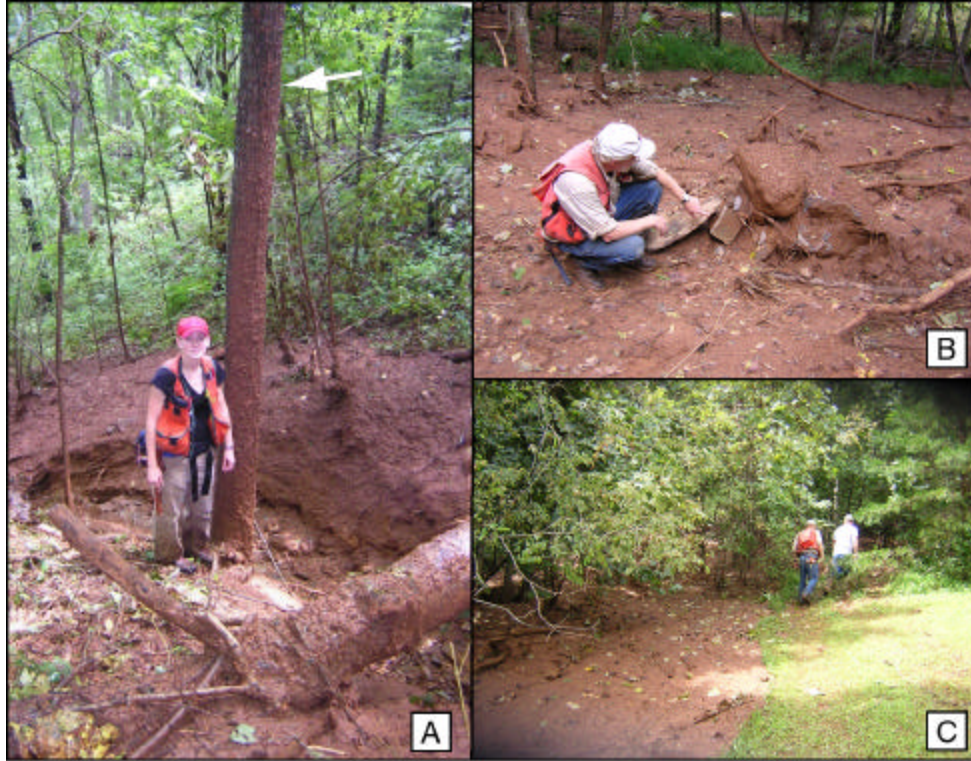
Figure 9 shows a sequence of images along the debris flow track downslope from Site 2. Older colluvial and/or debris flow deposits were observed in some of the incised sections of the debris flow track. Not shown in the photographs is a diversion ditch being constructed near the midpoint of the track to divert water and sediment away from the Ammons' property.

**Figure 9.** Photographs of debris flow that originated at Site 2. **A.** Mudline on tree (white arrow) along middle of track. Flow was downslope toward the left. **B.** Lower part of debris flow deposit with imbricated boulders and cinder block from destroyed springhouse. Flow direction was to right. **C.** Run out zone of debris flow deposit on yard of Ammons property. Flow direction was toward lower left of photograph.

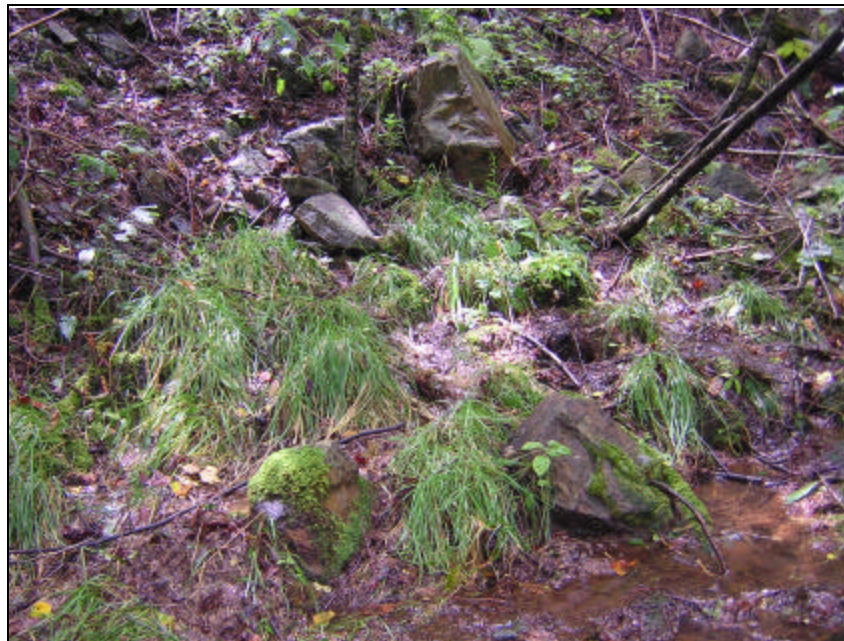
**SITE 3.** Figure 10 shows seepage (~10 gallons per minute) from the base of a rock slope constructed below the airport. Mr. Ammons reported that shortly after the August 22, 2005 slope failure events, the volume of water flowing from this location was considerably greater than at the time of the August 30, 2005 site visit, and was murky with sediment. If suspended sediment in the water occurs, it indicates that subsurface erosion (piping) beneath the rock slope may be occurring during high rainfall events. Clear water discharge may indicate a spring or some other form of groundwater discharge from the area beneath the rock slope. No culverts or other drainage structures that could be the immediate source of this water were observed in the man-made rock slope at this location.

Runoff from this area flows over a steep embankment along an old roadbed. The old roadbed may be an abandoned logging road, or an access road built during airport construction. This runoff could have a destabilizing affect on the old roadbed, and trigger a future slope failure.

The seepage and runoff at Site 3 will likely have a destabilizing affect on the old roadbed, and could trigger a future slope failure. Continued seepage and piping could also destabilize the rock slope at Site 3.

**Figure 10.** Seepage (~10 gallons per minute) from base of man-made rock slope (bottom right of photo) at Site 3. Downslope is toward bottom right.
