Investigation of the Peeks Creek Debris Flow of September 2004 and Its Relationship to Landslide Hazard Mapping in Macon County, North Carolina

Investigation of the Peaks Creek Debris Flow of September 2004 and Its Relationship to Landslide Hazard Mapping in Macon County, North Carolina

Rebecca Latham, Rick Wooten, Anne Witt, Ken Gillon, Tommy Douglas,
Stephen Fuemmeler and Jennifer Bauer
North Carolina Geological Survey, Swannanoa, North Carolina

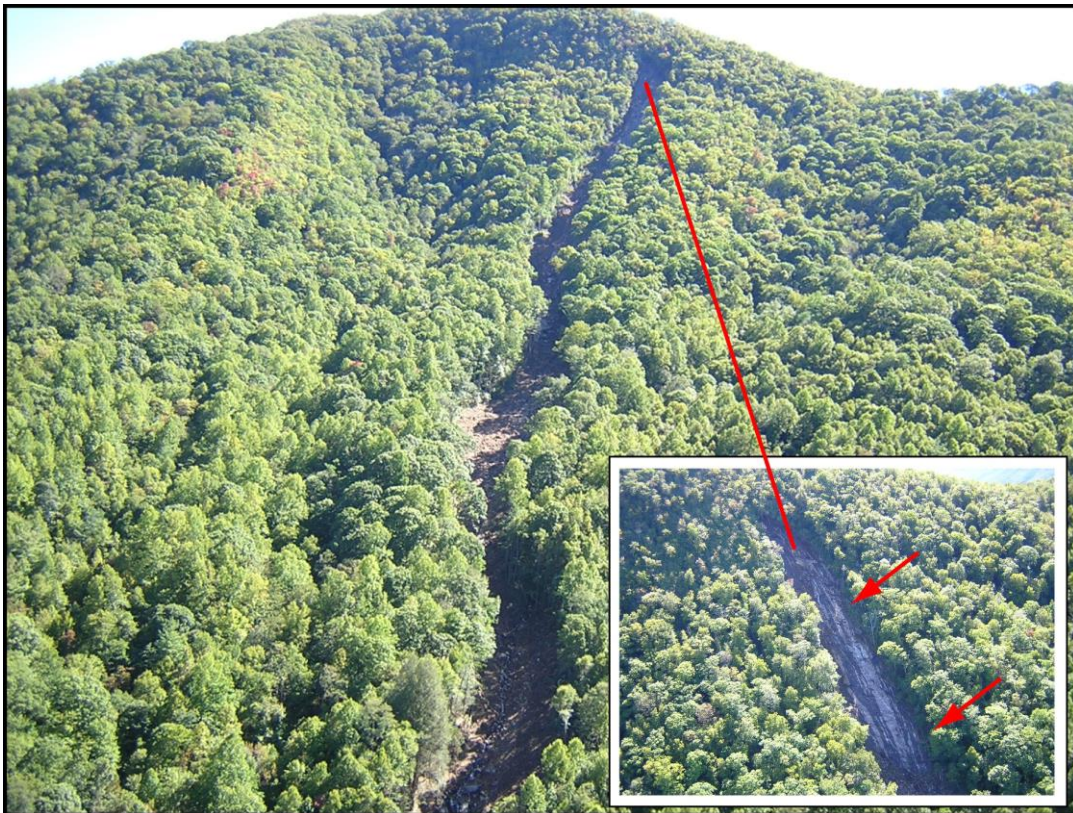
On September 16, 2004 the remnants of Hurricane Ivan dumped heavy rain on Macon County, North Carolina, triggering a debris slide near the top of Fishhawk Mountain (figure 1) at an elevation of 4,420 ft around 10:10 PM. This slide quickly mobilized into a debris flow that traveled approximately 2.25 miles and dropped 2,000 ft colliding with the Peaks Creek community and ultimately the Cullasaja River. Along its path, calculated estimates yield a maximum velocity of 33.2 miles per hour (mph) and a conservative discharge estimate of 45,000 cubic feet per second (cfs). The resulting debris flow destroyed fifteen homes in the downstream community adjacent to Peaks Creek and killed five people.

Figure 1: Initiation zone (shown in inset) and upper track of the September 16, 2004 debris flow on Fishhawk Mountain.

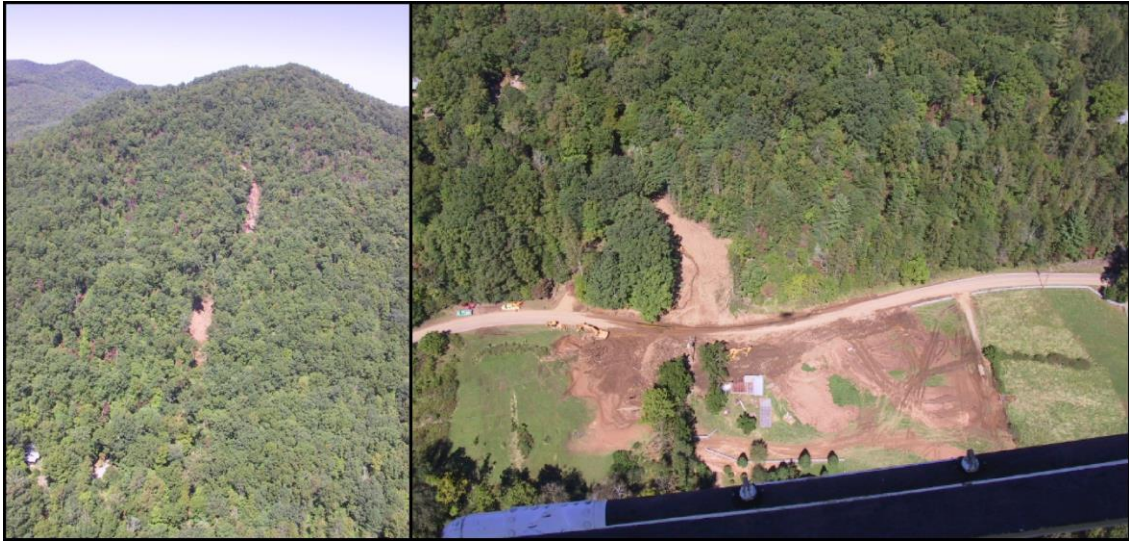
Two debris flows triggered by the remnants of Hurricane Ivan occurred above Wayah Creek (near the town of Franklin) less than a mile apart. Both of these debris flows originated on unmodified slopes, blocked the road with debris, and deposited sediment into Wayah Creek. Wayah debris flow 1 (figure 6) destroyed a barn at the toe of the slope. A small debris flow/blowout occurred in the Nickajack community near the reported location of the historical slope movement described above. This blowout sent minor amounts of sediment onto a private road and produced minimal damage.

Figure 6. Wayah 1 debris flow triggered in 2004 by Hurricane Ivan (Photos courtesy of U.S. Forest Service-Coweeta Hydrologic Laboratory). Photo at left shows the initiation zone and upper portions of the track. Photo at right shows the debris flow deposit that blocked the road and destroyed a barn.

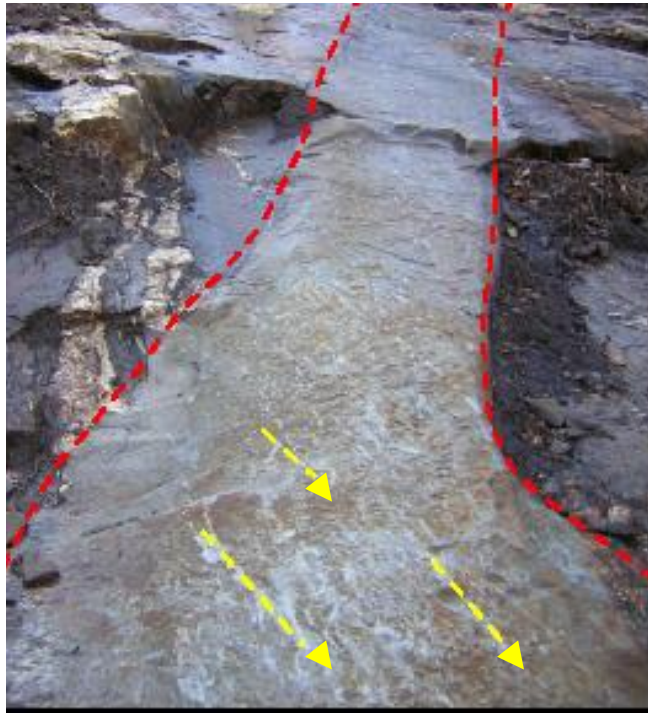
Figure 12. One of two tonalite-trondhjemite dikes that crosscuts the foliated metagraywacke exposed in the initiation zone. The arrows show the direction of the grooves created by the rock fragments in the sliding soil mass.

The Peeks Creek debris flow most likely began as a debris slide. Parallel scratch marks caused by rock fragments in the colluvial soil moving over the bedrock surface indicate that movement was in one direction as opposed to the turbulent motion associated with a debris flow (figure 12). The initial debris slide was approximately 75 feet wide, 350 feet long, and about 3 feet thick (figure 22, point 1 in figure 23). It quickly began to mobilize into a debris flow as water was added to the system. Erratic impact marks observed on bedrock in the debris flow track indicate that the material transformed into a debris flow and/or hyperconcentrated streamflow. The existence of a superelevation angle across a channel bend at section K-K' approximately 1,700 feet below the headscarp confirms that the transformation to flow had already occurred at that point.

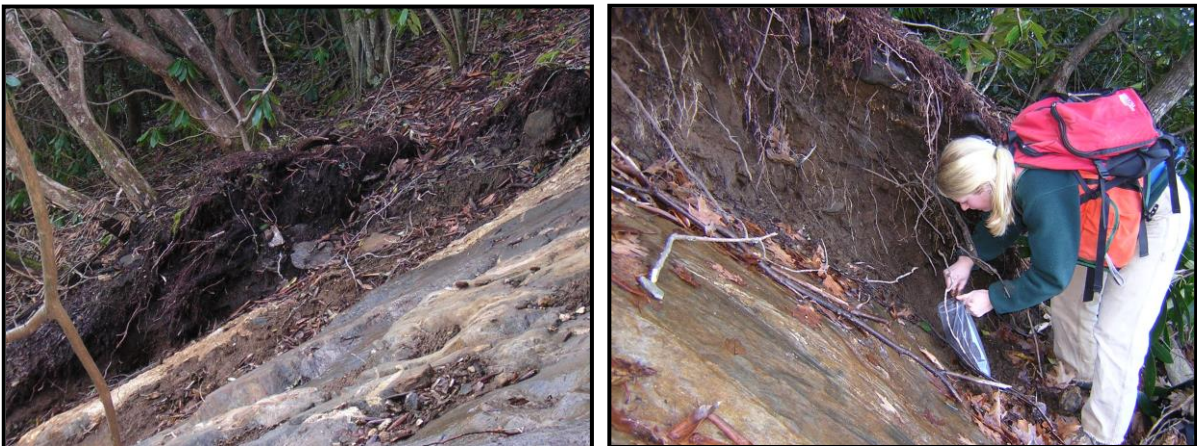
Figure 13. Soil in the initiation zone of the debris flow. Soil here is generally less than three feet thick and is in sharp contact with the steeply dipping ($35\text{-}55^\circ$), underlying bedrock.

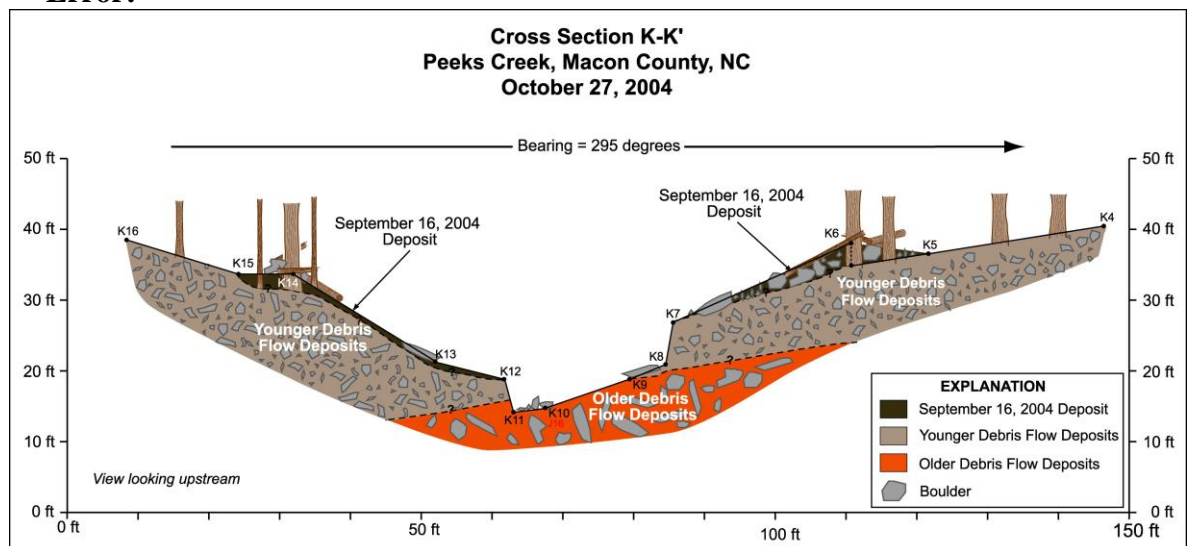
Figure 15. Cross-section in upper portion of the debris flow track showing older debris flow and colluvial deposits.

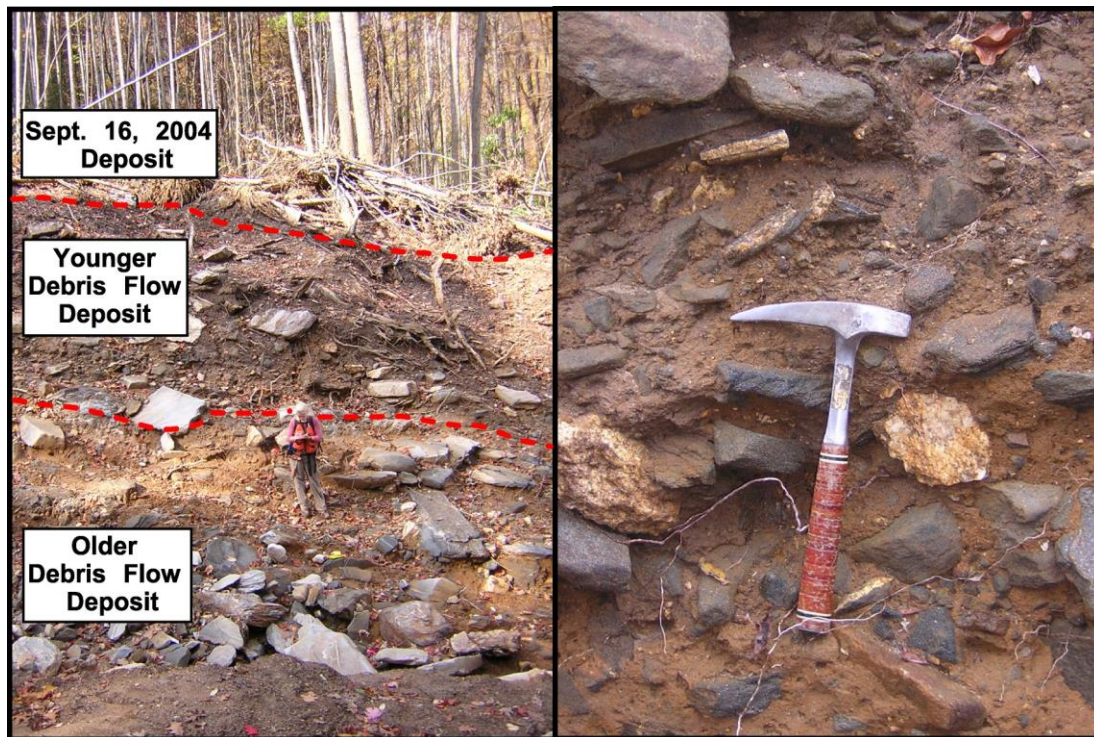
Figure 16. Multiple debris flow deposits exposed in the modern Peaks Creek debris flow track. Note crude imbrication and alignment of clasts in pre-2004 deposits in right photo.

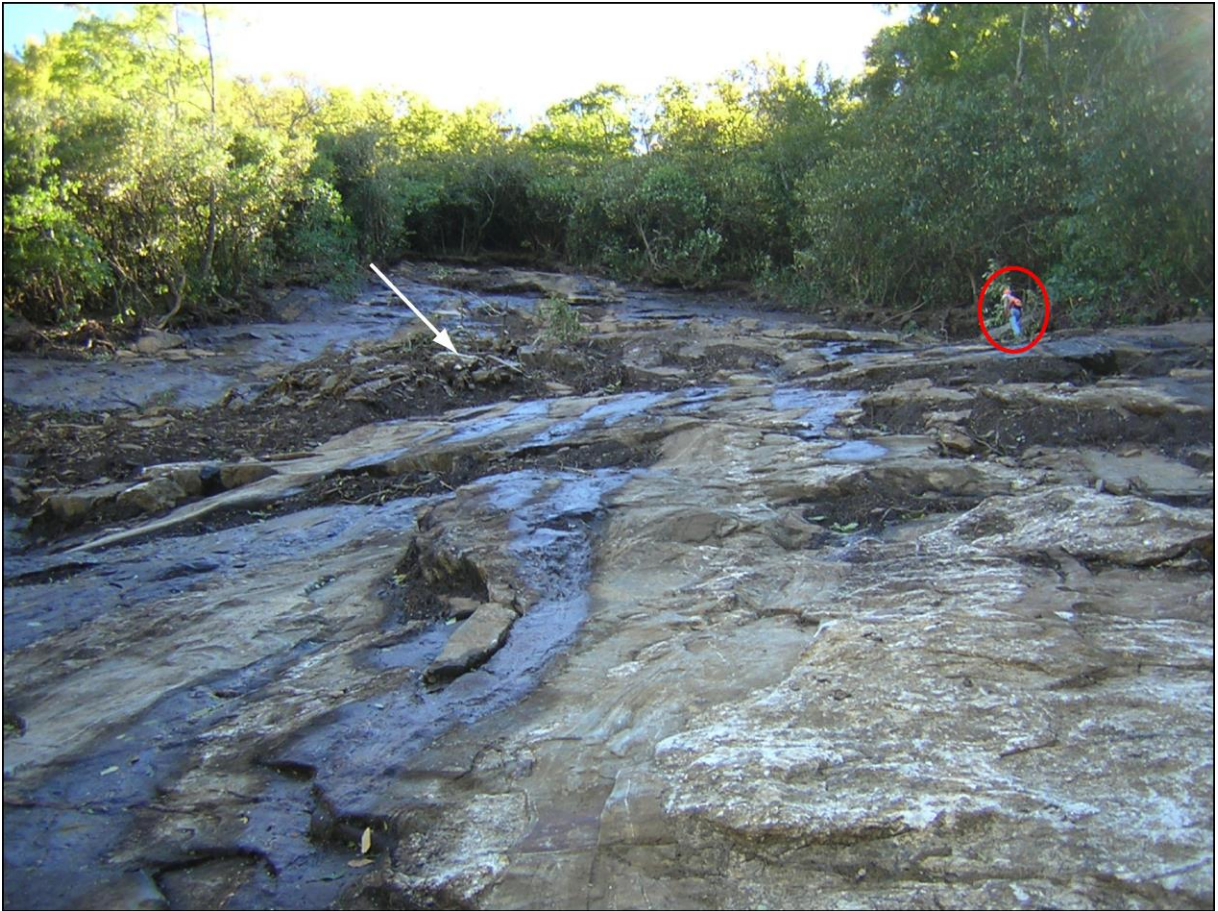
Figure 22. Looking uphill at the head scarp created by the debris slide. Arrow points to patch of colluvium not removed by the initial slide. Note person, circled in red, for scale.

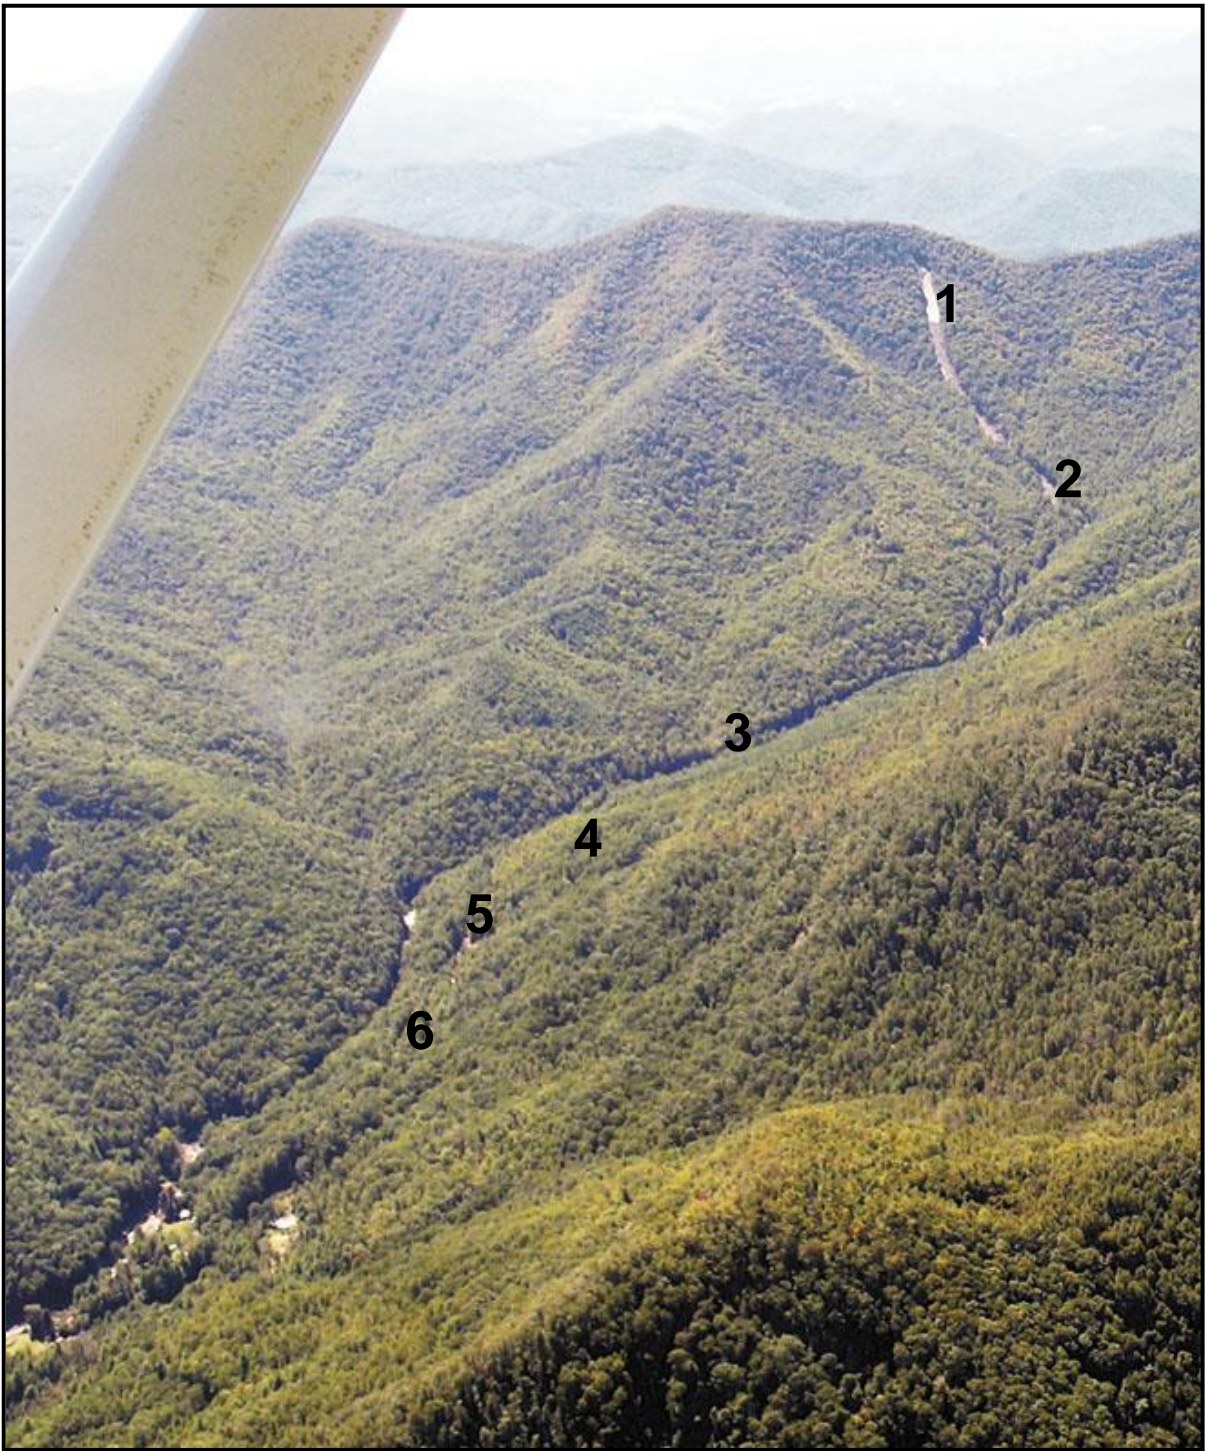
Downstream from the broad, flat area is a 0.6-mile, steeper, more incised portion of the track that ends just upstream of the Peeks Creek community (point 4 on figure 23). The upper boundary of this section is near the confluence of the North Fork of Peeks Creek with the main Peeks Creek channel. There are two side slope failures (figure 25) in this section that originated from Fishhawk Mountain Road on the north side of the stream channel. The

upstream failure appears to have been related to poor drainage along the road (point 5 on figure 23). Tension cracks and scarps continue to develop along this portion of the roadway. The downstream failure began as an embankment failure that quickly scoured the steep bedrock surface that leads down to the creek (point 6 on figure 23). It is possible that both these embankment failures created temporary debris dams along Peeks Creek before the main debris flow occurred, however any evidence for this was destroyed by the main debris flow. At the end of this section, the channel takes a nearly right angle turn to the north just before entering the Peeks Creek community. As the material in the debris flow rounded the bend, the woody debris was skimmed off the top and slammed into the house shown in figure 26. The house was pushed several feet off its foundation. Fortunately the woman inside did not sustain any major injuries. Major damage to homes began below this section and continued along the last quarter of the track.

Figure 23. Aerial view looking southwest at the Peeks Creek debris flow track. Numbered points refer to locations described in the text. Photo from Macon County News & Shopping Guide, September 23, 2004 issue

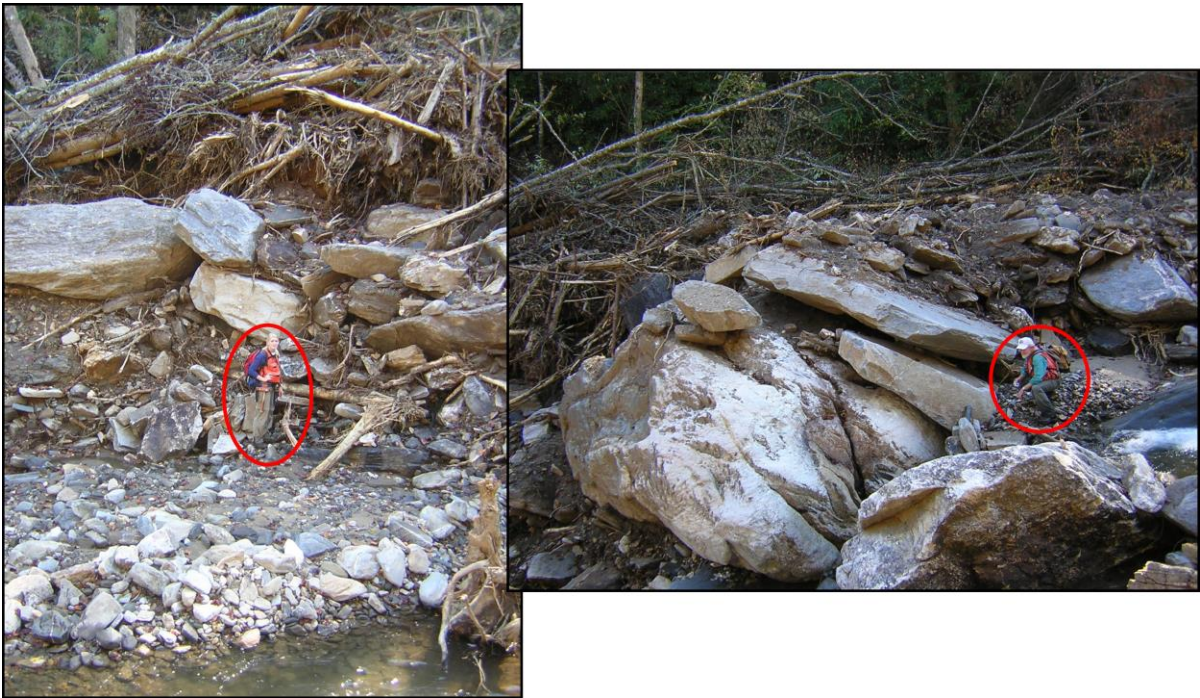
Figure 24. Imbricated boulders with woody debris deposited on top. Note people (circled in red) in each photo for scale.

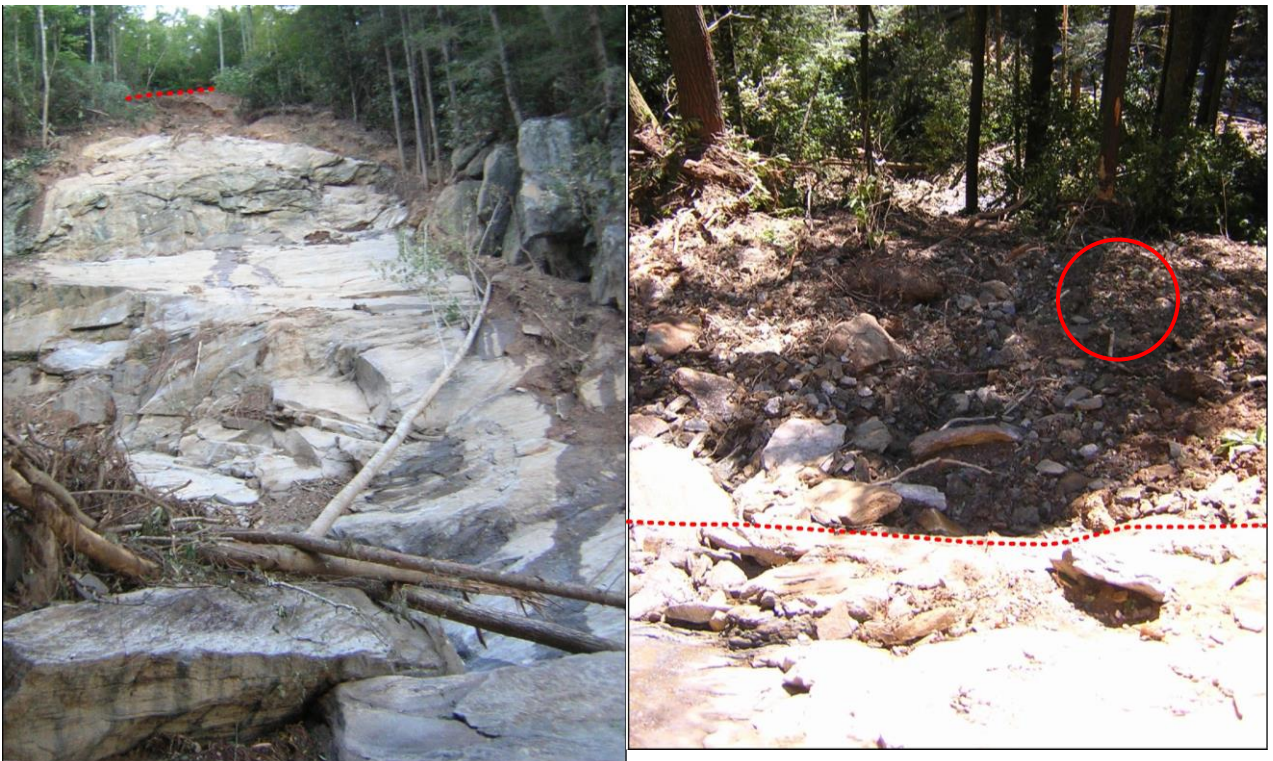
Figure 25. Embankment failures along Fishhawk Mountain Road upslope of the steep, incised portion of Peeks Creek. Photo at left is looking upslope from Peeks Creek at one of the failures. The red line indicates the location of Fishhawk Mountain Road. Photo on right is looking downslope from Fishhawk Mountain Road toward Peeks Creek at the second side slope failure. The red line indicates the edge of the road.

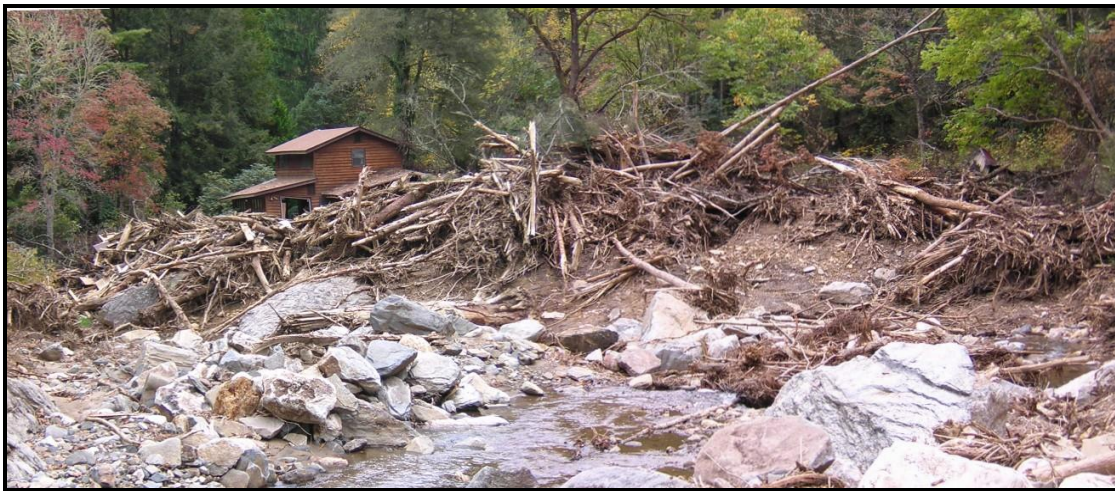
Figure 26. Base of the steep incised section of the channel in the lower portion of the debris flow track just upstream of the Peeks Creek community. The house in the left center was pushed several feet off its foundation by the woody debris (located about 500 feet below section H-H' in figure 32).

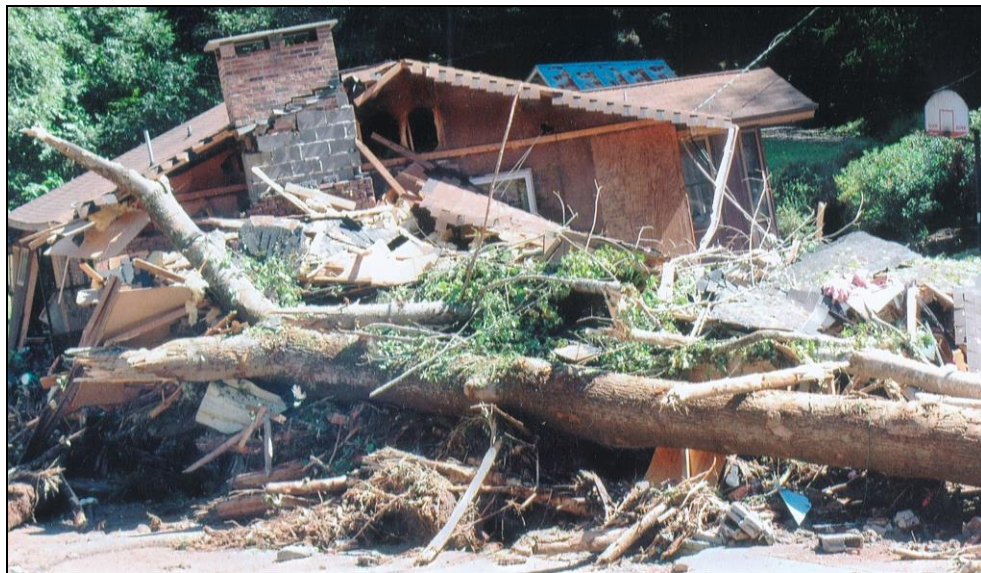
The Peeks Creek community was devastated by the debris flow. Several homes were pushed off their foundations. Figure 27 shows the Jones' residence displaced 30-40 feet downstream and debris that accumulated on the upstream side. Just before the debris flow, Mr. Jones was leaving for work and started down the road in his truck but stopped and returned to his house. He and his wife heard the flow coming down the valley and scrambled up the bank just before their house was destroyed (personal communication with Marilyn Jones, 2006). The debris flow moved another small house nearly 500 feet downstream where it collided with the Morris residence (figure 28). A woman inside the house at the time survived the ordeal with no major injuries (Lewicki, 2004).

Figure 27. Jones residence destroyed by debris flow (Photo courtesy of Marilyn Jones).

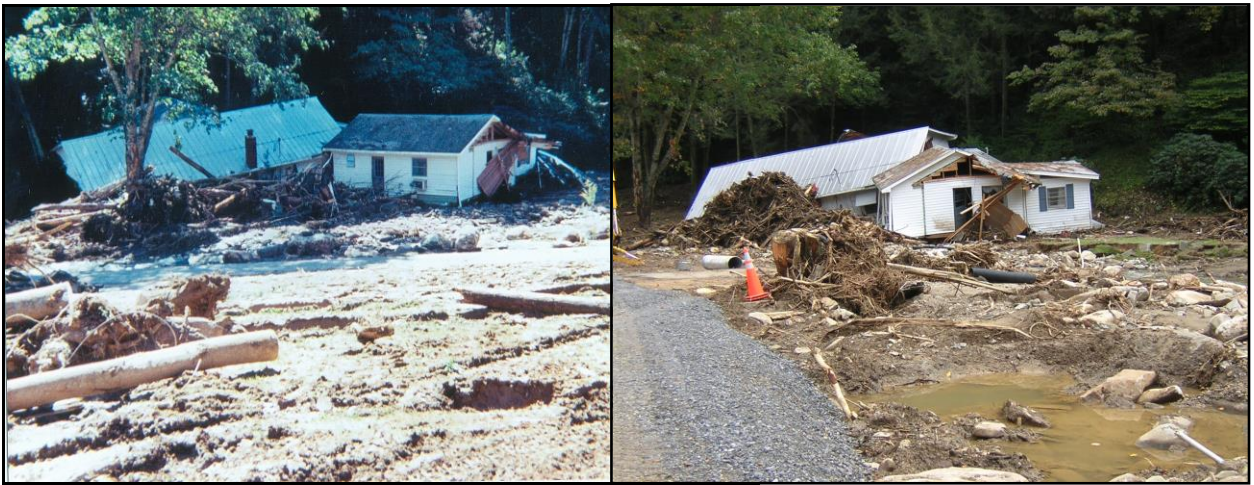
Figure 28. Two views of smaller house that moved 500 feet before colliding with the Morris' residence. Photo on left shows the valley before construction of the temporary road shown in the photo at right.

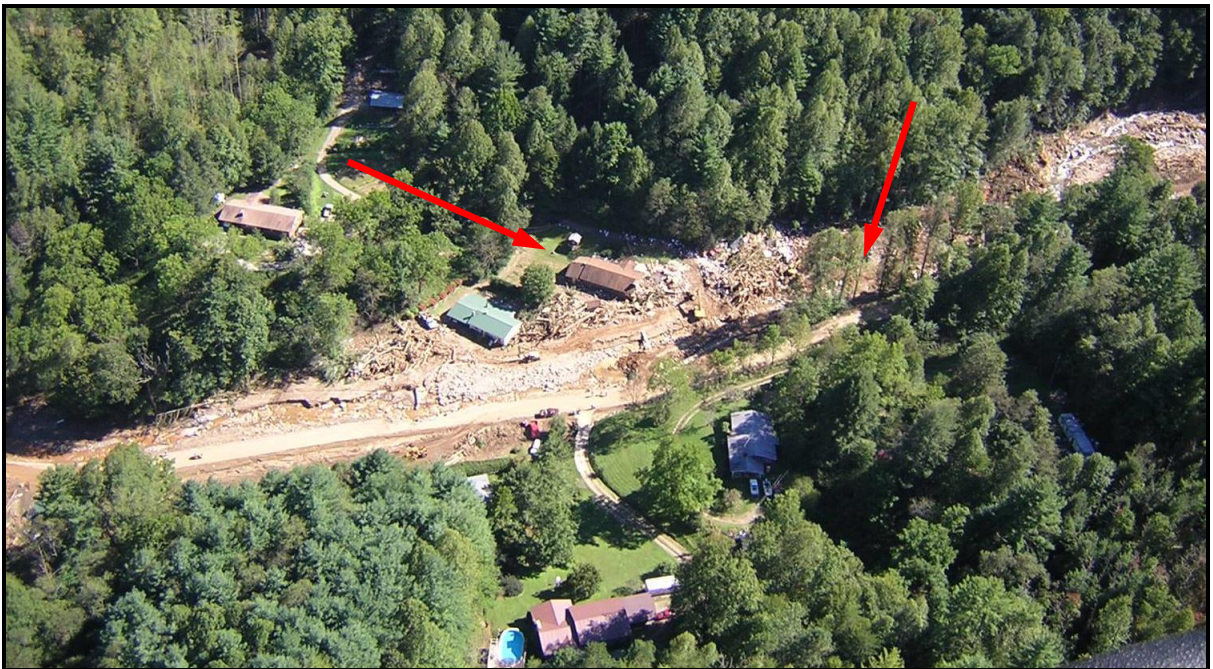
Figure 29. Aerial photo of debris flow damage. The red arrow on the left points to the Jones' residence, and the red arrow on the right points to the location of the three fatalities.

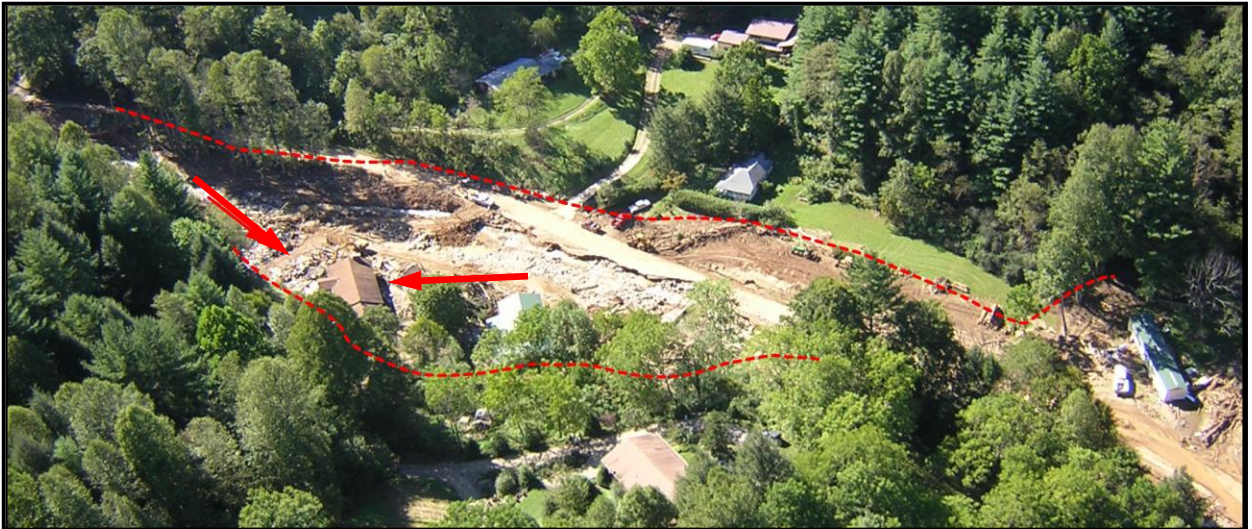
Figure 30: Aerial photo of some of the damage. The red arrow on the left points to the location of the 3 fatalities, and the red arrow on the right points to the Jones' residence. The red line indicates the boundary of the debris flow track. The main road was destroyed and the creek cut a new channel.

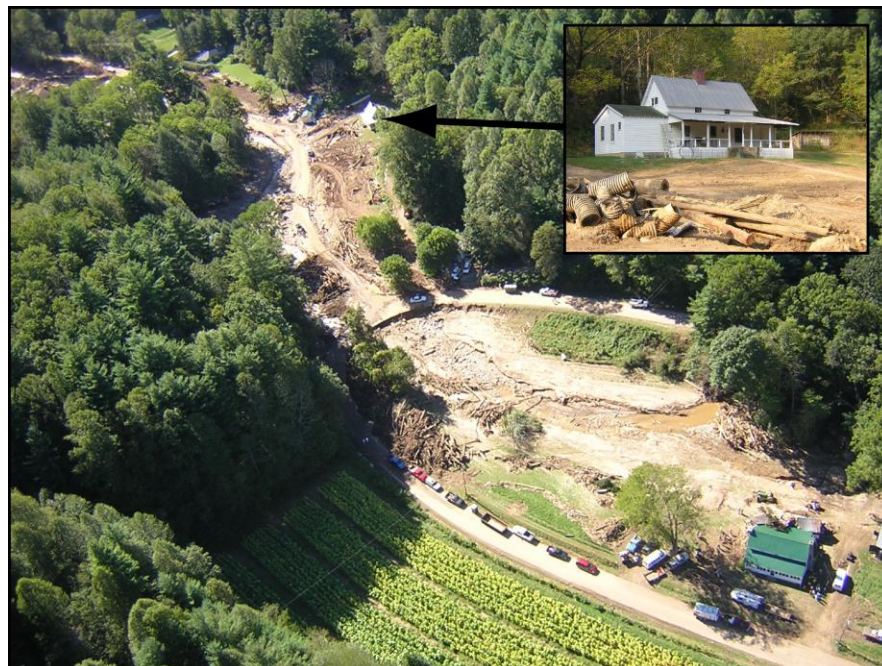
Not all of the houses in the Peeks Creek Community were destroyed. Several of the homes suffered only minimal damage. An aerial photo of the valley just downstream from the above images (figures 29 and 30) is shown in figure 31. The white house shown in the inset had a few mud splatters on it but was not damaged. The arrow points to its location in the air photo. Setbacks from the Creek could have reduced damage and possibly saved lives. The house with the green roof in the bottom right of the photograph is where some partial remains were reportedly found.

Figure 31: Aerial photo of lower part of valley showing house in floodplain that experienced only minor damage from the debris flow. This shows the value of setbacks.

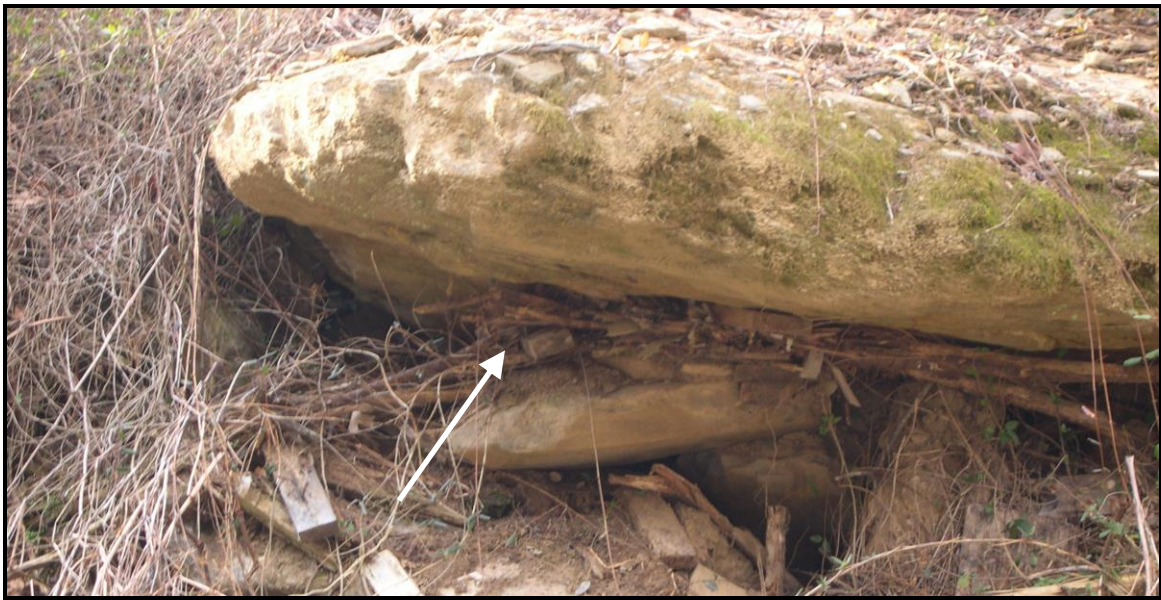
Figure 37. Imbricated boulder from an older debris flow deposit with lumber and other debris (shown by arrow) from the September 16, 2004 debris flow.

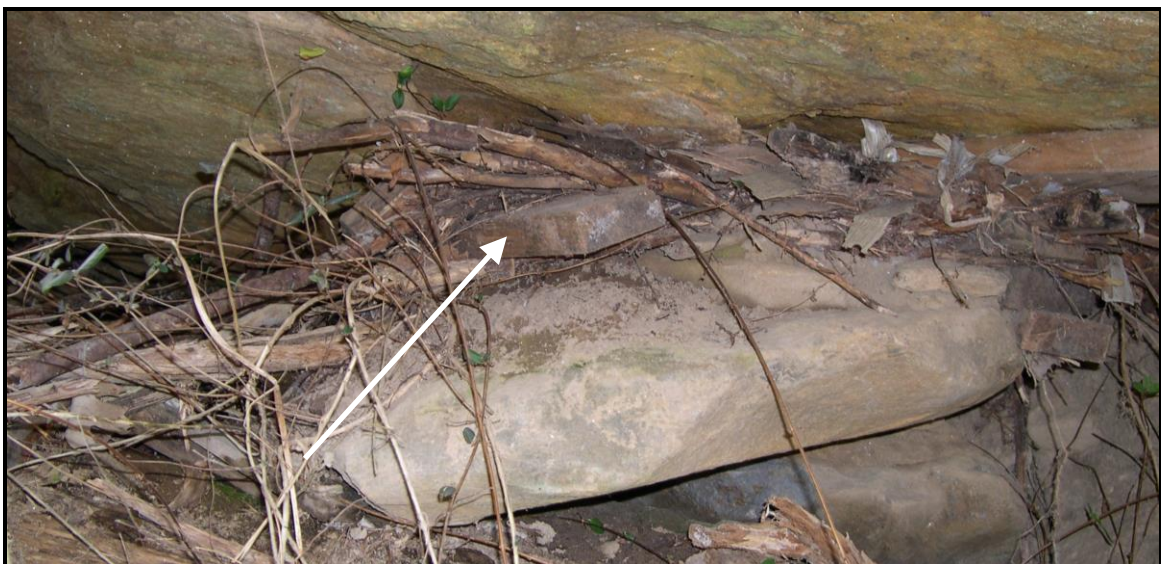
Figure 38. Close-up of 2"x 4" wedged between imbricated boulders of an older debris flow deposit exposed along the lower reach of Peeks Creek..

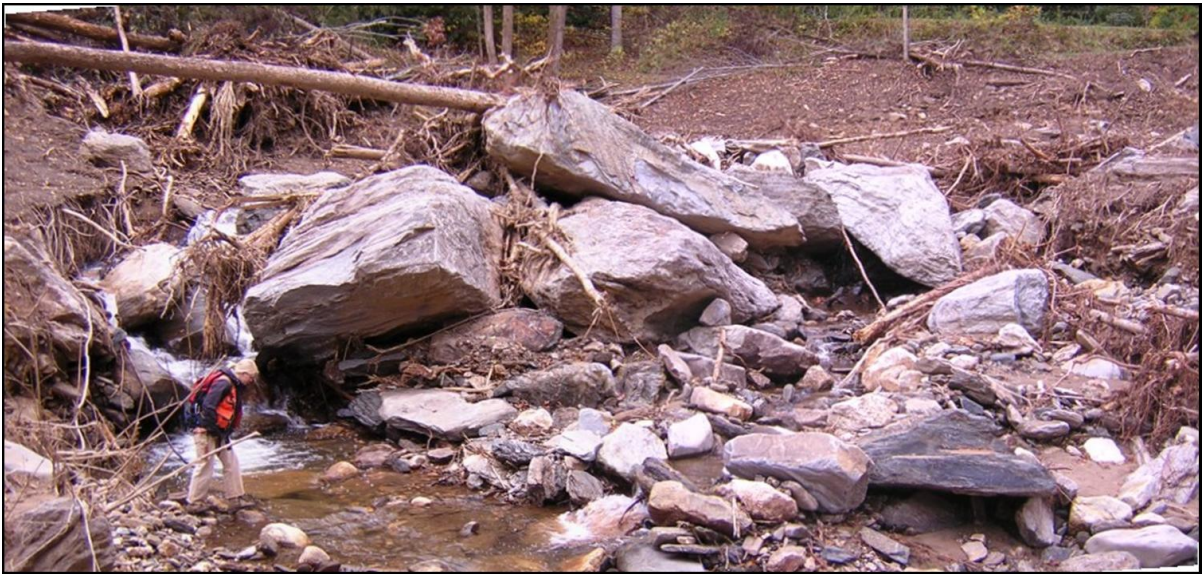
Unfortunately, no photos of the stream next to Mrs. Treadwell's house could be located. All of her photos were in her bedroom and were destroyed by the debris flow. She reported the stream next to her house as being "quite lovely" with 2 small waterfalls. Figure 39 shows the current condition of her streamside.

Figure 39. Peeks Creek next to the Treadwell property after the debris flow.

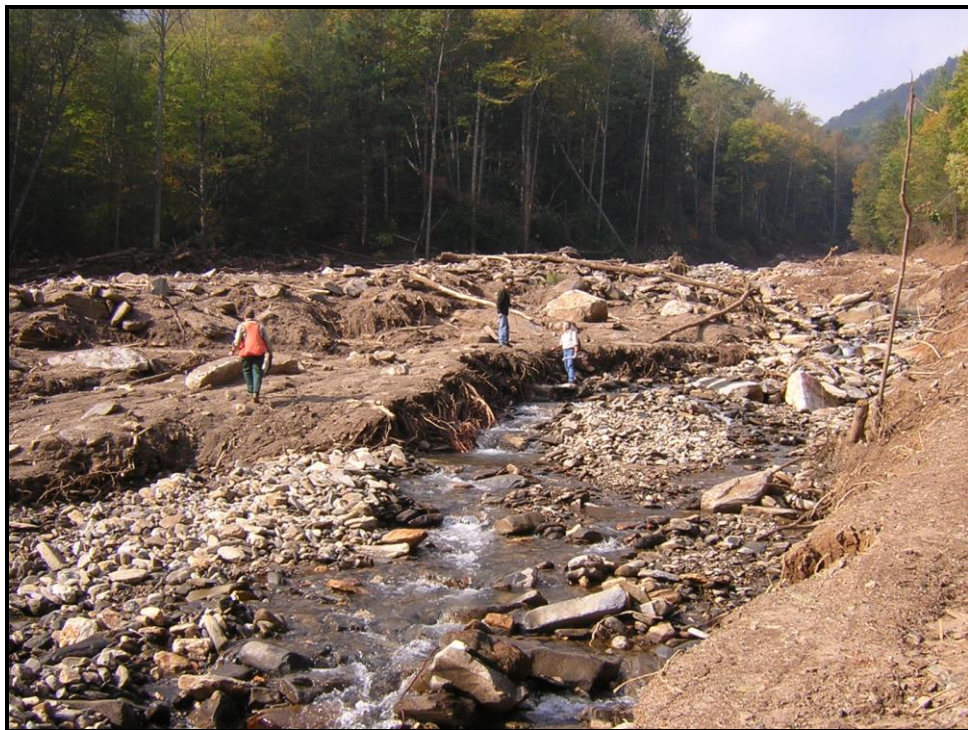
Figure 40. Wide, devastated channel of Peeks Creek at Stop 4.

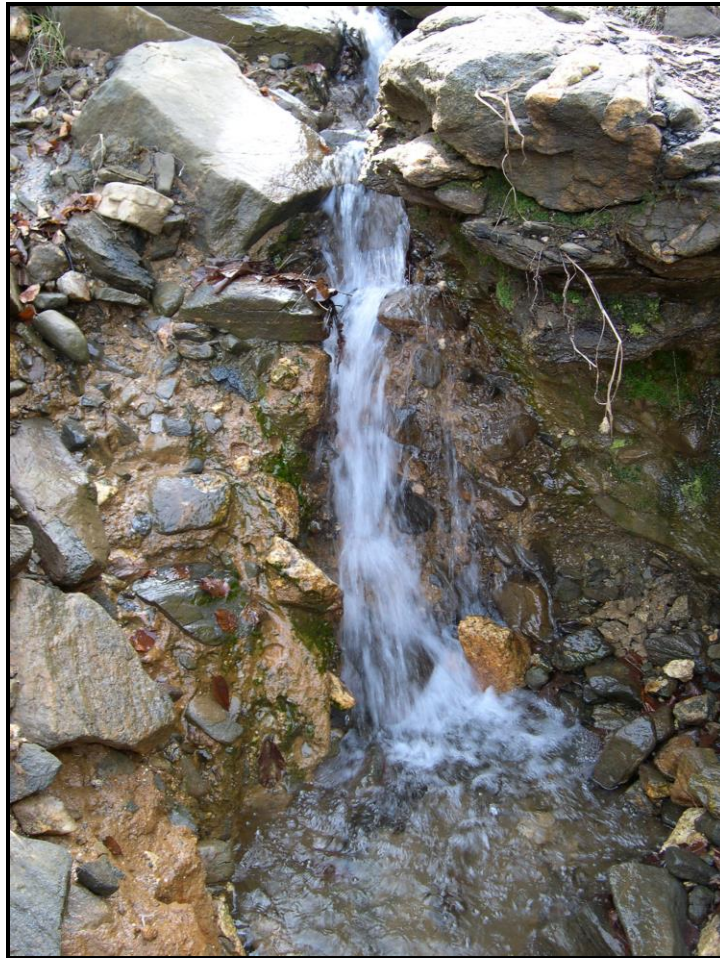
A culvert and bridge crosses the stream near Stop 5. From here, a short hike upstream shows the nature of the track up to the initiation zone. A short distance up the channel, the stream can be observed flowing over older debris flow deposits as opposed to bedrock (figure 41). Three distinct debris deposits can be observed here (Stop 6): the September 2004 event and two older deposits that are relatively aged as “younger” and “older” at this time. Age dating has been performed on these deposits.

Figure 41. Peeks Creek eroding away older debris flow deposits.

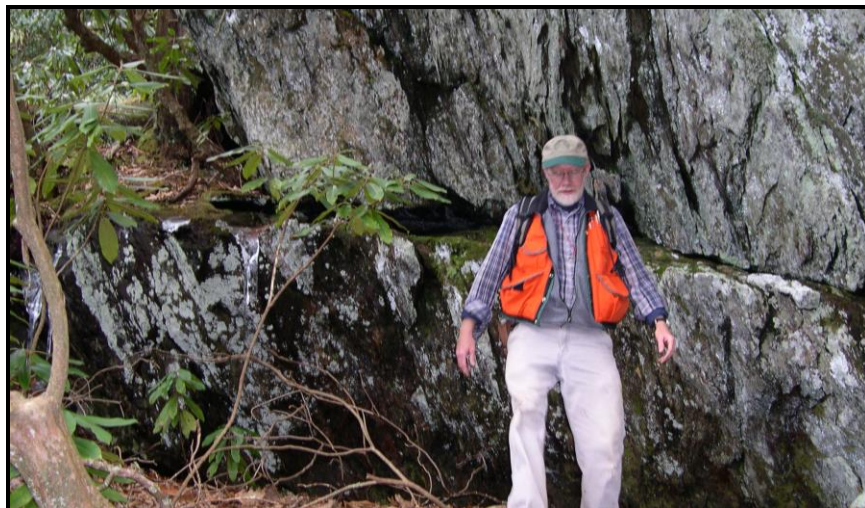
On the left side of the scar (if looking down from the top) is a nearly vertical foliation plane hidden in the trees (figure 43). The prominent horizontal fracture in the photo is an exfoliation plane; a similar type structure does not exist on the right side of the headscarp. The assumption is that slabs of rock were released along these fractures and created an exposed bedrock catchment. Over time the catchment accumulates soil and vegetation until an extreme rainfall event triggers a failure. The ~100 ft-wide by ~400 ft-long area that failed during Ivan is only a portion a larger colluvial catchment below the peak of Fishhawk Mountain (figures 1 and 44).

Figure 43. Rick Wooten of the NCGS in front of the steeply dipping foliation planes located off to the left flank of the scar and obscured by vegetation (see figure 44). The gently dipping discontinuity along the cliff face is an exfoliation fracture.

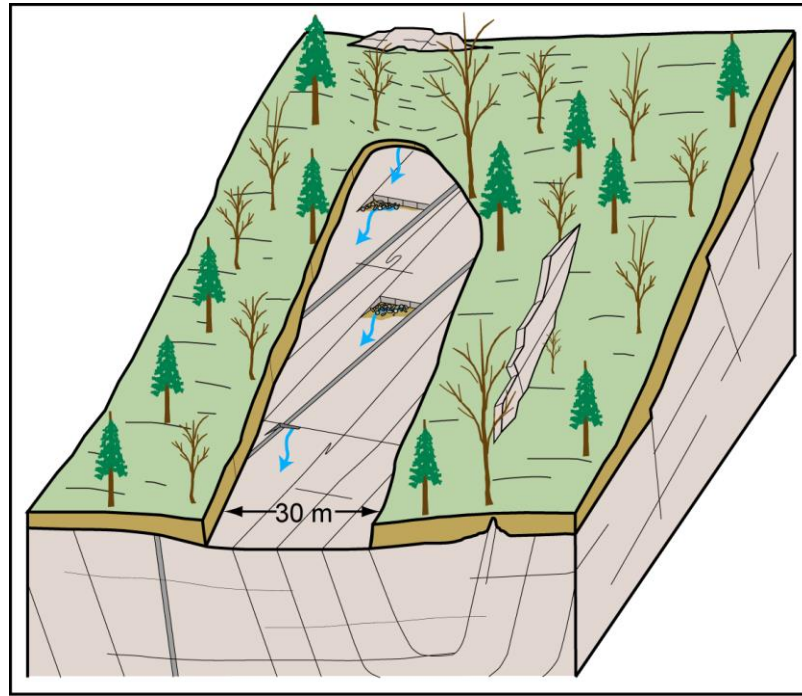
Figure 44. 3-D schematic of the September 16, 2004 (Ivan) Peek's Creek debris flow initiation zone within a large-scale colluvial catchment. Foliation and compositional layering in isoclinally folded bedrock strikes NE, subparallel to the long dimension of the scar. High-angle tectonic fractures strike NW, nearly orthogonal to foliation and compositional layering. Exfoliation fractures dip downslope 35°-53° and formed the slip surface between soil and bedrock. Blue arrows indicate areas of observed seepage. Dark grey bedrock features are thin (1 m thick) NE-striking, unfoliated tonalite-trondhjemite dikes.
