**Report On The May 5-7, 2003 Debris Flows  
on Slopes Underlain by Sulfidic Bedrock of the  
Wehutt, Nantahala and Copper Hill Formations,  
Swain County, North Carolina**

**North Carolina Geological Survey  
Division of Land Resources  
Department of Environment and Natural Resources**

**August 3, 2004**

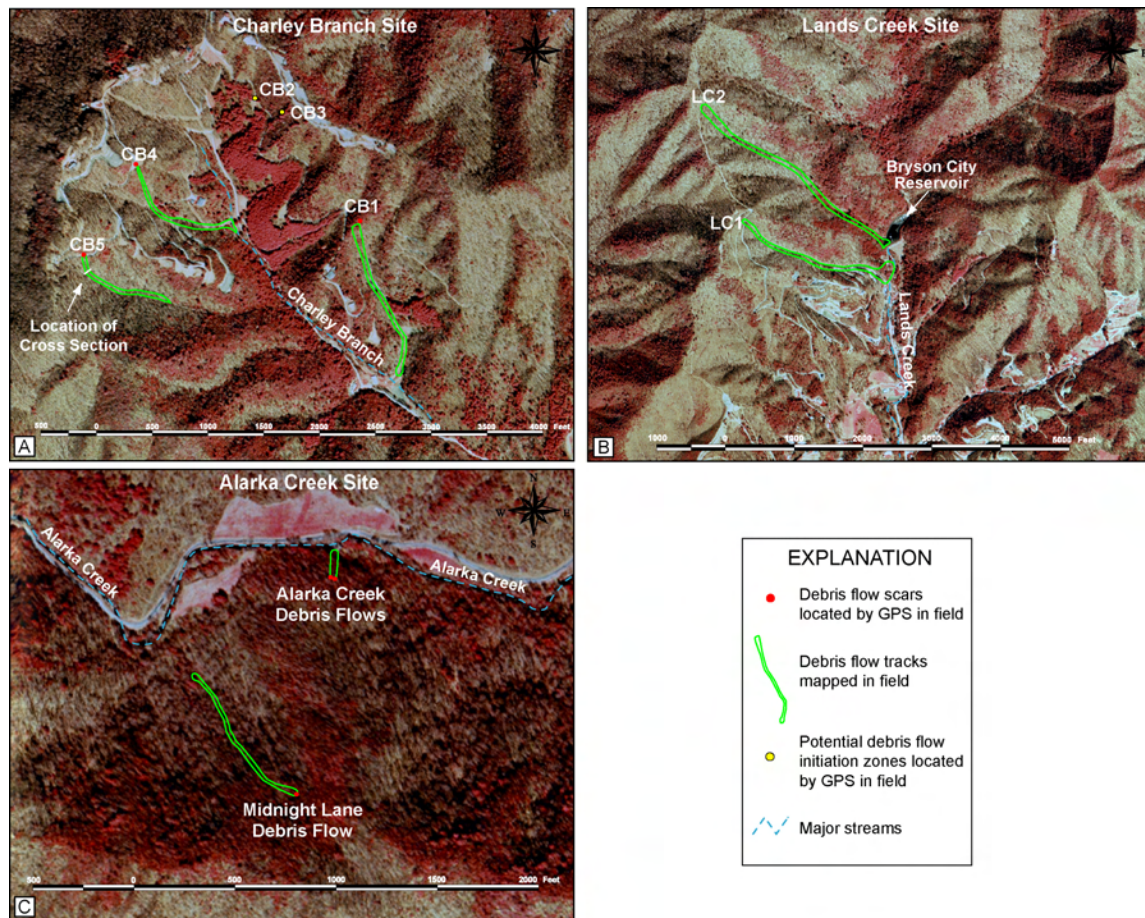
Figure 3A shows the location of the three debris flow tracks (labeled CB1, 4 and 5) that occurred in the Glory Mountain development around Charley Branch (CB). The tracks show the paths and distances the debris traveled down slope. The longest of the debris flow tracks is CB1 (approx. 1460 feet), followed by CB4 (approx. 1200 feet) and CB5 (approx. 960 feet). Sediment from all three debris flows was transported into Charley Branch by runoff during and after the debris flow event. Figures 4 and 5 show photographs of the various features observed around the debris flow sites during field visits in late June 2004.

**Figure 3.** Color infrared aerial photographs of the Charley Branch, Lands Creek, and Alarka Creek areas excerpted from the 1998 digital ortho-quarter quads (DOQQs). A. Color infrared photograph of the Charley Branch area. All debris flows at this location occurred during the May 5-7, 2003 storm event. B. Color infrared photograph of the Lands Creek area. The Bryson City Reservoir is in the middle of the photograph. The Lands Creek I debris flow (LC1) occurred December 12, 1990, and the Lands Creek II debris flow (LC2) occurred during the May 5-7, 2003 storm event. C. Color infrared photograph of the Alarka Creek area. All debris flows at this location occurred during the May 5-7, 2003 storm event. The aerial photograph was taken prior to construction of Midnight Lane and Timber Estates Drive.

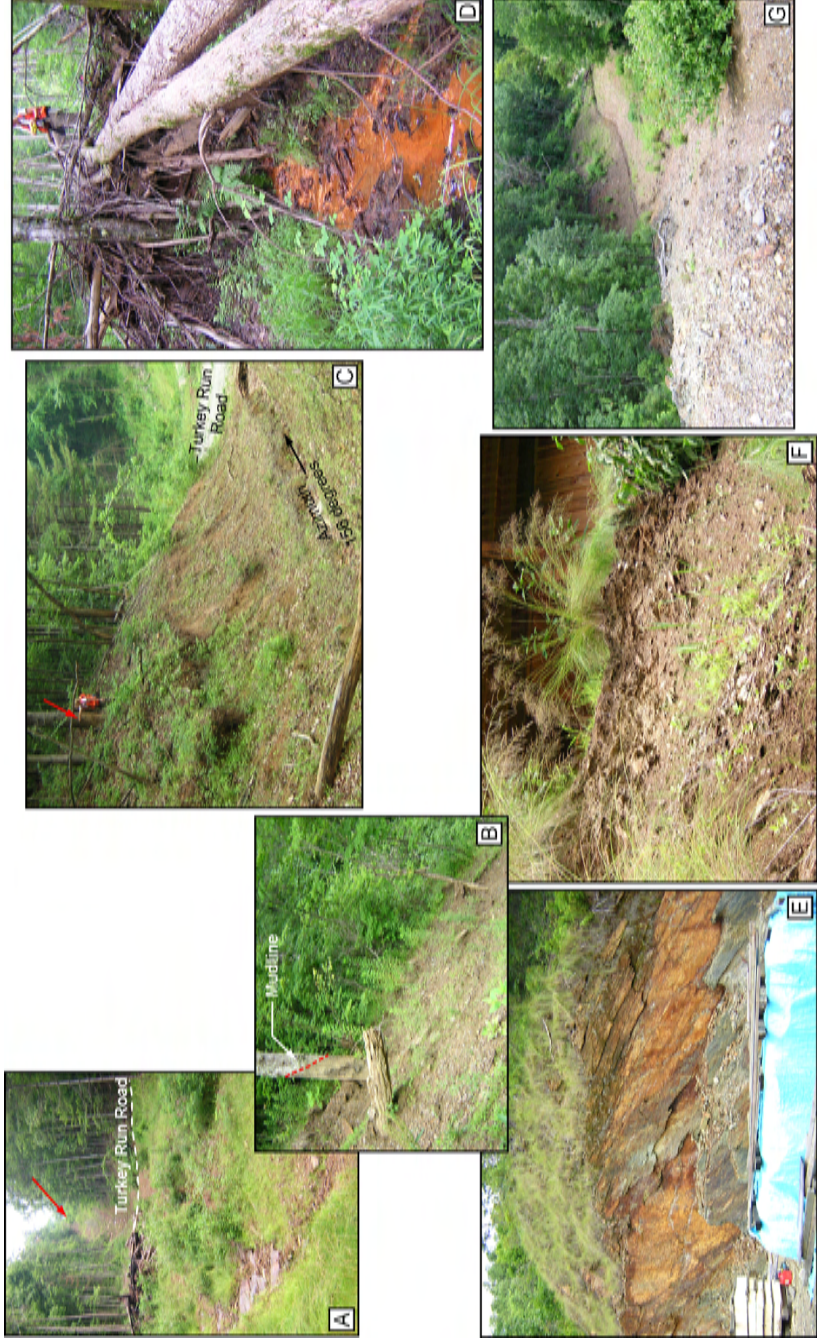
Debris flow CB1 probably caused the most damage of the three Charley Branch debris flows. It appears to have initiated in colluvium and fill used to construct a house site that was derived from sulfidic, graphitic schist and excavated nearby (figs. 4E and 4F). According to the homeowner, trees and other vegetation had been cut off the slope to improve the view from the front of the house. Removing the trees and vegetation probably contributed to the instability of the slope. The head scarp continues to erode toward the house, which is founded primarily on bedrock. Down slope the debris flow damaged another road in the development, filled in a pond, and destroyed spring boxes

Debris flow CB4 appears to have initiated in fill used to construct a house pad, although the lot is still vacant. Figure 4B shows a log exposed in the head scarp that apparently was originally incorporated within the fill material. Over time decaying woody debris in fill material can also have a destabilizing effect. Tension cracks and minor scarps were observed in other areas of the house pad fill at this location. This debris flow damaged two roads down slope and moved an old log cabin some 20 feet (?) from its original location. At the location just above Turkey Run Road, mud lines in trees indicate the top of debris flow was about 20 feet above the channel base.

**Figure 4.** Photographs of debris flows CB1, CB4, and CB5 in the Charley Branch area. A. View looking upslope at apparent source area for CB4 from just above Rhododendron Road. Turkey Run Road crosses the channel just above the pile of debris in the left central portion of the photograph. Arrow points to apparent initiation point. B. Photograph of the left flank of CB4 near the source area. Note mudline on tree approximately 2 feet above the scarp and the log sticking out of the debris. C. Middle portion of debris flow channel at CB4 just upslope of Turkey Run Road. Mudline on tree (shown by arrow) indicates material was moving through the channel approximately 20 feet above the base of the channel. D. Terminus of the main debris flow deposit downslope from CB5. Debris dam is approximately 4-5 feet high. Note orange colored iron oxide in the stream channel. This color is probably the result of iron oxidizing bacteria and may indicate acidic runoff from sulfidic rock in the debris. E. Rock outcrop just upslope of the apparent initiation point of debris flow at CB1. Gray rock towards the base of the outcrop is graphitic schist. Red-brown to orange staining on upper portion of outcrop indicates the sulfidic nature of the rock. F. Right flank of headscarp located at CB1. Fill material added to slope is micaceous, low plasticity silt with gravel and cobbles of schist. G. View from the source area of the debris flow at CB1. Material in the foreground is displaced fill material. Debris flow crossed the road in multiple locations before destroying the pump house for the neighborhood water system and filling in a pond.

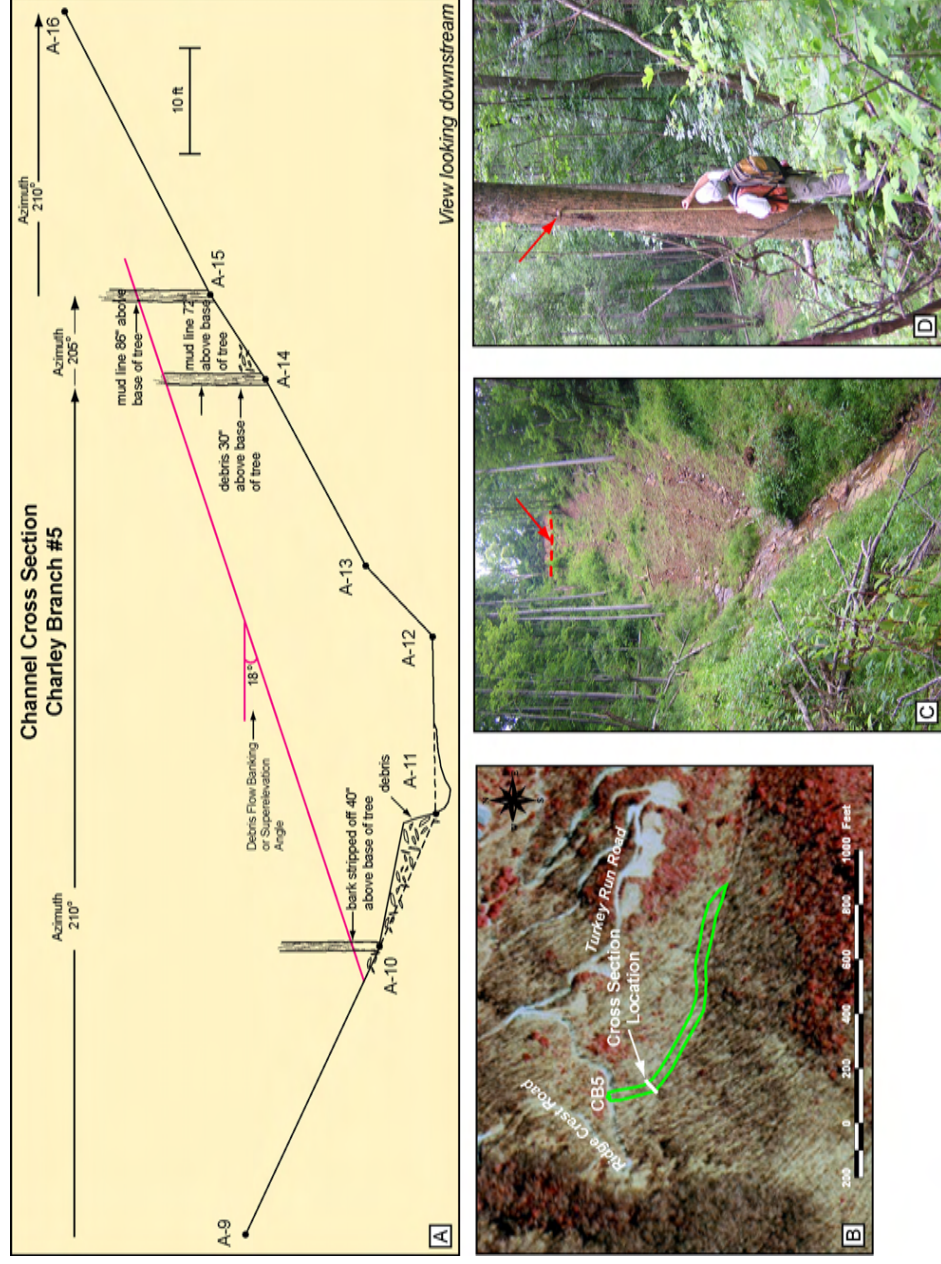
Debris flow CB5 appears to have originated in material used to construct a road fill (fig. 5C). At a location about 175 feet down slope from the head scarp the debris flow followed a bend in the channel (fig. 5A-C). Mud lines preserved in the trees on either side of the channel in the bend allows the banking, or superelevation, angle of the debris flow to be determined (fig. 5 A, D). This evidence, along with the channel gradient and radius of curvature allows the velocity and discharge of the debris flow to be estimated at this point (Johnson and Rodine, 1984). Here, the velocity of the debris flow was about 25 miles per hour (~37 feet per second), with a discharge of almost 30,000 cubic feet per second. The height of the debris flow measured from the channel bottom was about 15 to 17 feet. Owing to the relatively high velocity of the debris flow, the discharge of 30,000 cubic feet per second is over three times greater than that measured for the Little Tennessee River at the Needmore gaging station on May 7, 2003 (fig. 2A).

**Figure 5.** Cross section and photographs of debris flow CB5 in the Charley Branch area. A. Cross section through a bend in the debris flow channel located at CB5. The velocity of material in the channel was approximated using the superelevation angle of material around the bend, channel gradient, and radius of curvature. The velocity for the May debris flow was approximately 25 miles per hour (37 feet per second) with a discharge of almost 30,000 cubic feet per second of material. B. Map showing the location of the cross section within the debris flow channel at CB5. C. View looking up the debris flow track to the apparent initiation area (indicated by arrow) from the cross section location. D. Tree at station A-15 on the cross section. Note mud up the tree as well as piece of wood wedged into the side of the tree, approximately 7 feet above the ground surface indicating high flow at this location.

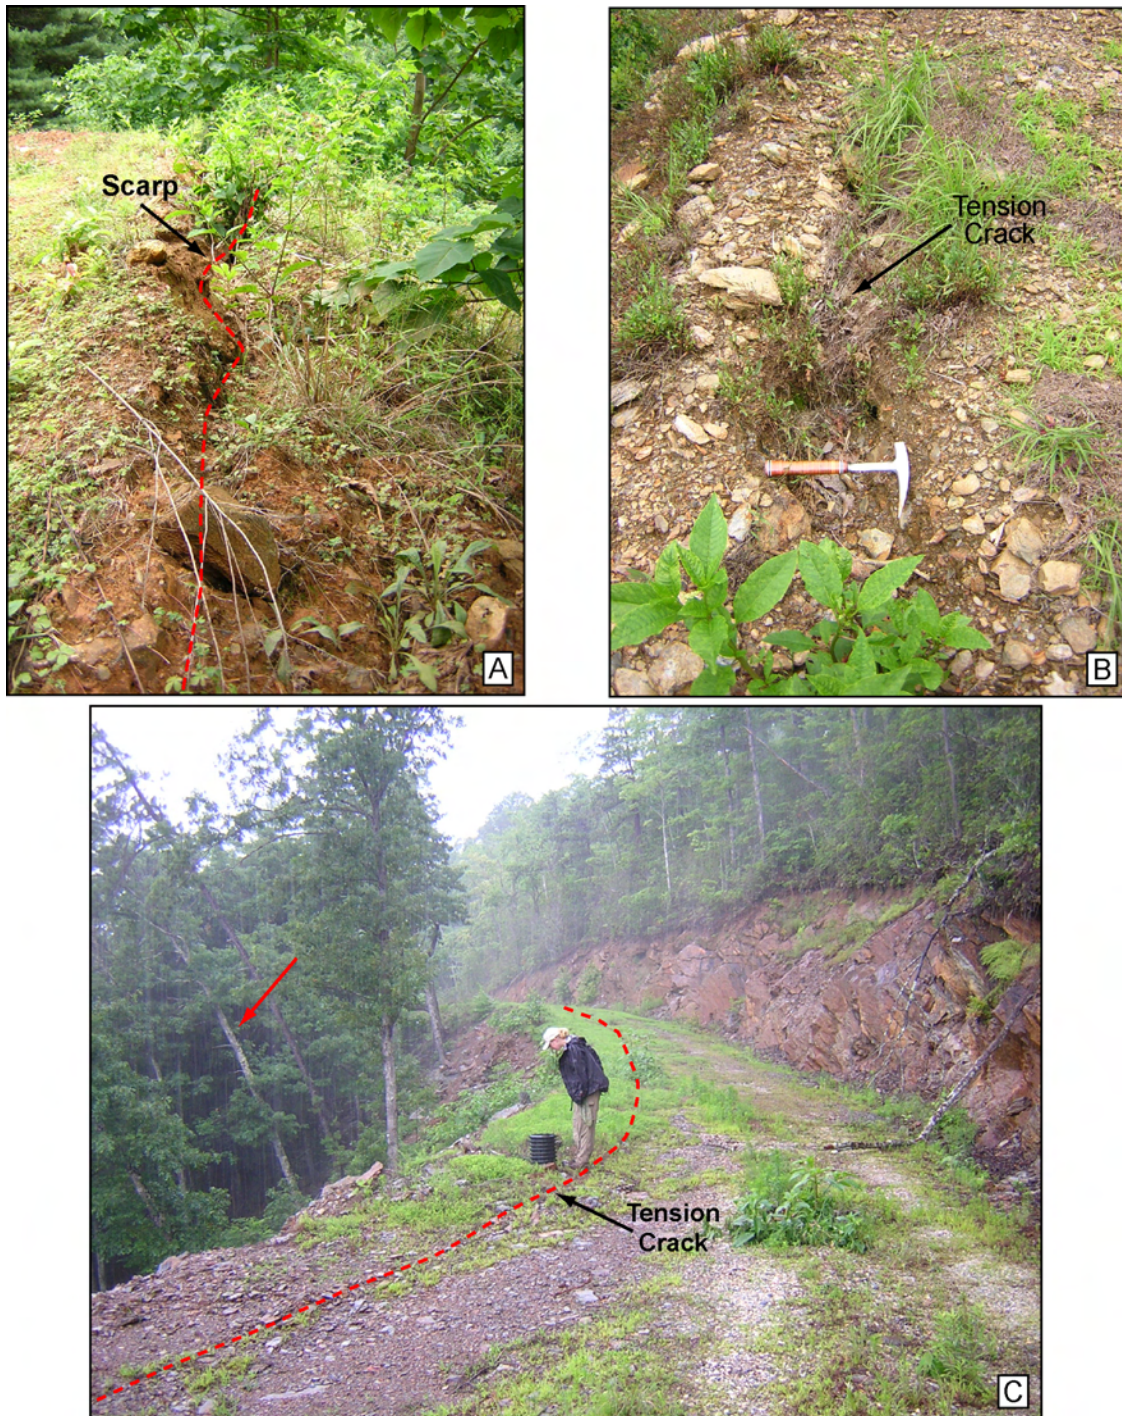
Tension cracks (horizontal ground displacement) and scarps (vertical ground displacement) in road and house pad fills observed at locations CB2 and CB3 indicate the potential for future debris flows in the Charley Branch area (fig. 6). These tension cracks and scarps allow precipitation and runoff to infiltrate quickly into an already unstable slope that can then mobilize into a rapidly moving debris flow. Of particular concern is the water line located outboard of the tension crack at CB3. Settlement and displacement of the fill can break the water line allowing water to infiltrate into the fill and trigger a debris flow. Should debris flows originate from the house pads southeast of CB3 they may severely damage the existing house down slope.

**Figure 6.** Photographs of scarps and tensions cracks in slopes at Charley Branch sites CB2 and CB3. A. Scarp developing along the embankment of the building pad at CB2. B. Tension crack that has developed along the road to the lower building pad at CB3. This crack is approximately 18 inches deep, 6 -7 inches wide, and 60 feet long (up to the water line). C. View looking at the water line to be connected to houses. The water line falls in line with the tension crack(s) developed along the road embankment. Note leaning trees on slope below.

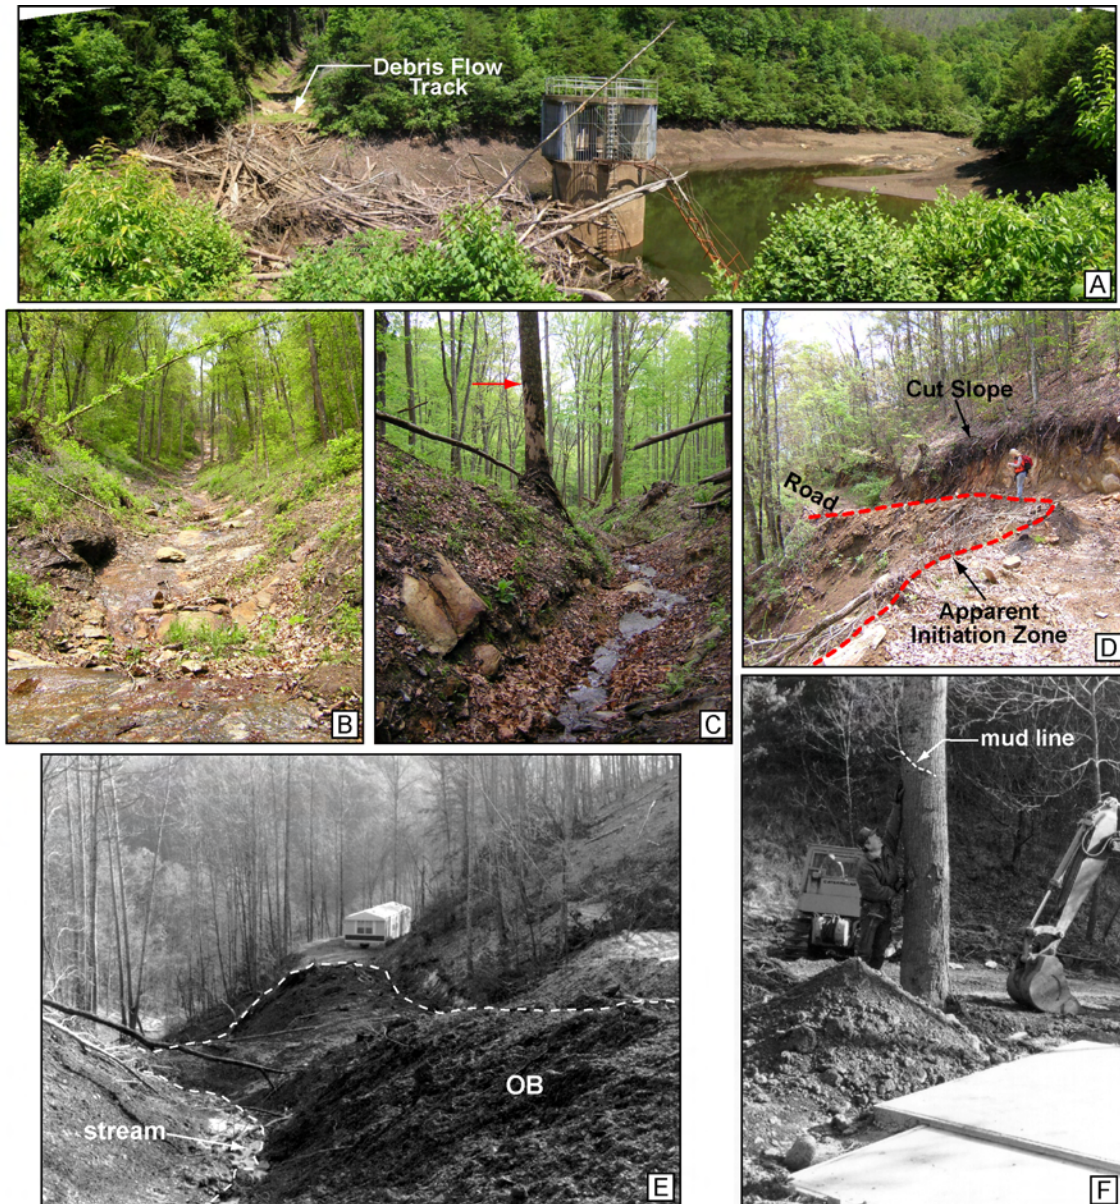
LC1 destroyed a mobile home and the chlorinator building for the Bryson City water system, as well as downing power lines and damaging roads (figs. 7E and 7F). The

track length for LC1 is about 2,400 feet, and it deposited about 10,000 cubic yards of silt, sand and rock fragments in the lower third of the track. Estimates of the debris flow velocity and discharge made at two locations along the track yielded values of 23 miles per hour and about 18,400 cubic feet per second; and, 10 miles per hour and 13,800 cubic feet per second respectively. Older deposits observed along the LC1 track and near Lands Creek indicated prior debris flow and flooding activity in this tributary to Lands Creek.

The track length for LC2 is about 3,400 feet. LC2 deposited silt, sand, rock fragments, and woody debris along the track and also into the Bryson City reservoir (fig. 7A and 7B). Logs from the debris flow accumulated near the intake for the dam. The reservoir was drained during the May-June, 2004 timeframe, and its use as a reservoir discontinued. Because of its limited water supply capacity, Bryson City officials had already decided to discontinue use of the reservoir prior to the May 2003 debris flow.

**Figure 7.** Photographs of the Lands Cree I (LC1) and Lands Creek II (LC2) debris flows. A. June 17, 2003 photograph of the Lands Creek II (LC2) debris flow track taken from the dam. Material from the debris flow was deposited into the now drained Bryson City Reservoir. B. Photograph of the upper part of the LC2 debris flow channel toward the apparent initiation zone. C. Bark removed from tree in the mid-section of the LC2 debris flow track. Height is approximately 15 feet above the base of the channel. D. Photograph of the initiation zone for the LC2 debris flow. Failure appears to be in the road embankment. E. Photograph of part of the December 23, 1991 debris flow deposit taken on January 23, 1991. Here the 1990 debris flow overbank deposit (OB) overlies an older (pre-1952) overbank deposit along the outside bend of the stream channel. The 1990 deposit blocks the access road to a mobile home, and downed utility lines. F. January 23, 1991 photograph of the lower depositional area of the Lands Creek I debris flow. The dashed line shows the height of the mud line on a tree near the destroyed chlorinator buildings for the Bryson City municipal water system. Most of the December 23, 1990 deposit had already been removed. Foundation slabs for the new chlorinator buildings are visible in the foreground. Here the December 23, 1990 debris flow deposit overlies older (pre-1952) debris fan deposits of previous flood and debris flow events originating in this tributary to Lands Creek.

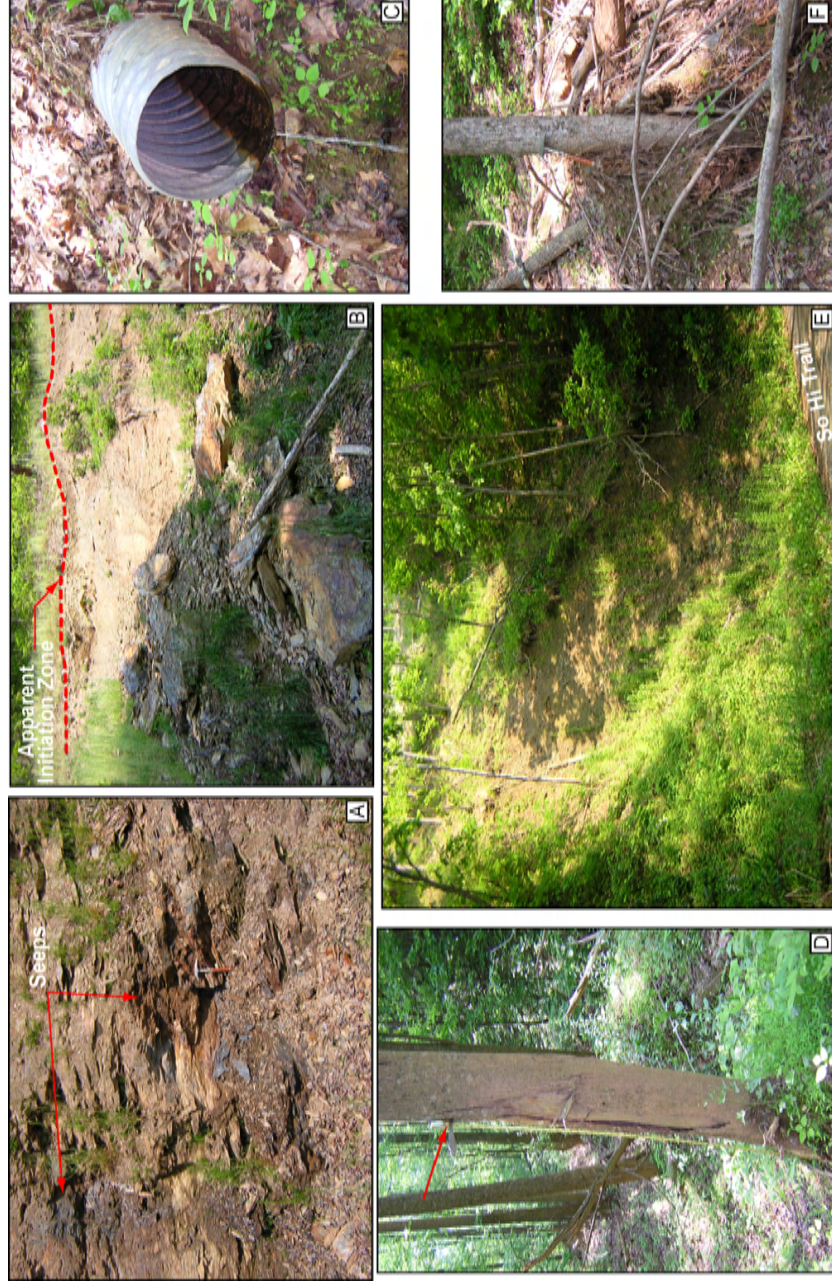
The So Hi Trail (road) debris flow appears to have originated in a road fill that included sulfidic, graphitic, mica schist from the Nantahala formation (fig. 8). The debris flow may have triggered a cut slope failure as the track crossed a lower segment of So Hi Trail (fig. 8E). The entire track length is about 625 feet, and mud lines and debris were observed up to 5 feet above the channel base. No damage other than to the road was reported for the So Hi debris flow.

The potential for acid drainage from the sulfidic rock types found in North Carolina, including Swain County, has long been recognized (see, for example, Schaeffer and Clawson, 1996). There are indicators at the Charley Branch and So Hi Trail sites that there may be acid drainage associated with areas of disturbed sulfidic rock. Iron bacteria can oxidize the iron released from the sulfide minerals and actually elevate the levels of acid production (Byerly, 1996). The bright orange growth observed in leachate from debris at the CB5 locality at Charley Branch indicates the presence of these bacteria (fig. 4D). Acid drainage can also accelerate the corrosion rate of metal culverts (Bryant and others, 2003). The heavy iron oxide coating and corrosion observed in a galvanized culvert at the So Hi Trail site (fig. 8C) indicates the presence of acid drainage.

**Figure 8.** Photographs of the So Hi Trail debris flow and acid drainage. A. Photograph of road cut on upper leg of So Hi Trail. Outcrop is stained state to partially decomposed sulfidic graphitic schist located upslope of the embankment failure where the debris flow apparently started. Bedrock seeps were observed at this location (indicated by arrow). B. Photograph of the apparent head scarp where the debris flow started. Material here is embankment fill composed of moderately plastic silt with pieces of schist present. Large boulders present on the slope were most likely placed there when excavation was done for road construction. C. Corroded culvert just downslope of lower leg of So Hi trail. Although the culvert looks relatively new, considerable staining has occurred where water consistently flows. This staining is most likely due to runoff from the sulfidic rock upslope. D. Mudline on a tree approximately 35 feet below lower leg of So Hi Trail. Height of mudline is 5 feet. E. Debris flow (cut slope failure) scar between lower leg of So Hi Trail and an abandoned dirt wheel track. Water was observed seeping from material. F. Photograph of tree in lower third of the debris flow track (below lower leg of So Hi Trail) with debris stacked against it. Note hammer for scale.

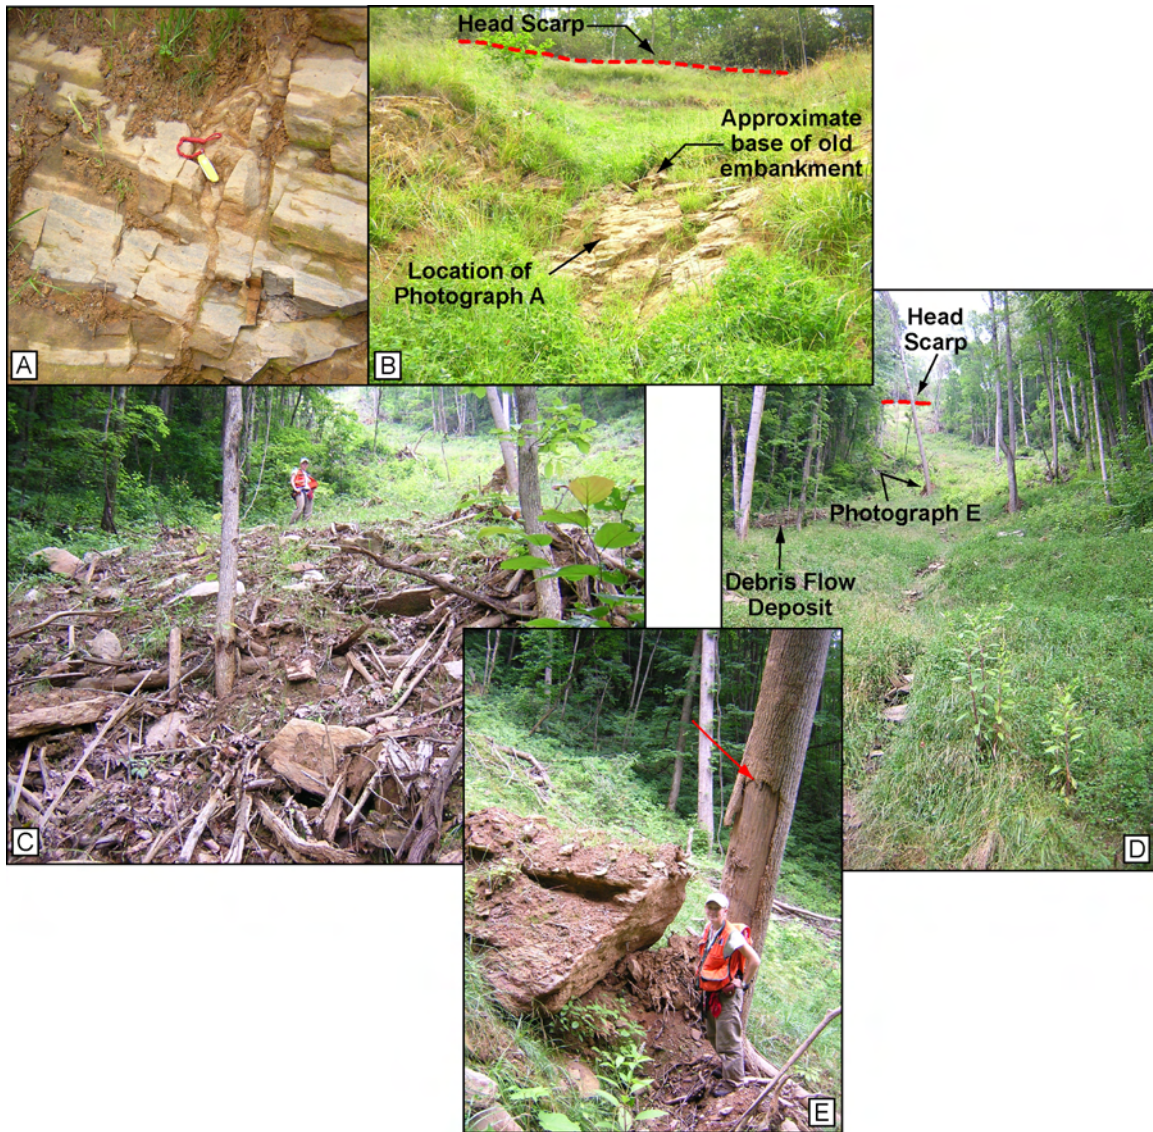
Three debris flow tracks were observed in the Timber Estates development above Alarka Creek. These slope movements originated on slopes underlain by sulfidic, mica schist, metasiltstone, and metagraywacke of the Copper Hill Formation. The largest of the Alarka debris flows appears to have initiated in a road fill on Midnight Lane (fig. 9) and has a track length over 600 feet. The debris flow moved a 60 cubic foot boulder (fig. 9E), and the top of the flow was at least 7 feet above the channel bottom in places. Two smaller debris flows occurred along Timber Estates Drive and moved down slope about 100 feet onto the floodplain of Alarka Creek. Head scarp areas of the Alarka Creek debris flows have been reseeded, and for the most part revegetated.

**Figure 9.** Photographs of the Midnight Lane debris flow in the Alarka Creek area. A. Photograph taken of the highly fractured sulfidic, garnet, biotite, muscovite schist and metagraywacke present in the stream channel. Here, closely spaced fractures have created planes of weakness in the material forming a low spot in the outcrop. Groundwater seepage along the bedrock low may have had a destabilizing effect on the fill. Location of outcrop can be seen in Photograph B. B. Photograph from the outcrop location toward the apparent source area and head scarp. The segment of Midnight Lane at the apparent initiation zone was destroyed in the debris flow and has since been reconstructed. C. Photograph of a portion of the debris flow deposit approximately two thirds of the way downslope. Location can be seen in Photograph D. D. Photograph taken from Starry Lane, the terminus of the debris flow, looking upslope at the apparent source area. Note the debris that has collected on the upslope side of most of the trees. E. Large boulder (~60 cubic feet) lodged against a tree in the debris flow deposit. Bark has been removed from tree approximately 7 feet above the ground surface. Tree location can be seen in Photograph D.
