*Review of
Erosion and Sedimentation Program
Delegation to the North Carolina Department
Of Transportation, Division of Highways*

November 20, 2014

*North Carolina Department of Environment
And Natural Resources
Division of Energy, Mineral, and Land Resources
Land Quality Section*

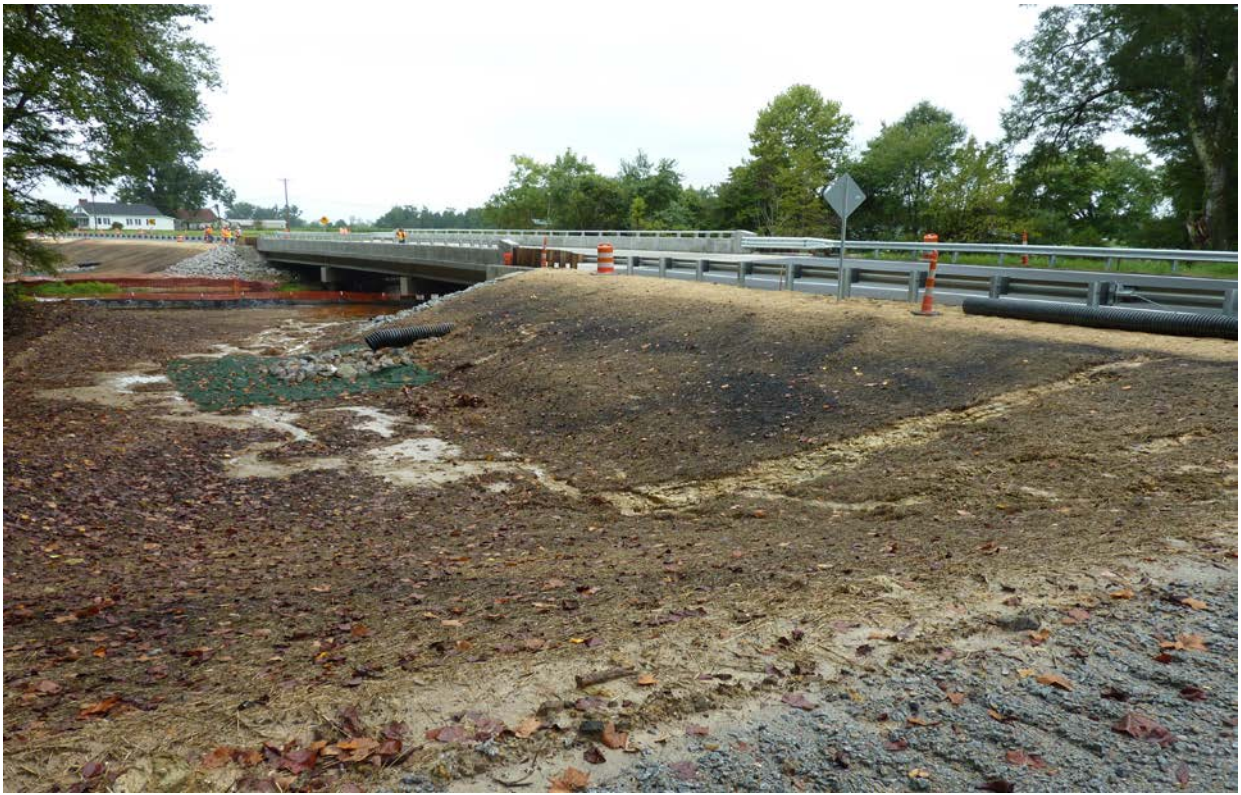
This is a 0.223 mile project with a contract for \$1,801,184.53. The project scored between 7s and 9s on inspections throughout its history to date. Inspections indicated primarily minor issues which were usually completely resolved by the next inspection. The plan was adequate and properly implemented at the present stage of construction. However, some measures shown on the plan were not installed (silt fence outlets, wattles in ditch draining to slope drains, etc.). Better annotations on the field set of plans were suggested to help identify measures that were not needed and therefore never installed. Self-inspection records were effective. The site had received 7+ inches of rain in the previous 2 days, and much of the site was inundated with water. Maintenance was needed in a few areas onsite where rills and washes were developing on back slopes. A small amount of sediment was deposited beyond the silt fence at the outlet of a ditch. The ditch and area of deposition needed to be stabilized. Overall rating was Good.

Rill developing on slope, Martin County

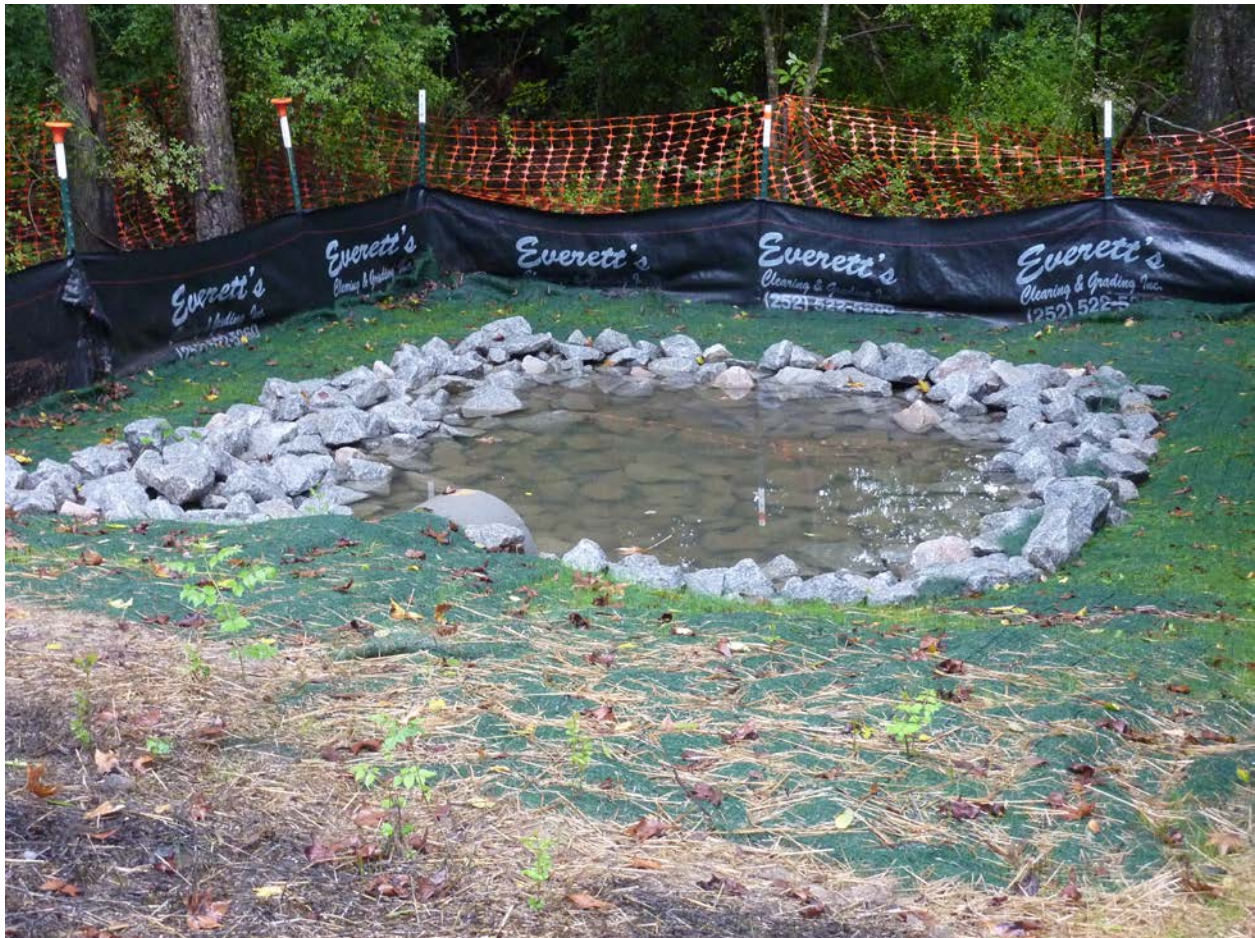
This is a NC DOT Bridge Replacement project that is 0.137 miles in length and has a contract for \$998,909.50. The project scored primarily 8s and 9s during recent inspections. Construction was recently completed on this project and permanent groundcover was being established. The plan was adequate and properly implemented. Sediment controls were adequate and effective. Self-inspection records were adequate. Some minor maintenance was needed in a ditch due to recent rains (5 inches over previous 2 days). Overall rating was Good.

Scour Hole, Pitt County Bridge Replacement

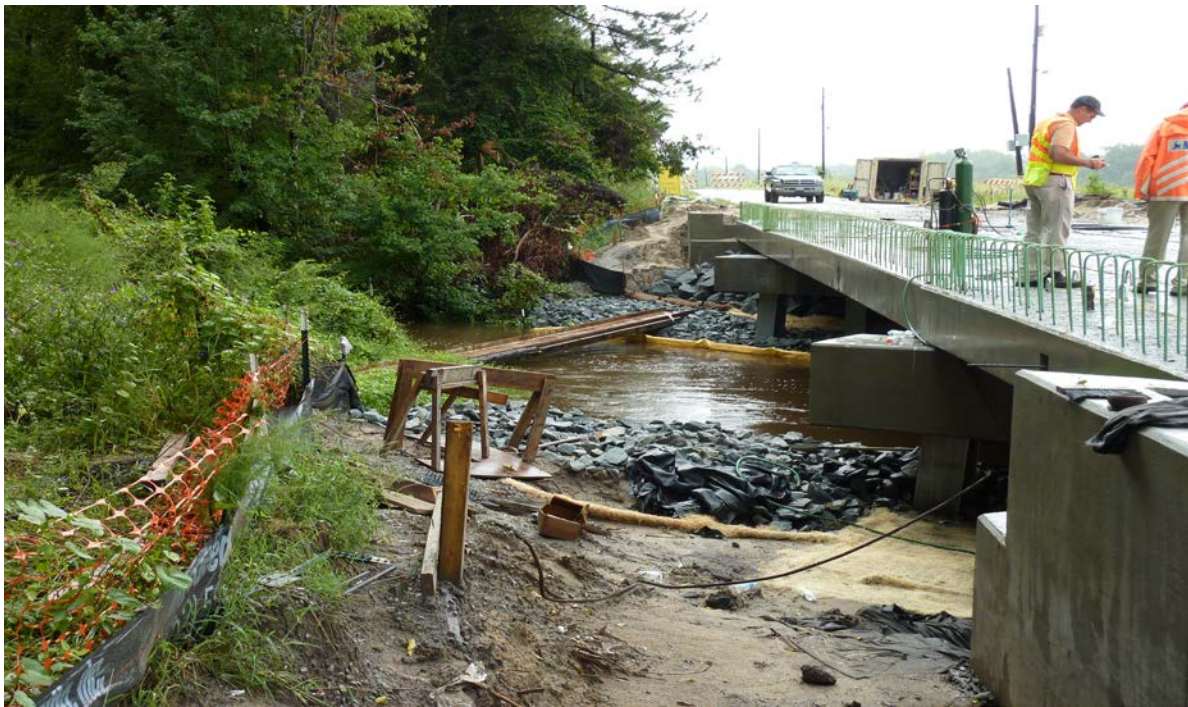
This is a NC DOT Bridge Replacement project that is 0.161 miles in length and has a contract for \$834,000.00. The project scored primarily 8s and 9s during recent inspections. The plan was adequate and properly implemented. Sediment controls were adequate and effective. Self-inspection records were adequate. The use of turbidity curtains and anchored geotextile covering stockpiles provided erosion and sediment control for this site. Minor maintenance in ditch (removal of deposition and restabilization) was needed due to recent rains (6+ inches over previous 2 days). In addition, it was noted that sensitive exposed areas near the stream should be provided with temporary cover at the end of the work day. Overall rating was Good.

Bridge Replacement Work, Pitt County

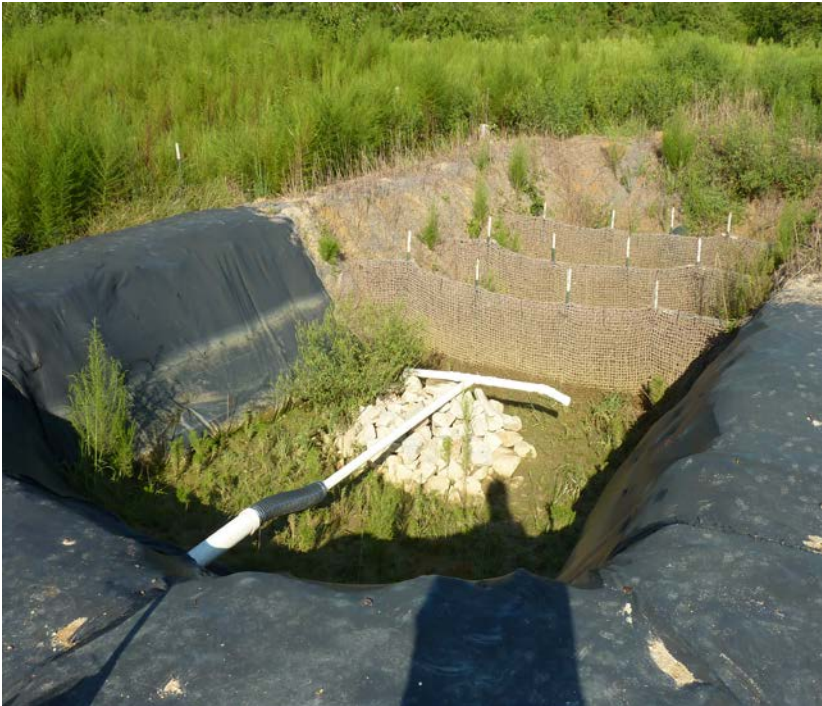
This is a 6.949 mile widening project with a contract amount of \$39,234,386.71. The plan was adequate but not implemented consistently. Maintenance was needed in several areas. Silt fence was undermined near basins 17.6 and 17.8, causing slight sedimentation into a natural watercourse. The site was using an IAS (Innovative Applied Solutions) skimmer with mixed results. The skimmer in basin 17.6 was unattached. Attention was needed around some slope drains to repair scoured areas and to ensure that slope drains were discharging to an appropriate area (i.e., not to silt fence). Several slopes had been tracked in the wrong direction. The stream relocation/bypass onsite looked excellent and was functioning well. The Self-inspection records were adequate. Overall rating was Fair.

Basin with IAS-Skimmer, NC 24 Widening

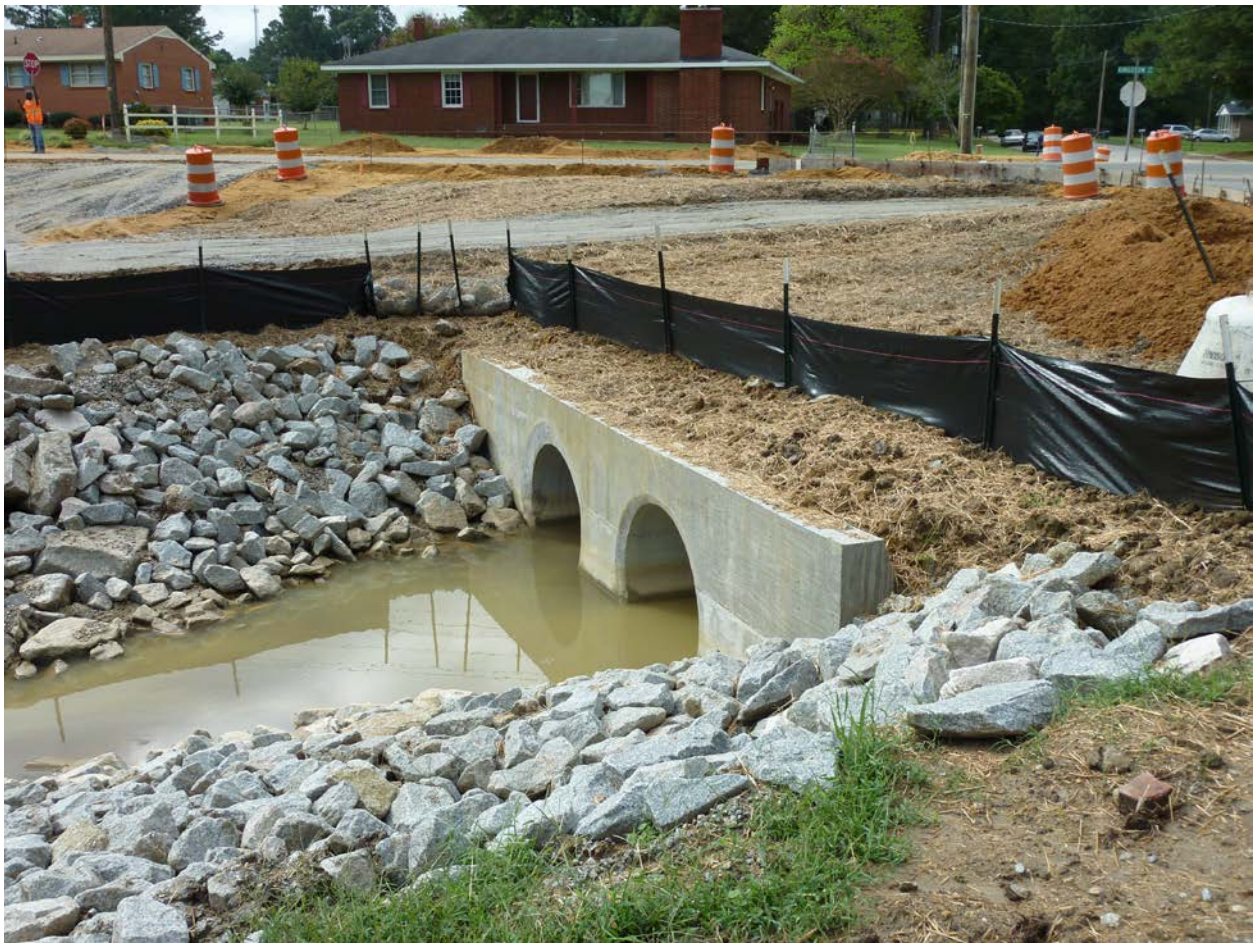
This is a 1.022 mile project with a contract for \$2,272,089.70. Site received 3.5 inches of rainfall previous two days. The plan was adequate and was generally implemented well; however, maintenance was needed to silt fence and inlet protection in several areas. Additional ditches/swales were needed in two areas to drain water toward inlets. A concrete washout location had been designated for use during the project. Self-inspection records were adequate. The temporary and permanent vegetation established throughout the site is very good. Overall rating was Fair+.

Culvert and Stream Protection, Kingston Ave Widening

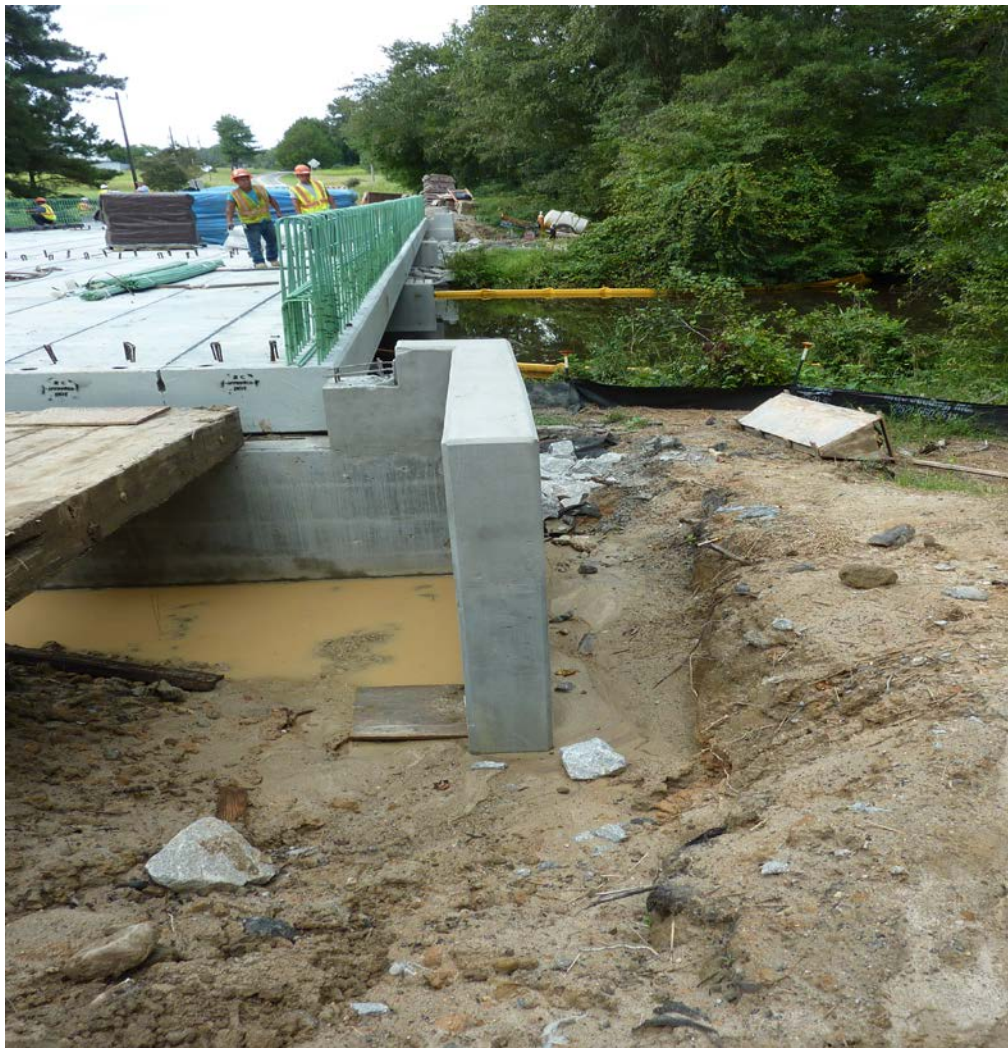
This is a 0.101 mile bridge replacement project with a contract for \$905,058.45. The plan was mostly adequate, although the site did need additional measures or stabilization before the riprap approach to the creek. Areas around the wing walls of the bridge were unstabilized. Concrete was not being washed out in a designated and contained area. Stabilization (vegetative, tarp, etc.) was needed for exposed stockpiles. Self-inspection records were adequate. The site recently received 3.75 inches of rain. Despite the issues noted, no sediment was being lost from the site. Overall rating was Fair+.

Unstabilized areas around wingwalls, Bridge 201 Over Little River

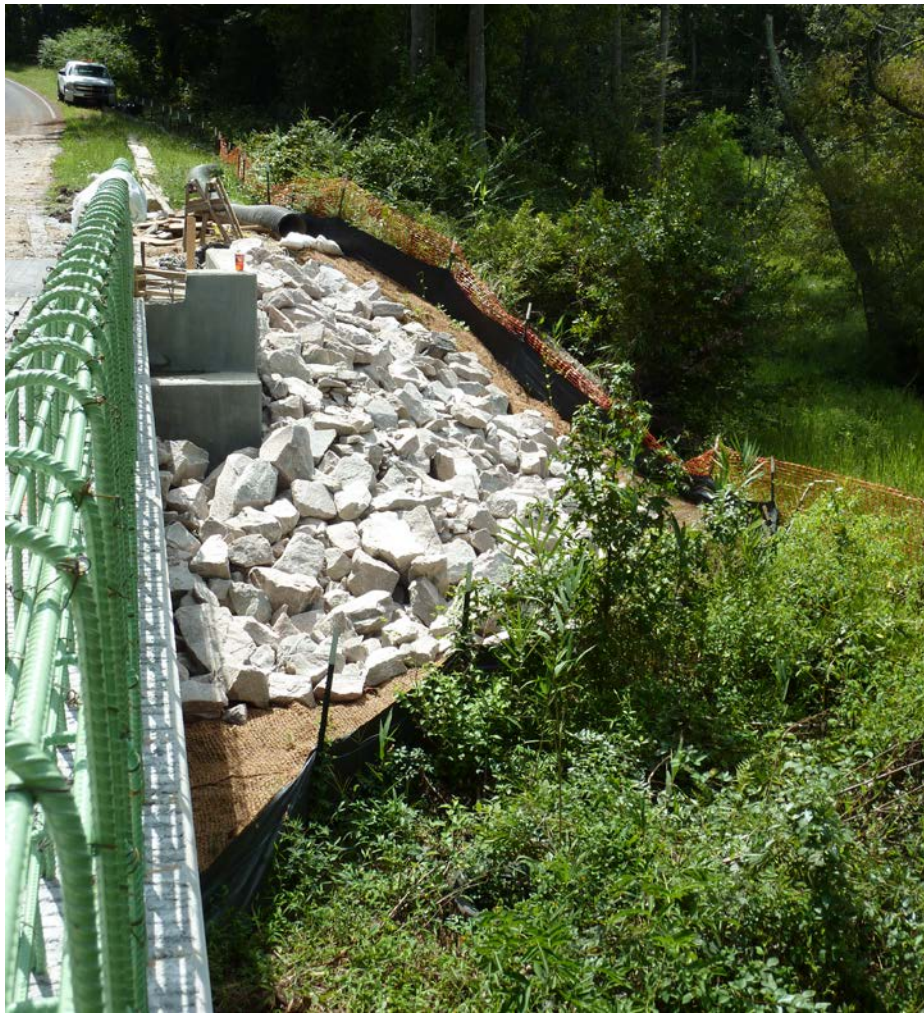
This is a 0.101 mile bridge replacement project with a contract for \$647,647.00. The project scored primarily 8's and 9's on previous inspections. The plan was adequate and properly implemented. Sediment controls were adequate and effective. Matting and additional silt fence was used to protect sensitive areas around wingwalls. Concrete washout should be done in a designated area. Self-inspection records were adequate. The site is well contained. Overall rating was Good.

Well protected area along wingwall, Wake County

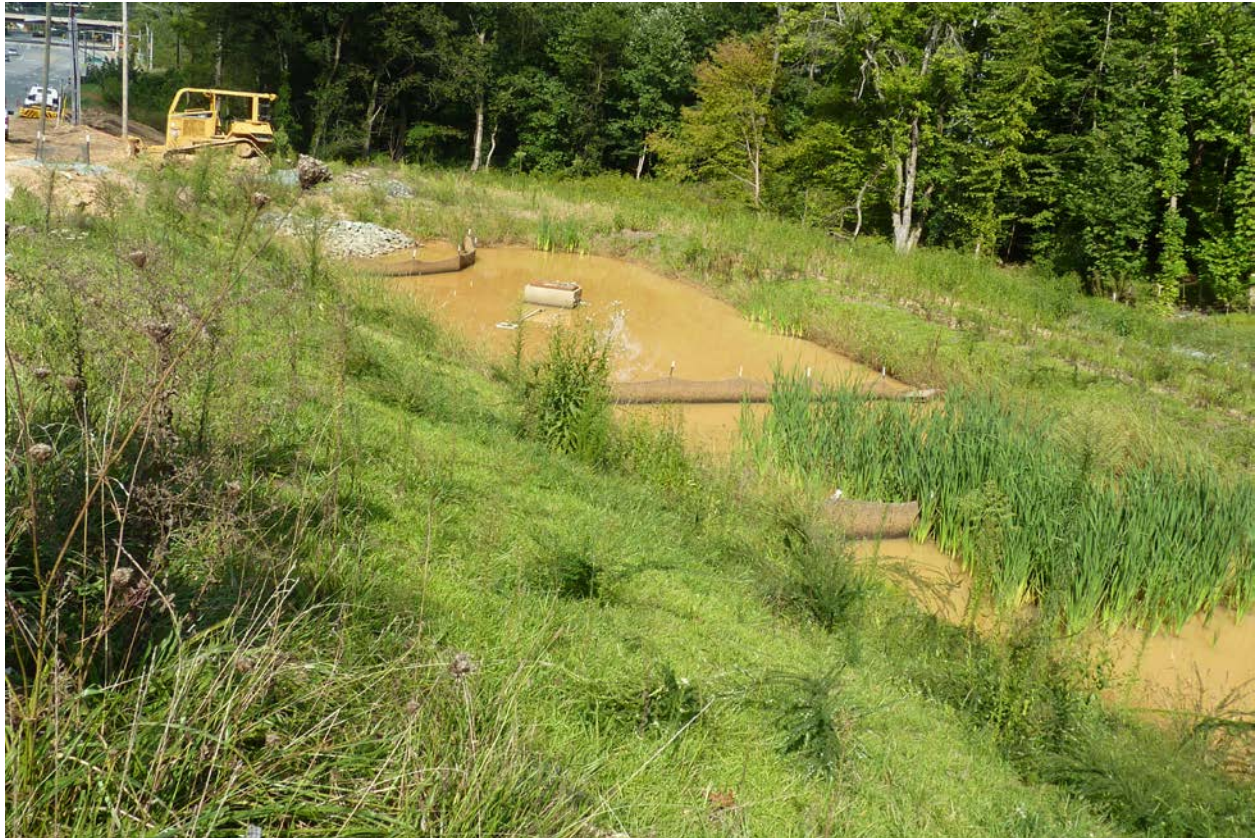
This is a 0.809 mile project with a contract for \$4,946,197.82. The project had scored 7's through 9's on previous inspections. A history of maintenance issues were noted throughout the inspections, with some items appearing on multiple inspection reports. The plan was mostly adequate with minor field adjustments. One area along the side street needed additional protection in the form of silt fence at the low end of disturbance. Areas where the sidewalk was completed were seeded, mulched, and tacked. Wattles, sandbags, or alternative needed to be used to direct water into inlets. Most inlets drained to a large skimmer basin; however, water onsite was able to bypass inlets along the slope until reaching the lowest inlet(s). Several inlets needed maintenance. Concrete washout needed to be done in designated, contained areas. Self-inspection records were adequate. Site received 0.3 inches of rain the previous day. Overall rating was Fair.

Large skimmer basin, Smith Level Road Widening

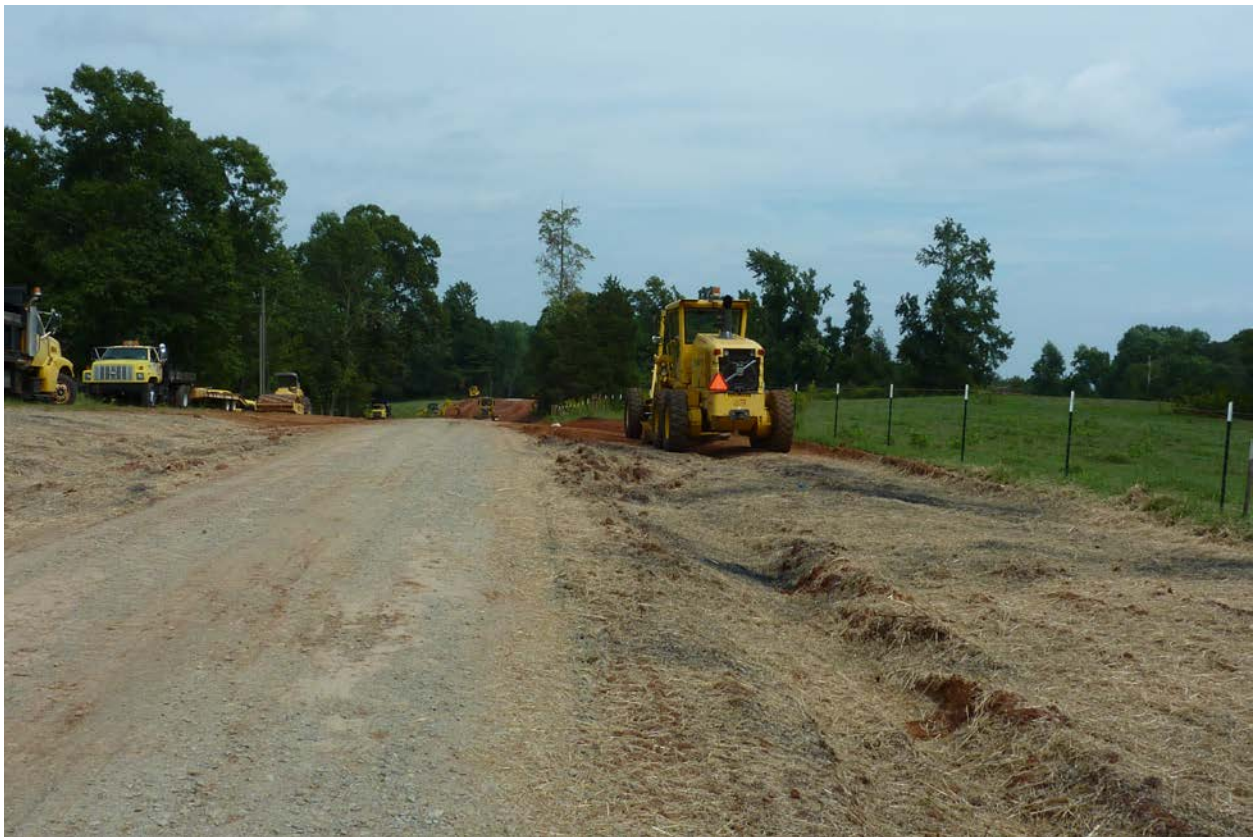
This is a 0.7 mile road maintenance project being undertaken on a cul-de-sac with occupied homes, requiring access to be maintained during construction. Previous inspections revealed scores of primarily 8's and 9's. The plan was adequately implemented and measures were effective. Project was phased well, with inactive areas seeded and mulched. Wattles were removed during the work day and then replaced at the end of the day. Additional silt fence and stone were suggested in two small areas along driveways. The overall project condition was Good.

Phased Construction on Road Maintenance Project, Chatham County

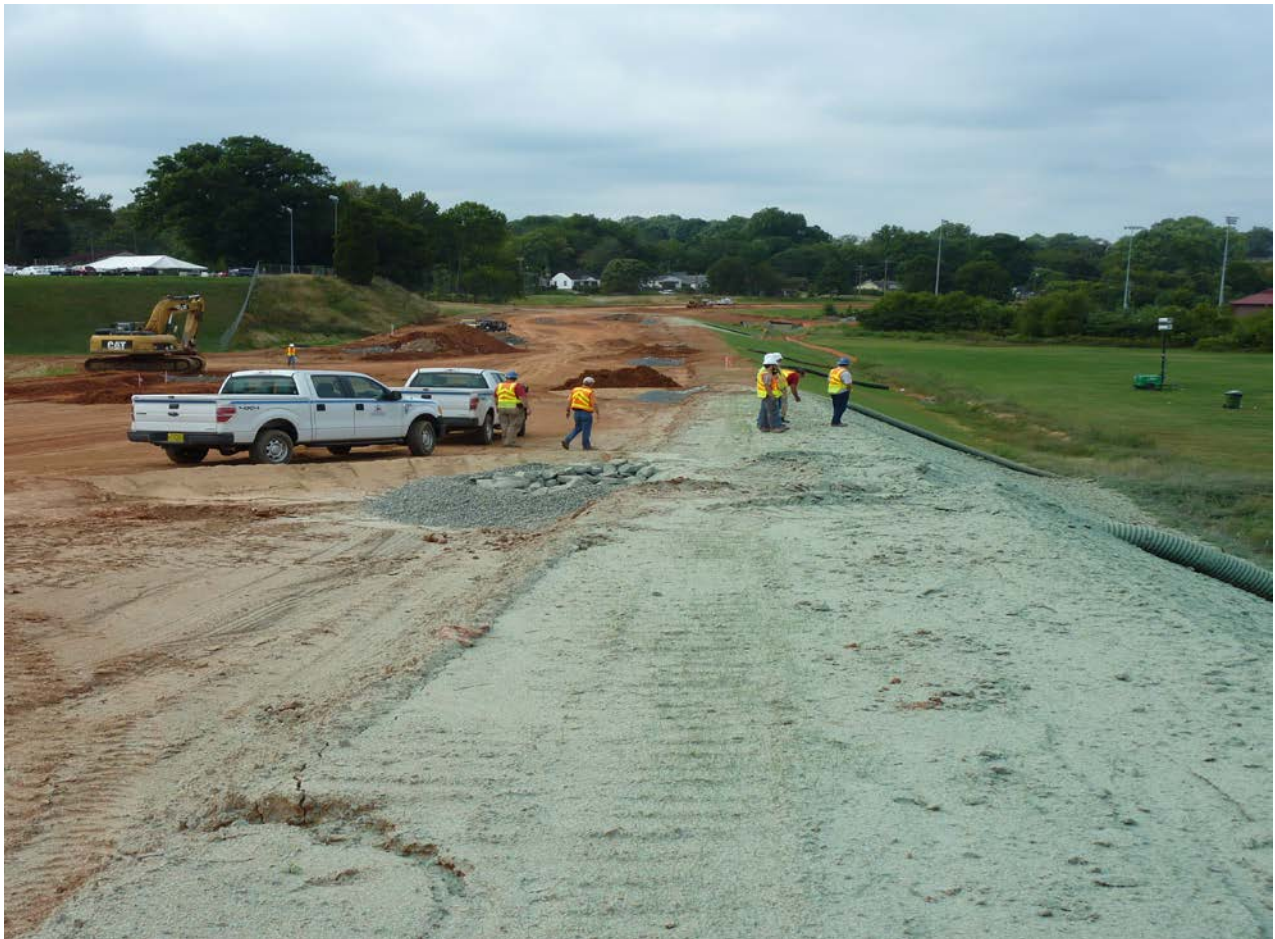
This is a 1.094 mile design-build project with a contract for \$68,925,000.00. At the time of inspection, the project was approximately 40% completed. The plan appeared adequate overall. Measures appeared to be effective and were, in general, well maintained. Flexterra had been used on several slopes throughout the site with good success. The creek through the site was well protected. The overall project rating was Good.

Flexterra used on slope, Salem Creek Connector, Forsyth County

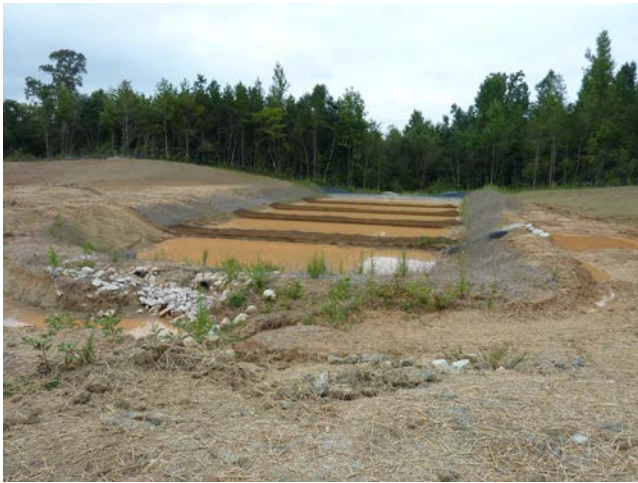
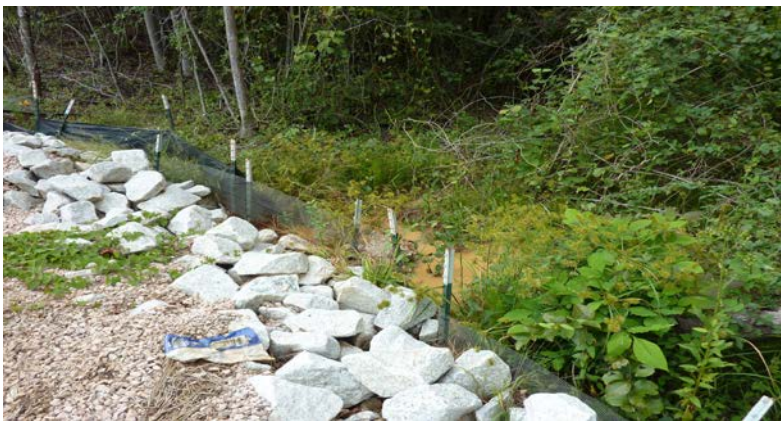
This is a 0.854 mile project with a contract for \$9,327,385.16. At the time of inspection, the project was approximately 50% complete. Plans for the site were adequate, and self-inspection records had been well maintained. Measures onsite appeared to be functioning well with the exception of the area around a stream, where some sediment deposited into the jurisdictional area. Maintenance of upstream measures was needed along with removal/restabilization of the affected area. Deposition in ditches also needed removal and the areas restabilized. Along with the main project, an associated borrow pit was also inspected. There was significant turbidity coming from the skimmer basin. Perimeter slopes of the pit had been permanently seeded, and inactive areas were provided with temporary seed and mulch. PAMs had been used onsite, but it was suggested that the type of PAM used should be evaluated and the proper type used further upstream at the entrance of the basin. The project was rated Fair because of the maintenance issues which led to a small amount of sediment in the jurisdictional stream, as well as the turbidity issues from the skimmer basin at the borrow site.

Skimmer Basin at Borrow Pit; Below, Turbid Water at Skimmer Basin Outlet

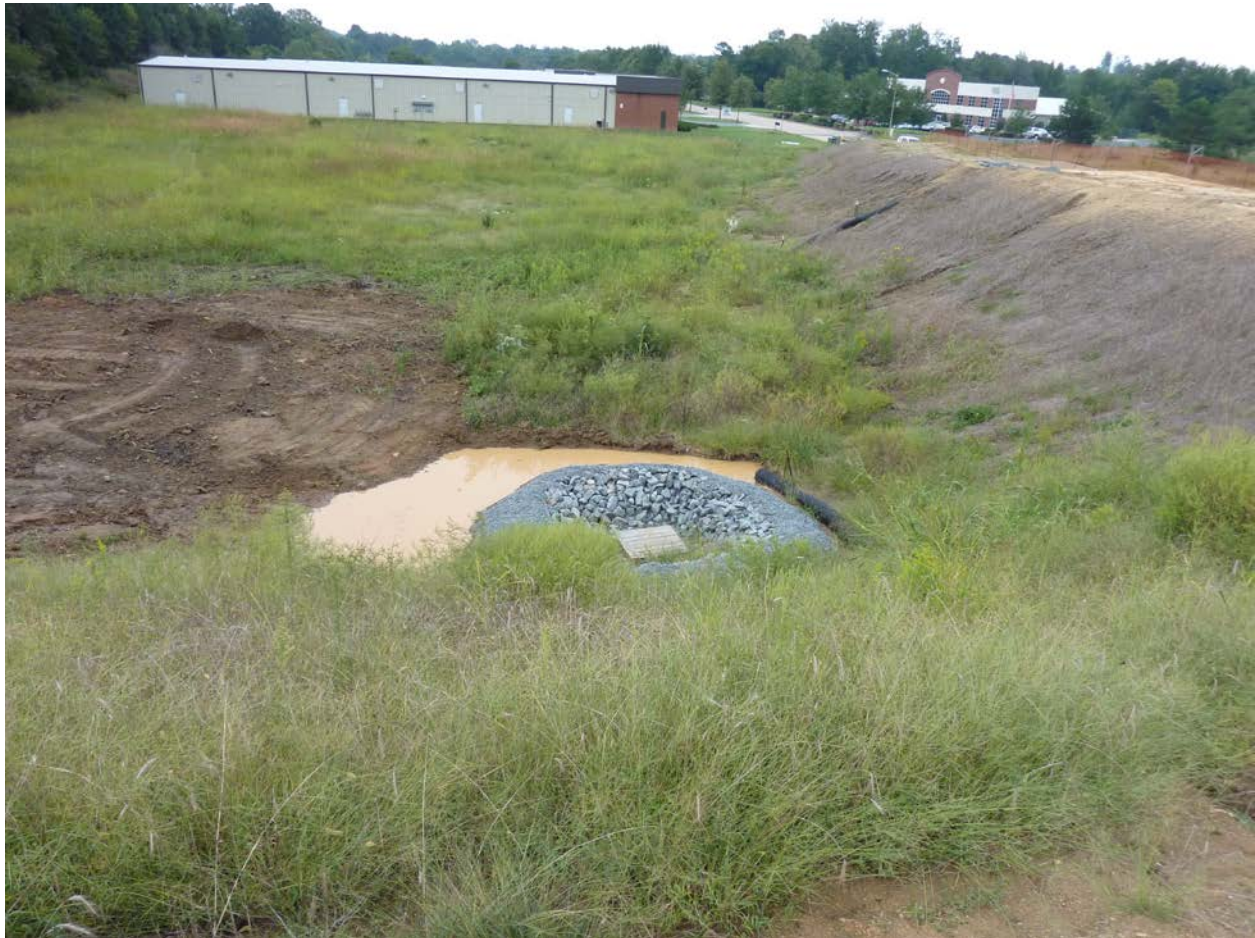
The only issue of concern was temporary seed mix used on a slope which had not been worked for some time. Scheduling issues (especially with utilities) delayed work in this area, but the timeframe elapsed indicated that a longer term mix (permanent) should have been used to seed the slope(s). The overall project rating was Good.

Slope with Temporary Seed Mix, Mecklenburg County

With the delays in projects (due to utility work or other circumstances), care needs to be taken to provide appropriate stabilization of sites that are inactive for a given time. Measures still need to be maintained onsite unless drainage areas are fully stabilized. If areas will not be worked for at least 3-4 months, a permanent seeding would be more appropriate than temporary seeding.

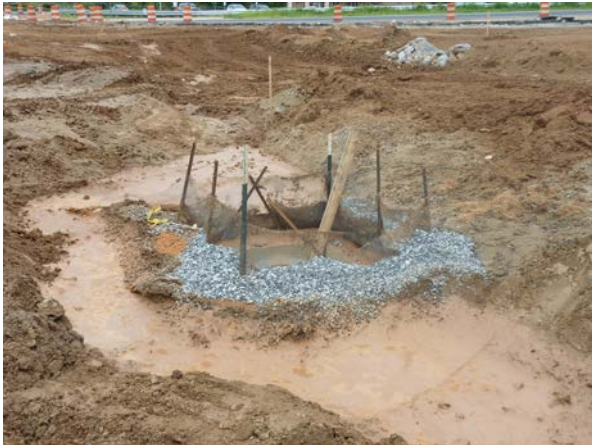
This is a 0.641 mile project with a contract for \$21,229,384.79 and was approximately 80% complete at the time of inspection. The plans and self-inspection records for the site were adequate. Previous inspections revealed a history of compliance; however, several issues were noted during this inspection. In general, inlet protection needed maintenance throughout the site. Several protections had failed, resulting in sediment in inlets. Silt fence around two culvert headwalls was being undermined – one was a minor maintenance issue, but the second was a more significant concern due to the severity of the undermining. There was a borrow area associated with this project which was not well executed or maintained. Measures had been provided for the borrow area, but rills and gullies were forming as some stormwater bypassed the trap and ditch. The site received approximately 4.5 inches of rain recently, and while the rain contributed to maintenance issues onsite, many could have been avoided with proper attention and planning. The overall project condition was Poor.

NC-18 and I-40 Interchange—Inlet in Need of Maintenance

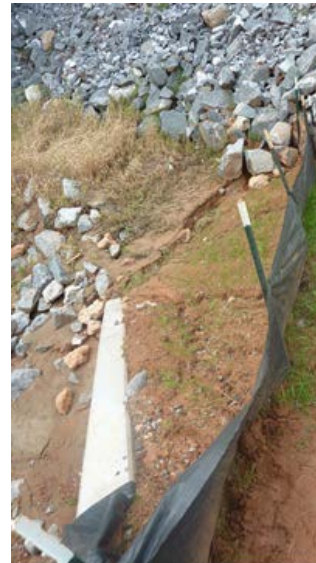
Undermining of Silt Fence and Erosion at Ditch Outlet Near Culvert Headwall

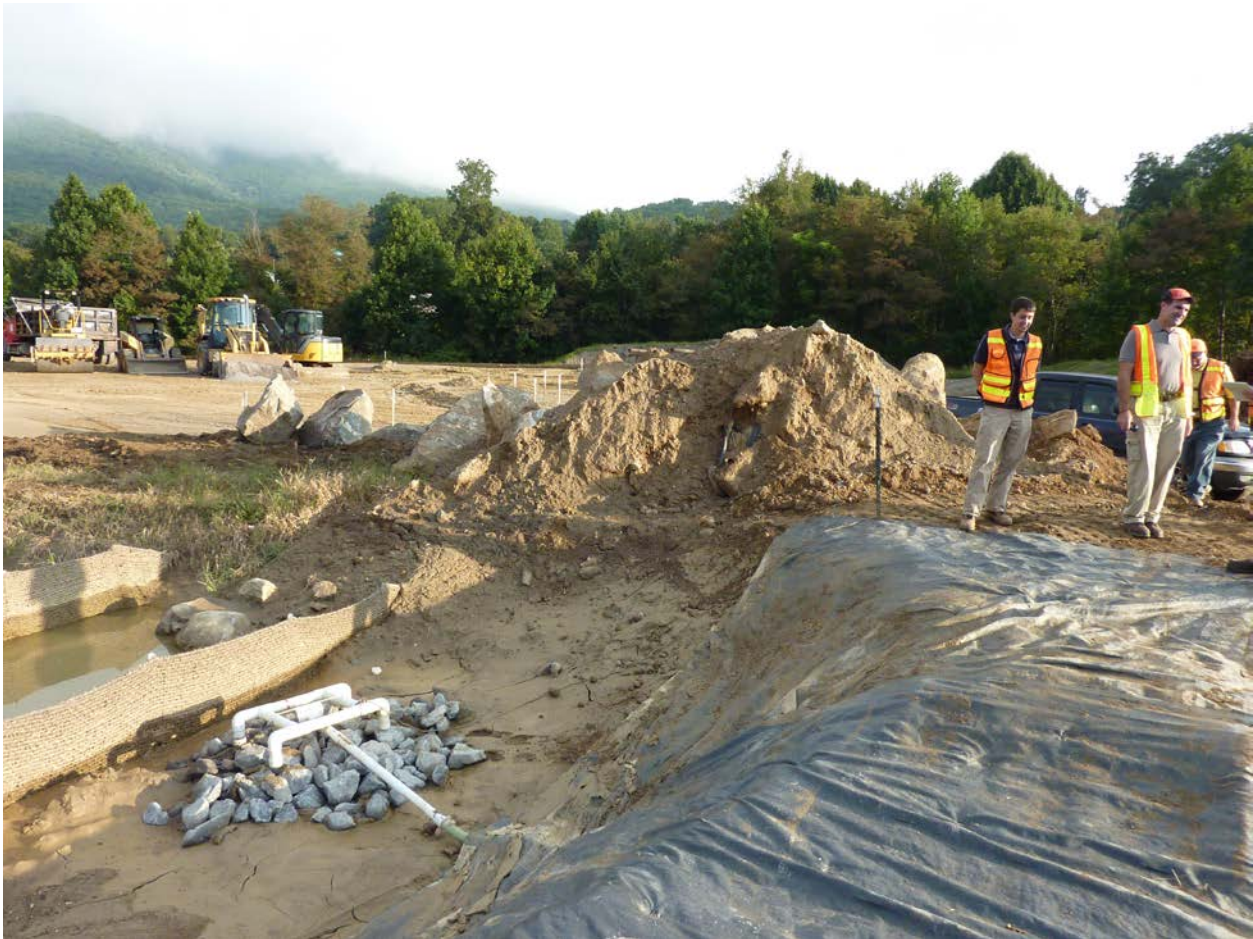
This is a 0.265 mile vertical construction project with a contract for \$6,151,716.03. It involves construction of a new rest area and renovations of an existing northbound rest area. The plan appeared to be adequate and well implemented onsite. Self-inspection records were well-maintained. One basin onsite could use maintenance; however, it was to be converted into a bioretention area very soon and had very little drainage to it. Once concrete is being poured, a concrete washout area needs to be designated onsite. The only issue noted was that a rock/dirt pile was located at the outlet third of one skimmer basin and had not been provided stabilization. It was suggested that the pile be relocated or provided with temporary groundcover to lessen the potential of that material exiting the skimmer basin too quickly. No sediment was leaving the site. The overall project condition was Good.

Rock/Dirt Pile at Outlet of Skimmer Basin, US 23/74 Southbound Rest Area

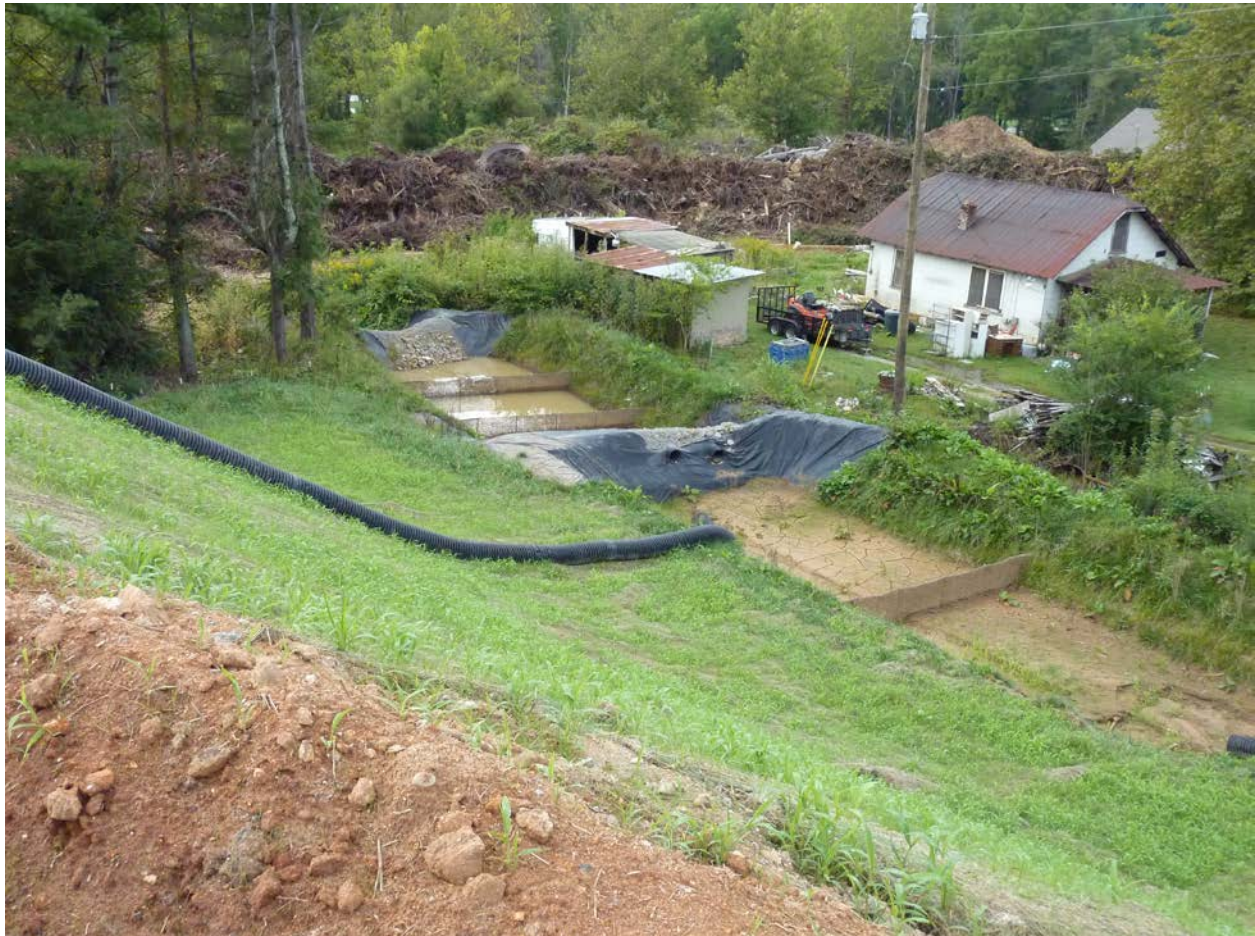
This is a 1.42 mile secondary road widening and paving project (which was approximately 45% complete) with a contract of \$11,688,234.11. The plan for the project was adequate, and field personnel had implemented several additional measures proactively to improve containment and treatment onsite. Minor maintenance was needed for a couple of basins, and near a newly installed culvert. Work had stopped temporarily on one end of the project due to the discovery of contaminated soils. The area in question had been properly covered/stabilized with tarp; however, the area adjacent to the contaminated soil was still bare. Although the bare area was contained, rills were developing and the area should, at a minimum, have received temporary groundcover. The overall rating was Good.

Tiered Basin at Howell Mill Road Widening Project, Haywood County
