*Review of  
Erosion and Sedimentation Program  
Delegation to the North Carolina Department  
of Transportation, Division of Highways*

*November 4, 2019*

*North Carolina Department of Environmental Quality  
Division of Energy, Mineral, and Land Resources  
Land Quality Section*

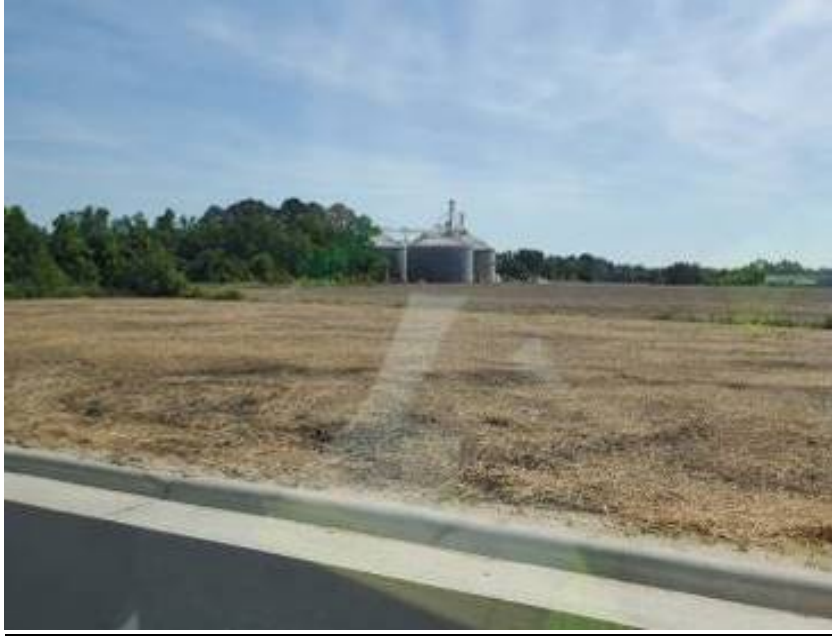
Photo - Straw and Tack Coverage. (5/16/2019)

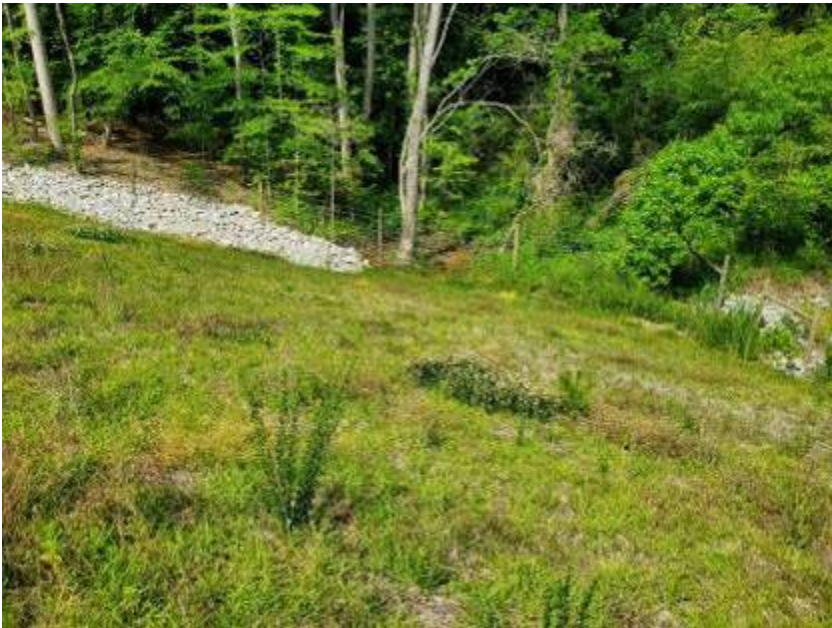
Photo - Riprap Diversion Ditch (5/16/2019)

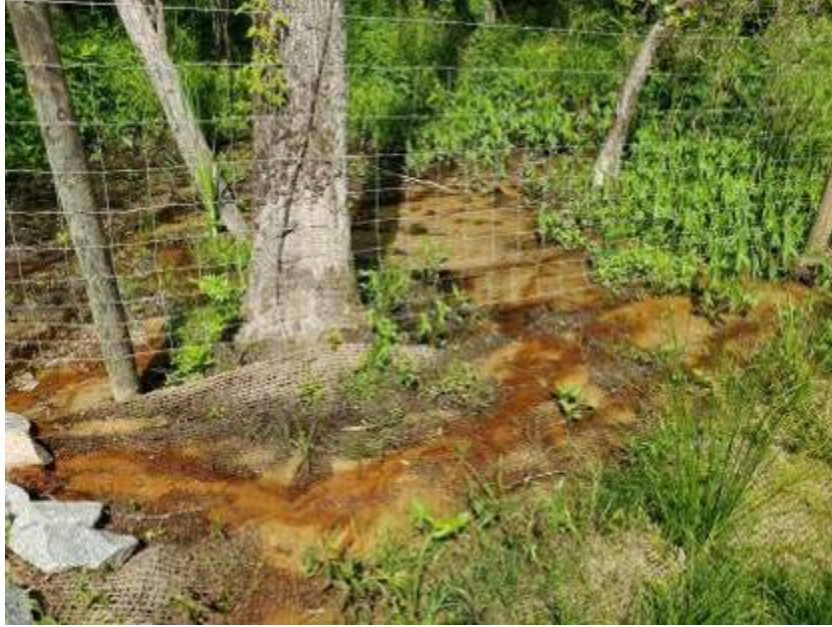
Photo - Location of Nov. 2018 Offsite Sedimentation. (5/16/2019)

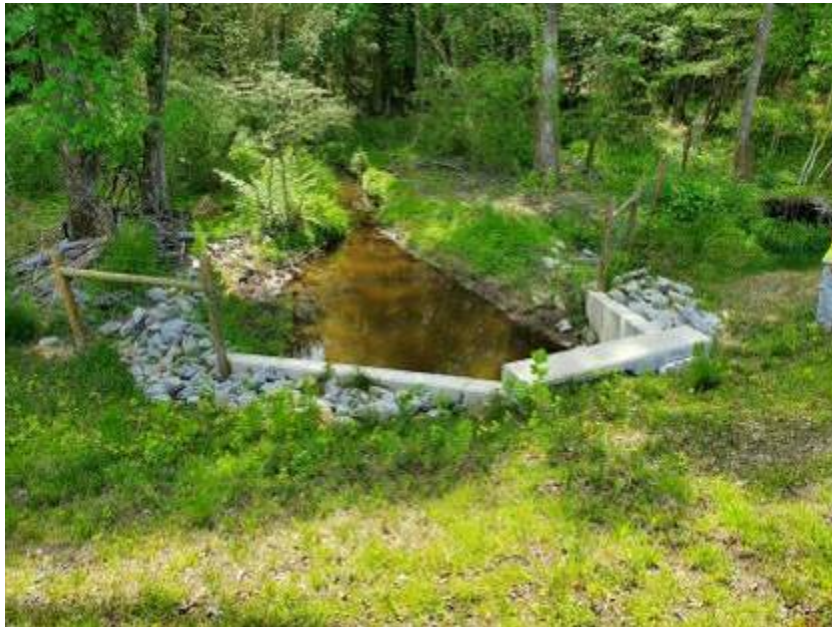
Photo - Culvert with Good Vegetation and Maintained Stone. (5/16/2019)

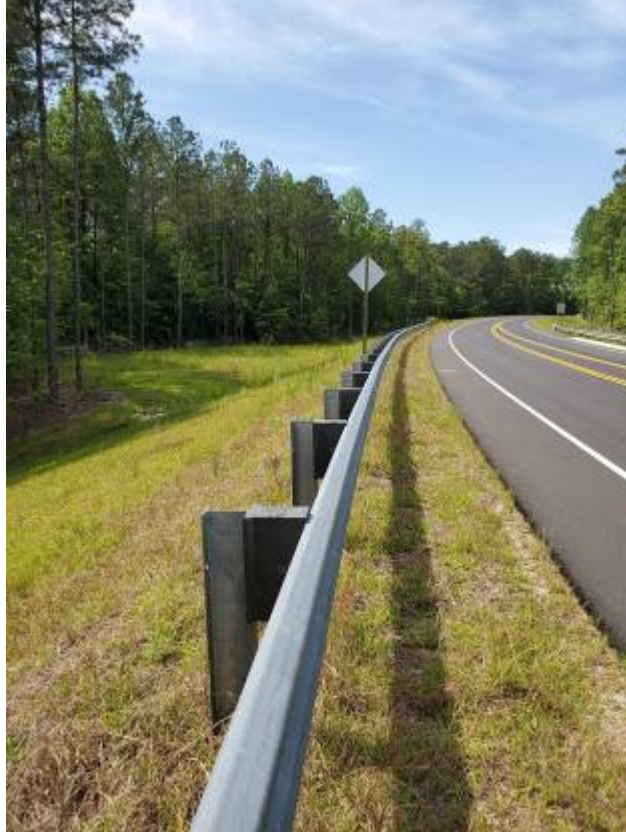
Photo - Roadside Slope with Good Vegetation. (5/16/2019)

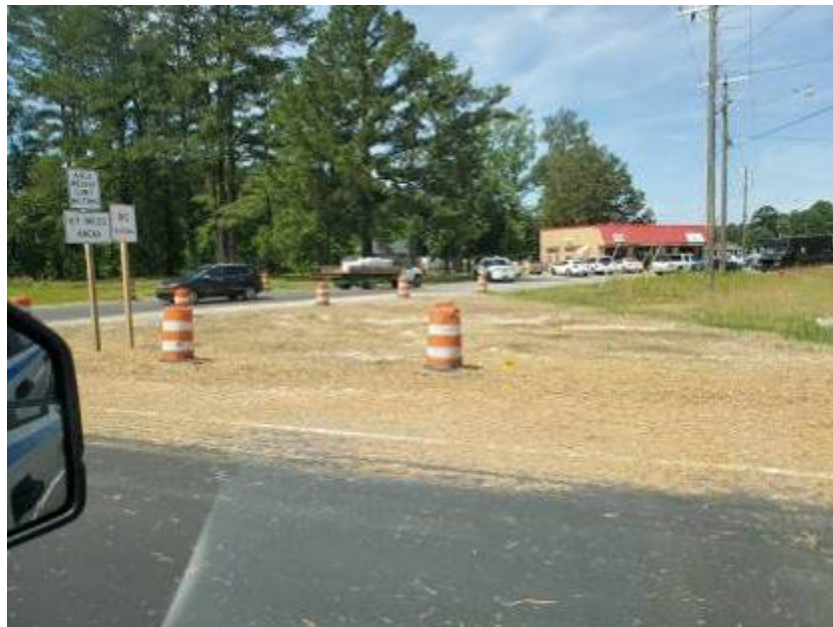
Photo - Straw and Tack with Bare Patches. (5/16/2019)

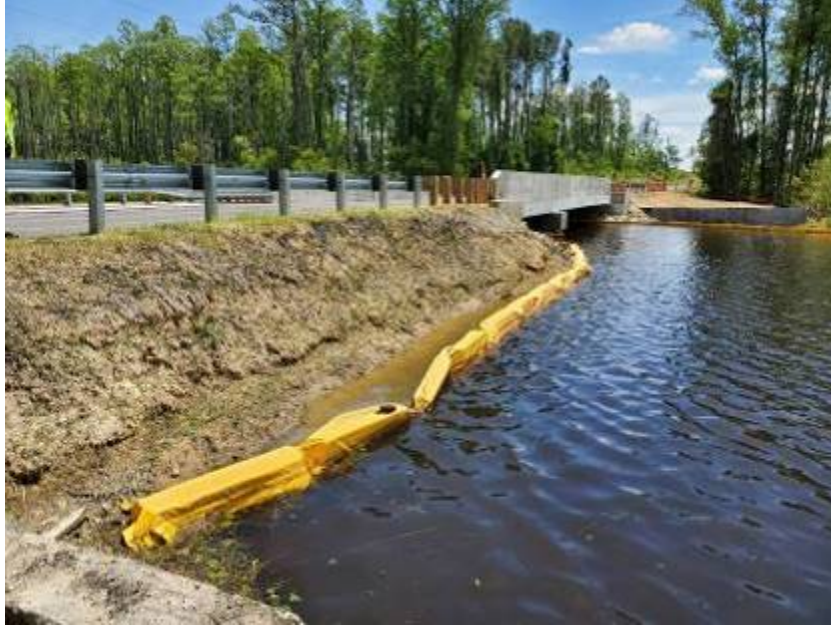
Photo - High risk fill slope leading into Duck Creek. (5/16/19)

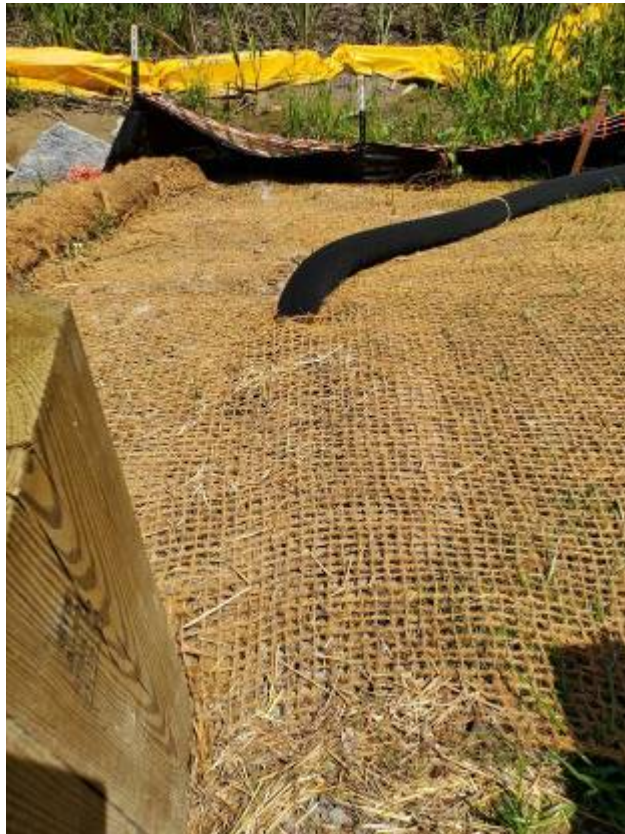
This is a 0.2-mile project with a budget of \$2,121,457.06. This project was approximately 65% completed at the time of inspection. The plan appeared to be adequate and measures were installed. The site was in compliance at the time of inspection but there were a few areas of concern. The biggest concern was a very steep roadway fill slope that leads into Duck Creek with high risk of slope failure. The slope was nearing a vertical cliff, and due to the steepness was struggling to establish ground cover. The DOT currently has a silt curtain in place at the base of the slope, however due to the height of the slope, it could easily overtop the silt curtain if it were to experience slope failure. The DOT wished to add riprap and expand the slope outward, however a moratorium stopped all water work in the area. The DOT is in the process of having a revised plan for this fill slope accepted so that they can prevent any future sediment damage. Another area of concern was an undersized slope drain on a fill slope leading into the waterway. Water has gone around the slope drains inlet and has created a rill underneath the erosion mat currently placed on the slope. If not fixed this could lead to further erosion of the slope and sedimentation into the creek. Overall the site had well maintained measures, and good groundcover. Recommendations made at the site were to get a revised plan to regrade and stabilize the fill slope with riprap, and install a new, bigger slope drain to prevent water from flowing around the device.

Photo - Undersized slope drain. Rill erosion underneath mat. (5/16/19)

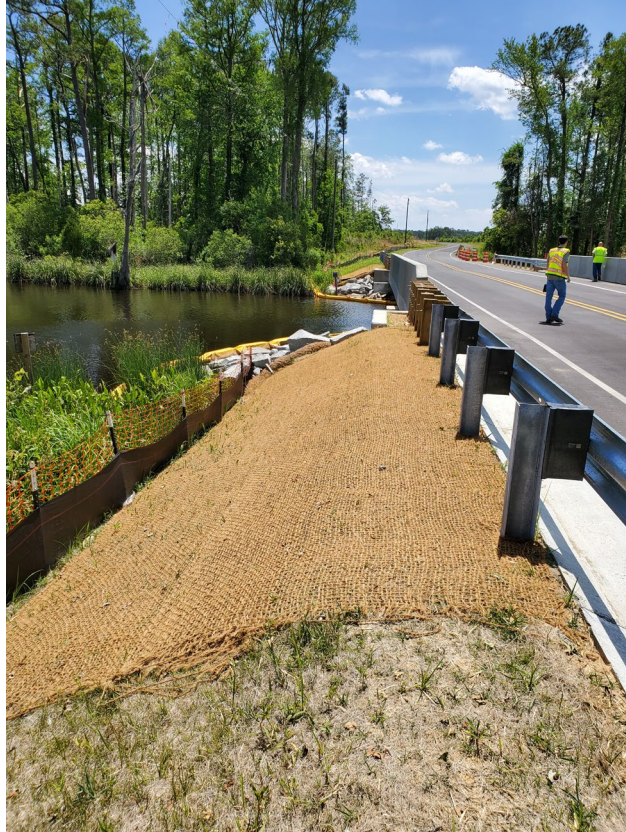
Photo - Good temporary ground cover on the slope. (5/16/19)

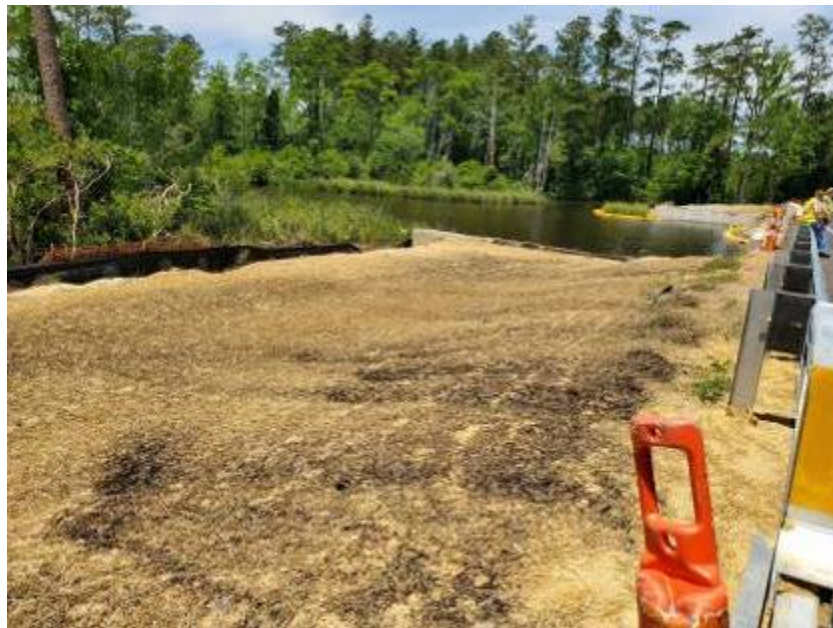
Photo - straw and tack on fill slope. (5/16/19)

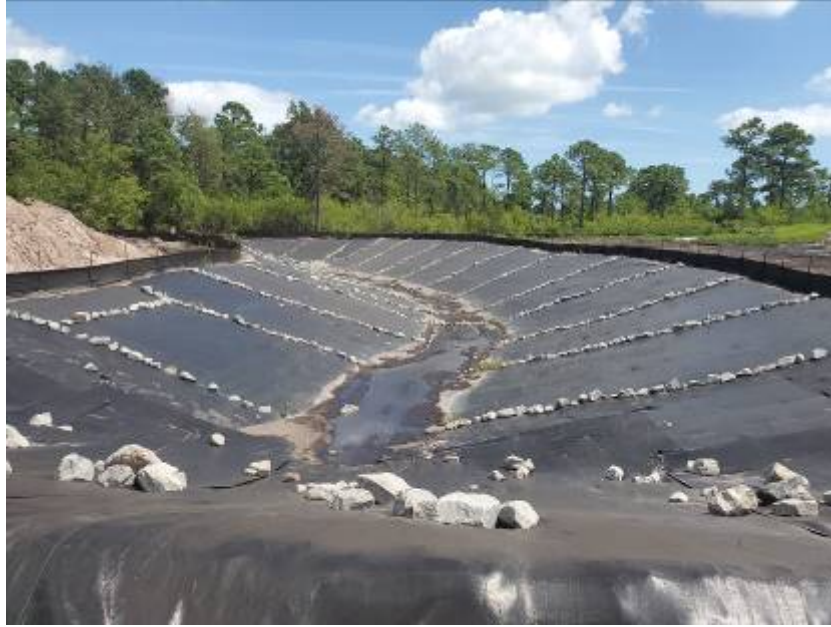
Photo - Stream diversion channel. (8/27/2019)

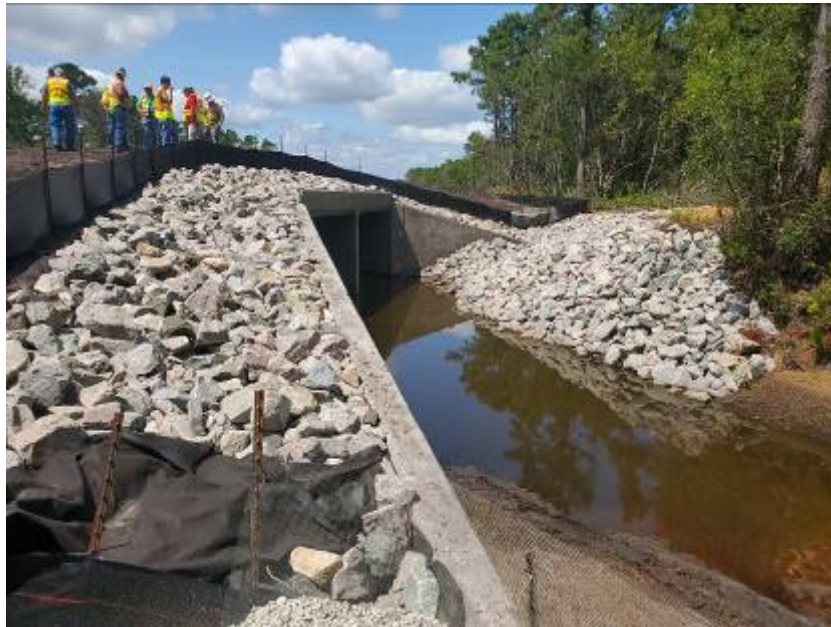
Photo - Stream box culvert. (8/27/2019)

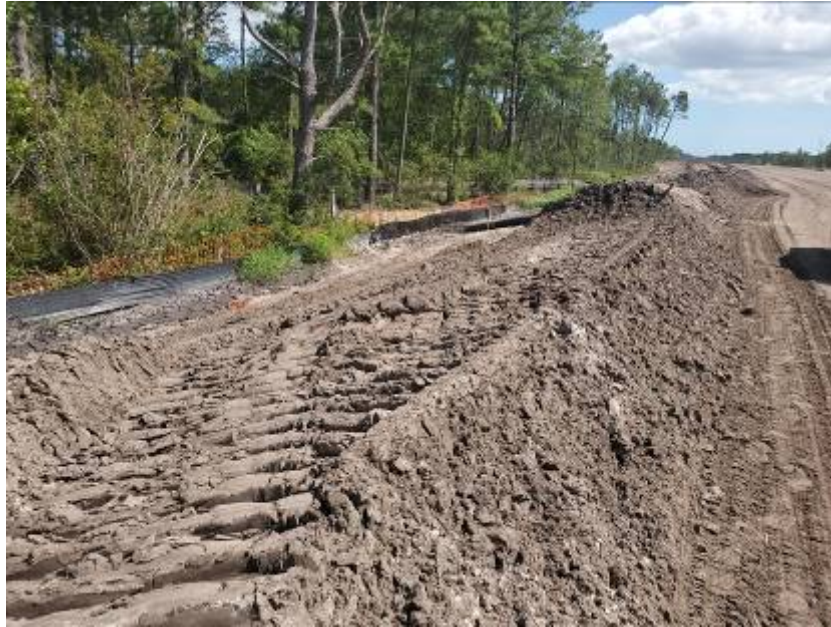
Photo - Location of offsite sedimentation post large rain event. (8/27/2019)

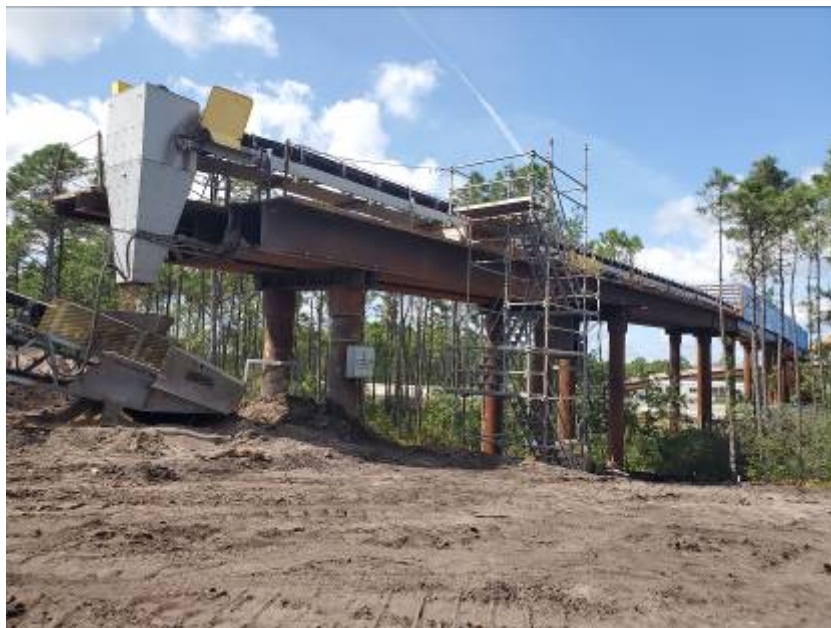
Photo - Conveyor bring soil from borrow pit to site. (8/27/2019)

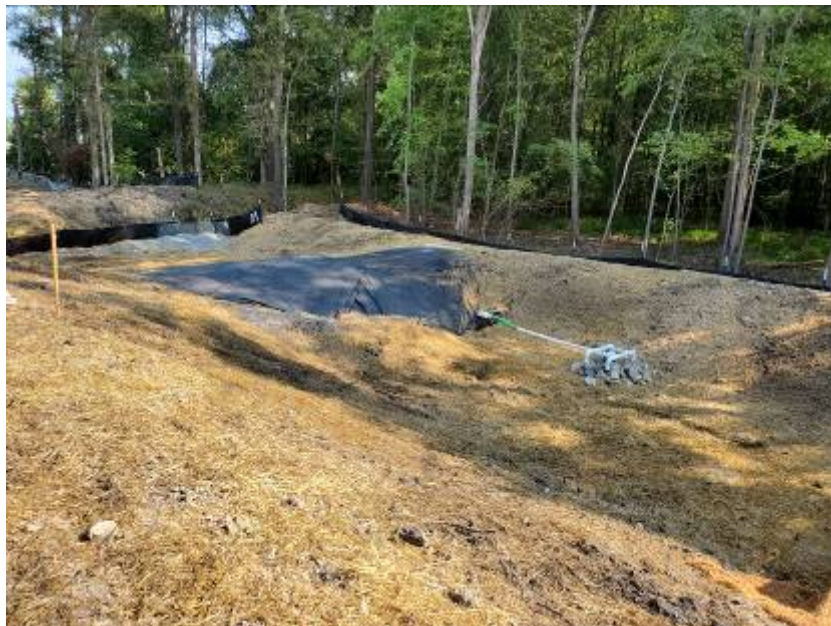
Photo - Seeded and tacked basin (10/2/2019)

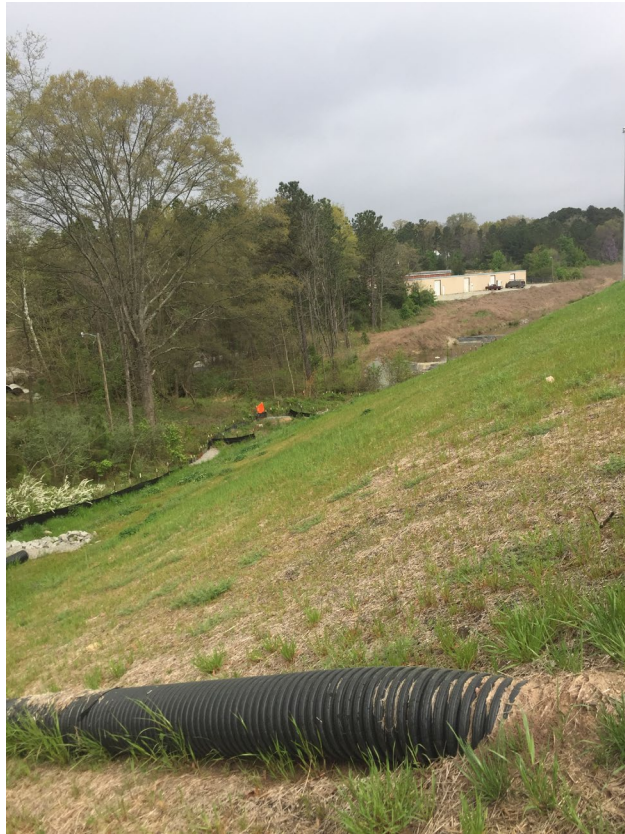
Photo - Good vegetation on slope and diversion ditch w/ check dams. (4/5/2019)

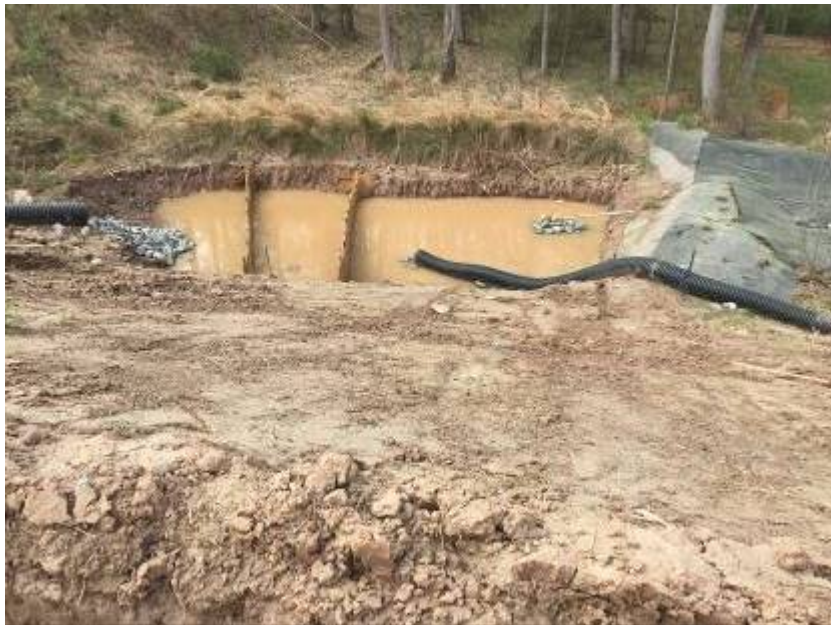
Photo - Skimmer basin with damaged liner and no bank stabilization. (4/5/2019)

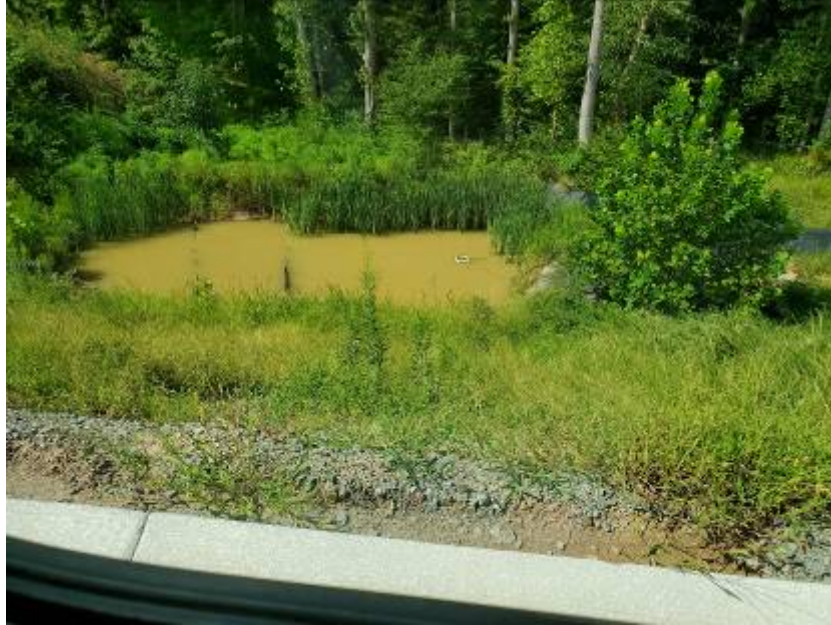
Photo - Skimmer basin with well-established groundcover on embankments. (8/28/2019)

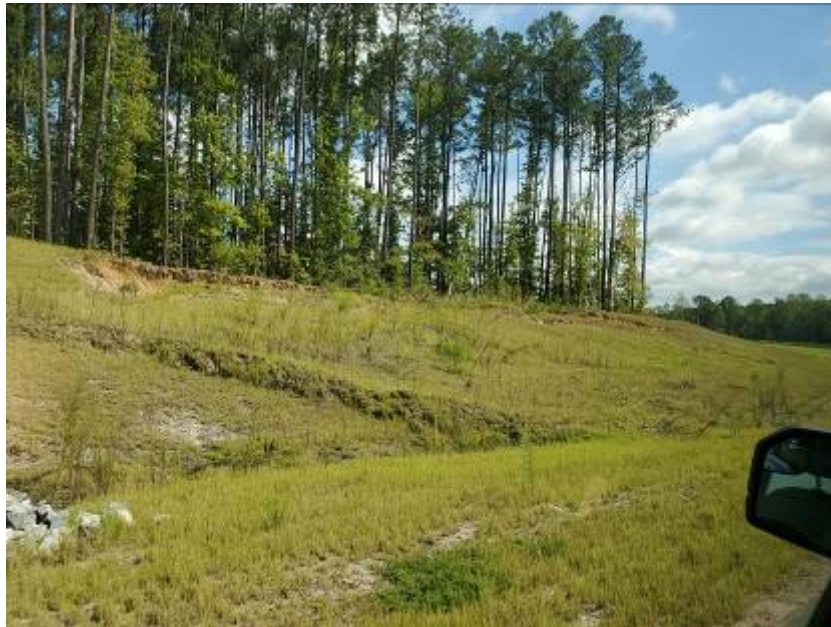
This is a 4-mile-long project with a budget of \$ 141,949,500. The project was approximately 65% completed at the time of the first inspection. The approved plan appeared adequate and had been implemented properly. The site was in compliance based on the first inspection but had several maintenance issues that needed to be resolved. One of the slopes on site had failed. DOT staff believe this was due to the Triassic rock on site. DOT is in discussion with the geotechnical unit on how to solve the slope failure. Some of the matting on one of the basins was damaged and need to be replaced, and some slopes required some temporary or permanent ground cover. Overall, the site appeared to be in good shape. Recommendations were made during the first visit: 1) Apply supplemental seeding to improve the ground cover as needed. 2) repair and replace all damaged silt fence and basin lining. 3) Come up with a solution for the slope failure to prevent future issues.

Photo - Slope Failure. (8/28/2019)

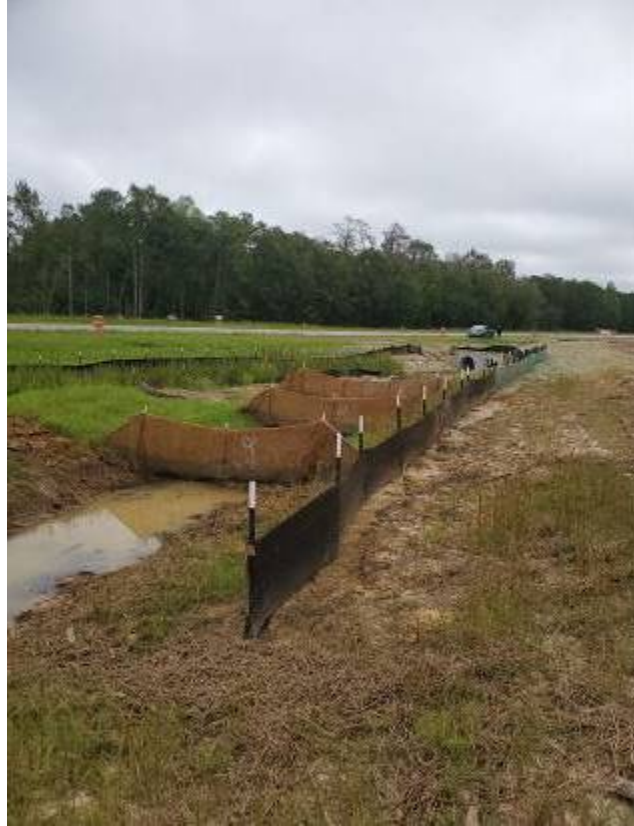
Photo -Well maintained skimmer diversion ditch. (8/27/2019)

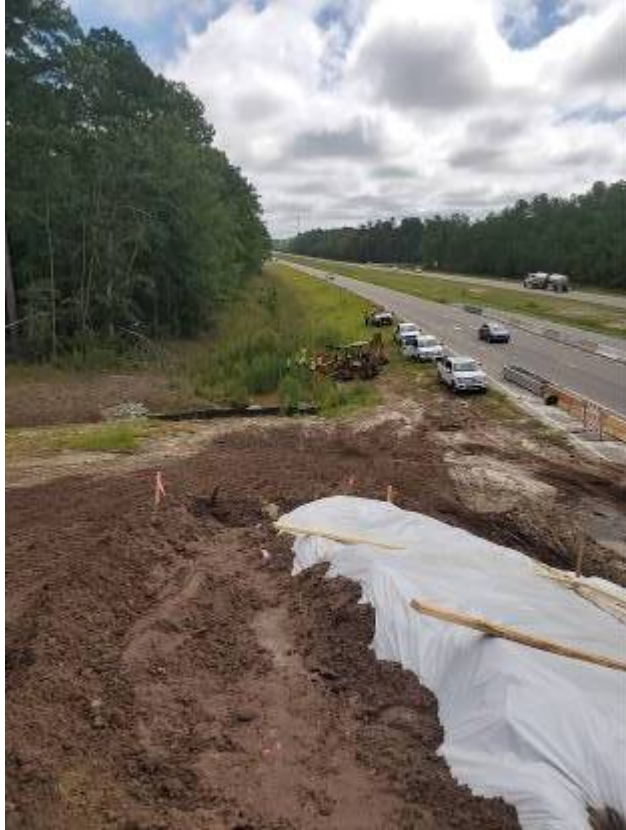
Photo - Bucket crew cleaning up slight offsite sediment. (8/27/2019)

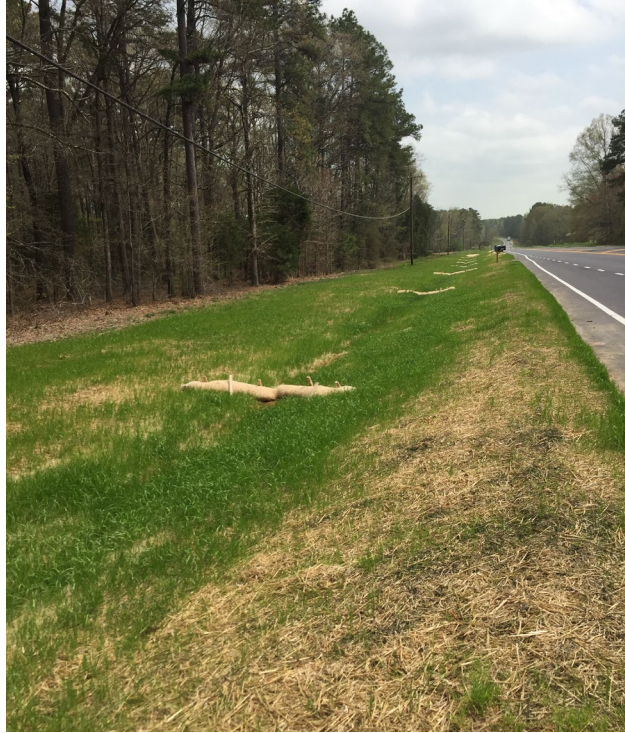
Photo - Good ground cover in permanent diversion ditch. (4/5/2019)

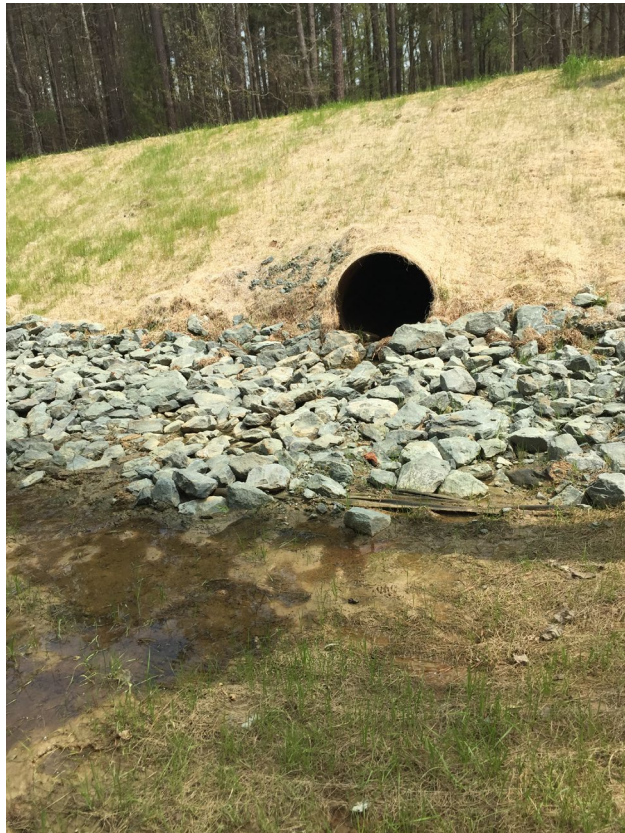
Photo - Culvert outlet. (4/5/2019)

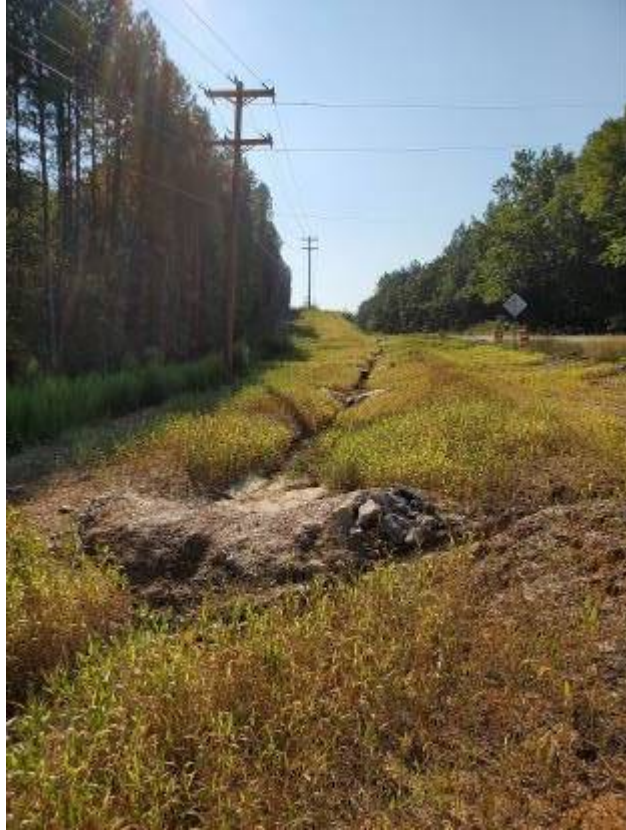
Photo - Well maintain diversion ditch with check dams (9/12/19)

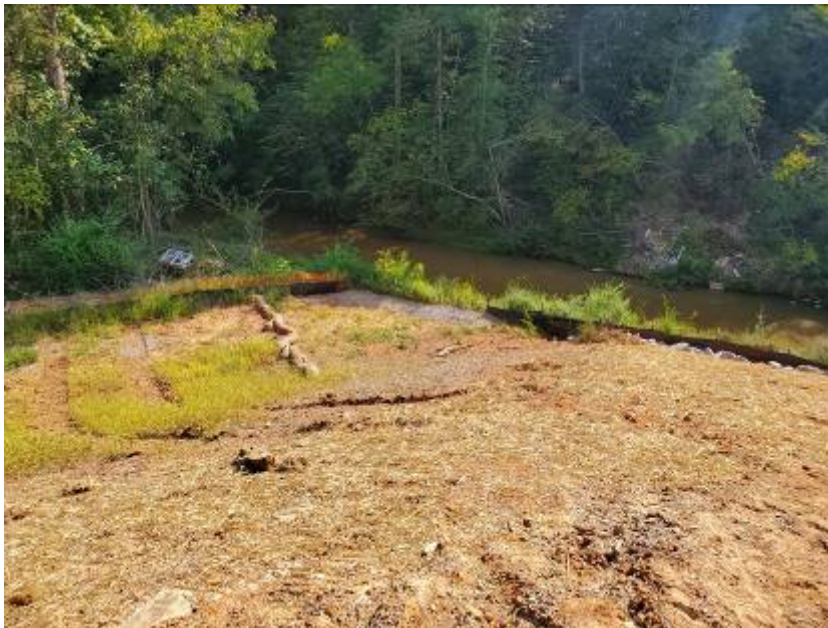
Photo - Slope above outlet in need for more straw and seeding. (9/12/19)

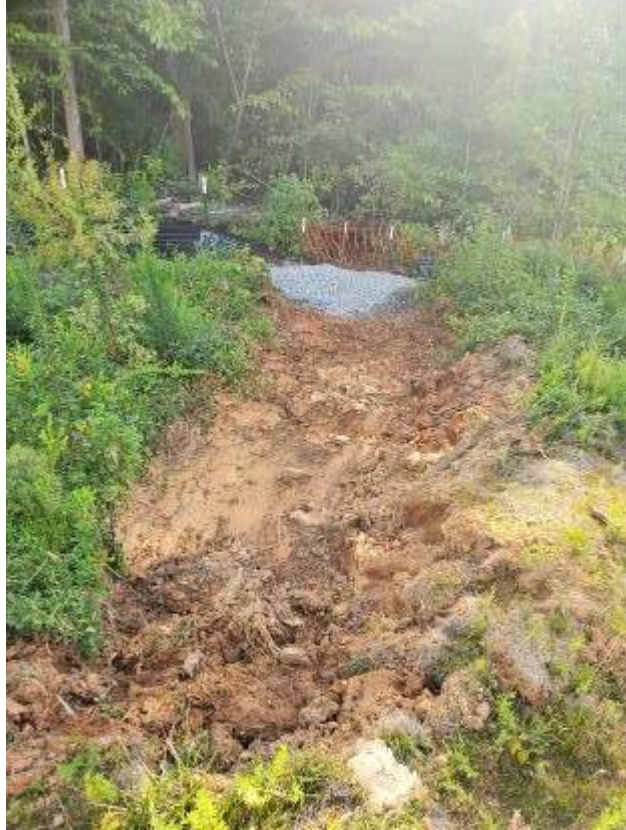
Photo - Unprotected soil between skimmer basin outlet and silt fence outlet. (8/7/2019)

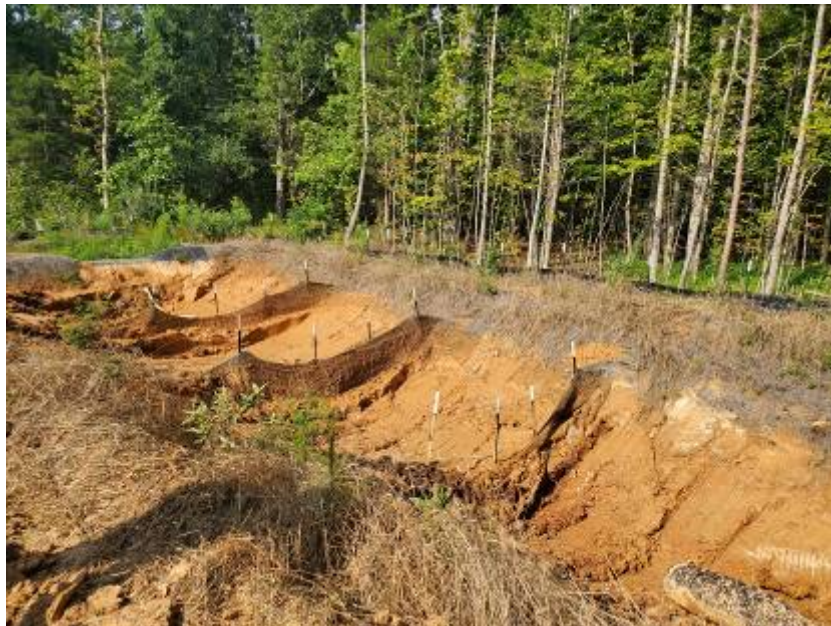
Photo - Recently mucked basin in need for baffles to be replaced. (8/7/2019)

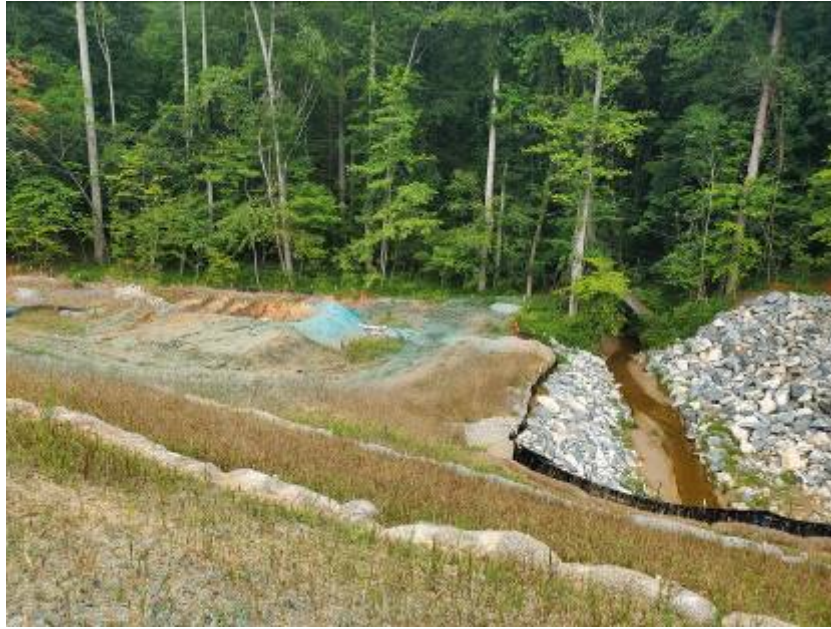
Photo - Skimmer basin outlet to well protected creek. (8/7/2019)

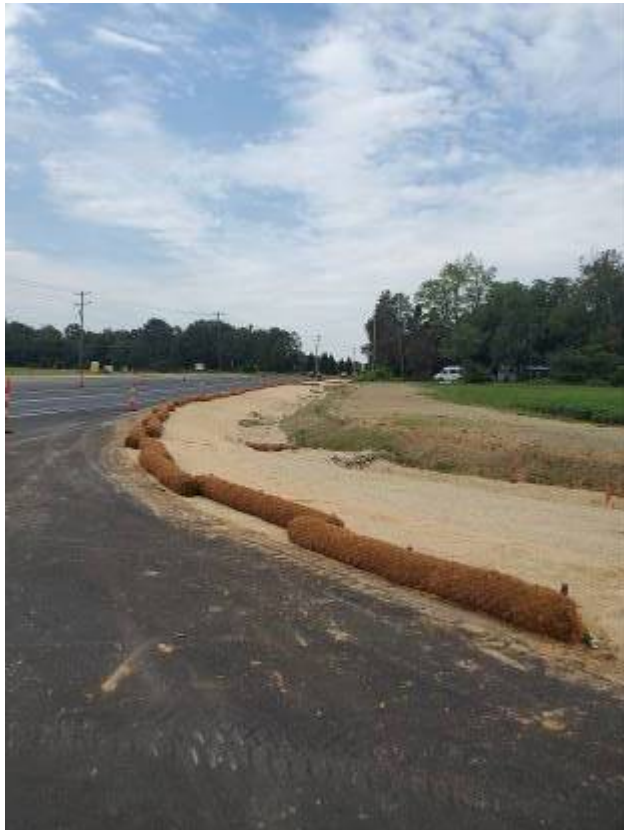
Photo - Good groundcover along roadside. (8/7/2019)

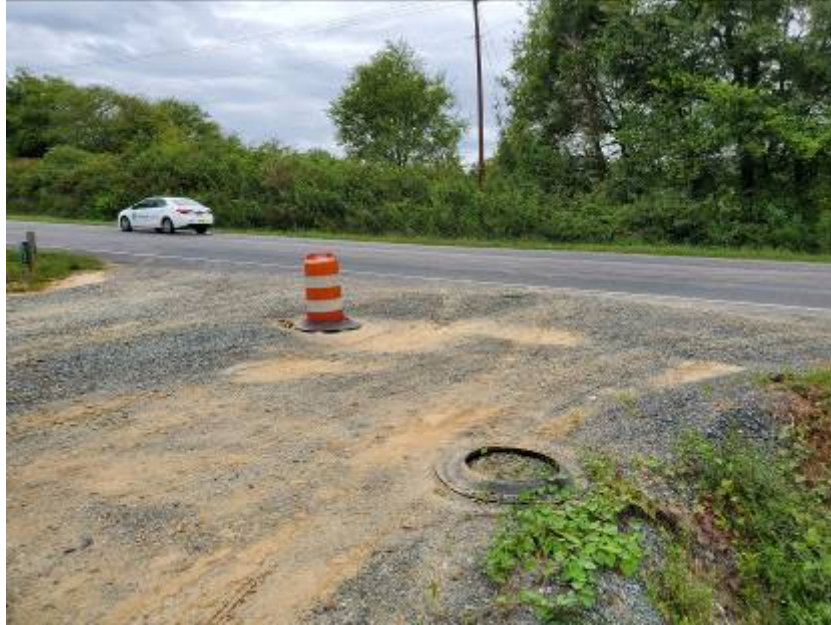
Photo - Construction entrance needs to be freshened up. (9/5/2019)

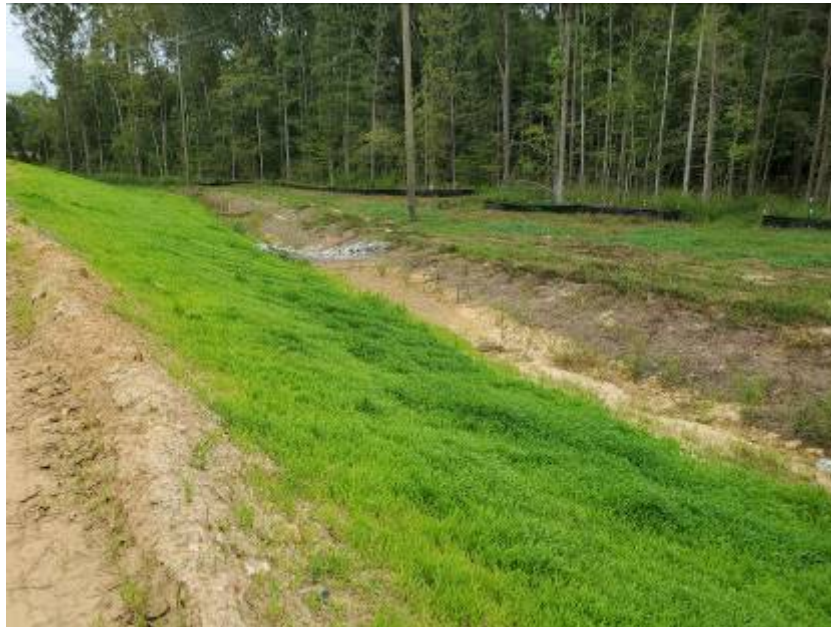
Photo - Well maintained diversion ditch and good slope stabilization. (9/5/2019)

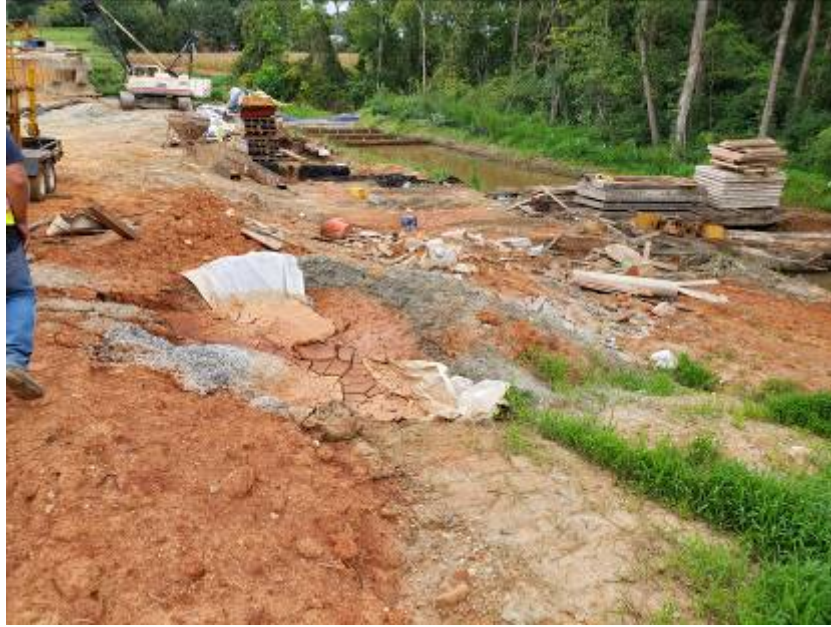
Photo - Construction debris and unmaintained concrete washout. (9/5/2019)

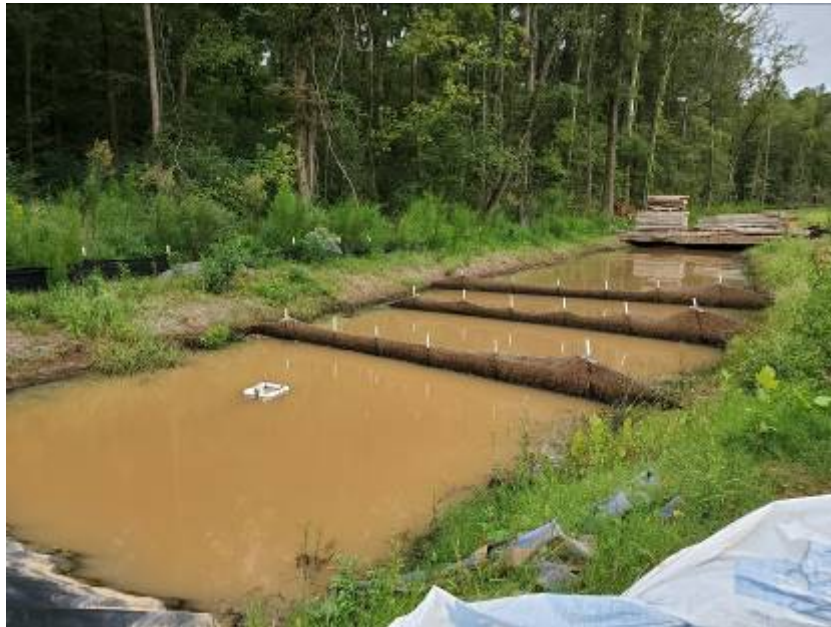
Photo - Well maintained skimmer basin. (9/5/2019)

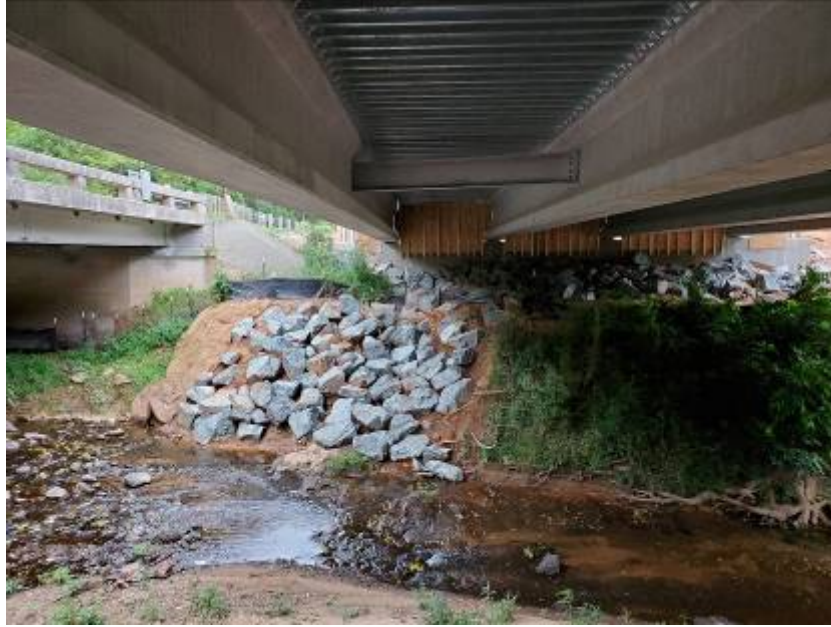
Photo - Slope failure temporarily stabilized with rock. (9/5/2019)

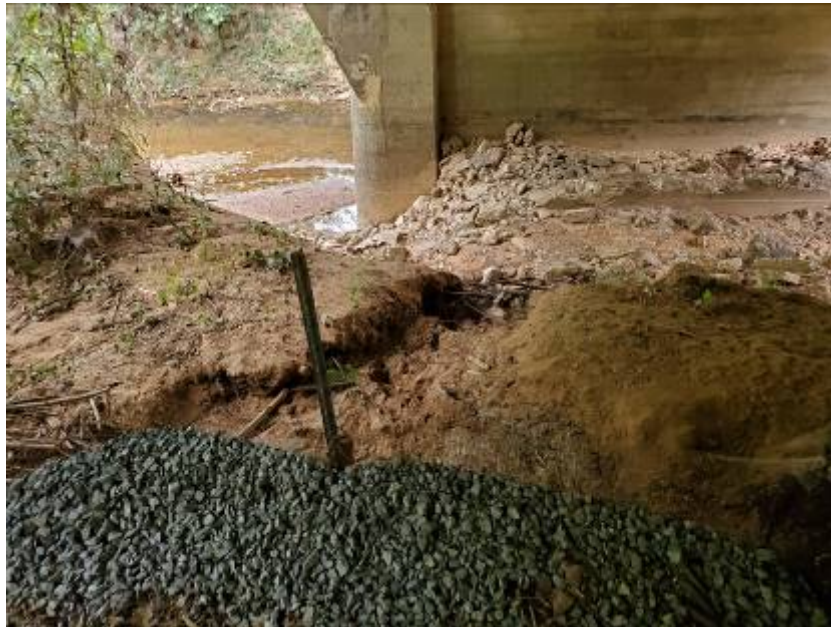
Photo - Gully erosion beyond silt fence outlet. (9/5/2019)

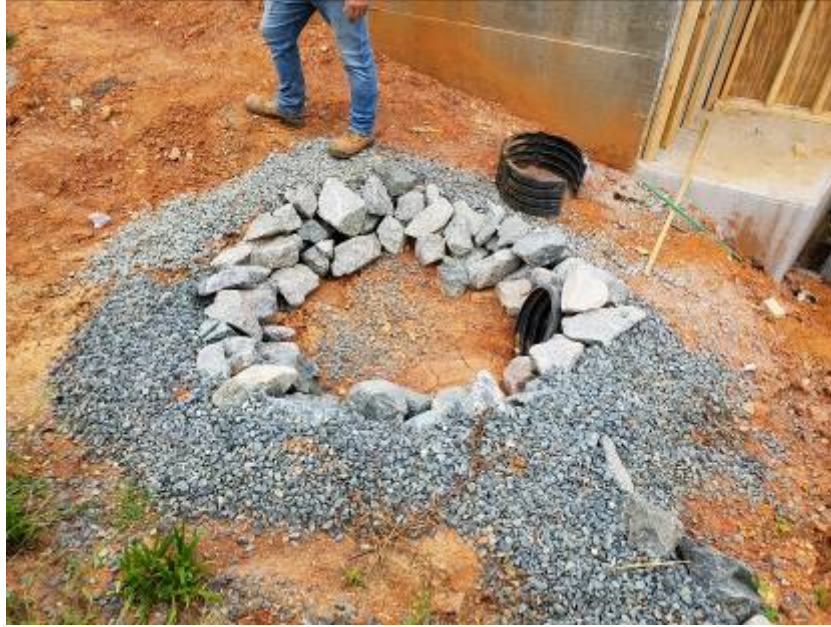
Photo - Slope drain protection. (9/5/2019)

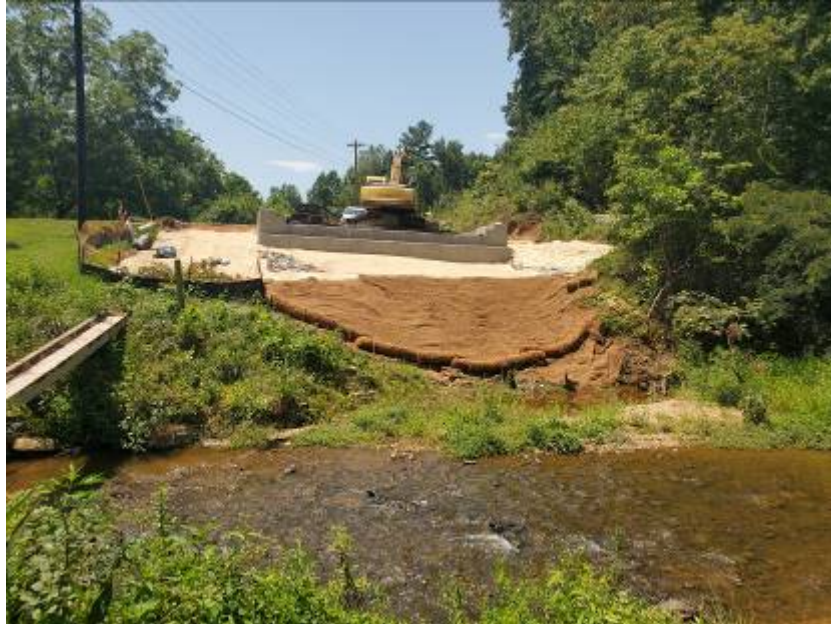
Photo - Slope protected with matting. (8/7/2019)

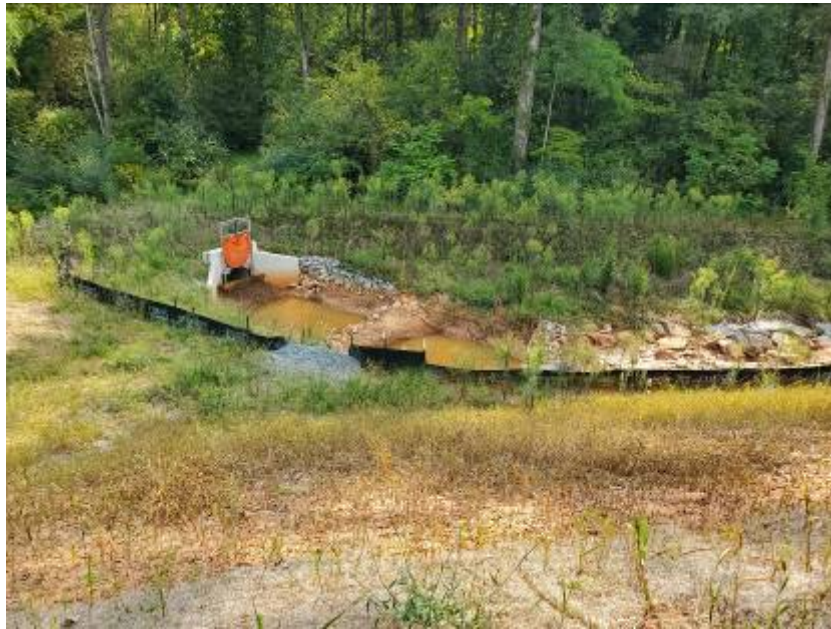
Photo - Well maintained diversion channel and forebay. (9/18/19)

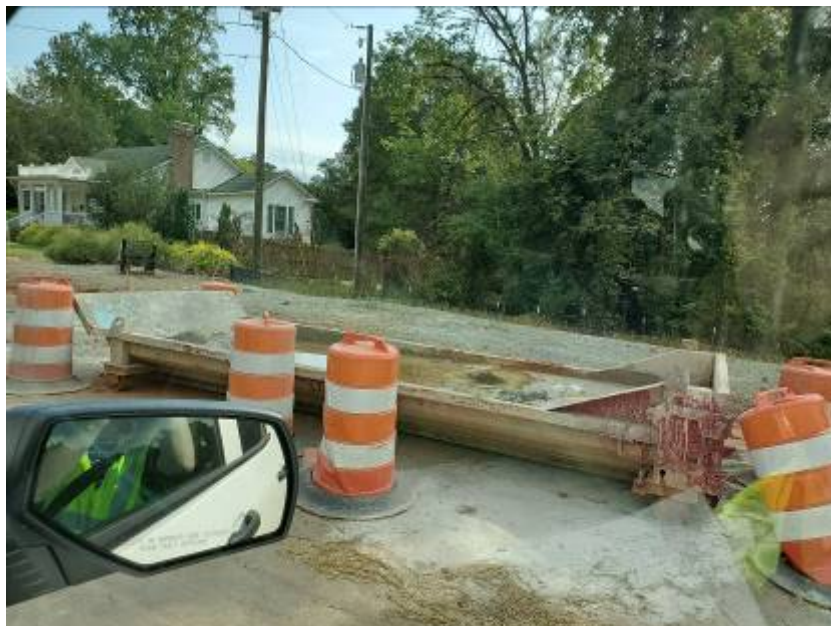
Photo - Concrete washout with no secondary containment. (9/18/19)

Any project involving concrete (including those with sidewalks or curb and gutter) should have a designated concrete washout, and a detail(s) provided for its construction/maintenance. Concrete washouts (and earthen material stockpiles) should be located at least 50 feet from storm drains and streams unless no reasonable alternatives are available. Improvement in the installation of concrete washouts onsite was noted throughout this year's review. However, DOT contractors need to be reminded to use the washouts; there were several instances of improperly installed, maintained, or improperly used concrete washout pits during this review. Similarly, we observed multiple occurrences of improper fuel tank storage on site and a lack of secondary containment.

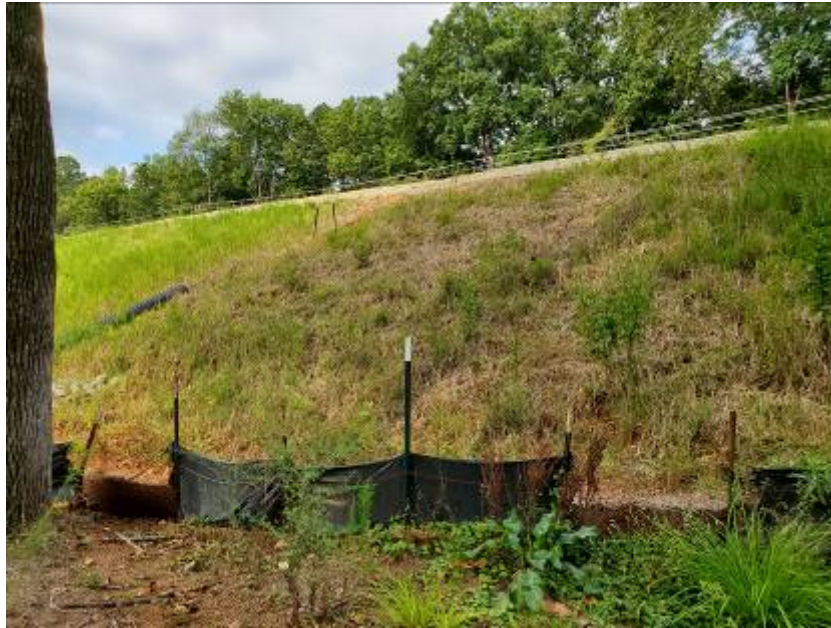
Photo - Good groundcover on slope. (9/18/19)

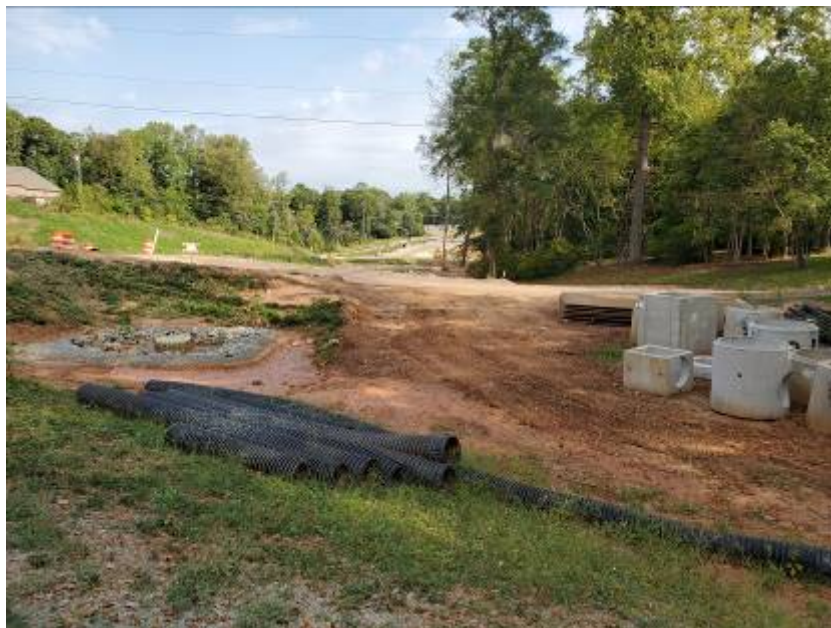
where mud and dirt were being tracked into the roads from the disturbed area. DOT was advised to install a new/repair existing construction entrances at these locations. There was also no liner being used in the concrete washout on site. No off-site sedimentation was observed during our inspection.

Photo - Construction entrance needed. (9/18/19)
