*Review of  
Erosion and Sedimentation Program  
Delegation to the North Carolina Department  
of Transportation, Division of Highways*

*November 4, 2019*

*North Carolina Department of Environmental Quality  
Division of Energy, Mineral, and Land Resources  
Land Quality Section*

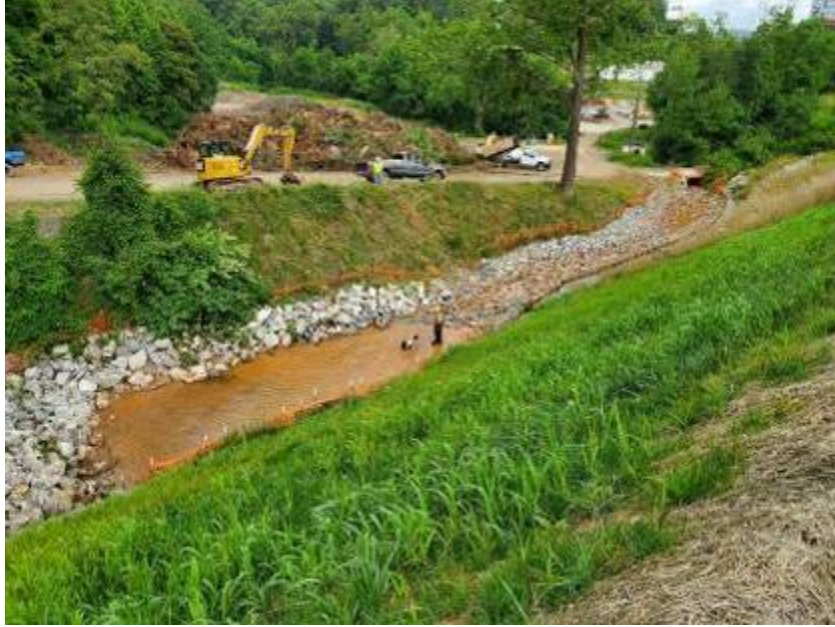
Photo - Pumping offsite sedimentation out of creek. (6/25/2019)

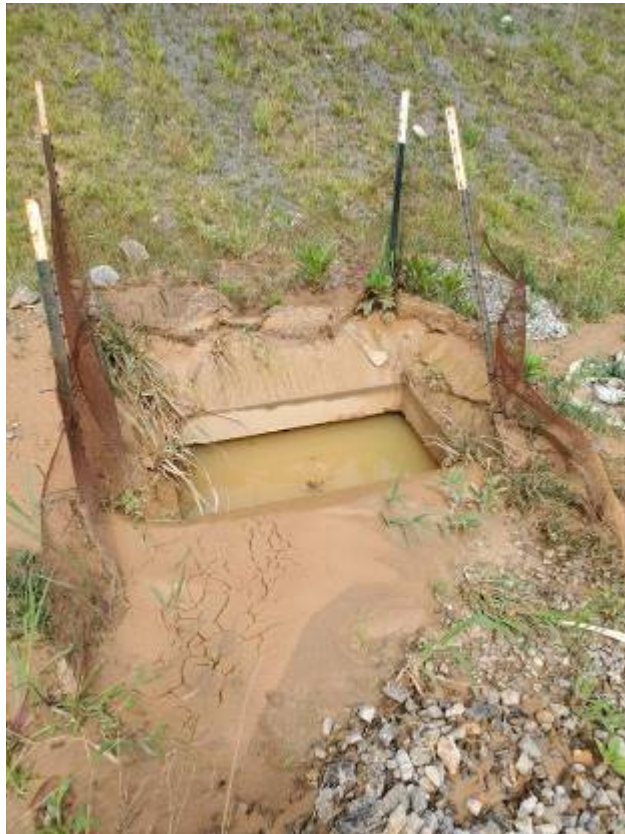
Photo - Unmaintained inlet protection full of sediment and water. (6/25/2019)

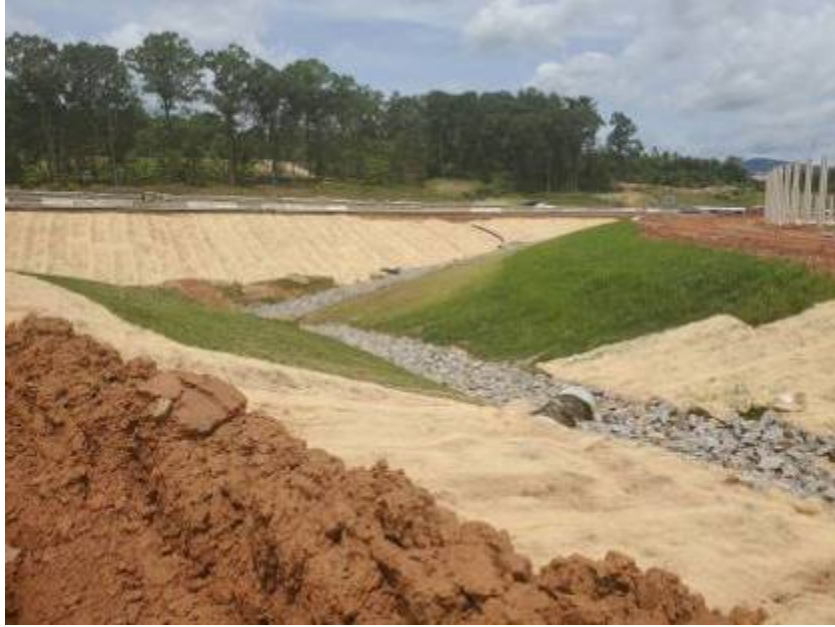
Photo - Good stabilization on slopes and well-maintained channel. (6/25/2019)

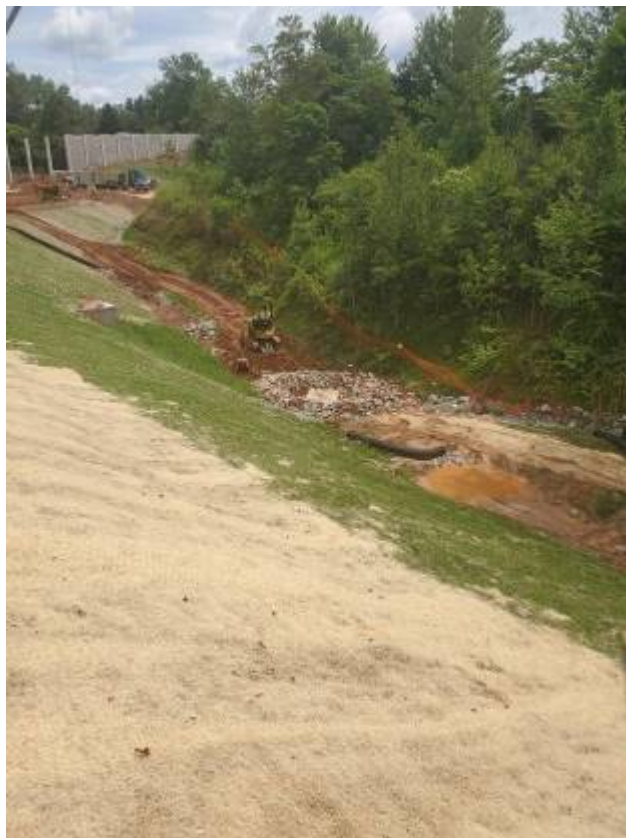
Photo - Increasing control measures. (6/25/2019)

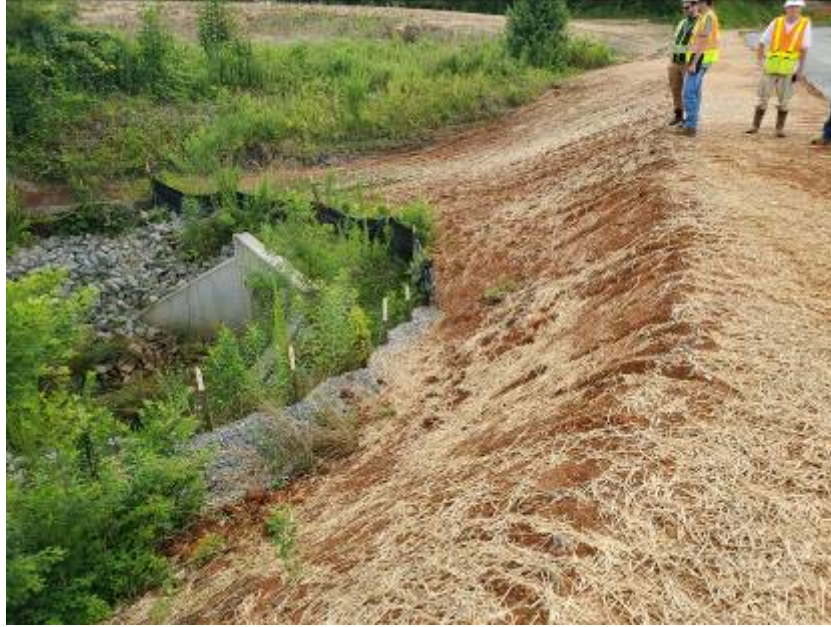
Photo - Slope above permitted creek needing more groundcover. (6/25/2019)

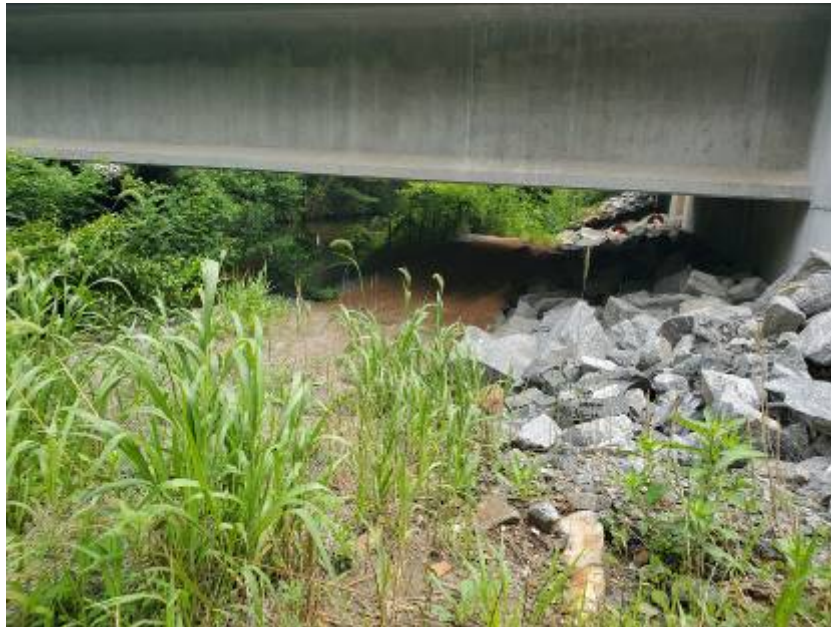
Photo - Well maintained measures underneath new bridge. (6/25/2019)

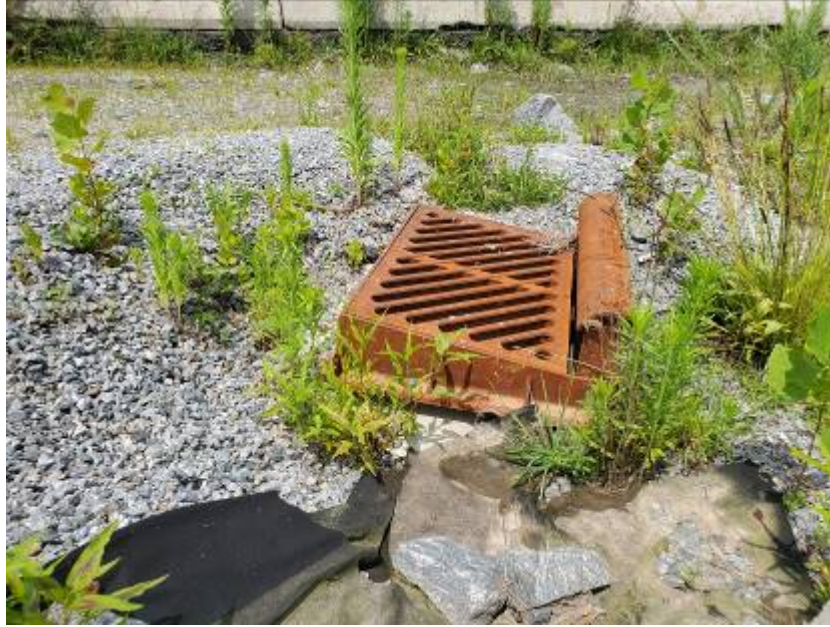
Photo - Poorly protected inlet. (6/25/2019)
