LEITNER

12/4/20
NC DEQ
Attention: Kenny Llywelyn
Mooresville Regional Office
610 East Center Ave., Suite 301
Mooresville, NC 28115

Leitner Construction received the Notice of Violations Letter via email on December 2nd, and empathically apologize for the condition of the erosion control measures that were witnessed on site and provide some explanation of the events that lead to the condition of the site.

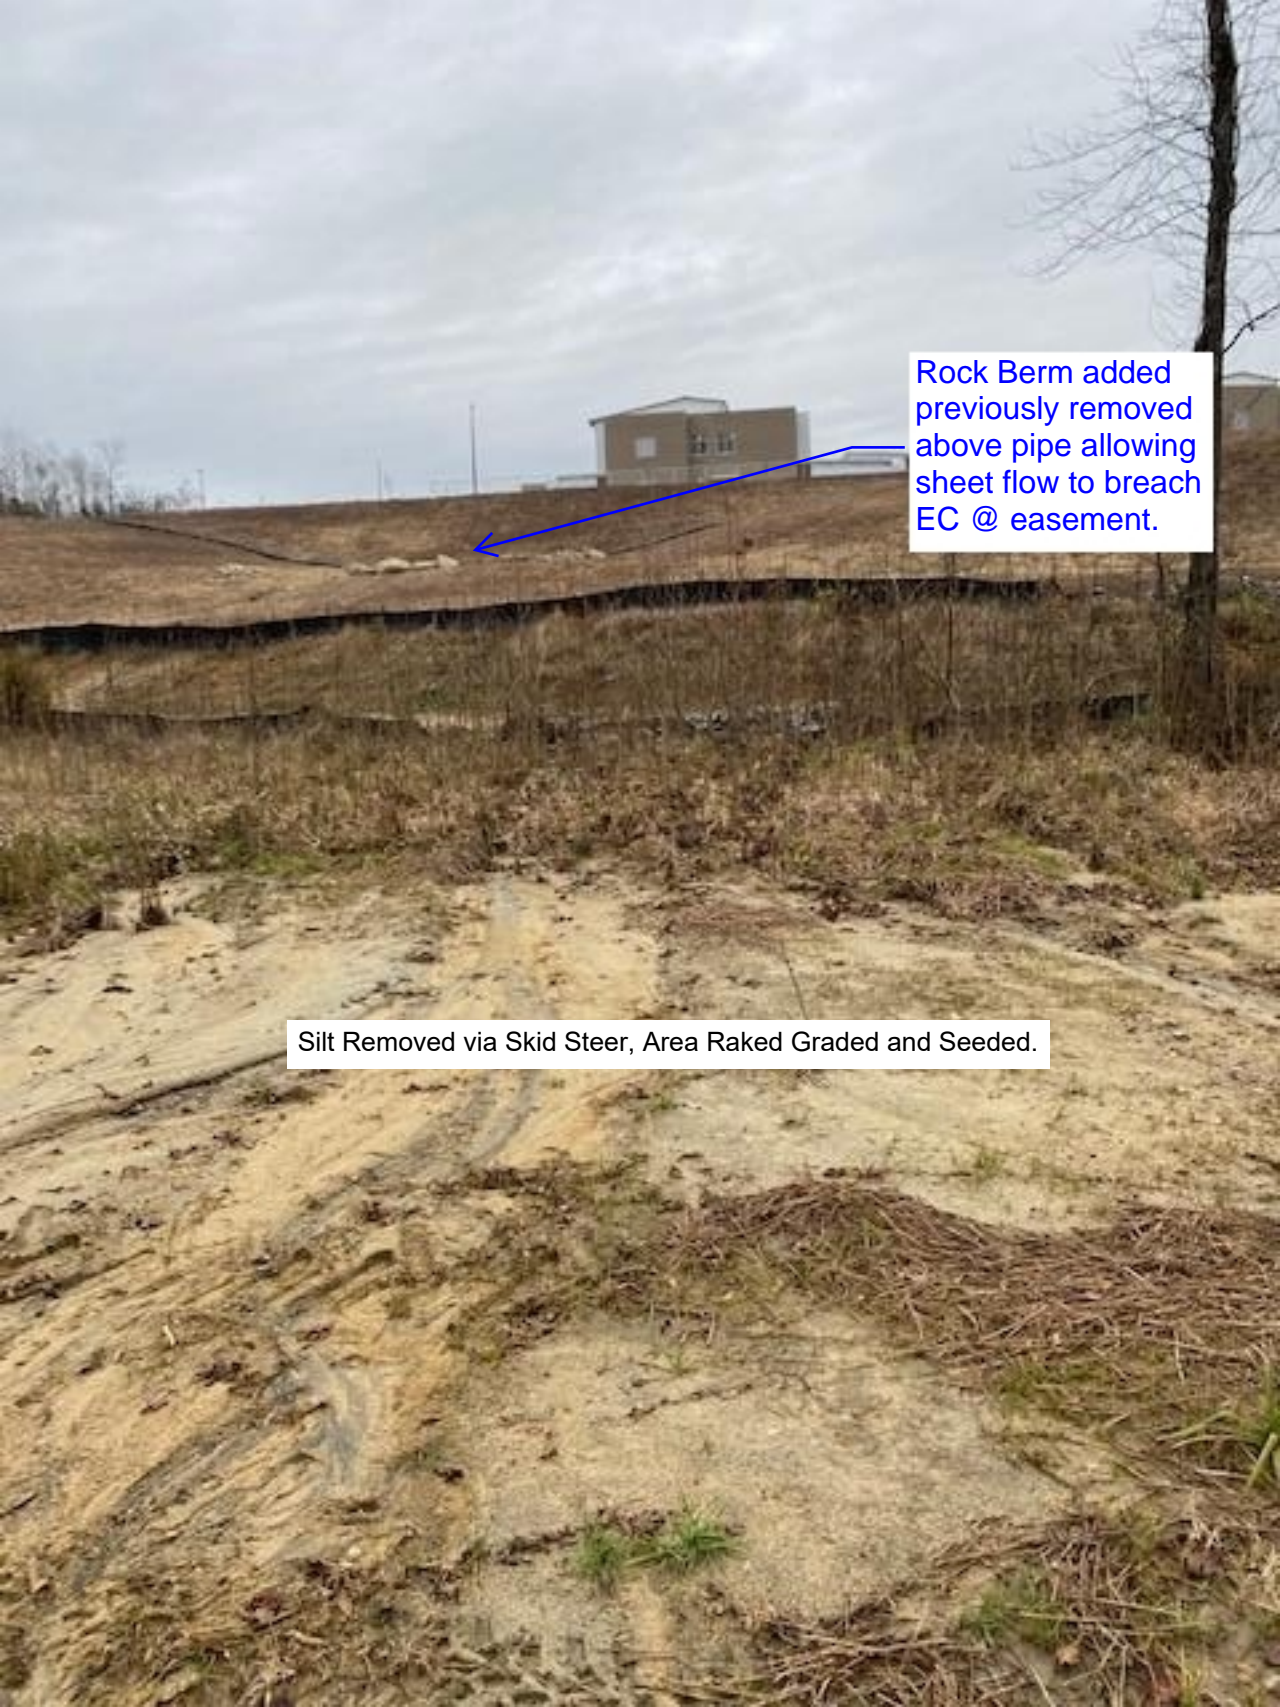
Rock Berm added previously removed above pipe allowing sheet flow to breach EC @ easement.

Silt Removed via Skid Steer, Area Raked Graded and Seeded.

Add Rock Berm
and/or Silt Fence
prior to easement

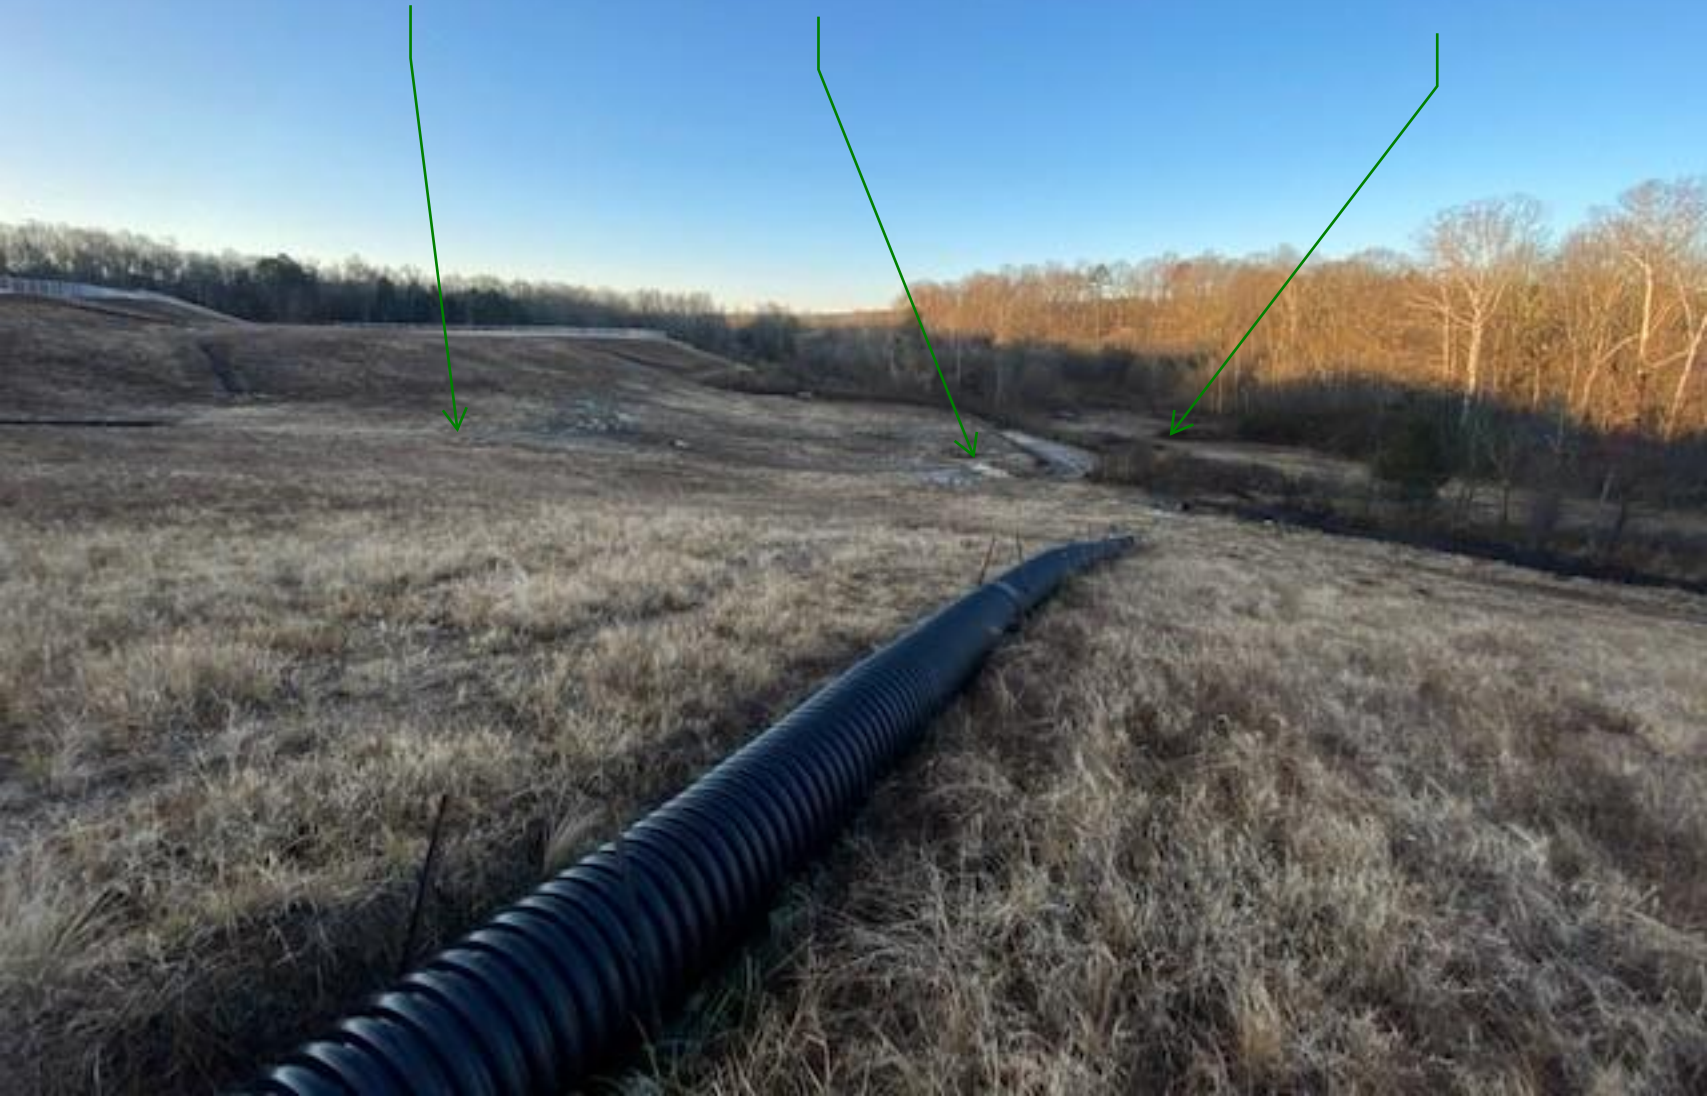
Berm moved per
Harrisburg, regraded
area

Relocated some
stone, re graded to
drain

Cleaned Silt Breach,
Seed and Straw

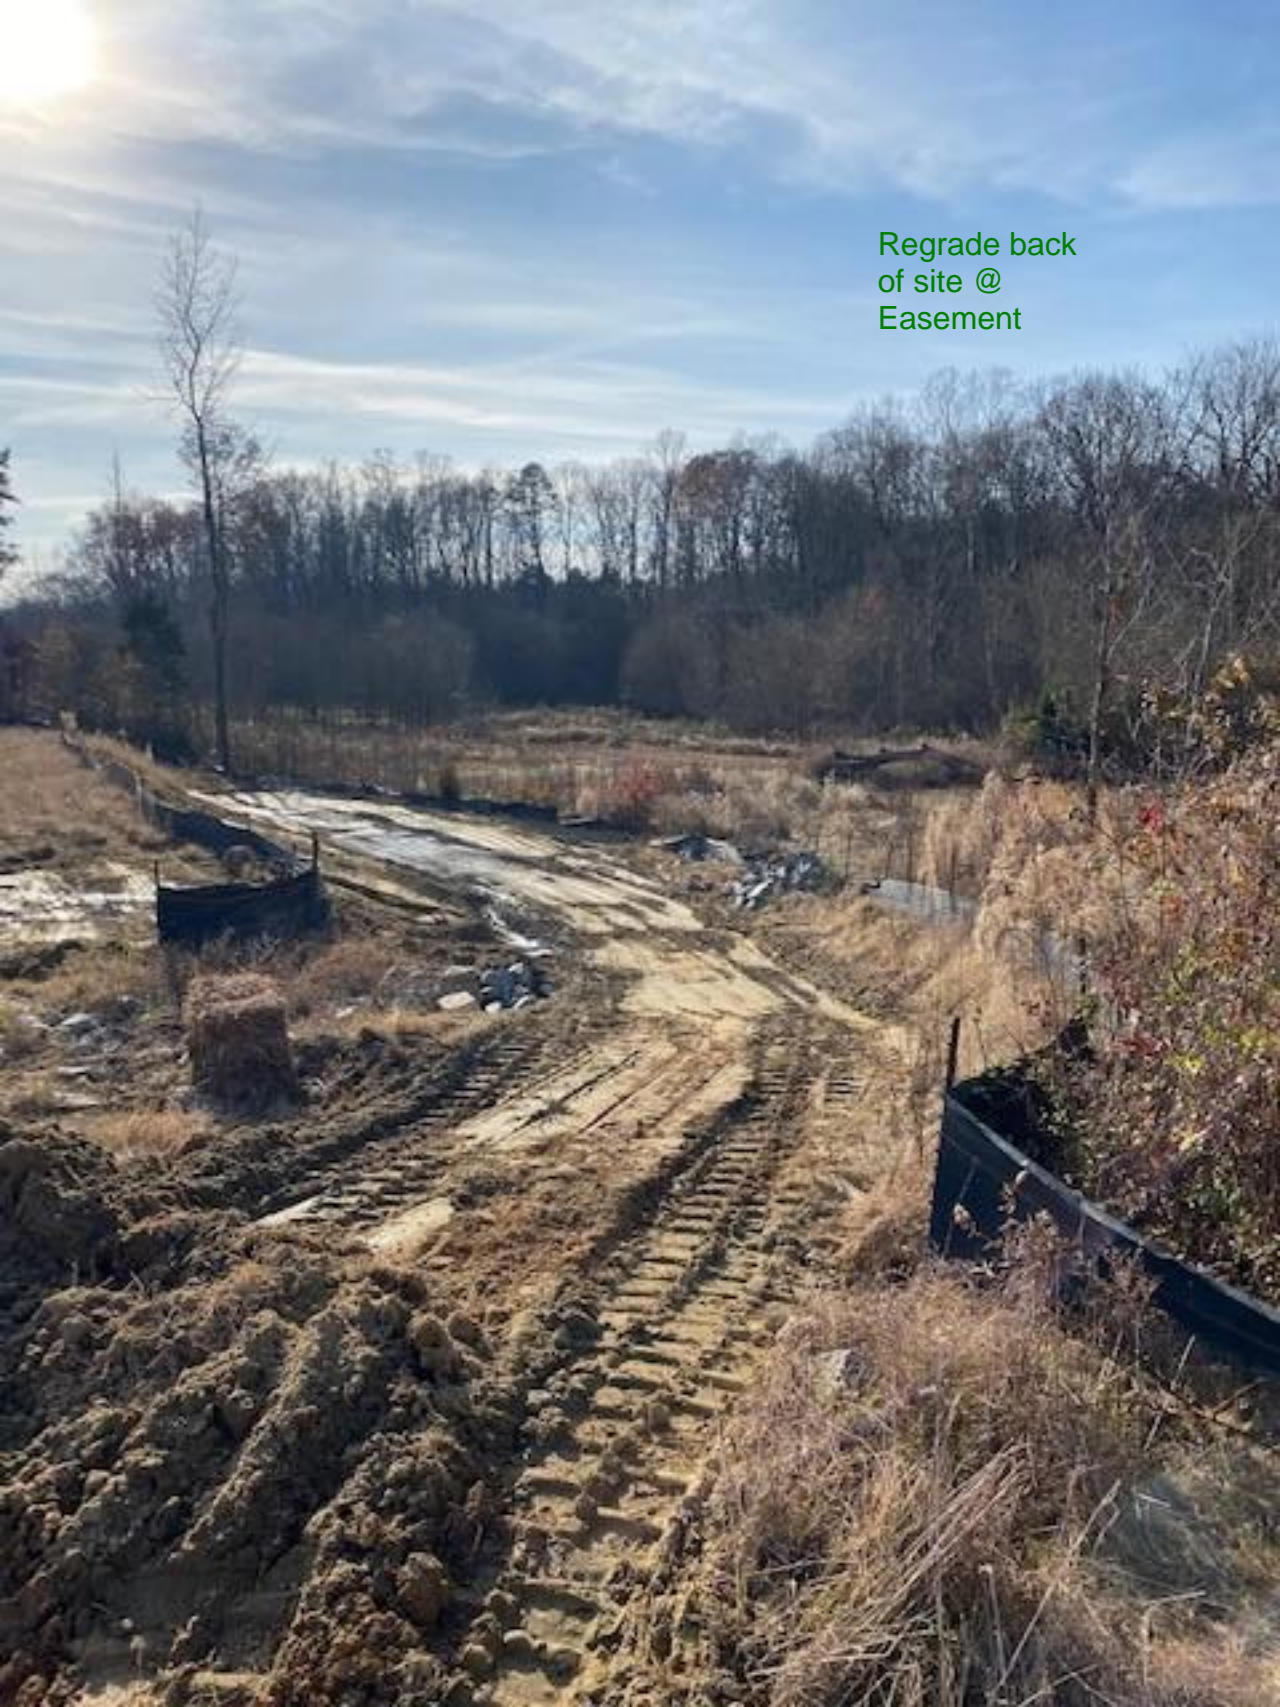
Regrade back
of site @
Easement

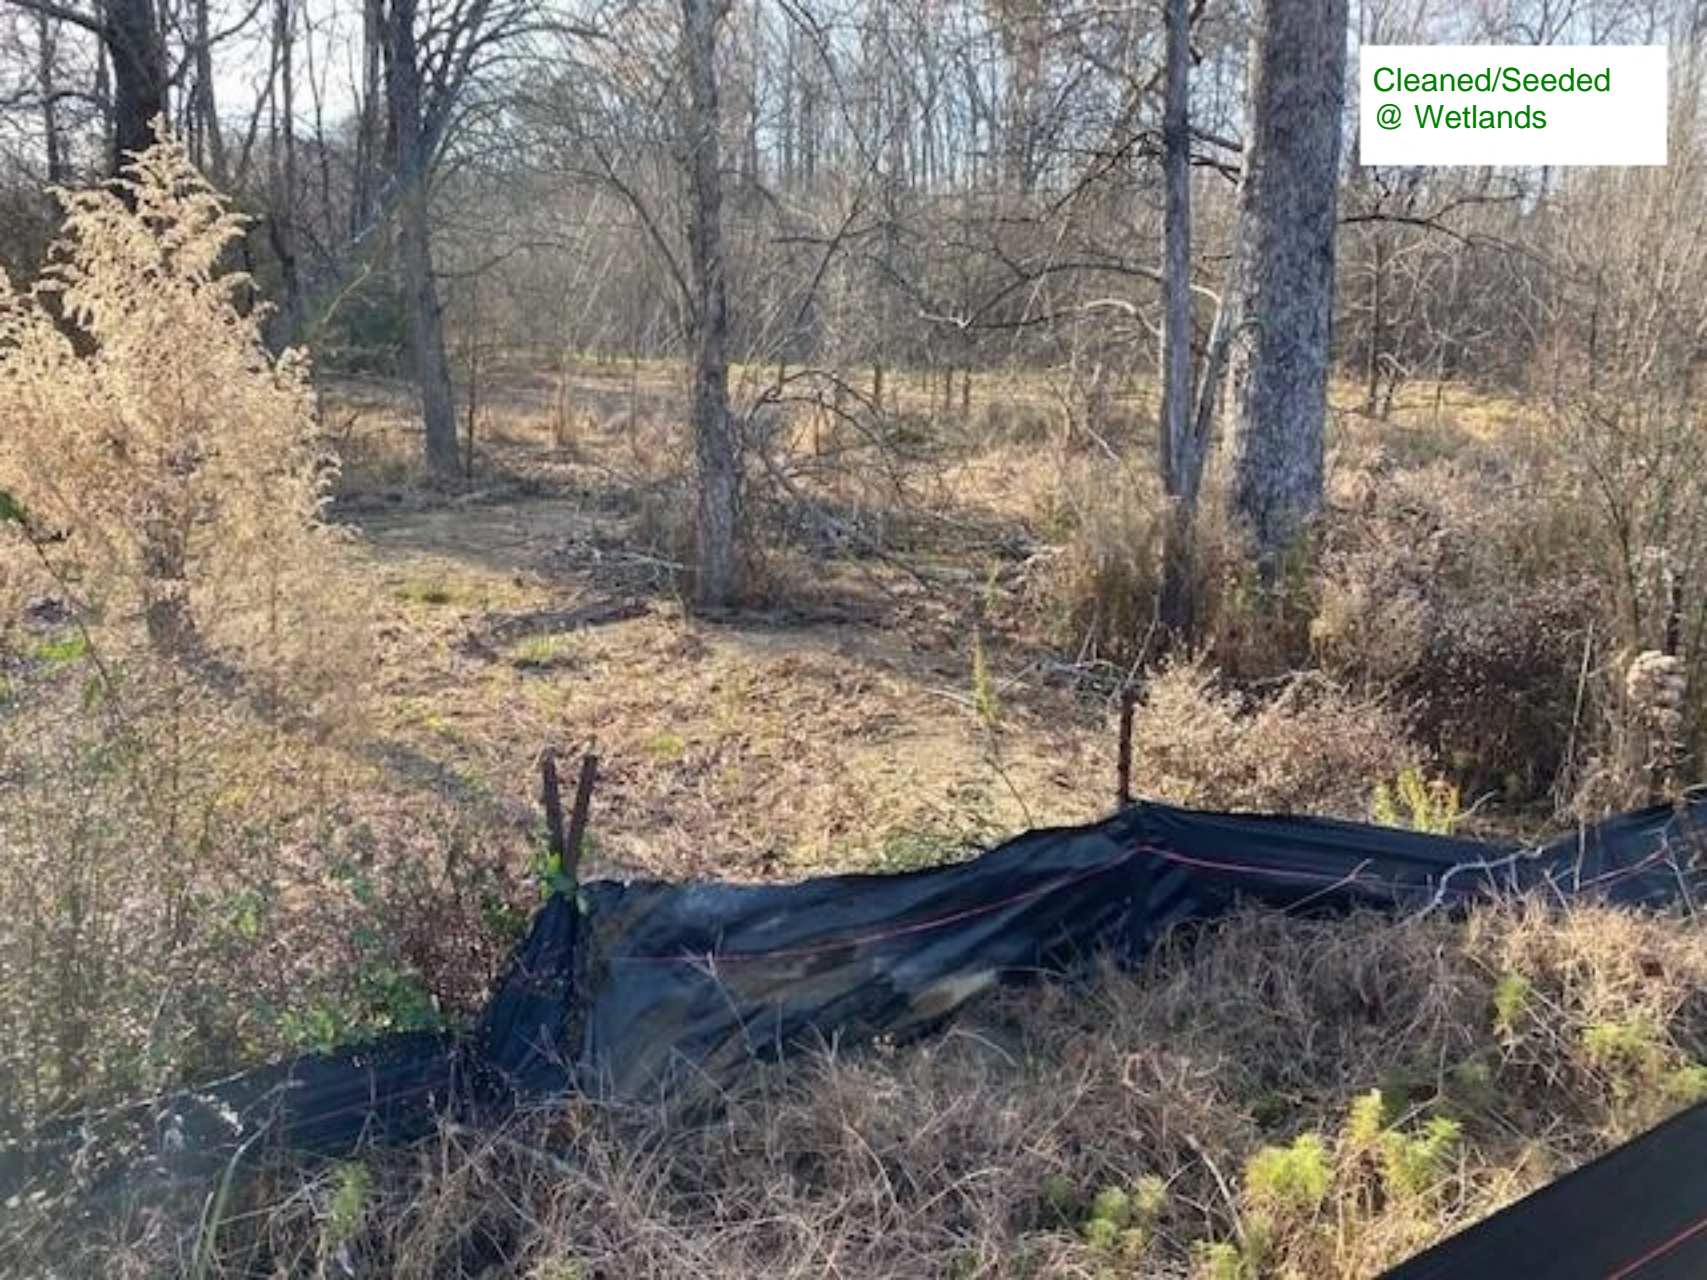
Cleaned/Seeded
@ Wetlands

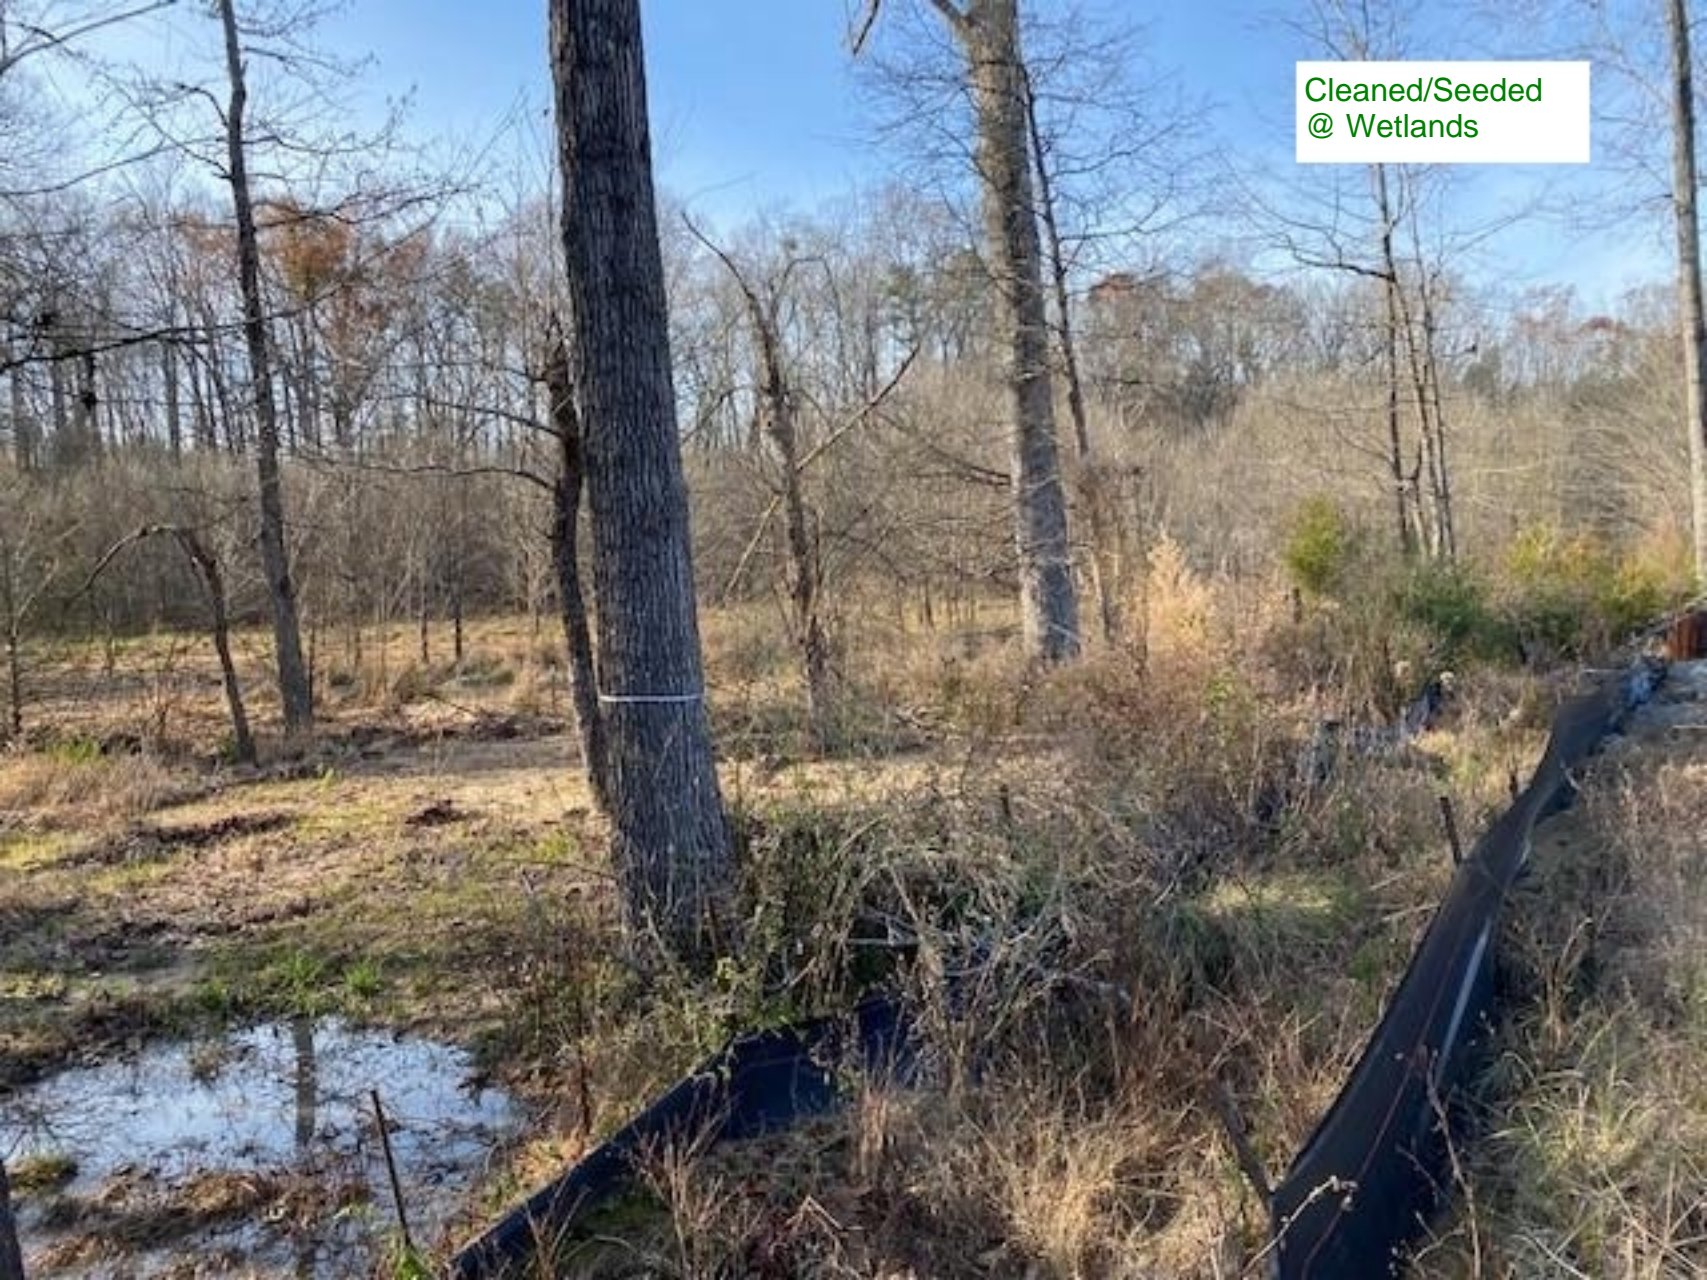
Cleaned/Seeded
@ Wetlands

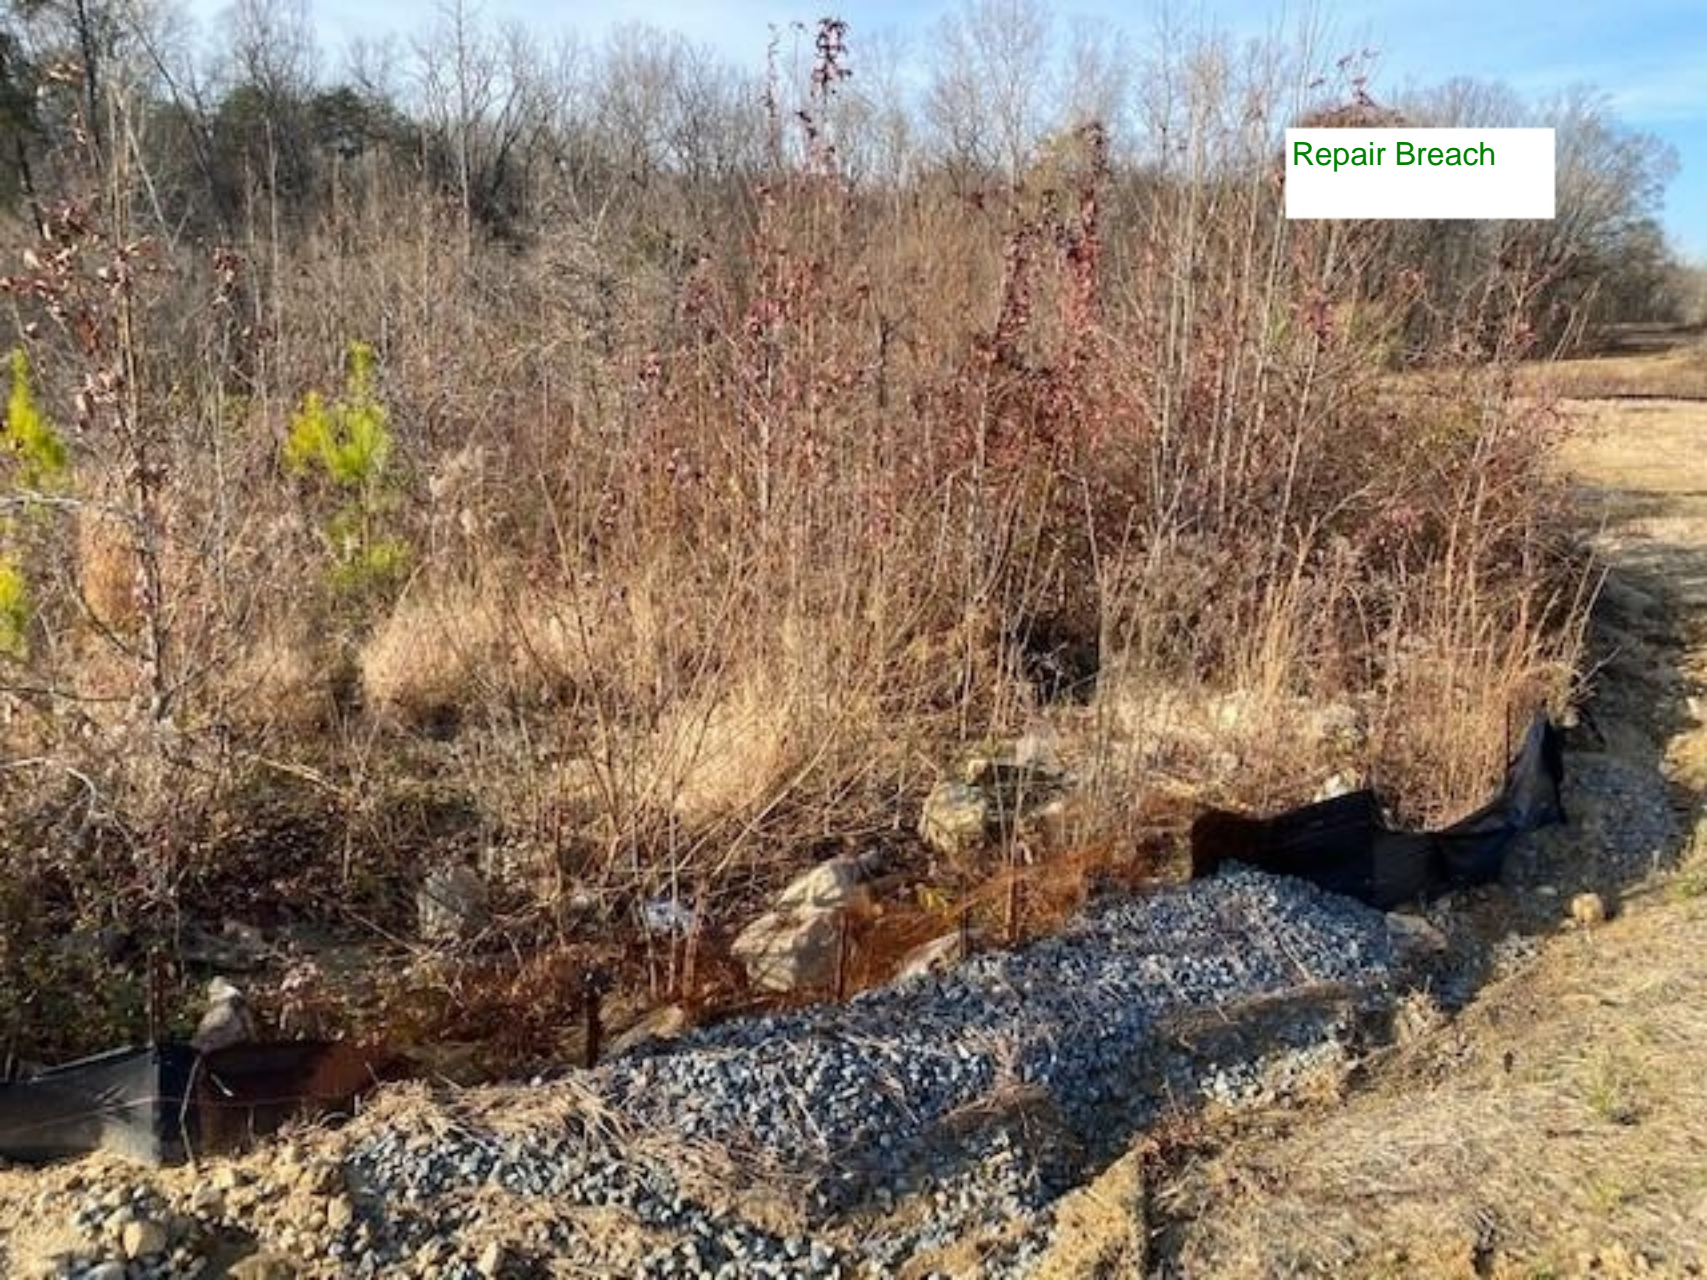
Repair Breach

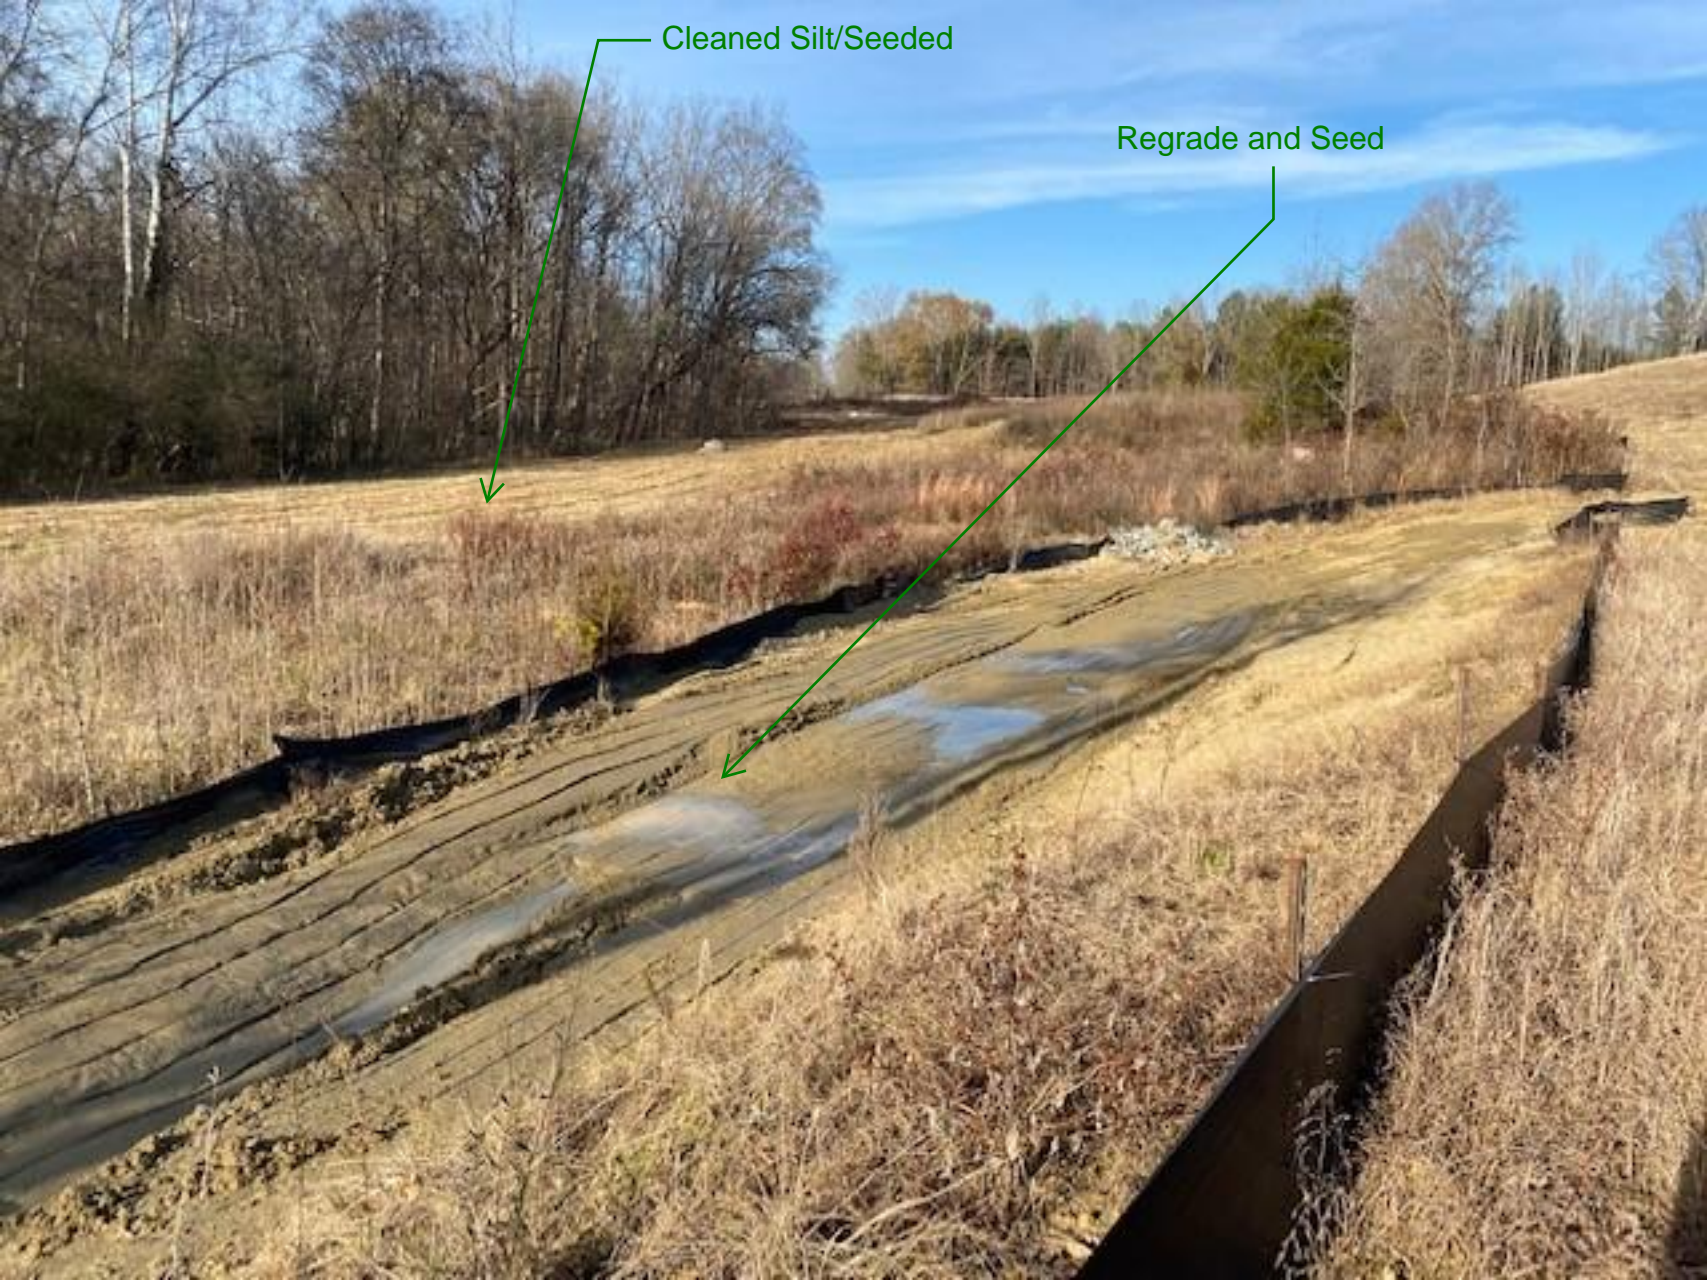
Cleaned Silt/Seeded

Regrade and Seed

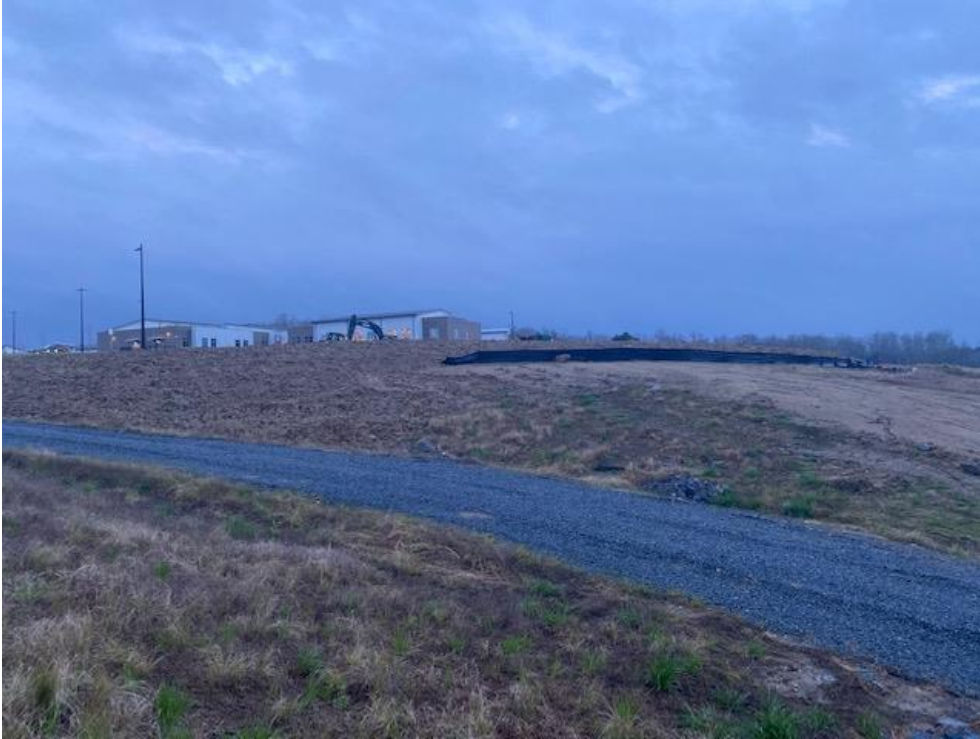
Sediment Stockpile Grading

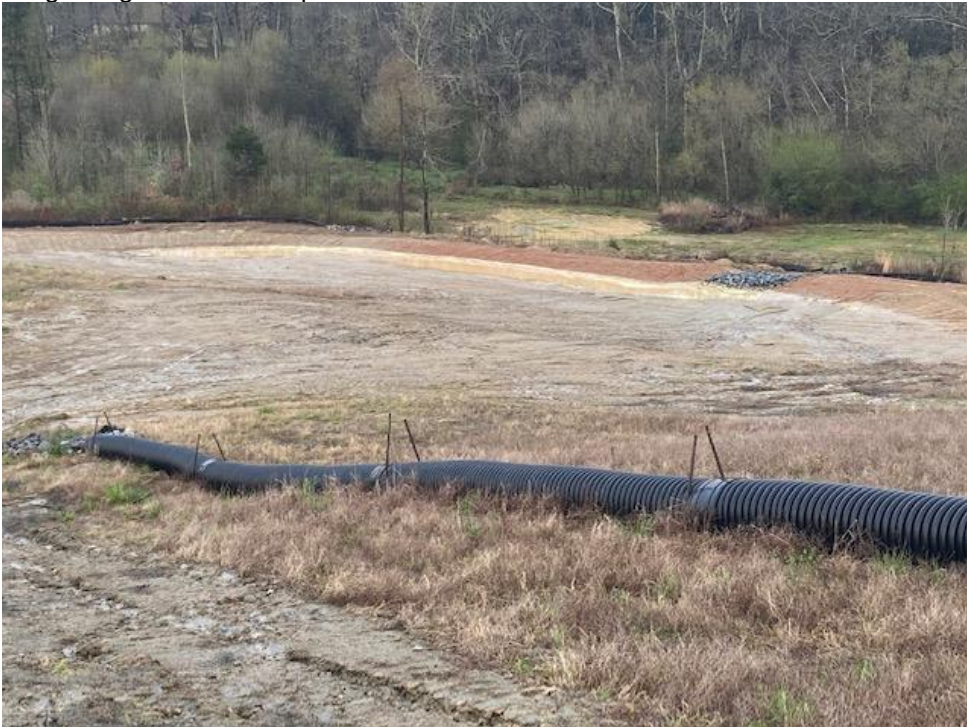
Re-grading Bottom of Slope

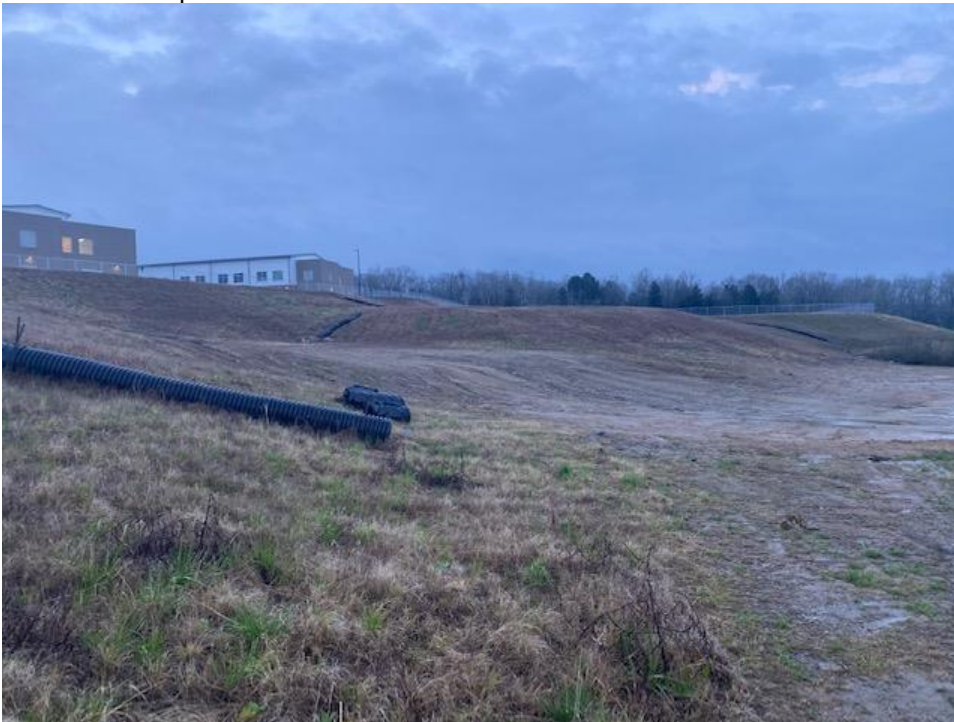
Re-Graded Slope

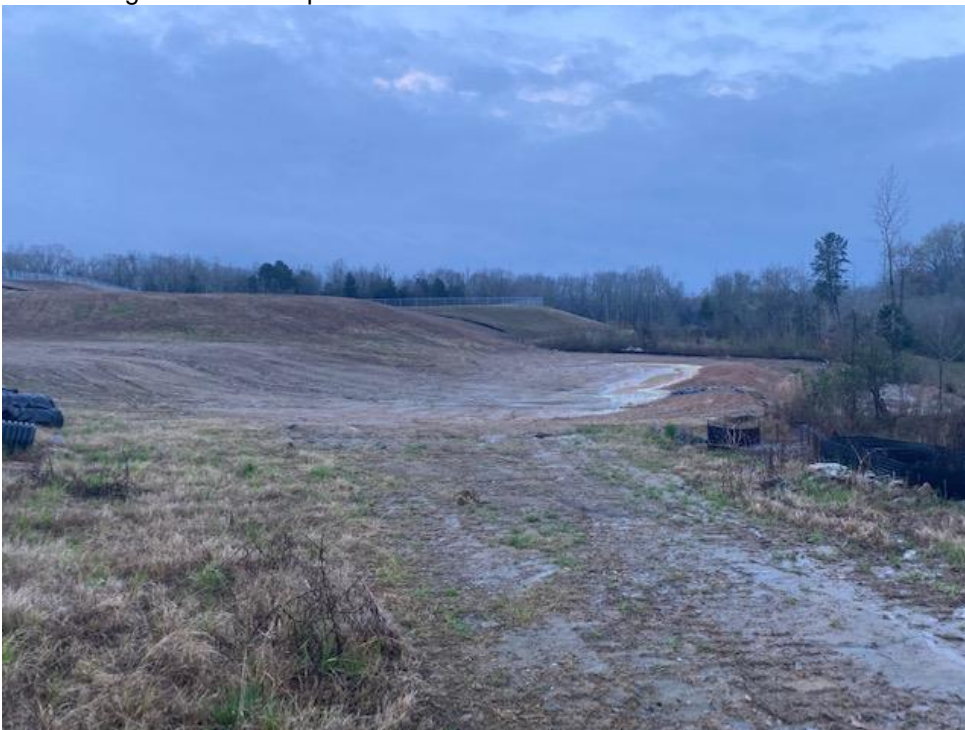
Re-Grading Bottom of Slope

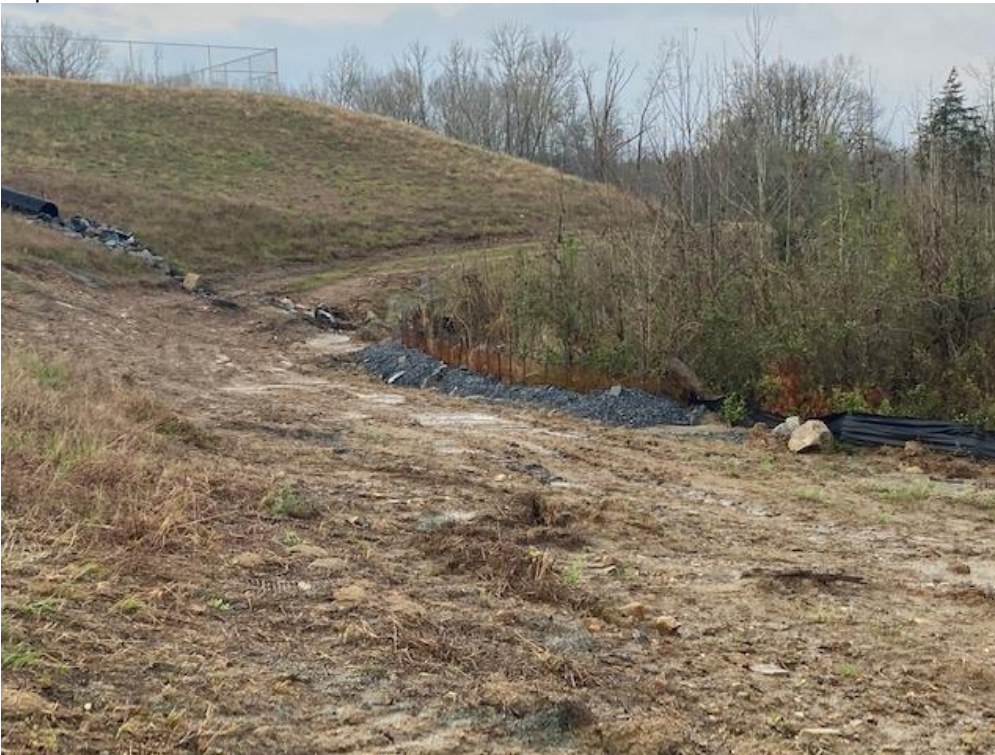
Repaired Stone Outfall

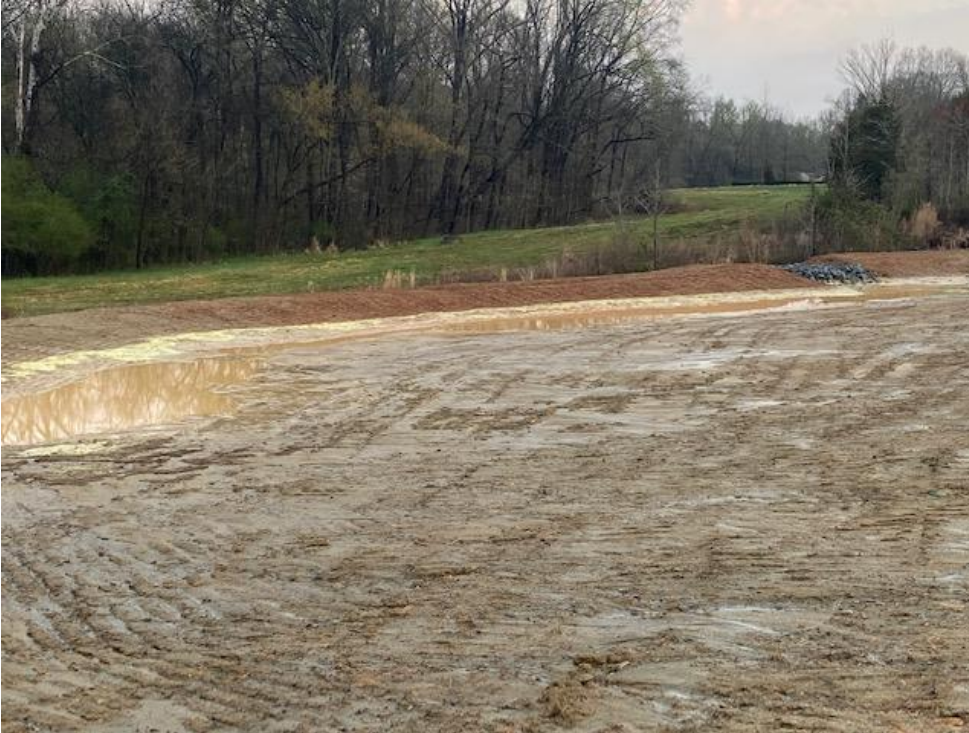
Re-Graded Bottom of Slope

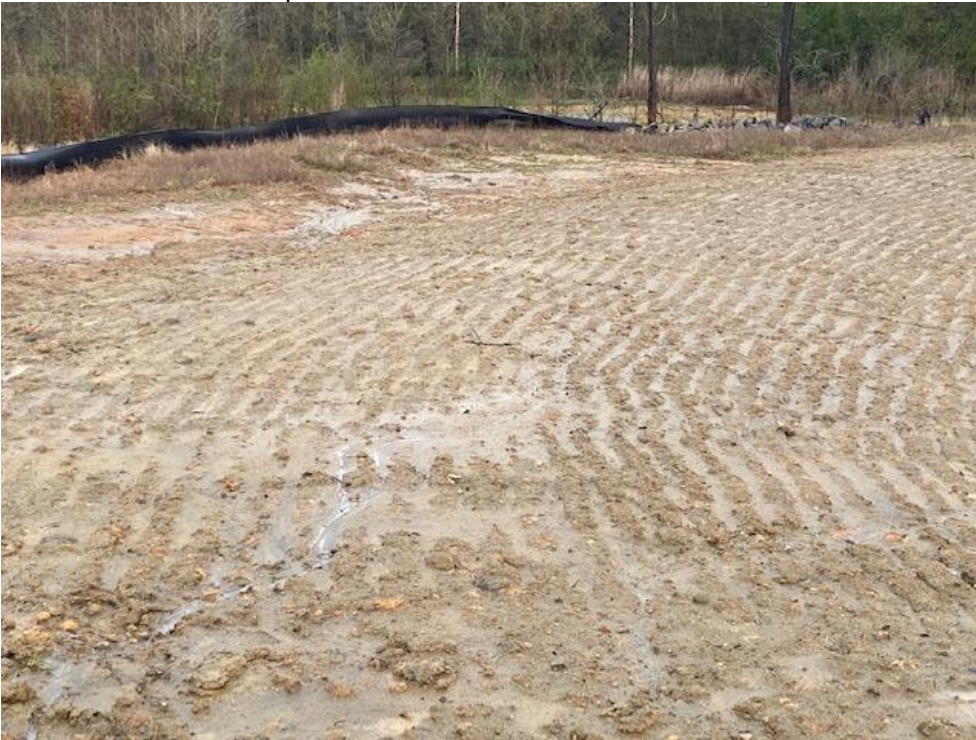
Re-Grade Bottom of Slope

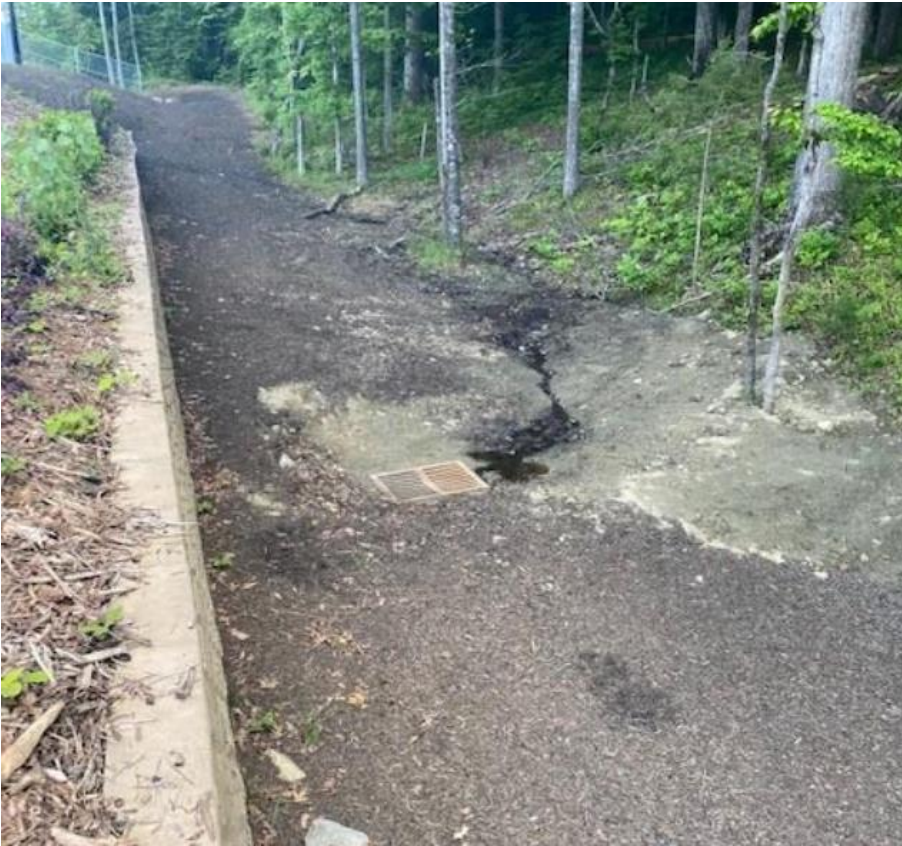
Lowered Basin

- Drop inlet below retaining wall was lowered to allow small groundwater spring to drain to the basin, pipe and outlet provided.
- Approximately 25% ground coverage on the pond.

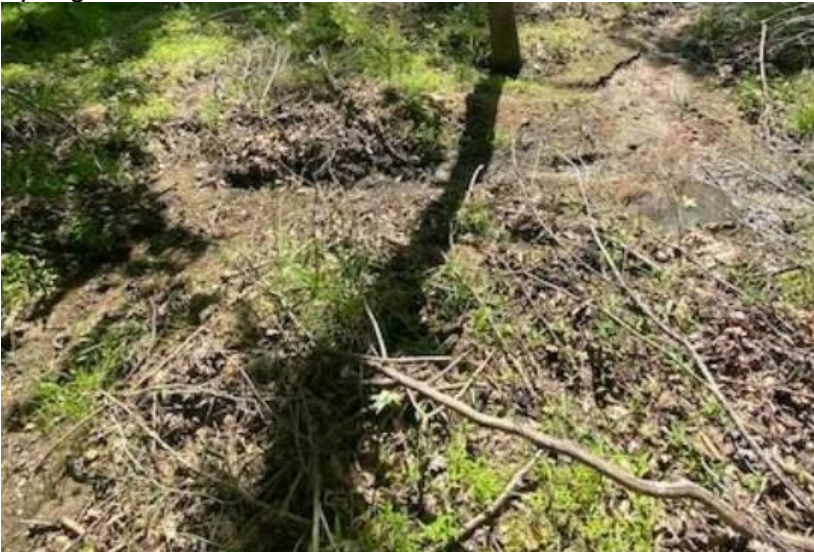
Spring Debris Removed

- Sediment and natural debris (limbs) was removed from small spring of wetlands.
- Sediment was removed and stone cleaned from the flume outlet and small spring below the modular retaining wall.

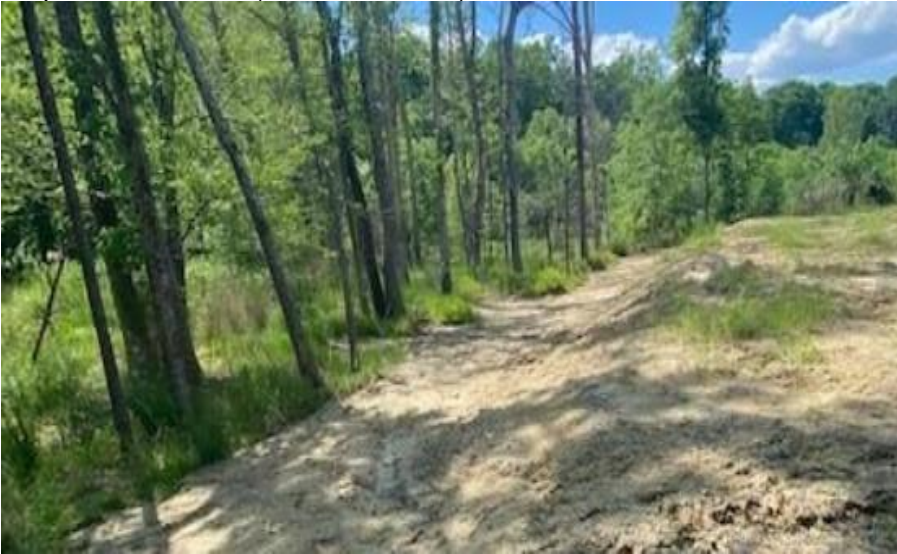
Slope @ Wetlands (To Be Mulched)

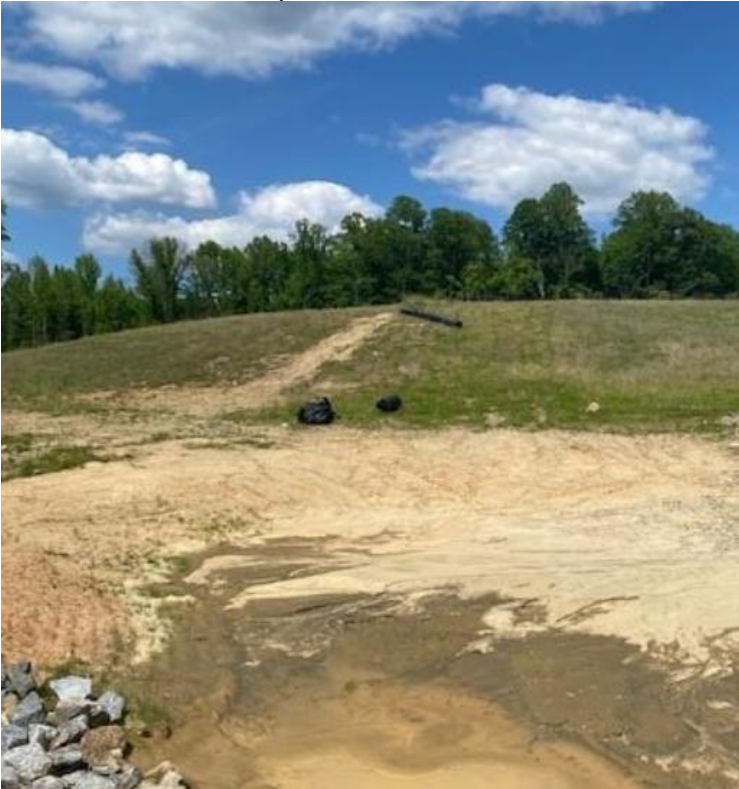
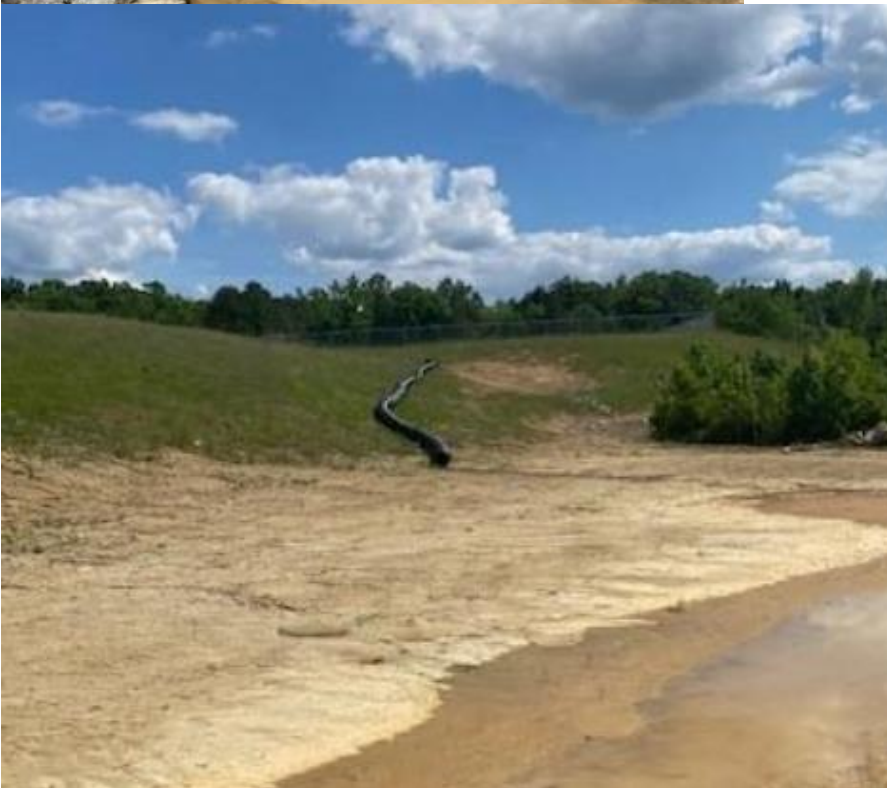
Drain Work/Scour Repair
