# MY3 FINAL MONITORING REPORT Burnetts Chapel Mitigation Site-Phase II

Guilford County, NC Randleman Lake Watershed Cape Fear River Basin HUC 03030003

DMS Project No. 100045 DMS Contract No. 7430 DMS RFP No. 16-007242 DWR Project Number 2011-0841

Monitoring Year 3 Annual Report

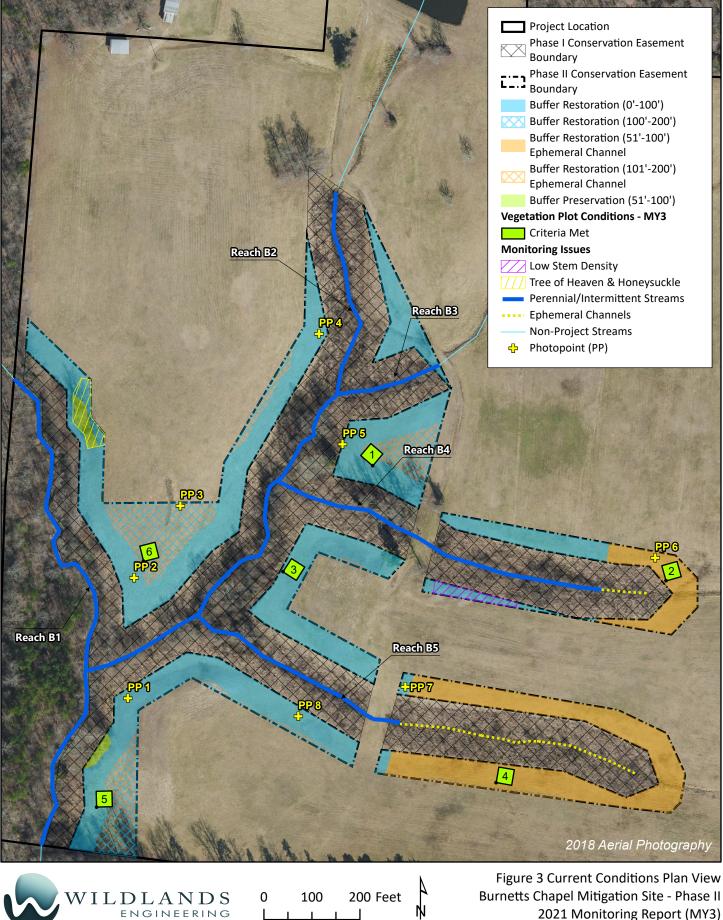
An assessment of the vegetation condition was conducted throughout the site. Similar to last year, there were no bare or encroachment areas, and only 0.2 acres of vegetative areas of concern which continue to be minimal and are not negatively affecting the overall vegetative success of the Site. These areas are outlined below, presented in Table 6, and are depicted in Figure 3 of Appendix B.

As in previous monitoring years, a small patch of tree of heaven (*Ailanthus altissima*) and Japanese honeysuckle (*Lonicera japonica*) is present within a patch of intact forest located within the easement. Several areas of Johnsongrass (*Sorghum halepense*) totaling 1.2 acres were identified within the easement but have not expanded since the previous year. Spot herbicide treatments were applied around the base of the trees in April 2021 to reduce the competition from *S. halepense* and allow the trees to grow up and shade out the grass. The Johnsongrass is not shown on the CCPV Map (Figure 3) since it is listed as a species of low/moderate concern and is not suppressing the viability, density, or growth of the planted woody stems. Invasive species populations will continue to be monitored and spot herbicide treatments will be conducted as needed during the appropriate time of year.

Planted and volunteer stems were observed in portions of the low planted stem density area along the left bank of Reach B4. This area shrunk 28% since last year to less than 0.1 acres during MY3. It is likely that this area's stem density will increase throughout the monitoring period by way of resprouts and the continued introduction of volunteer species; therefore, no additional planting is needed at this time. Wildlands will continue to monitor this area for emergence of woody species.
