YEAR 7 (2021) MONITORING REPORT

**ABBAY LAMM
STREAM AND WETLAND MITIGATION SITE**

Alamance County, North Carolina
Full Delivery Contract No. 5790
DMS Project No. 96311
NCDWR Project No. 20140336
USACE Action ID No. SAW-2014-01710

December 2021

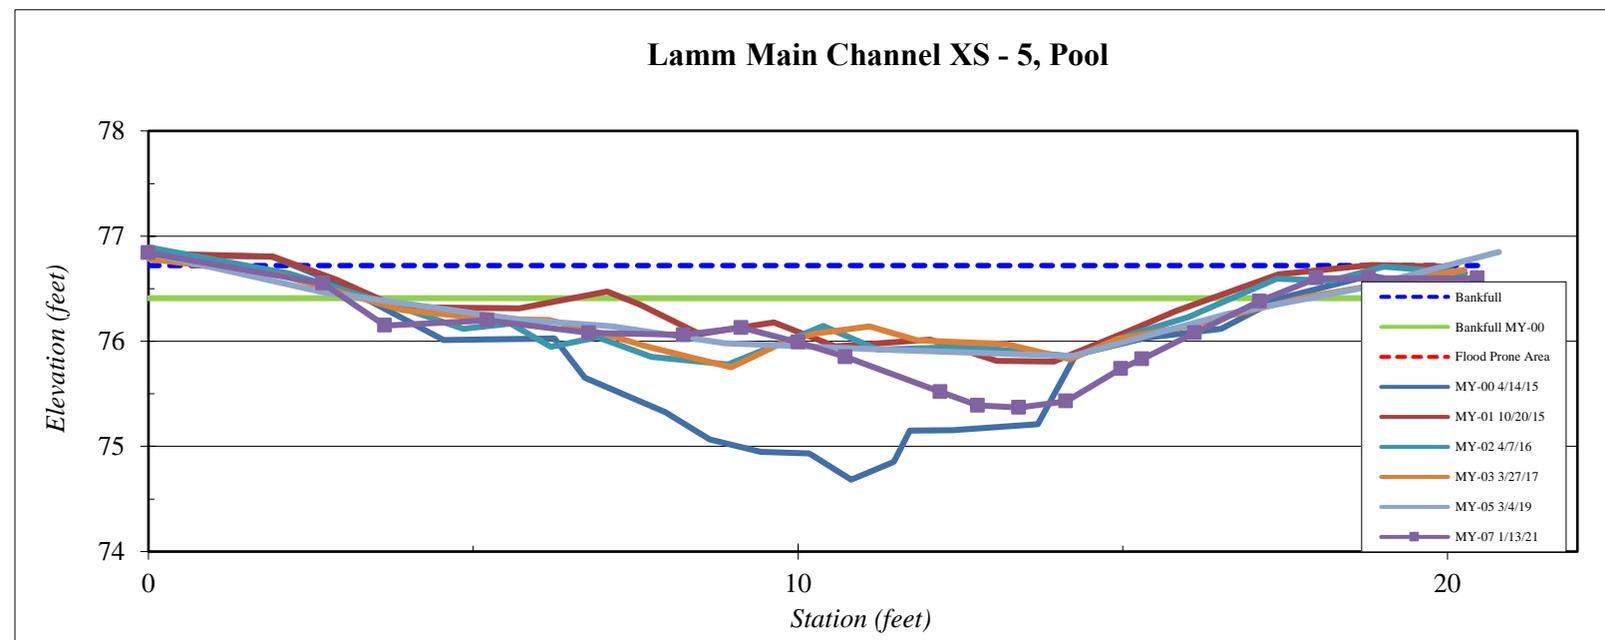
Sediment deposition in pool appears natural and is not expected to lead to instability.

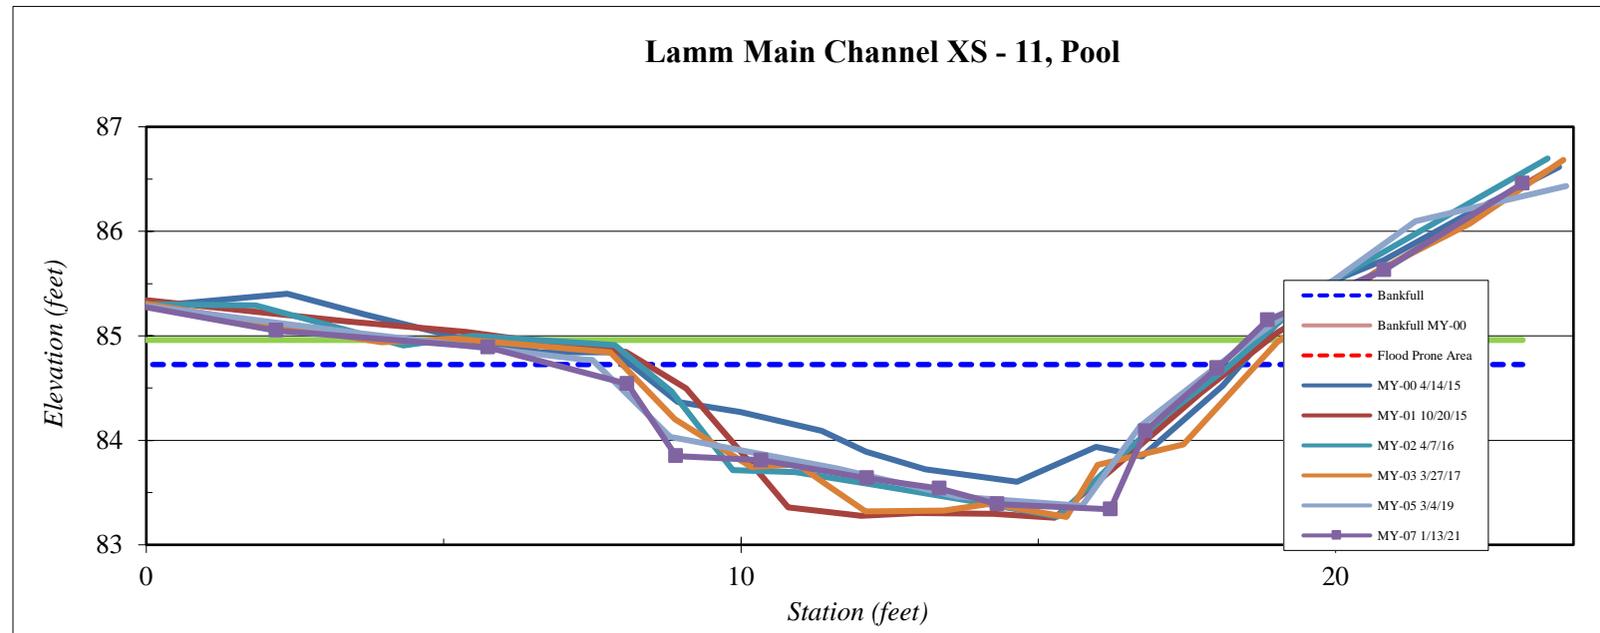
Some downcutting occurred just after asbuilt but has stabilized throughout monitoring period.

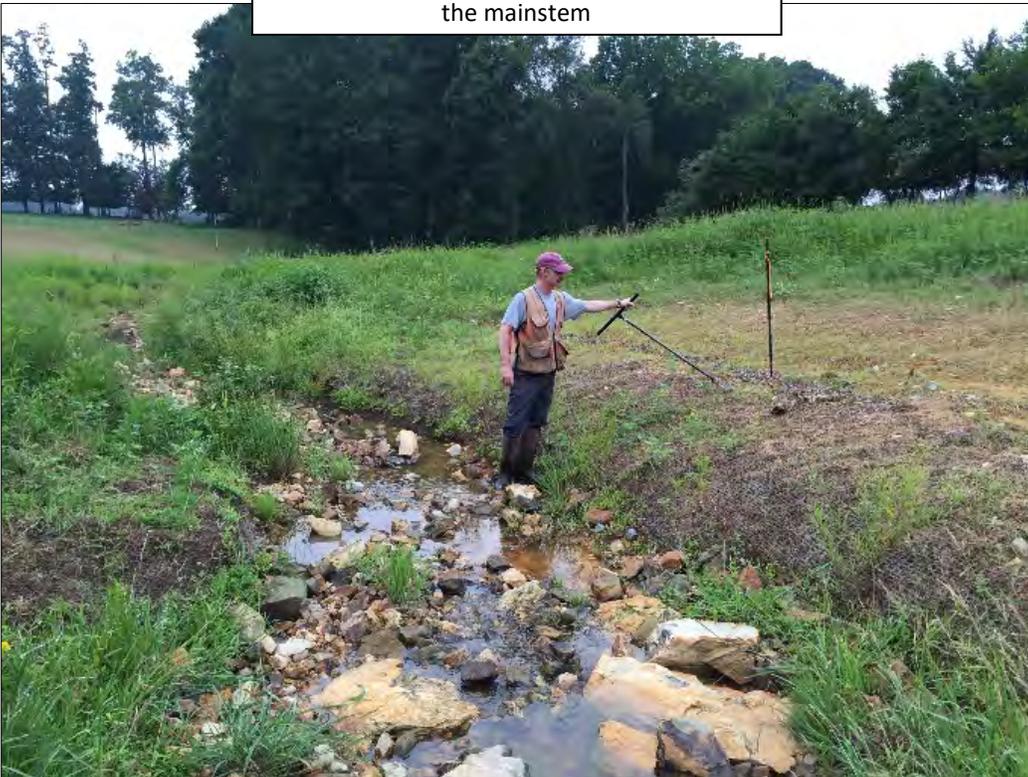
Bankfull Photo 2: Wrack in the floodplain of the mainstem

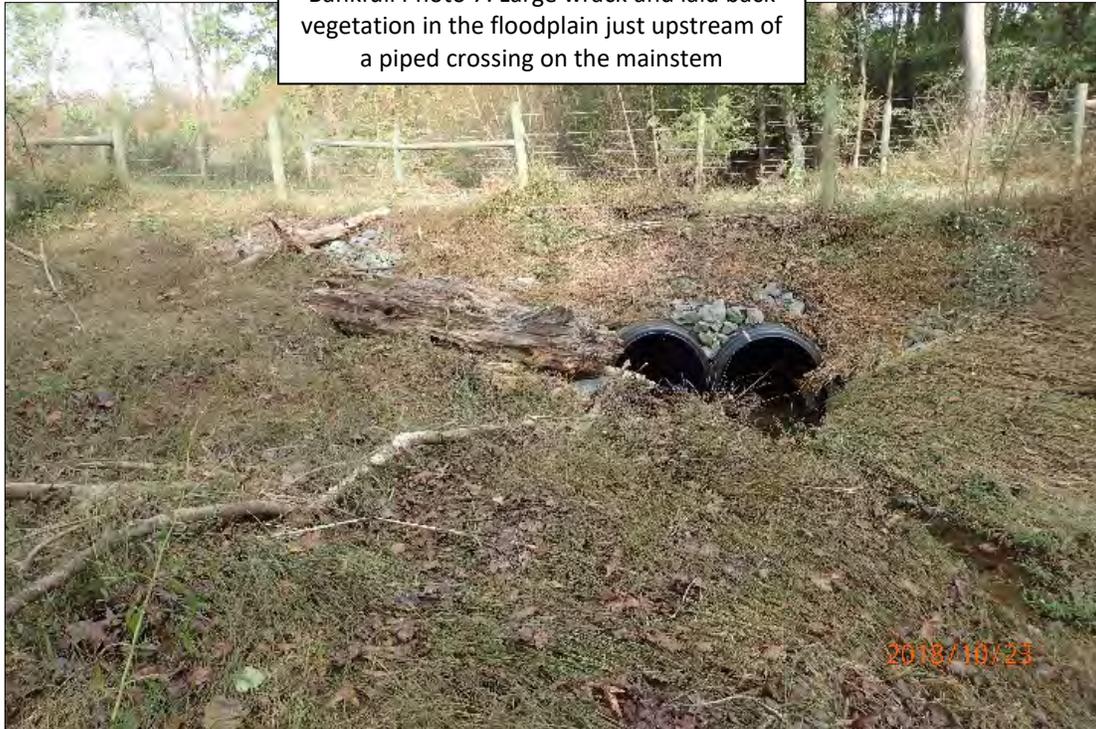
Bankfull Photo 7: Large wrack and laid back vegetation in the floodplain just upstream of a piped crossing on the mainstem

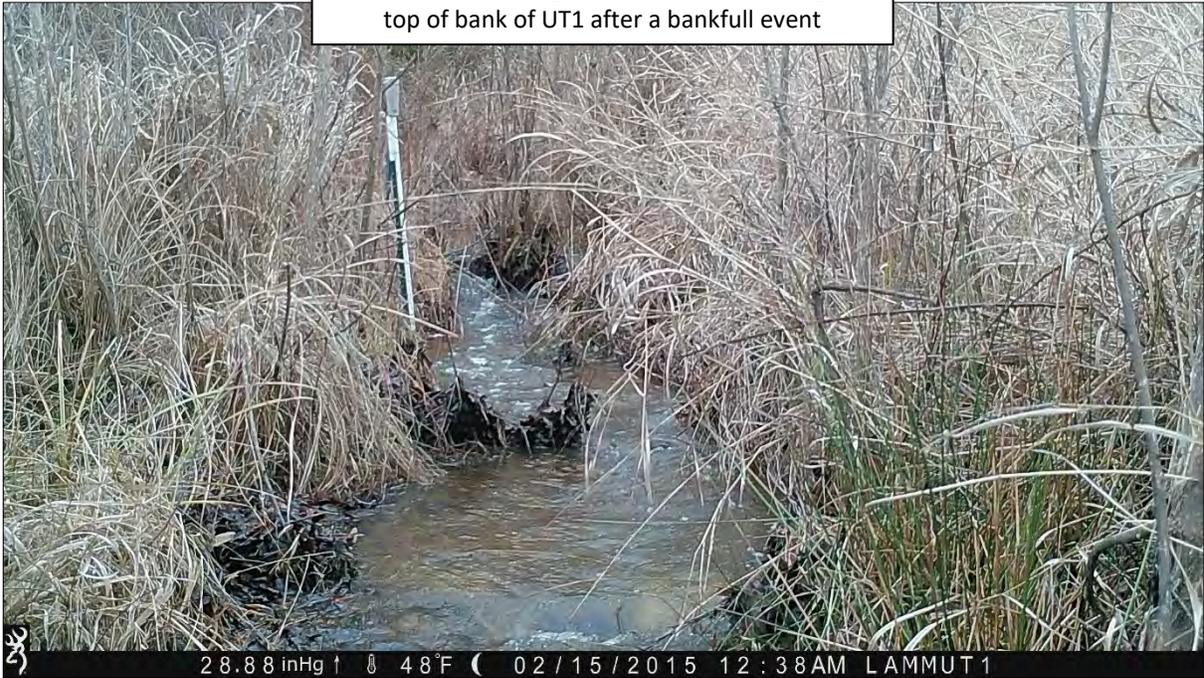
Bankfull Photo 9: High water and wrack along the top of bank of UT1 after a bankfull event

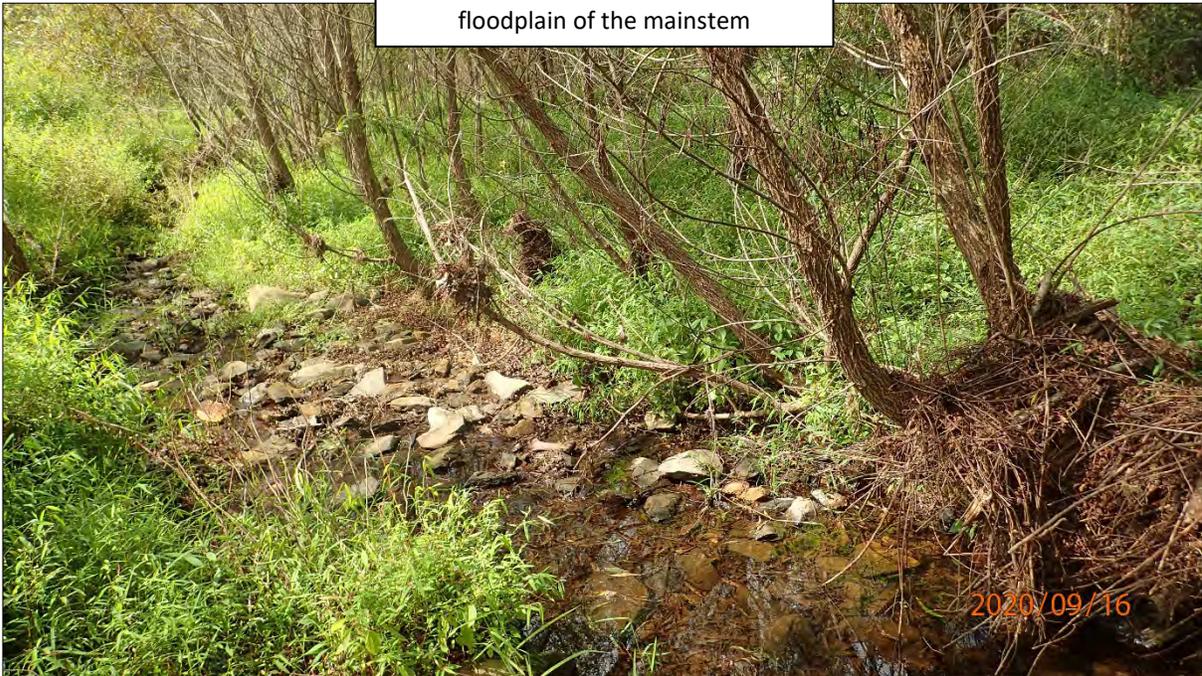
Bankfull Photo 10: Wrack in the floodplain of the mainstem

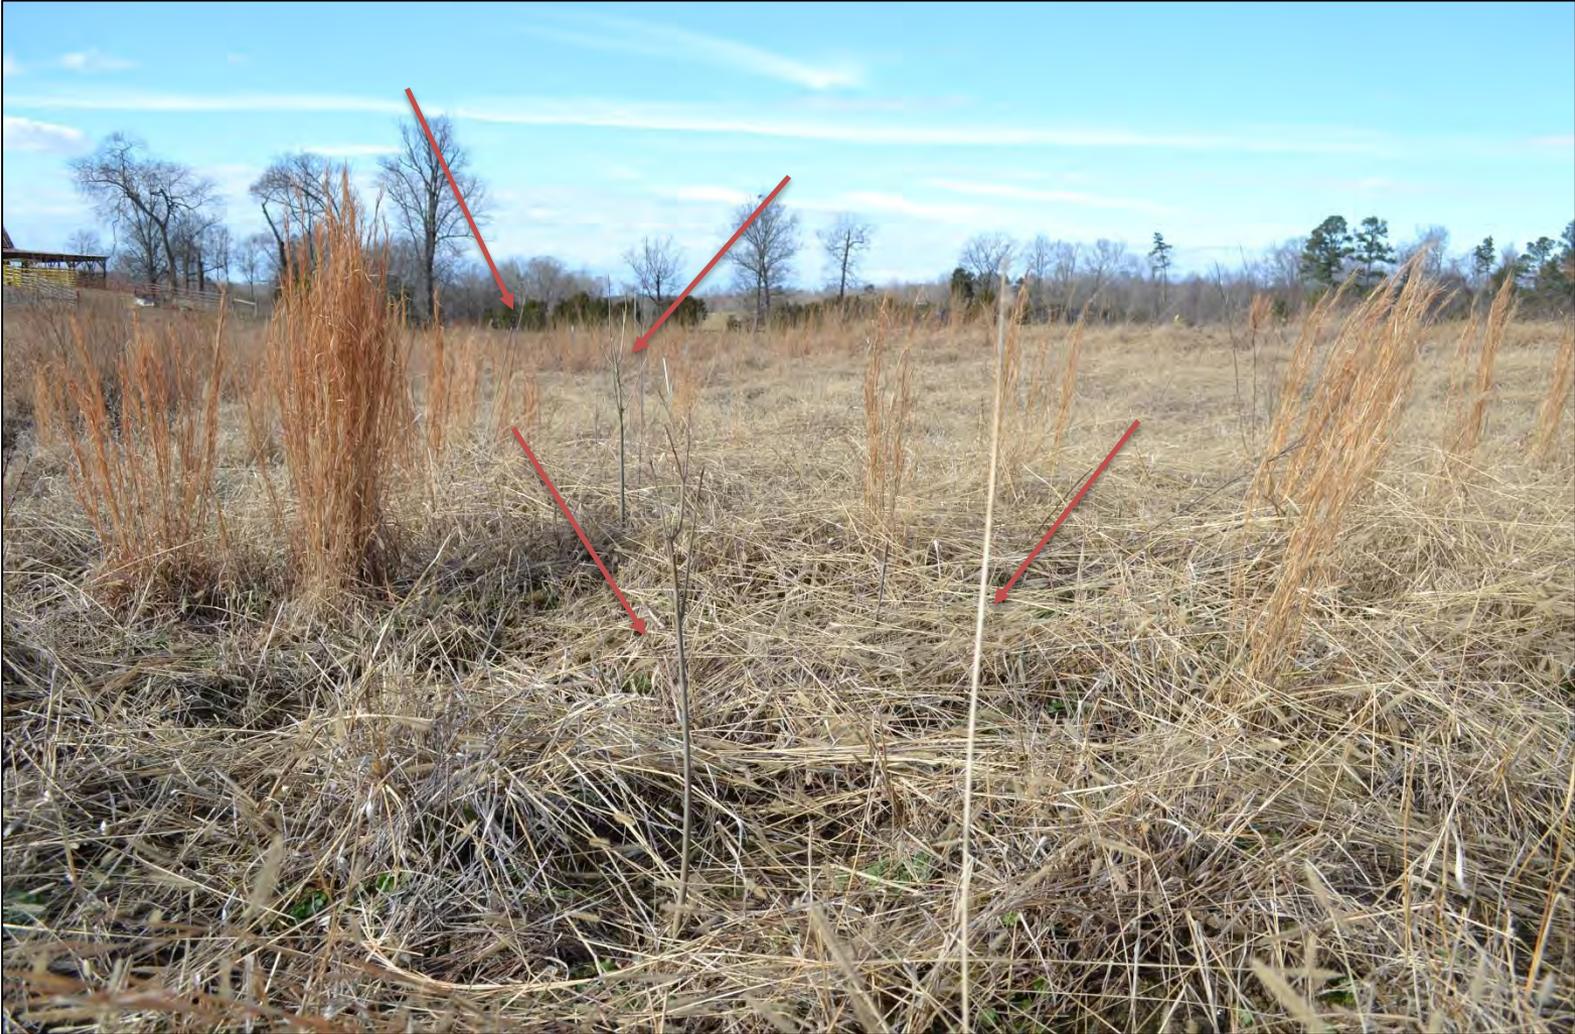
Photo 9: Surviving bear roots outside of replant area

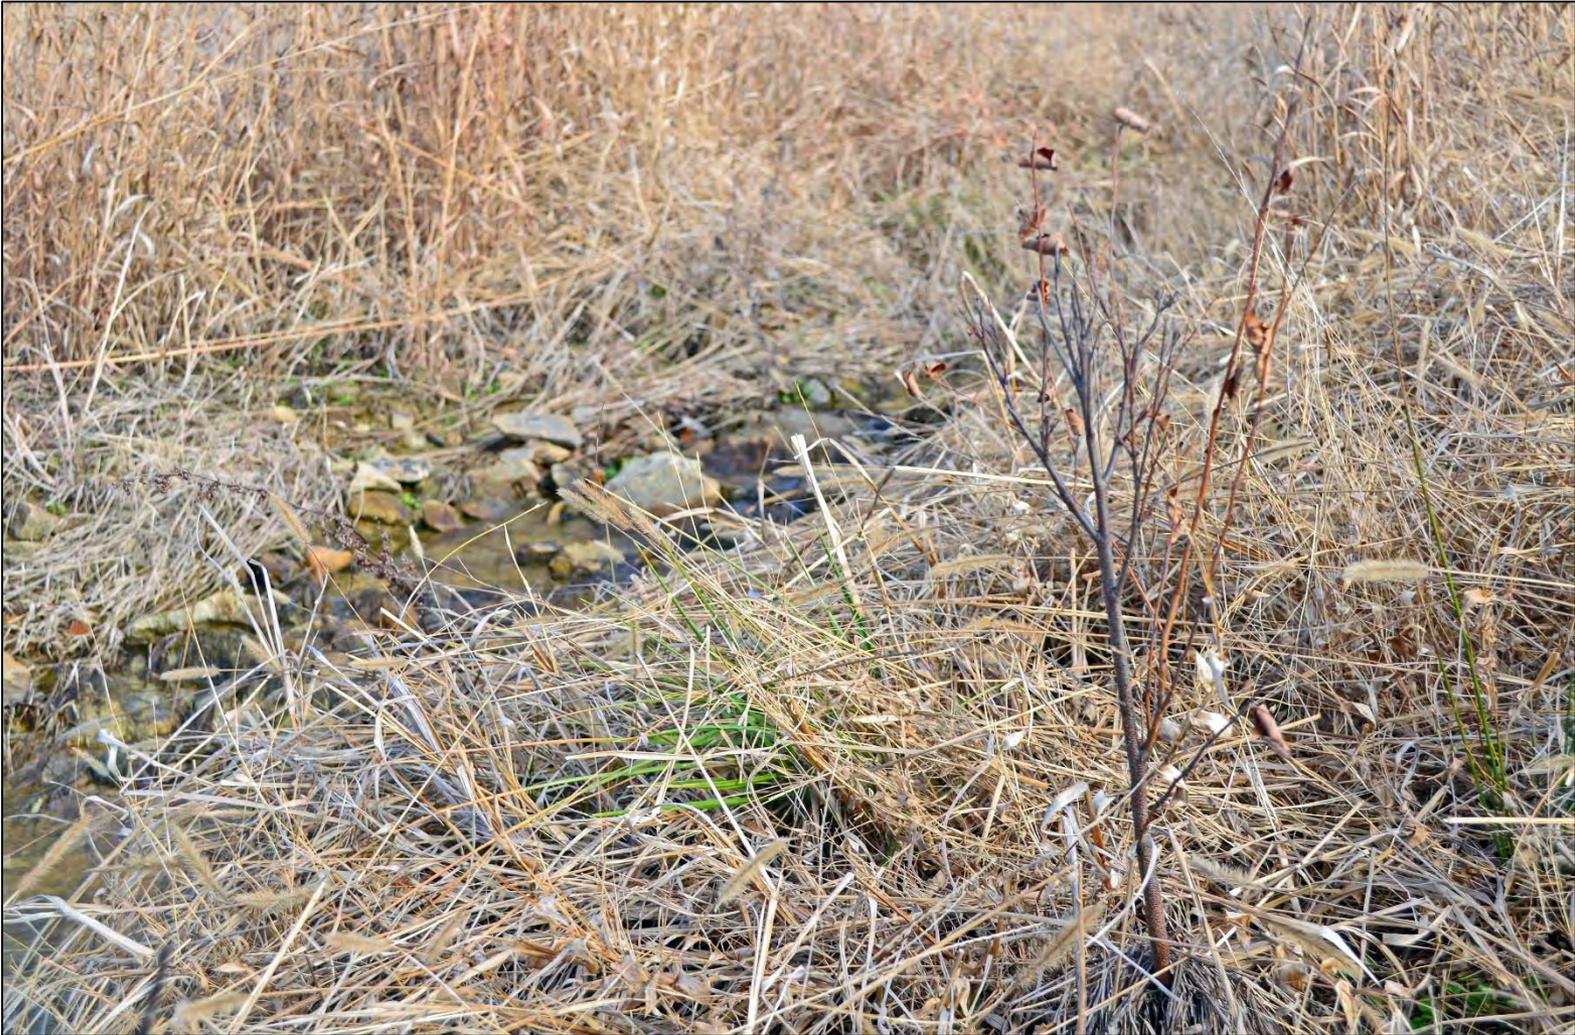
Photo 10: Surviving bear root outside of replant area

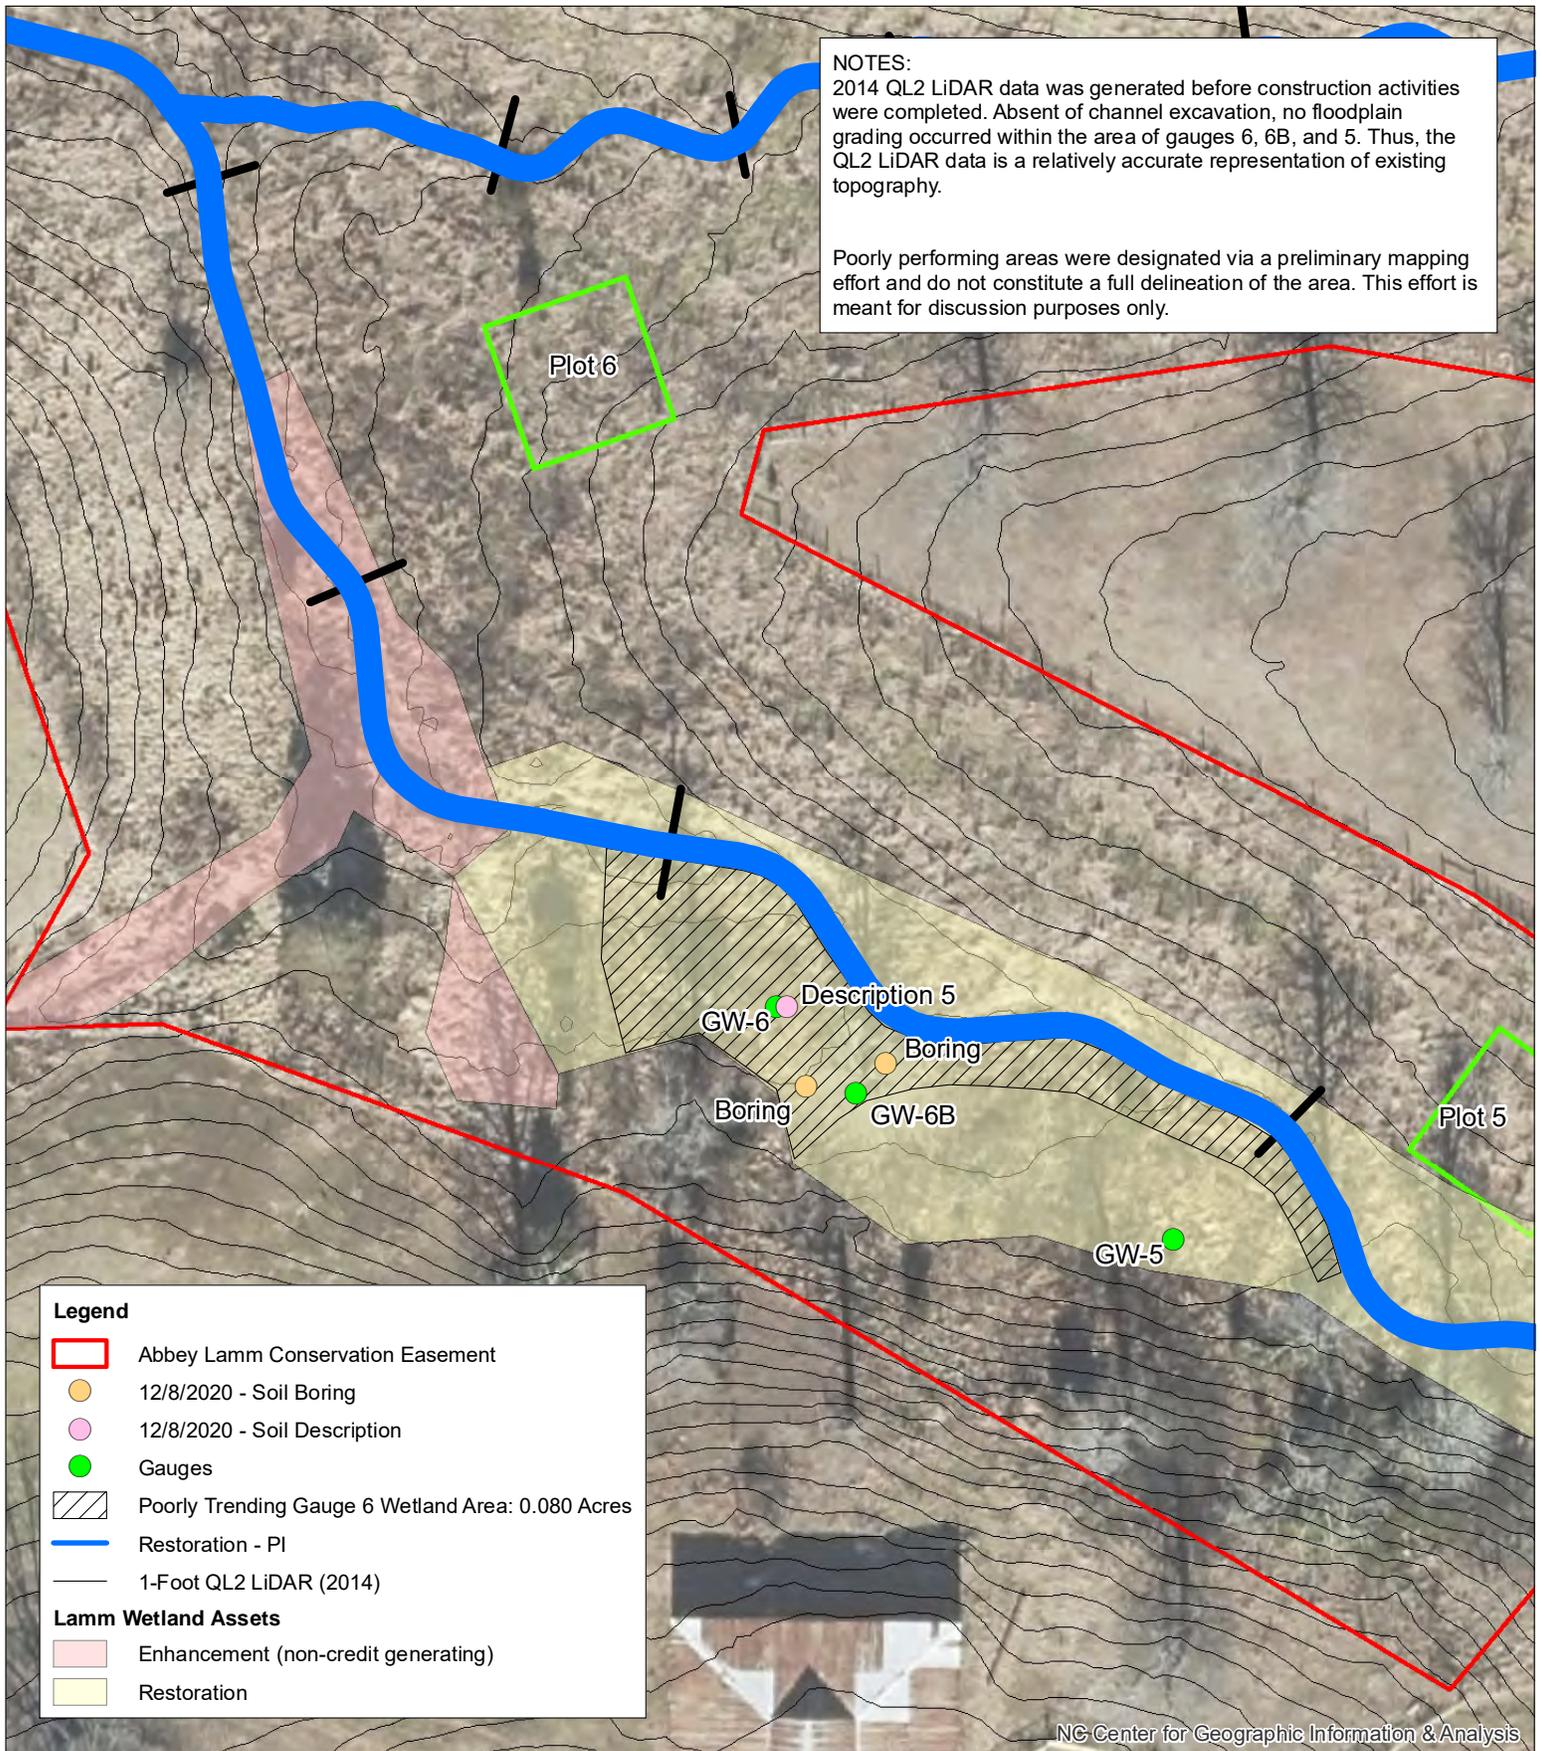
Poorly performing areas were designated via a preliminary mapping effort and do not constitute a full delineation of the area. This effort is meant for discussion purposes only.
