MONITORING YEAR 7 ANNUAL REPORT

AGONY ACRES MITIGATION SITE

Guilford County, NC

DMS Project Number 95716

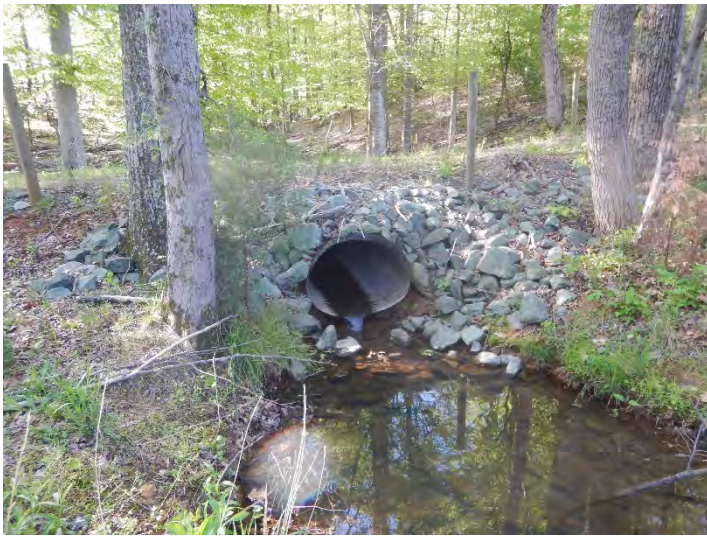
During MY6, a perched culvert on UT1A, log sills on UT2, and a small, isolated occurrence of bank erosion on lower UT1 were identified as needing improvement. The perched culvert was repaired by installing a log sill with a boulder immediately downstream of the log to lessen the water surface drop and make it resemble a naturally occurring feature. The log sills downstream of the crossing on UT2 were replaced using a small excavator and have remained stable. The small machine was able to navigate between rows of trees and disturbance to soil and vegetation was minimal. The UT2 log sills above the crossing that were reported as piping in MY6 have been partially hand repaired. Some stream flow has been restored over the top of these two sills but a portion of the flow is still piping around or underneath. This minor piping does not appear to present risk of failure, bank erosion, or channel instability. The area of isolated bank erosion in lower UT1 was live-staked during the 2020-2021 dormant season and seeded. The resulting vegetative stabilization appears to have improved the condition and stability of this bank. Photographs of these repairs are included in Appendix 2.

UT1A Perched Culvert – (04/17/2020)

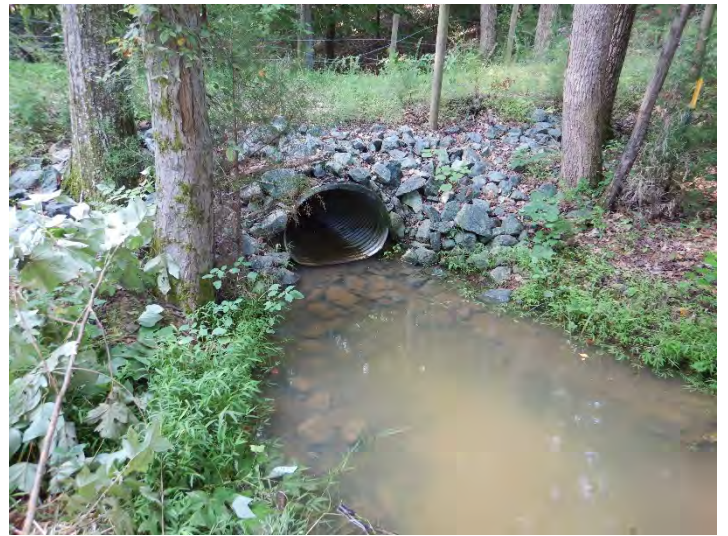
UT1A Culvert Repaired – (07/21/2021)

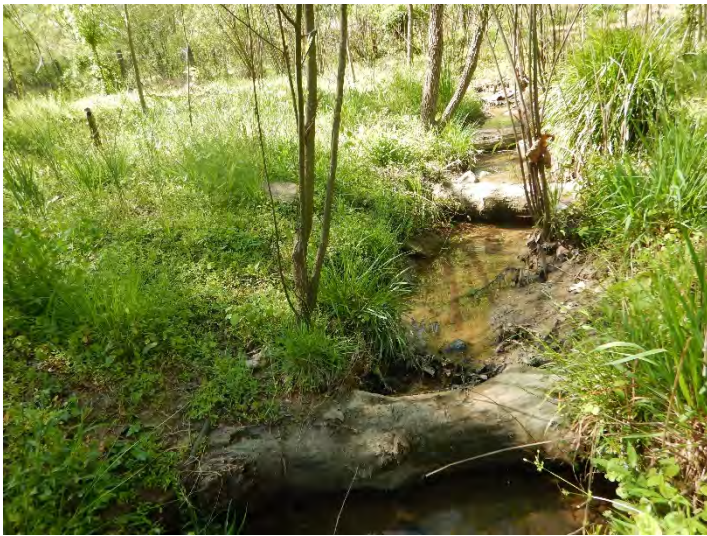
UT2 Piping Log Sills – (04/17/2020)

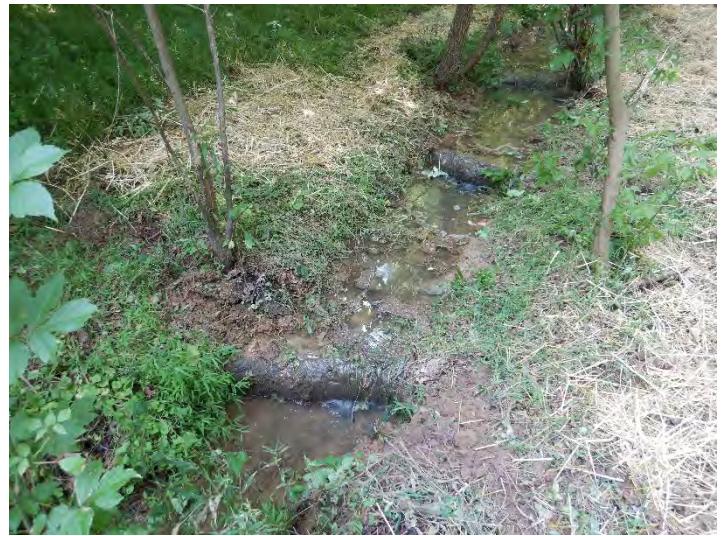
UT2 Log Sills Repaired – (07/21/2021)

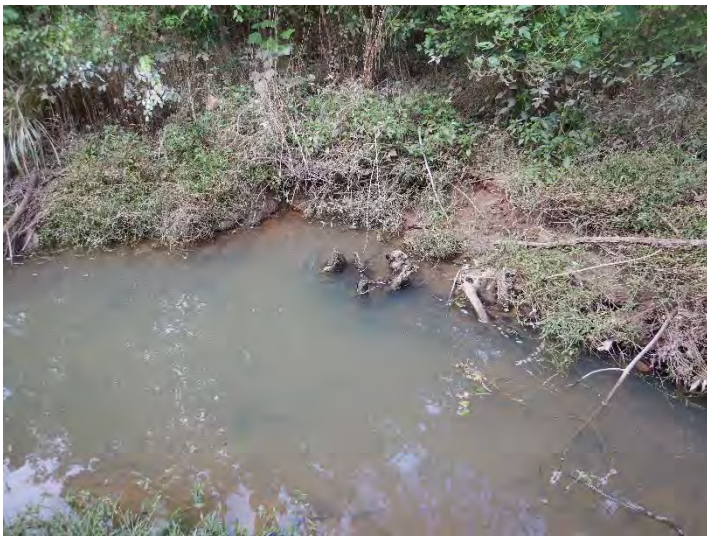
UT1 Isolated Bank Erosion – (09/23/2020)
