FINAL
MONITORING REPORT (MY2)

ALLIANCE HEADWATERS MITIGATION SITE

Johnston County, North Carolina

DMS ID No. 97086

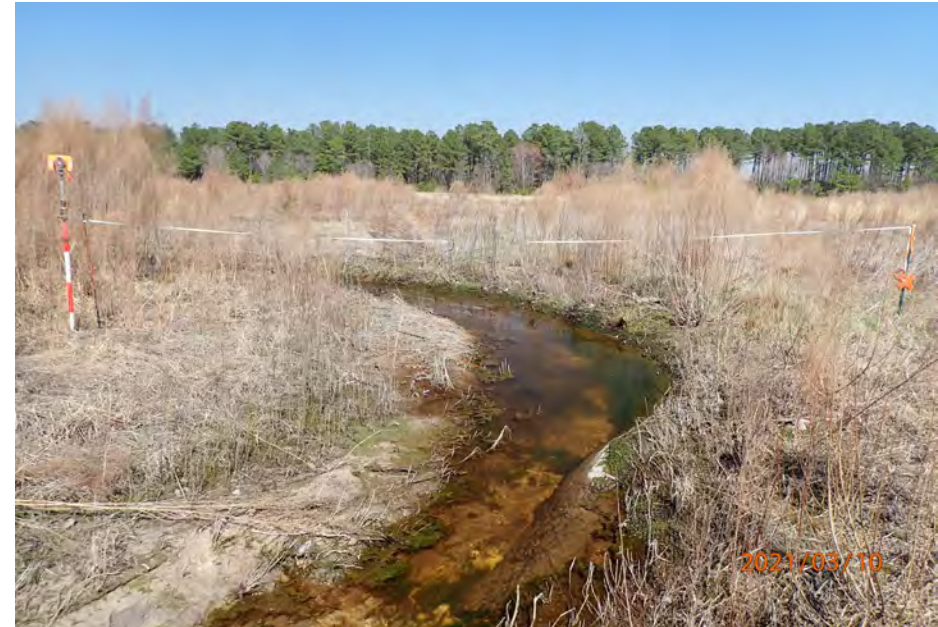
Site	Alliance Headwaters
Watershed:	Neuse River, 03020201
XS ID	UT 3 Reach 2, XS - 3
Feature	Pool
Date:	3/10/2021
Field Crew:	Adams, Lawson, Perkinson

SUMMARY DATA	
Bankfull Elevation:	113.7
Bankfull Cross-Sectional Area:	12.7
Bankfull Width:	13.5
Flood Prone Area Elevation:	NA
Flood Prone Width:	NA
Max Depth at Bankfull:	2.1
Low Bank Height:	1.8
Mean Depth at Bankfull:	0.9
W / D Ratio:	NA
Entrenchment Ratio:	NA
Bank Height Ratio:	0.88

Stream Type	C5
--------------------	----

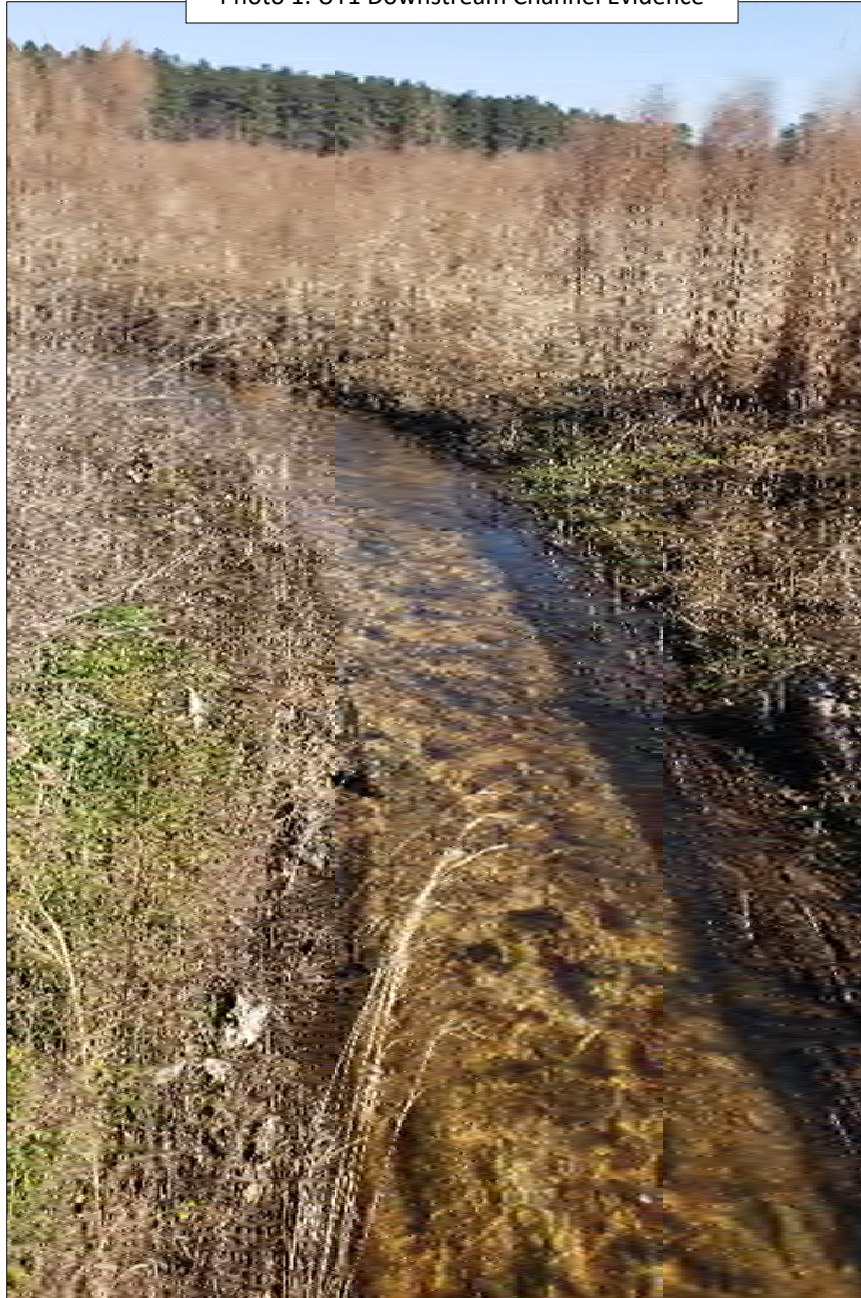
Photo 1: UT1 Downstream Channel Evidence

UT1 Downstream Channel Evidence	Year 1 (2020)	Year 2 (2021)	Year 3 (2022)	Year 4 (2023)	Year 5 (2024)	Year 6 (2025)	Year 7 (2026)
Max consecutive days channel flow	201	119					
Presence of litter and debris (wracking)	Yes	Yes					
Leaf litter disturbed or washed away	Yes	Yes					
Matted, bent, or absence of vegetation (herbaceous or otherwise)	Yes	Yes					
Sediment deposition and/or scour indicating sediment transport	Yes	Yes					
Water staining due to continual presence of water	Yes	Yes					
Formation of channel bed and banks	Yes	Yes					
Sediment sorting within the primary path of flow	Yes	Yes					
Sediment shelving or a natural line impressed on the banks	Yes	Yes					
Change in plant community (absence or destruction of terrestrial vegetation and/or transition to species adapted for flow or inundation for a long duration, including hydrophytes)	Yes	Yes					
Development of channel pattern (meander bends and/or channel braiding) at natural topographic breaks, woody debris piles, or plant root systems	Yes	Yes

Exposure of woody plant roots within the primary path of flow	No	No					
Other:

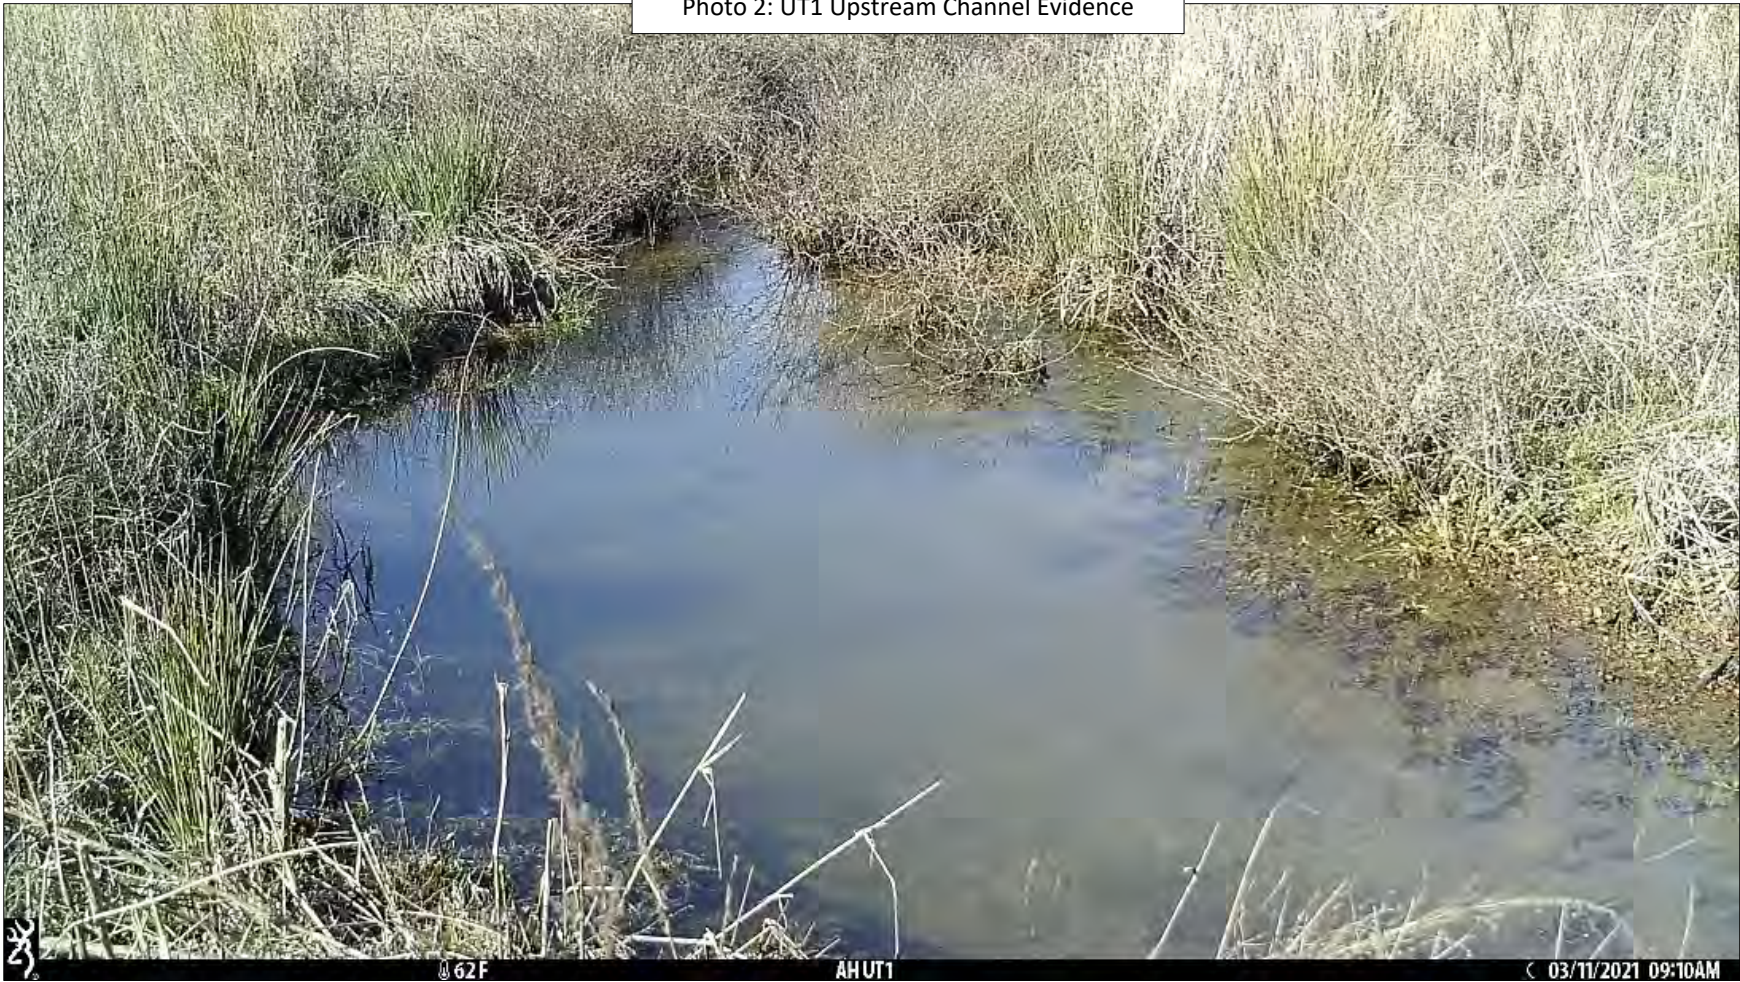
Photo 2: UT1 Upstream Channel Evidence

UT1 Upstream Channel Evidence	Year 1 (2020)	Year 2 (2021)	Year 3 (2022)	Year 4 (2023)	Year 5 (2024)	Year 6 (2025)	Year 7 (2026)
Max consecutive days channel flow	190	160					
Presence of litter and debris (wracking)	Yes	Yes					
Leaf litter disturbed or washed away	Yes	Yes					
Matted, bent, or absence of vegetation (herbaceous or otherwise)	Yes	Yes					
Sediment deposition and/or scour indicating sediment transport	Yes	Yes					
Water staining due to continual presence of water	Yes	Yes					
Formation of channel bed and banks	Yes	Yes					
Sediment sorting within the primary path of flow	Yes	Yes					
Sediment shelving or a natural line impressed on the banks	Yes	Yes					
Change in plant community (absence or destruction of terrestrial vegetation and/or transition to species adapted for flow or inundation for a long duration, including hydrophytes)	Yes	Yes					
Development of channel pattern (meander bends and/or channel braiding) at natural topographic breaks, woody debris piles, or plant root systems	Yes	Yes

Exposure of woody plant roots within the primary path of flow	No	No					
Other:

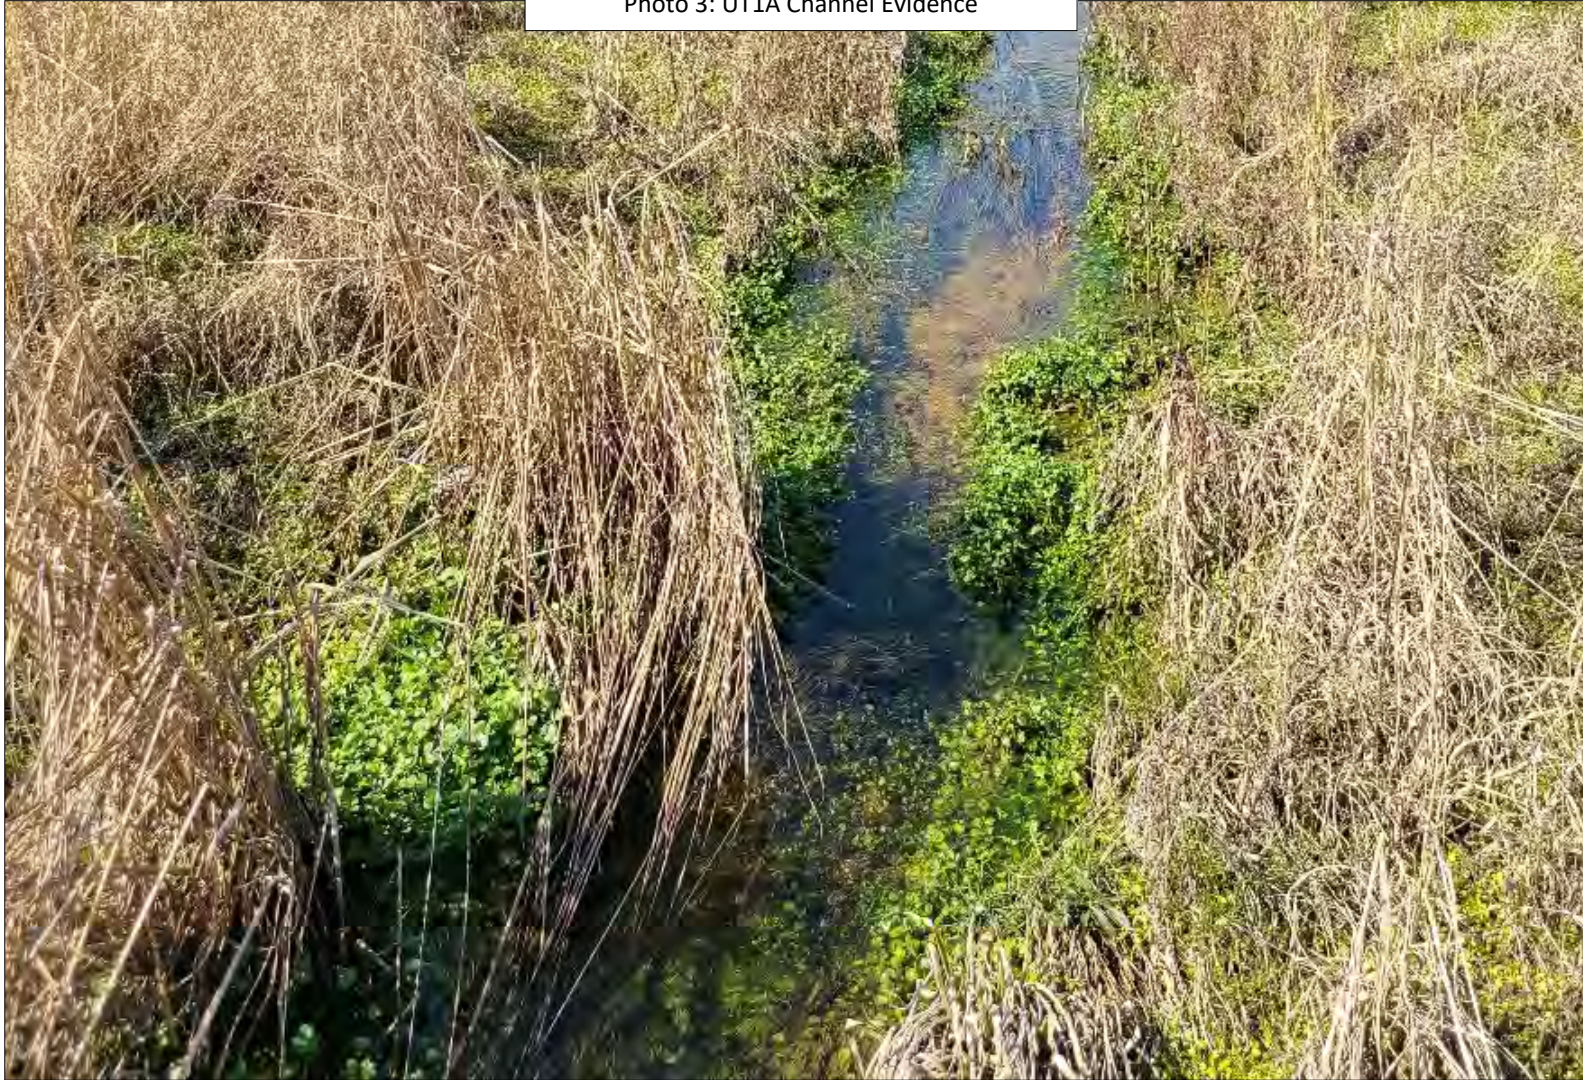
Photo 3: UT1A Channel Evidence

UT1A Channel Evidence	Year 1 (2020)	Year 2 (2021)	Year 3 (2022)	Year 4 (2023)	Year 5 (2024)	Year 6 (2025)	Year 7 (2026)
Max consecutive days channel flow	97	73					
Presence of litter and debris (wracking)	Yes	Yes					
Leaf litter disturbed or washed away	Yes	Yes					
Matted, bent, or absence of vegetation (herbaceous or otherwise)	Yes	Yes					
Sediment deposition and/or scour indicating sediment transport	Yes	Yes					
Water staining due to continual presence of water	Yes	Yes					
Formation of channel bed and banks	Yes	Yes					
Sediment sorting within the primary path of flow	Yes	Yes					
Sediment shelving or a natural line impressed on the banks	Yes	Yes					
Change in plant community (absence or destruction of terrestrial vegetation and/or transition to species adapted for flow or inundation for a long duration, including hydrophytes)	Yes	Yes					
Development of channel pattern (meander bends and/or channel braiding) at natural topographic breaks, woody debris piles, or plant root systems	Yes	Yes

Exposure of woody plant roots within the primary path of flow	No	No					
Other:

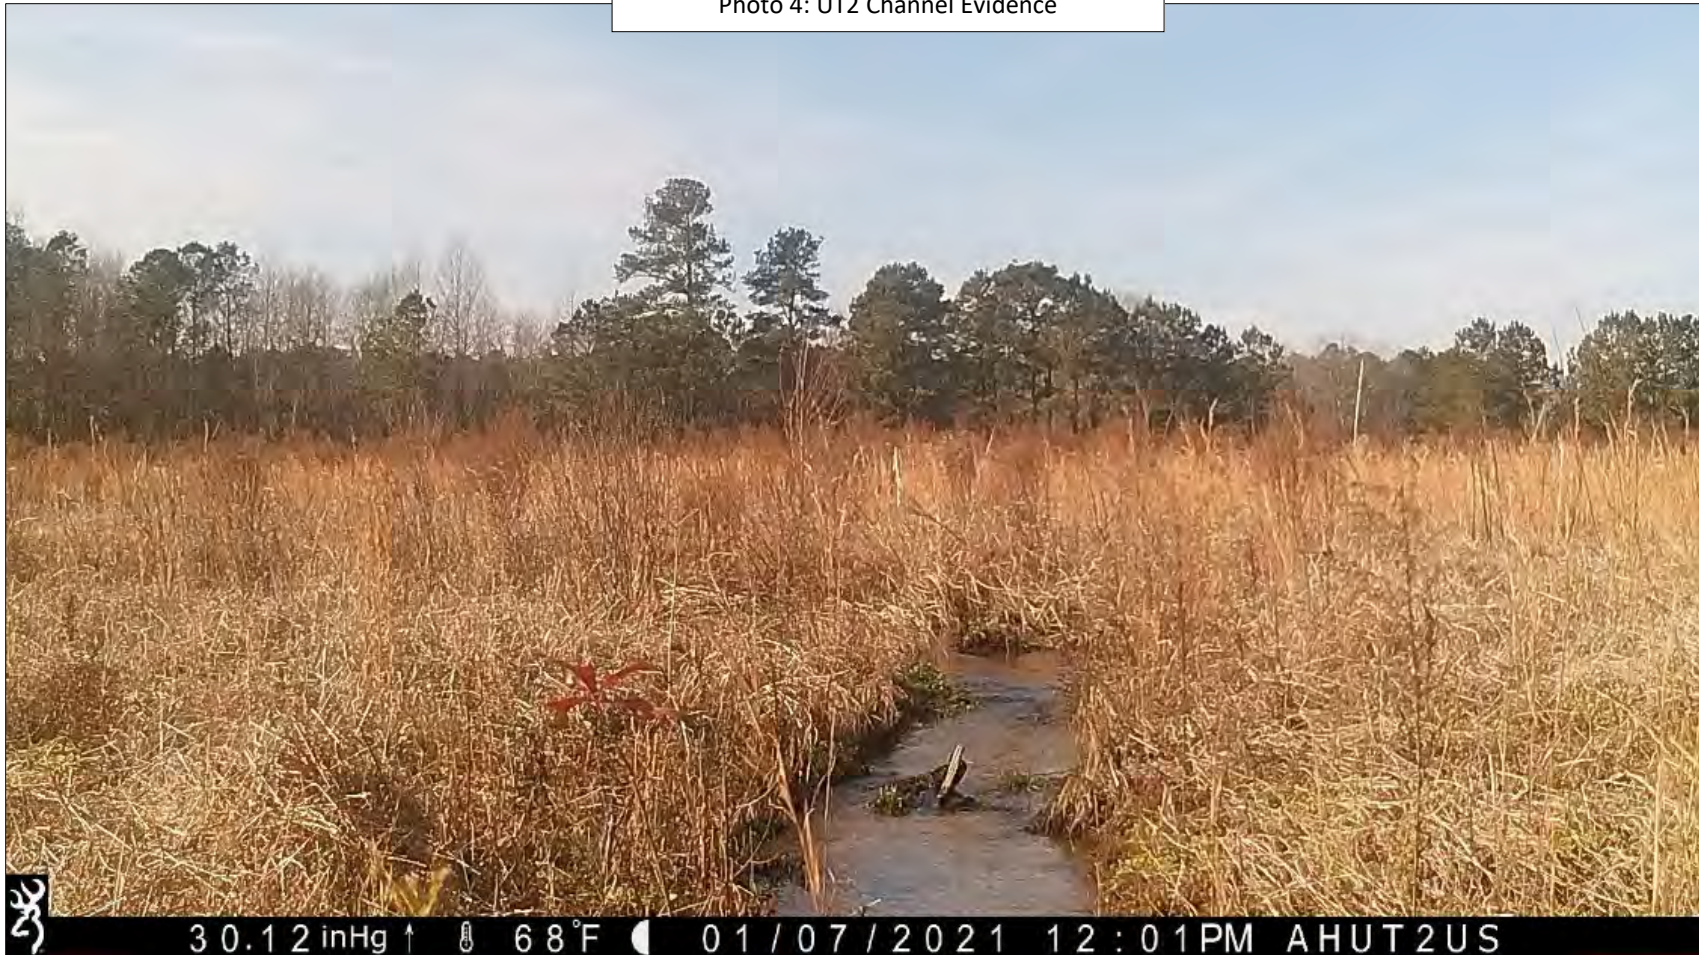
Photo 4: UT2 Channel Evidence

UT2 Channel Evidence	Year 1 (2020)	Year 2 (2021)	Year 3 (2022)	Year 4 (2023)	Year 5 (2024)	Year 6 (2025)	Year 7 (2026)
Max consecutive days channel flow	199	125					
Presence of litter and debris (wracking)	Yes	Yes					
Leaf litter disturbed or washed away	Yes	Yes					
Matted, bent, or absence of vegetation (herbaceous or otherwise)	Yes	Yes					
Sediment deposition and/or scour indicating sediment transport	Yes	Yes					
Water staining due to continual presence of water	Yes	Yes					
Formation of channel bed and banks	Yes	Yes					
Sediment sorting within the primary path of flow	Yes	Yes					
Sediment shelving or a natural line impressed on the banks	Yes	Yes					
Change in plant community (absence or destruction of terrestrial vegetation and/or transition to species adapted for flow or inundation for a long duration, including hydrophytes)	Yes	Yes					
Development of channel pattern (meander bends and/or channel braiding) at natural topographic breaks, woody debris piles, or plant root systems	Yes	Yes

Exposure of woody plant roots within the primary path of flow	No	No					
Other:

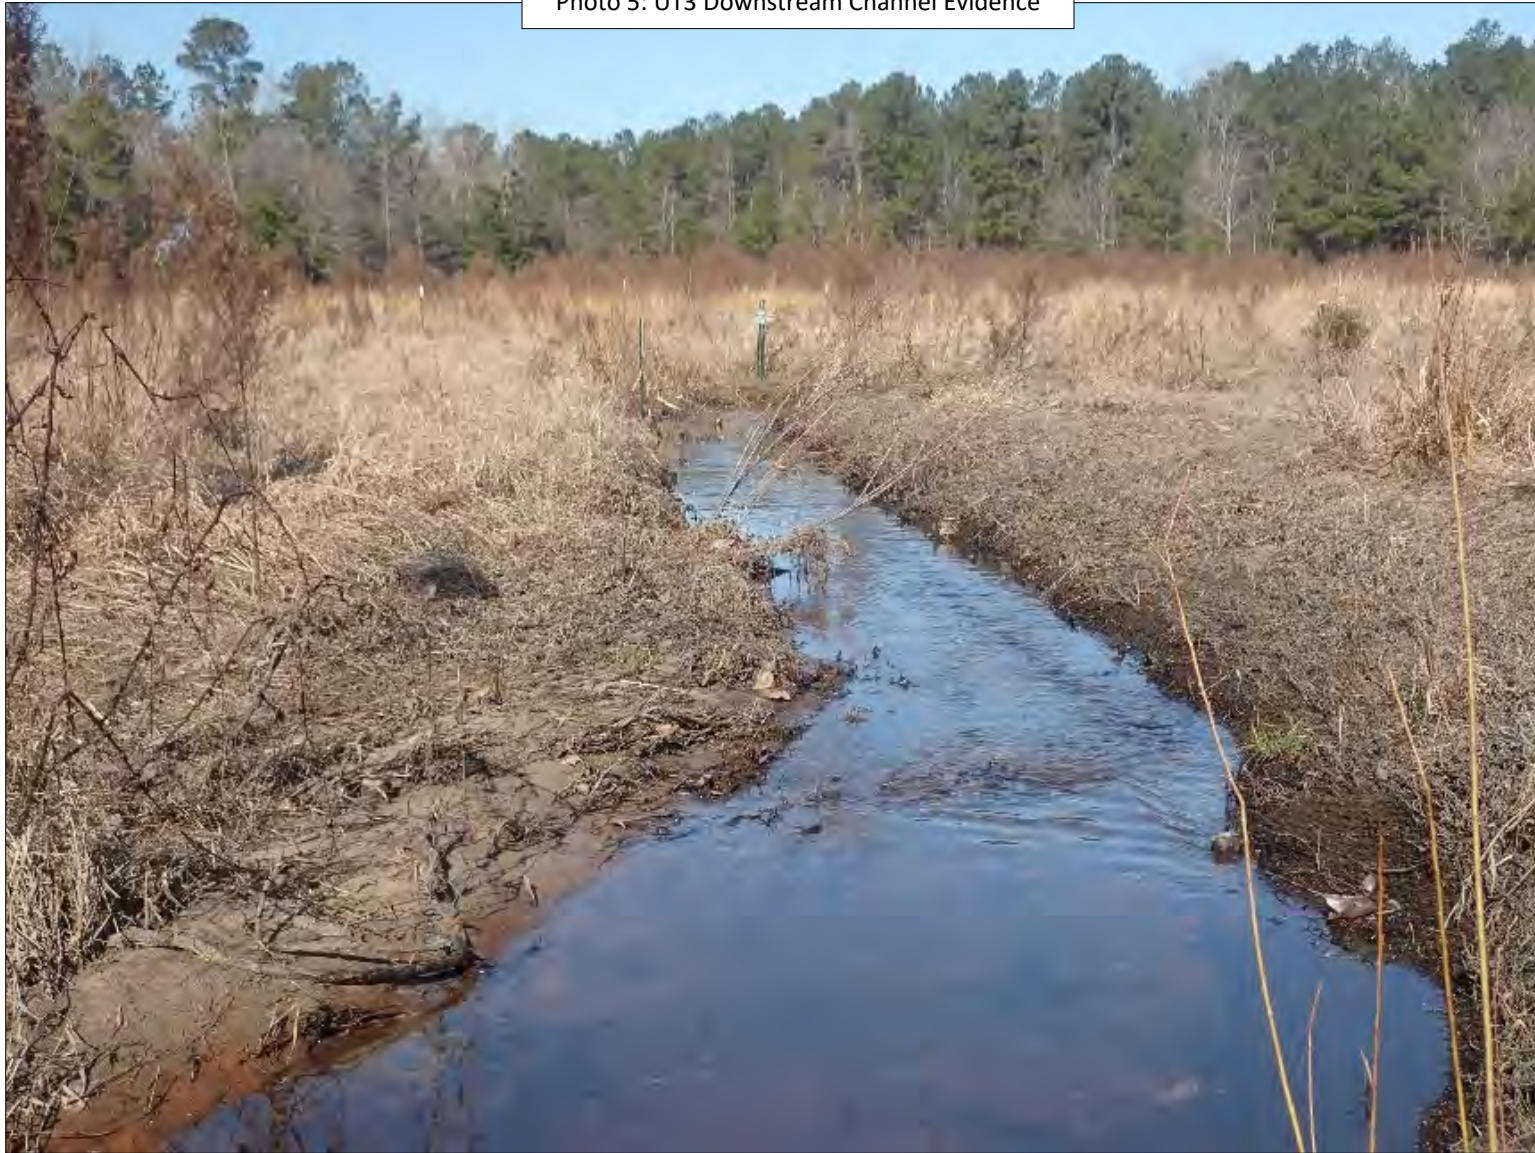
Photo 5: UT3 Downstream Channel Evidence

UT3 Downstream Channel Evidence	Year 1 (2020)	Year 2 (2021)	Year 3 (2022)	Year 4 (2023)	Year 5 (2024)	Year 6 (2025)	Year 7 (2026)
Max consecutive days channel flow	119	234					
Presence of litter and debris (wracking)	Yes	Yes					
Leaf litter disturbed or washed away	Yes	Yes					
Matted, bent, or absence of vegetation (herbaceous or otherwise)	Yes	Yes					
Sediment deposition and/or scour indicating sediment transport	Yes	Yes					
Water staining due to continual presence of water	Yes	Yes					
Formation of channel bed and banks	Yes	Yes					
Sediment sorting within the primary path of flow	Yes	Yes					
Sediment shelving or a natural line impressed on the banks	Yes	Yes					
Change in plant community (absence or destruction of terrestrial vegetation and/or transition to species adapted for flow or inundation for a long duration, including hydrophytes)	Yes	Yes					
Development of channel pattern (meander bends and/or channel braiding) at natural topographic breaks, woody debris piles, or plant root systems	Yes	Yes

Exposure of woody plant roots within the primary path of flow	No	No					
Other:

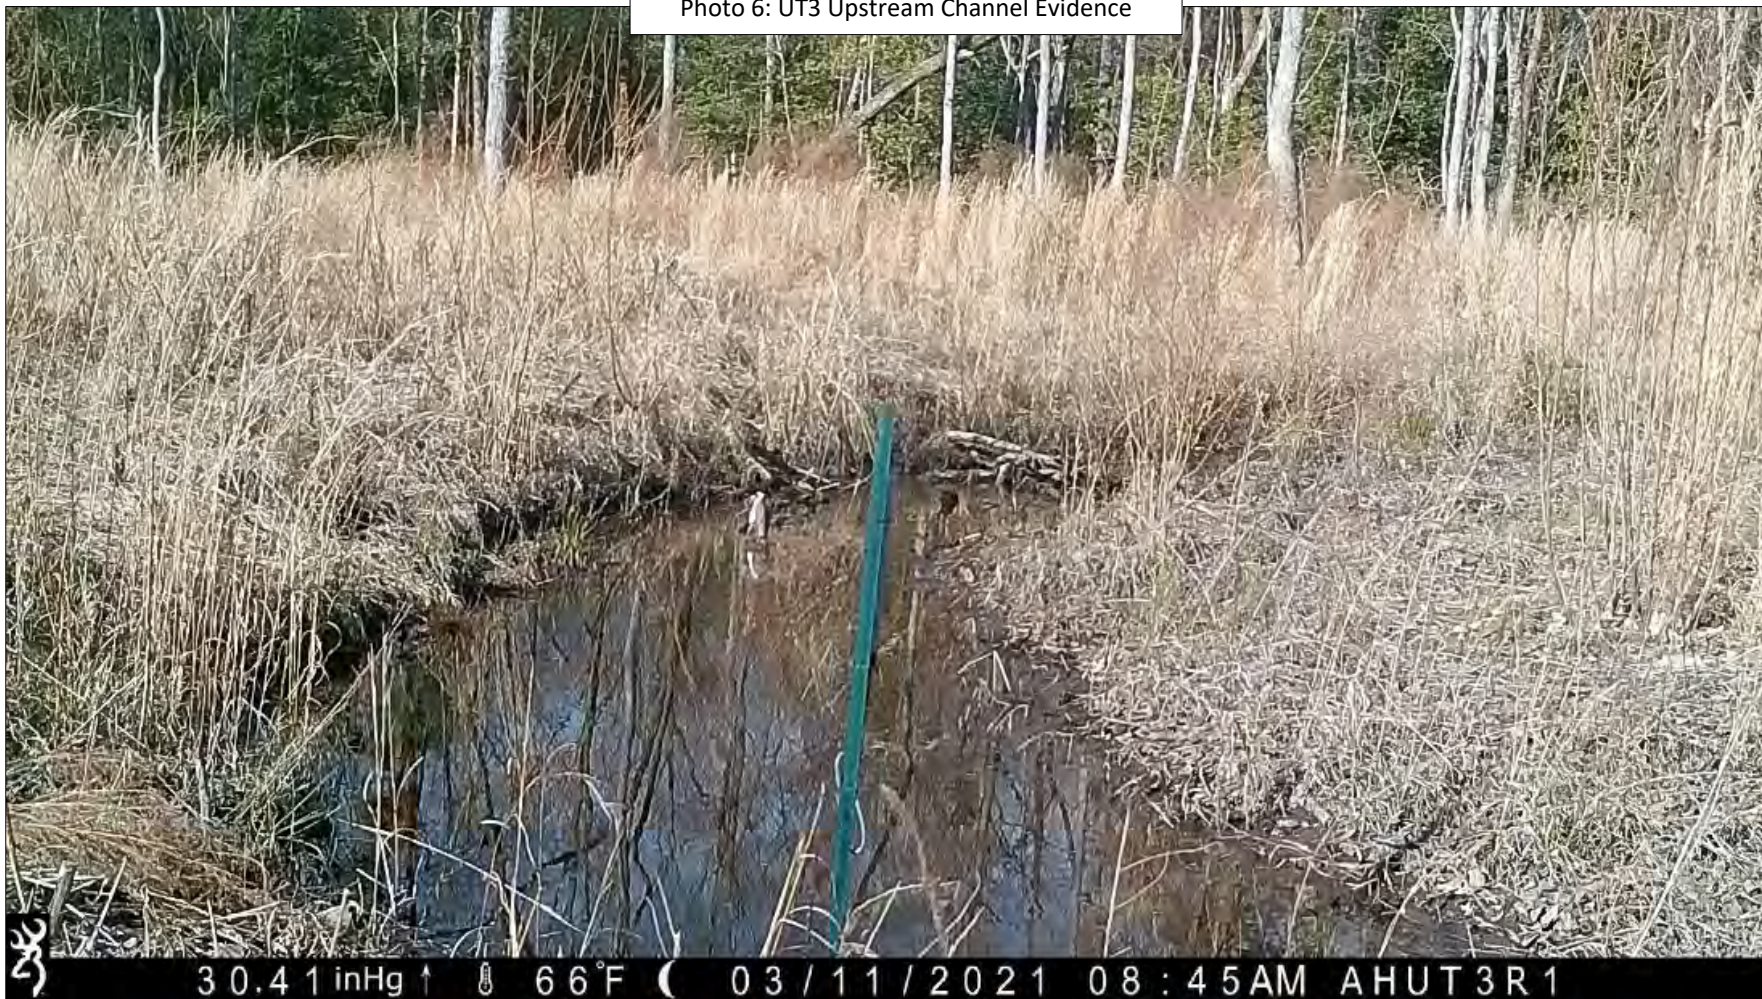
Photo 6: UT3 Upstream Channel Evidence

UT3 Upstream Channel Evidence	Year 1 (2020)	Year 2 (2021)	Year 3 (2022)	Year 4 (2023)	Year 5 (2024)	Year 6 (2025)	Year 7 (2026)
Max consecutive days channel flow	136	127					
Presence of litter and debris (wracking)	Yes	Yes					
Leaf litter disturbed or washed away	Yes	Yes					
Matted, bent, or absence of vegetation (herbaceous or otherwise)	Yes	Yes					
Sediment deposition and/or scour indicating sediment transport	Yes	Yes					
Water staining due to continual presence of water	Yes	Yes					
Formation of channel bed and banks	Yes	Yes					
Sediment sorting within the primary path of flow	Yes	Yes					
Sediment shelving or a natural line impressed on the banks	Yes	Yes					
Change in plant community (absence or destruction of terrestrial vegetation and/or transition to species adapted for flow or inundation for a long duration, including hydrophytes)	Yes	Yes					
Development of channel pattern (meander bends and/or channel braiding) at natural topographic breaks, woody debris piles, or plant root systems	Yes	Yes

Exposure of woody plant roots within the primary path of flow	No	No					
Other:

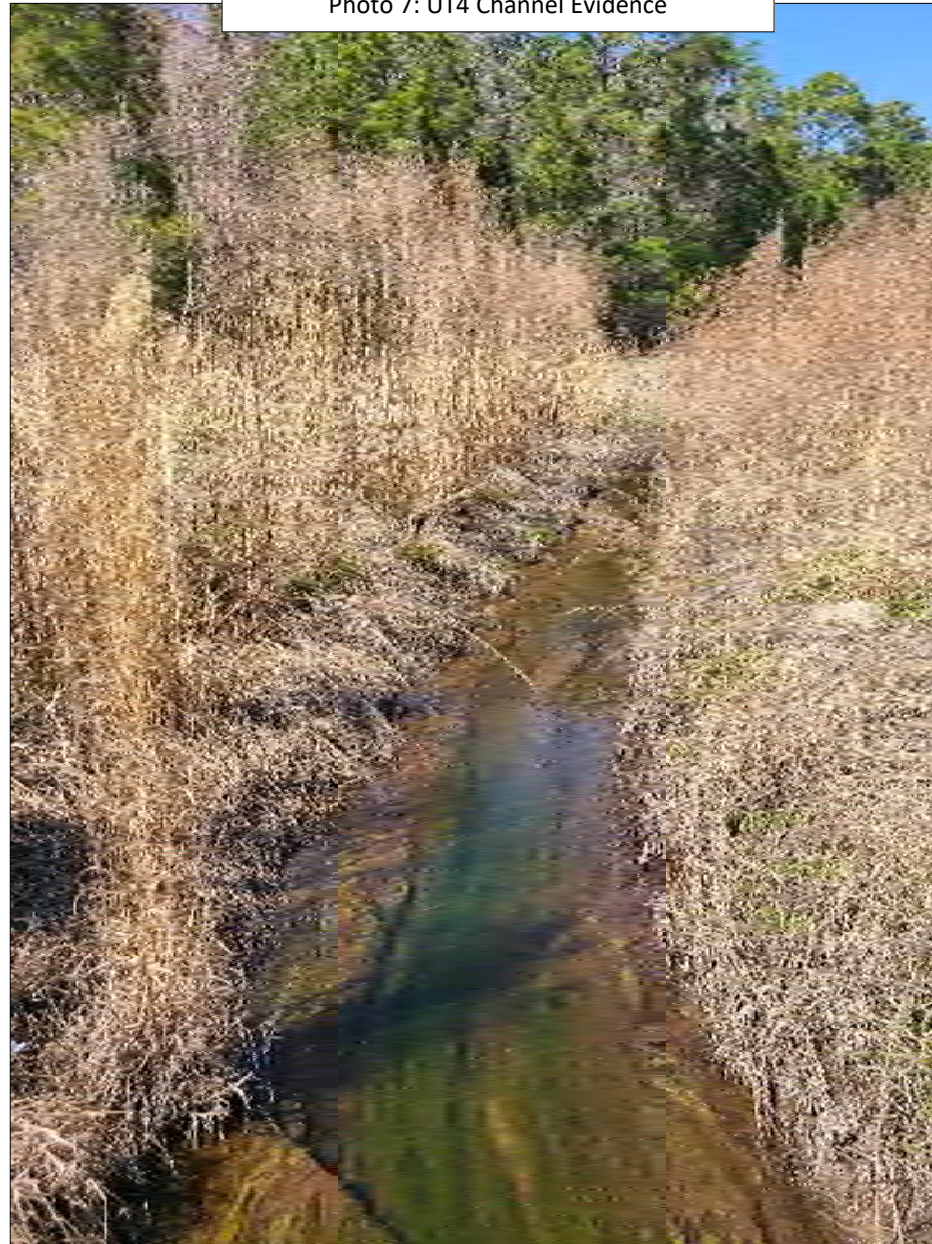
Photo 7: UT4 Channel Evidence

UT4 Channel Evidence	Year 1 (2020)	Year 2 (2021)	Year 3 (2022)	Year 4 (2023)	Year 5 (2024)	Year 6 (2025)	Year 7 (2026)
Max consecutive days channel flow	130	228					
Presence of litter and debris (wracking)	Yes	Yes					
Leaf litter disturbed or washed away	Yes	Yes					
Matted, bent, or absence of vegetation (herbaceous or otherwise)	Yes	Yes					
Sediment deposition and/or scour indicating sediment transport	Yes	Yes					
Water staining due to continual presence of water	Yes	Yes					
Formation of channel bed and banks	Yes	Yes					
Sediment sorting within the primary path of flow	Yes	Yes					
Sediment shelving or a natural line impressed on the banks	Yes	Yes					
Change in plant community (absence or destruction of terrestrial vegetation and/or transition to species adapted for flow or inundation for a long duration, including hydrophytes)	Yes	Yes					
Development of channel pattern (meander bends and/or channel braiding) at natural topographic breaks, woody debris piles, or plant root systems	Yes	Yes

Exposure of woody plant roots within the primary path of flow	No	No					
Other:

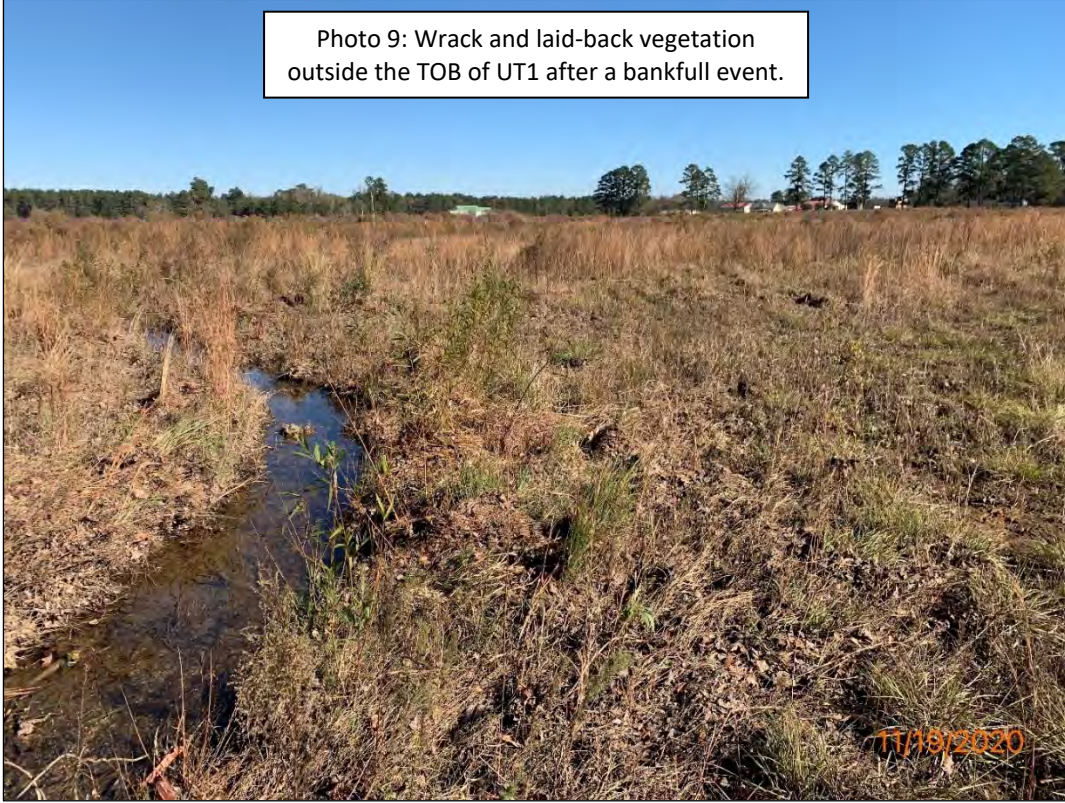
Photo 9: Wrack and laid-back vegetation outside the TOB of UT1 after a bankfull event.

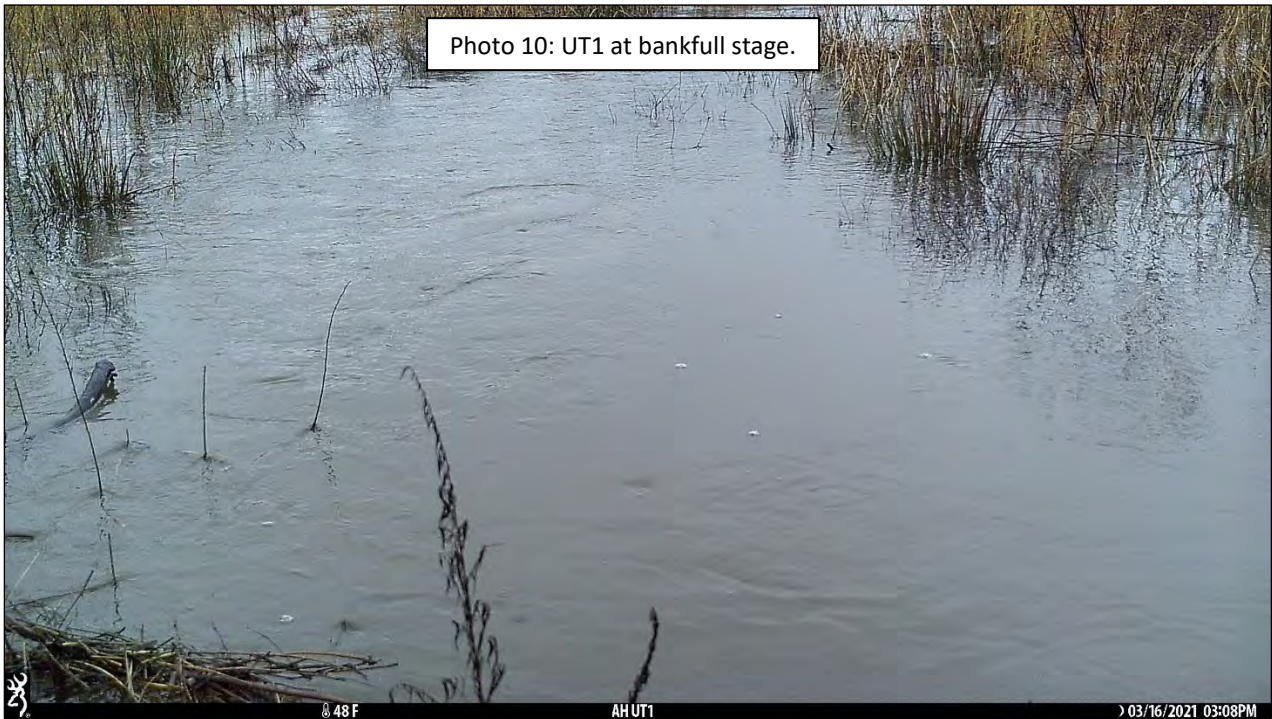
Photo 10: UT1 at bankfull stage.
