YEAR 6 (2021) MONITORING REPORT
AYCOCK SPRINGS
STREAM AND WETLAND MITIGATION SITE

ALAMANCE COUNTY, NORTH CAROLINA
DMS PROJECT No. 96312
FULL DELIVERY CONTRACT No. 5791
NCDWR PROJECT No. 20140335
USACE ACTION ID No. SAW-2014-01711

Data Collection – January-October 2021

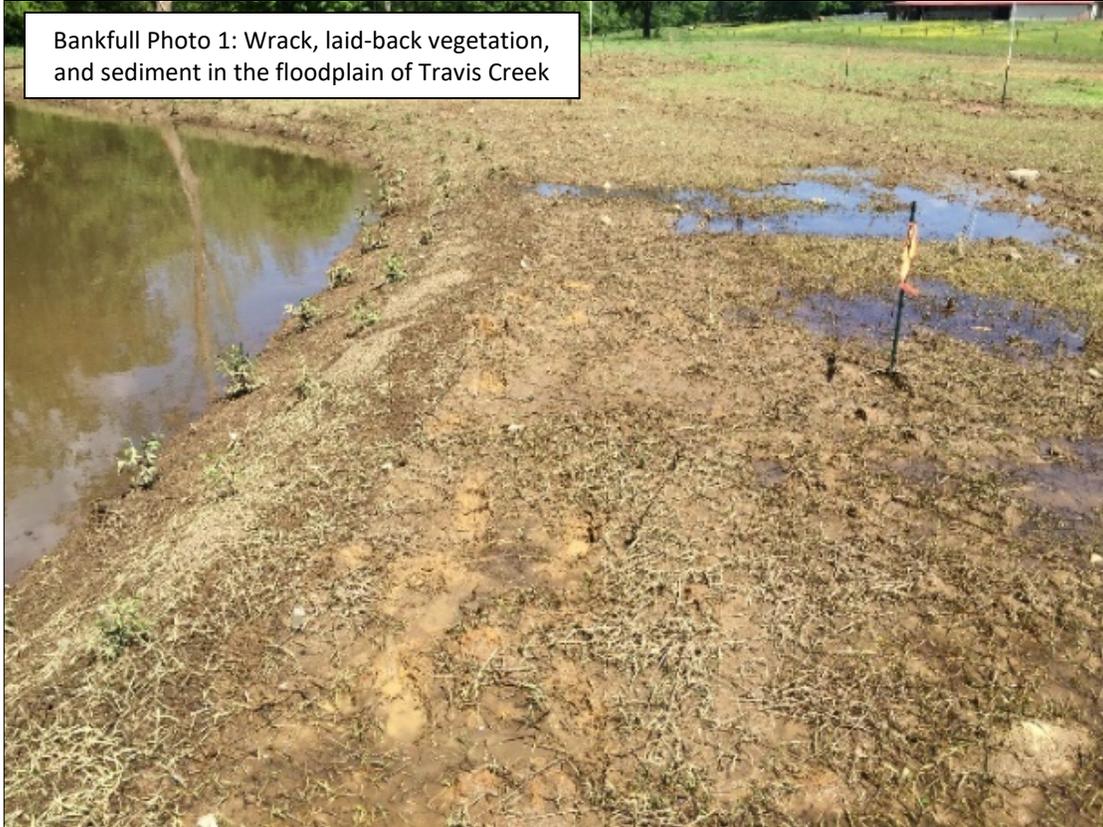
Bankfull Photo 1: Wrack, laid-back vegetation, and sediment in the floodplain of Travis Creek

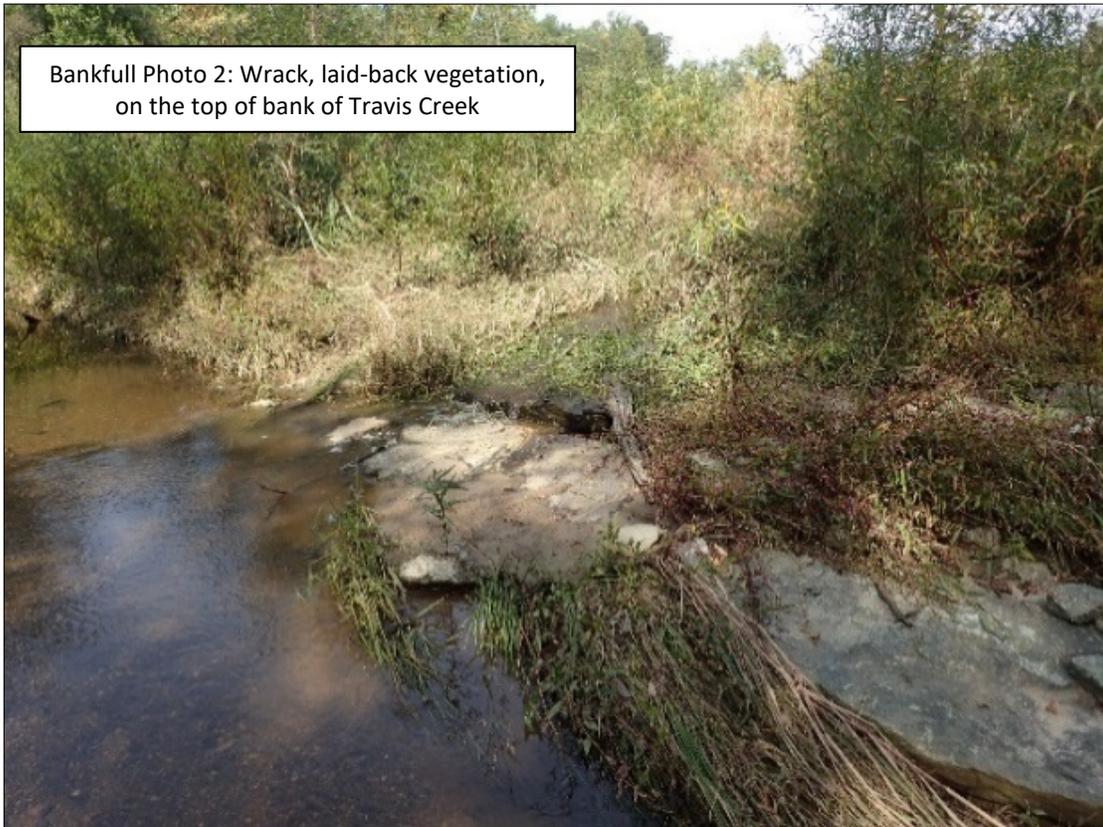
Bankfull Photo 2: Wrack, laid-back vegetation, on the top of bank of Travis Creek

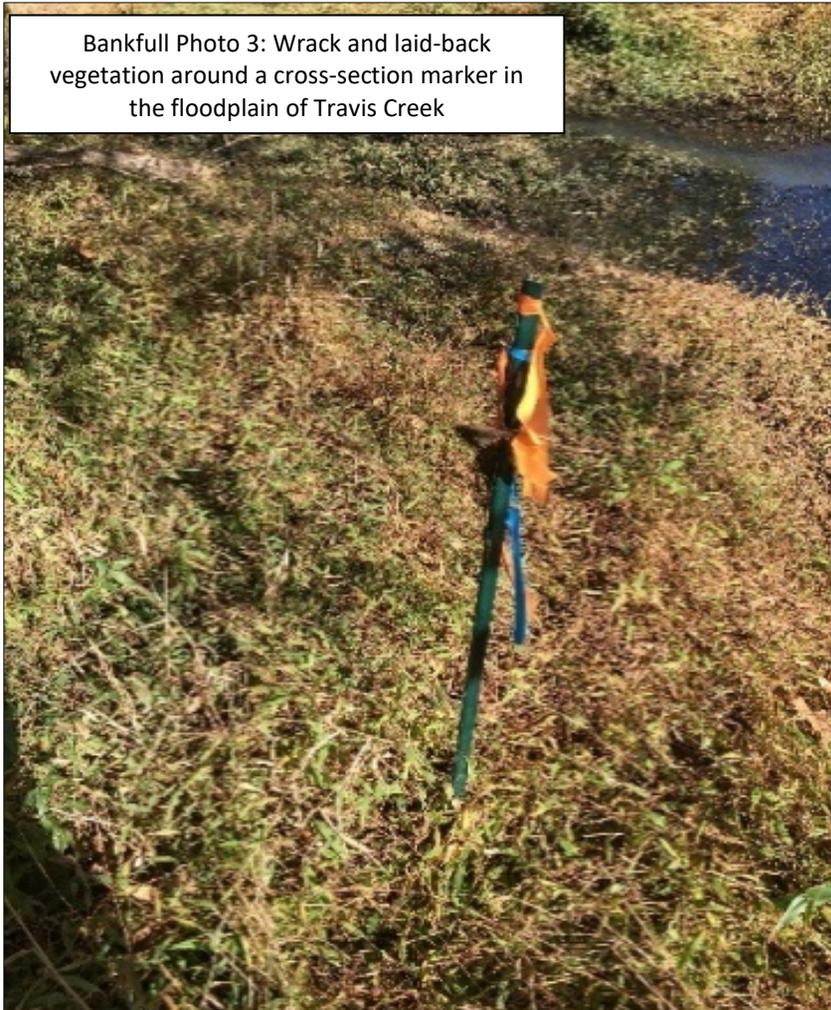
Bankfull Photo 3: Wrack and laid-back vegetation around a cross-section marker in the floodplain of Travis Creek

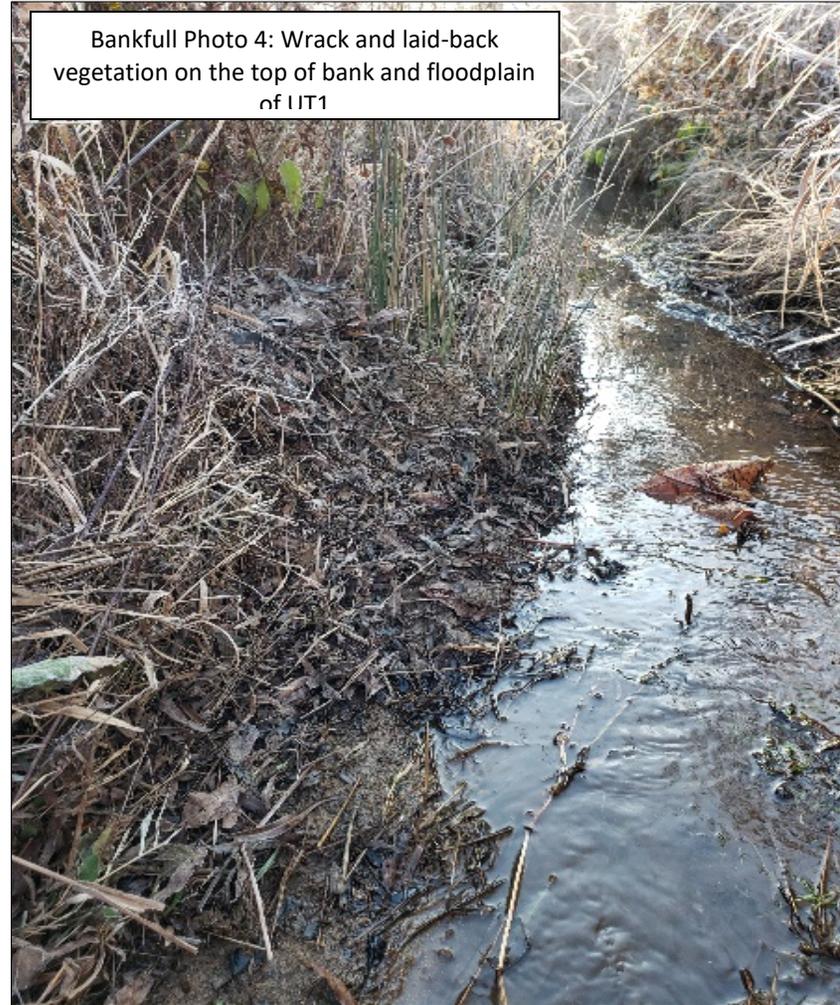
Bankfull Photo 4: Wrack and laid-back vegetation on the top of bank and floodplain of IIT1

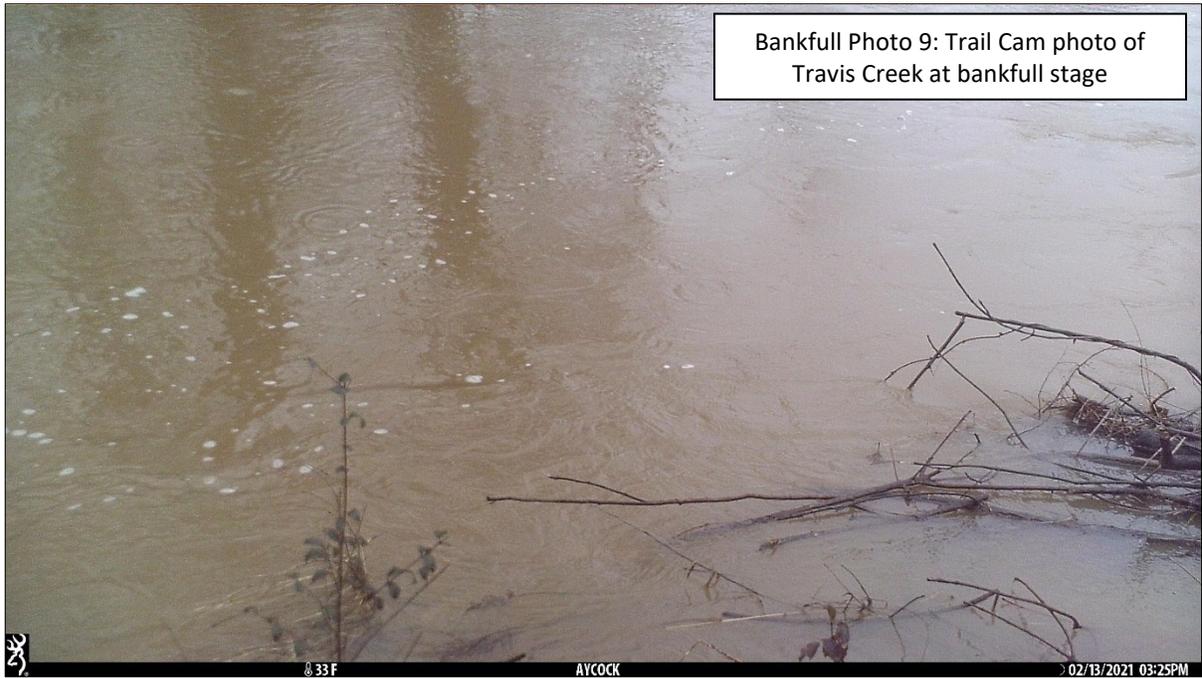
Bankfull Photo 9: Trail Cam photo of Travis Creek at bankfull stage

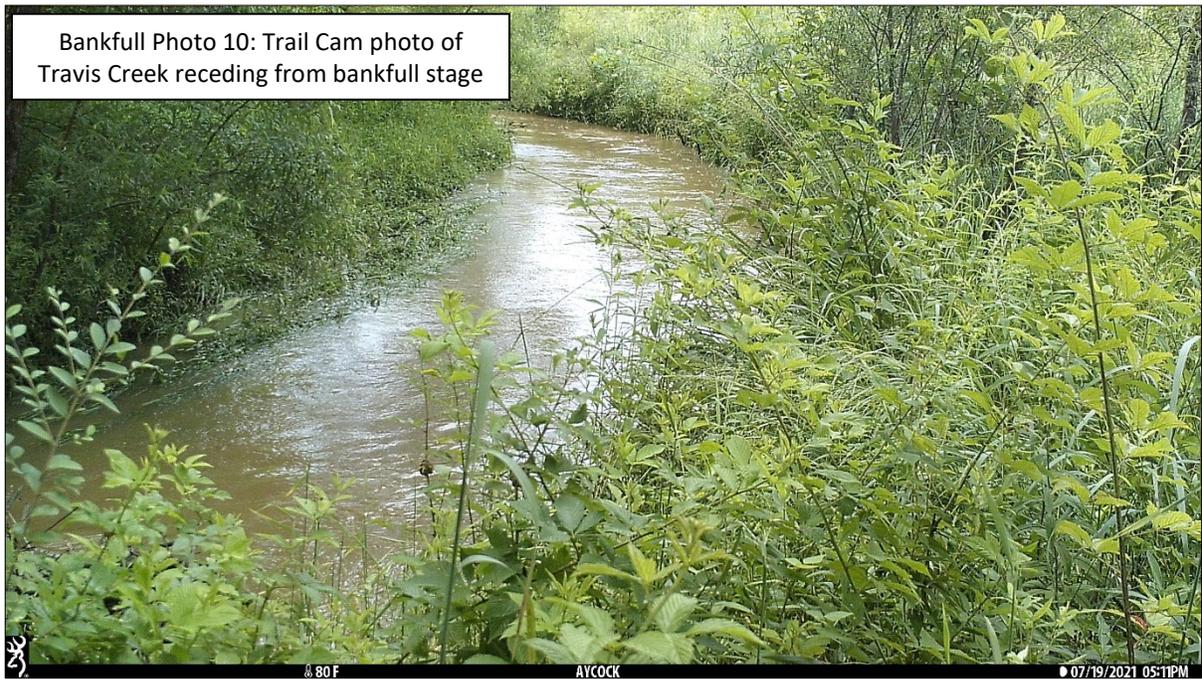
Bankfull Photo 10: Trail Cam photo of Travis Creek receding from bankfull stage

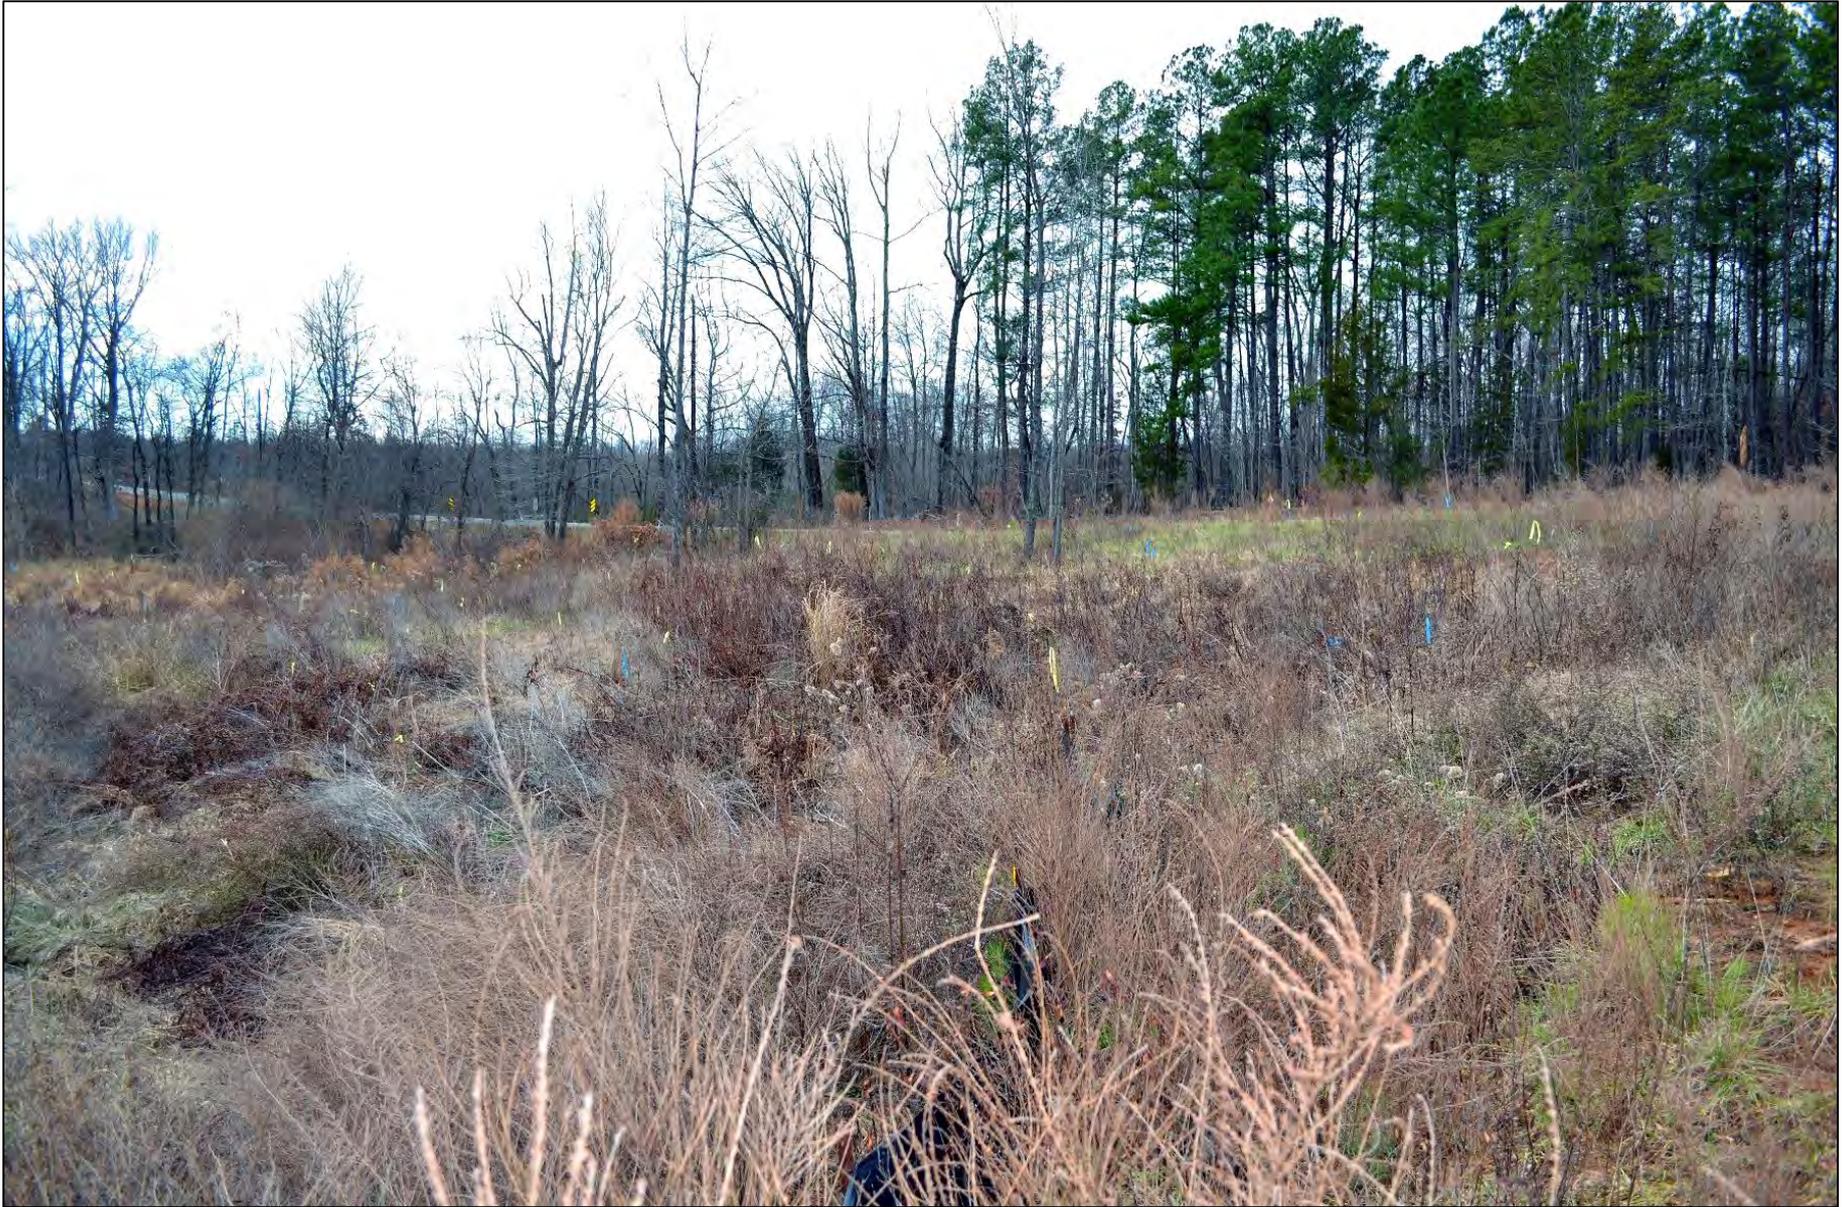
Photo 1: Looking SW. along Replant Area -1

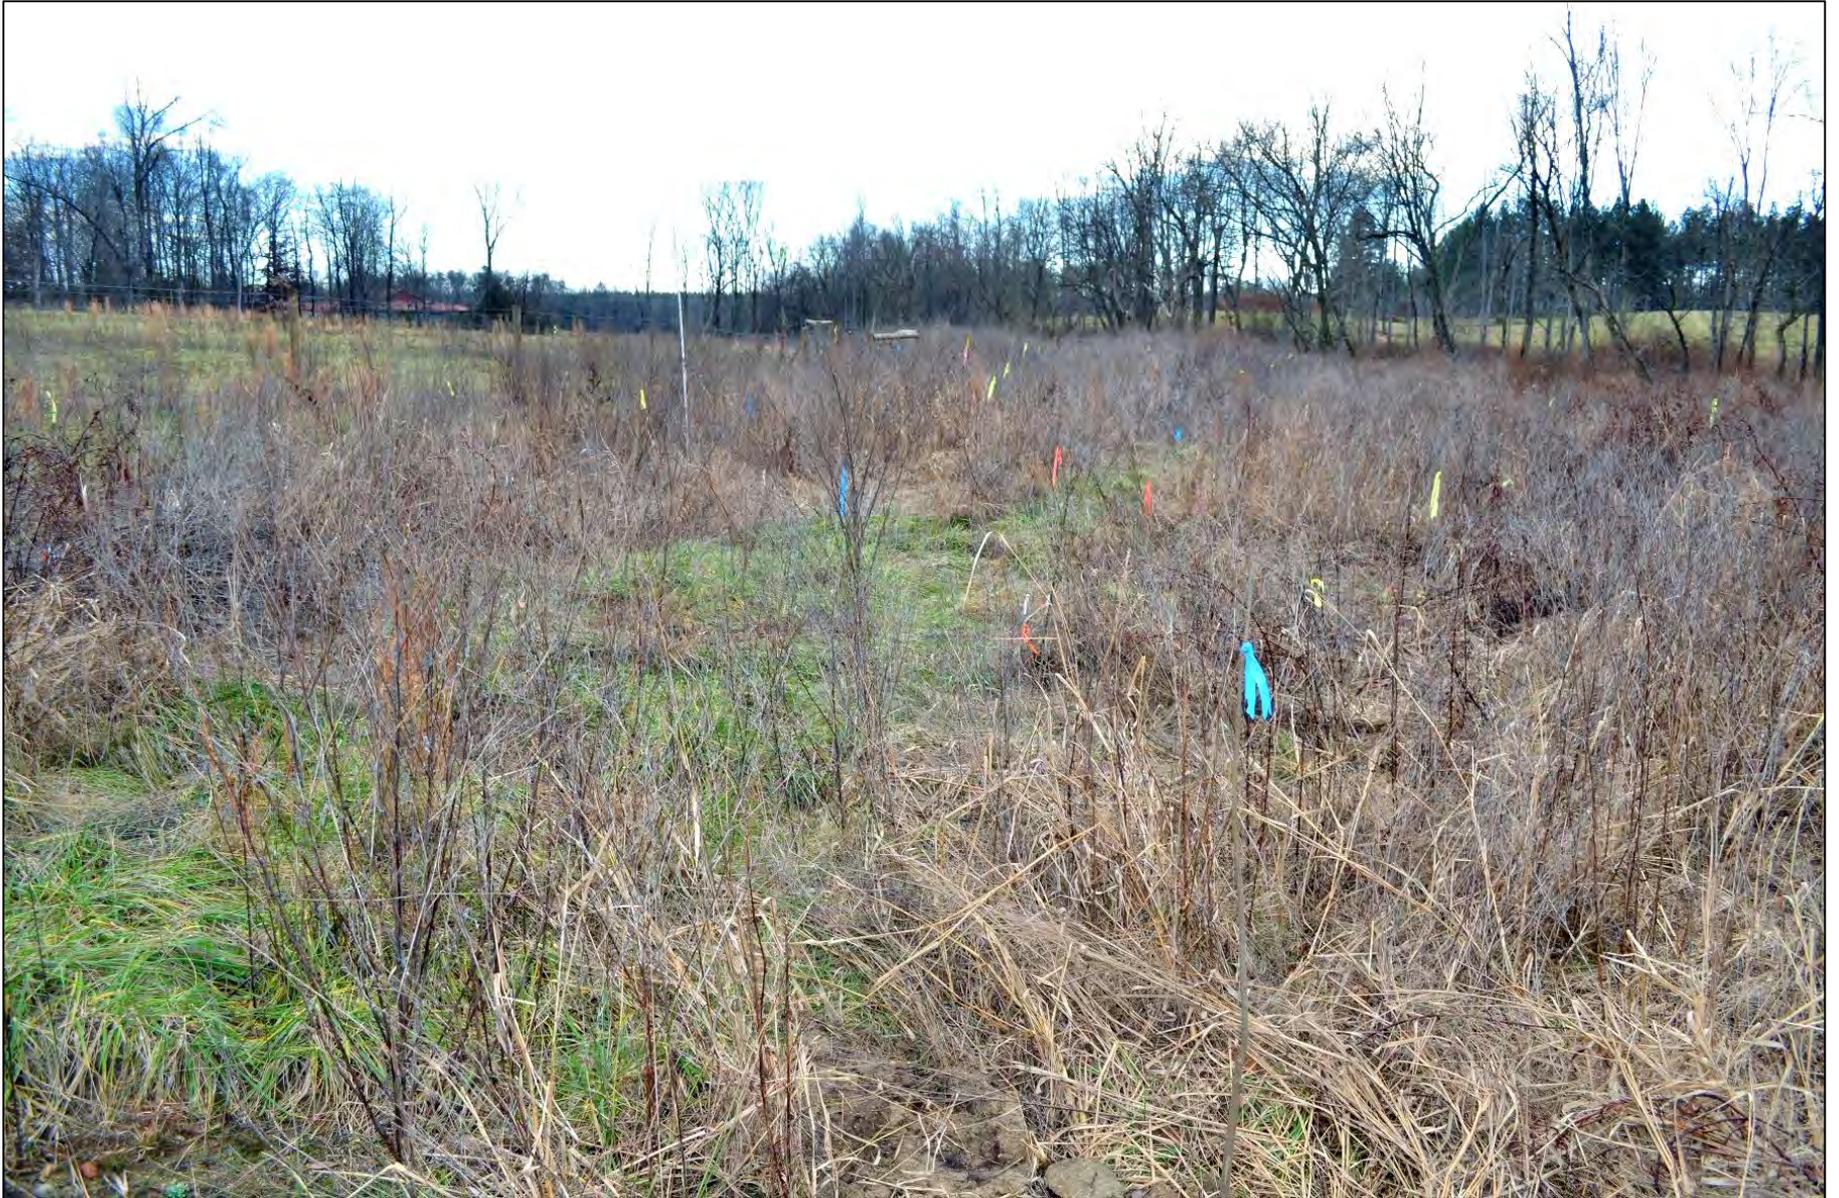
Photo 2: Looking S. in Replant Area 2, just N. of veg. plot 14

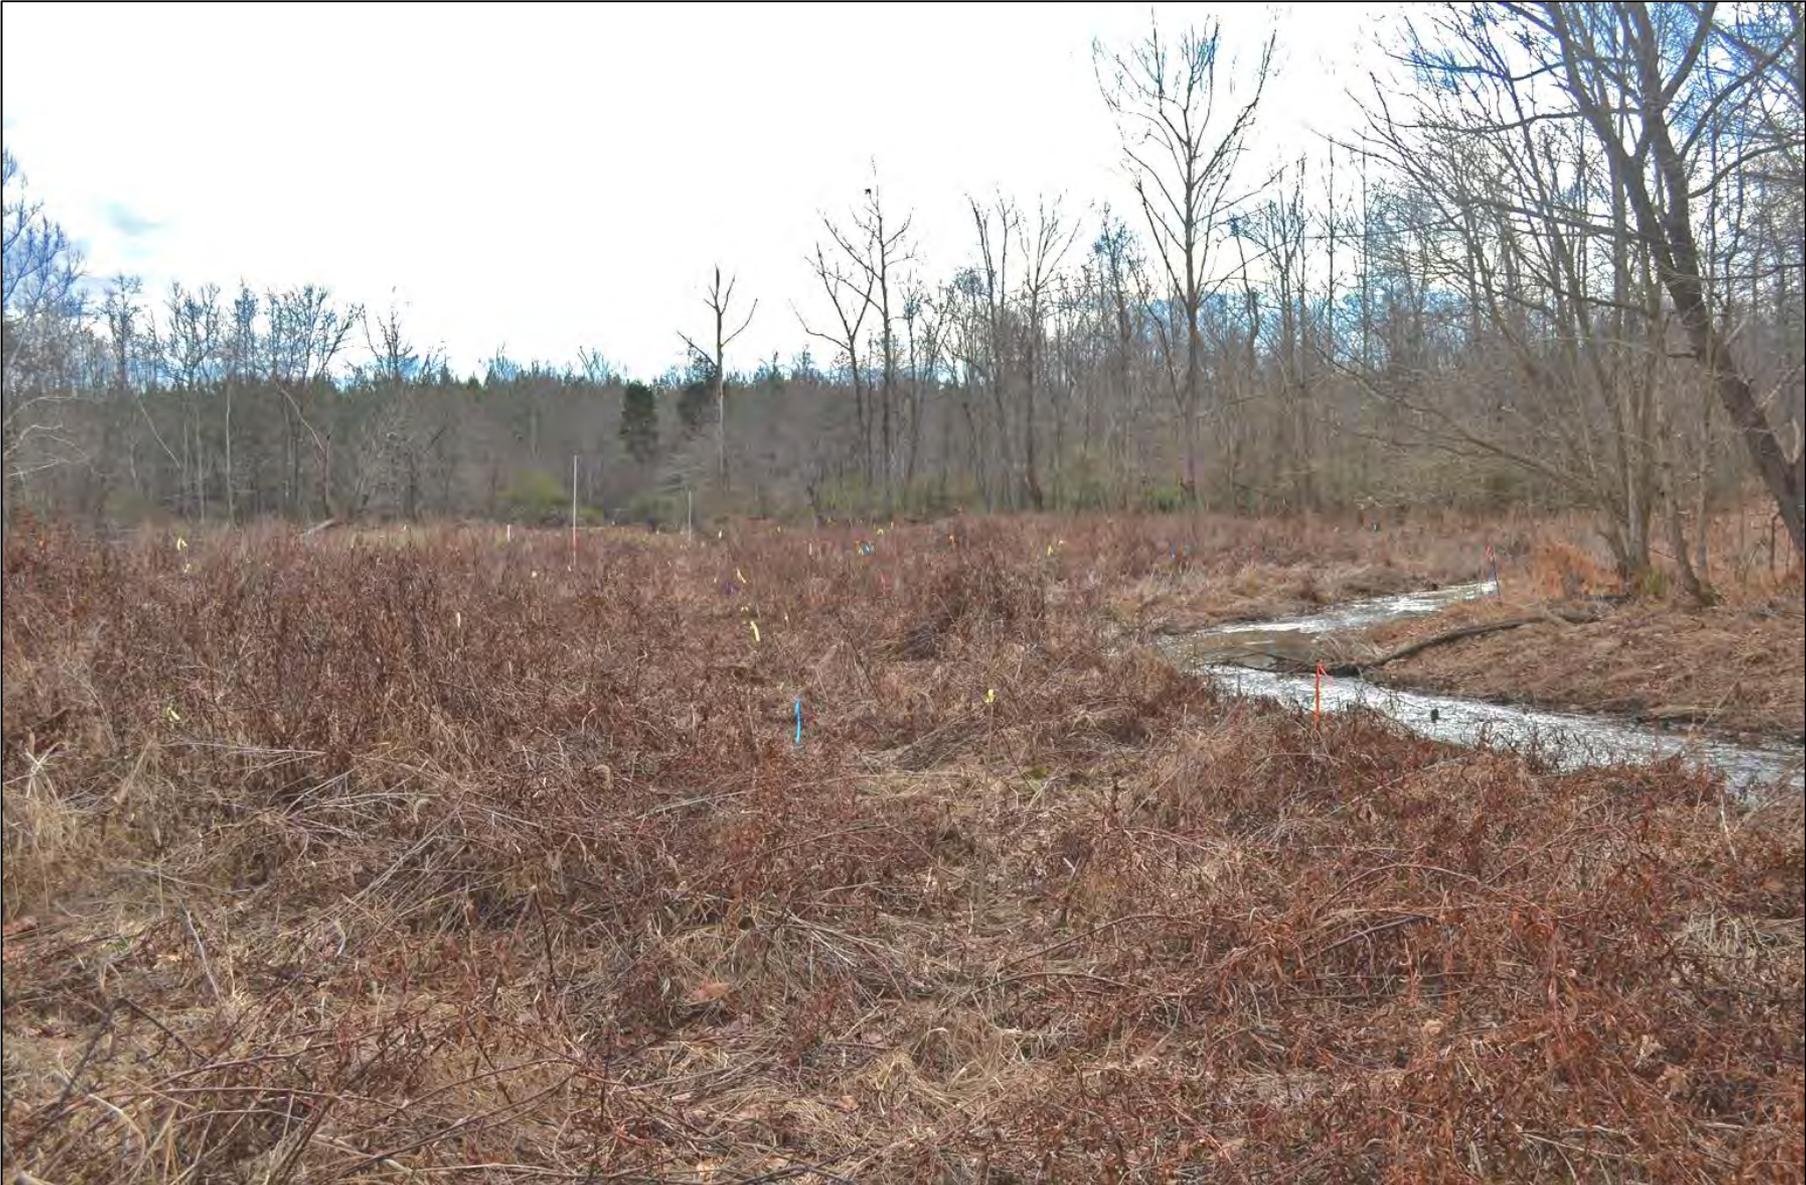
Photo 3: Looking SE. in Replant Area 4, near veg. plot 9

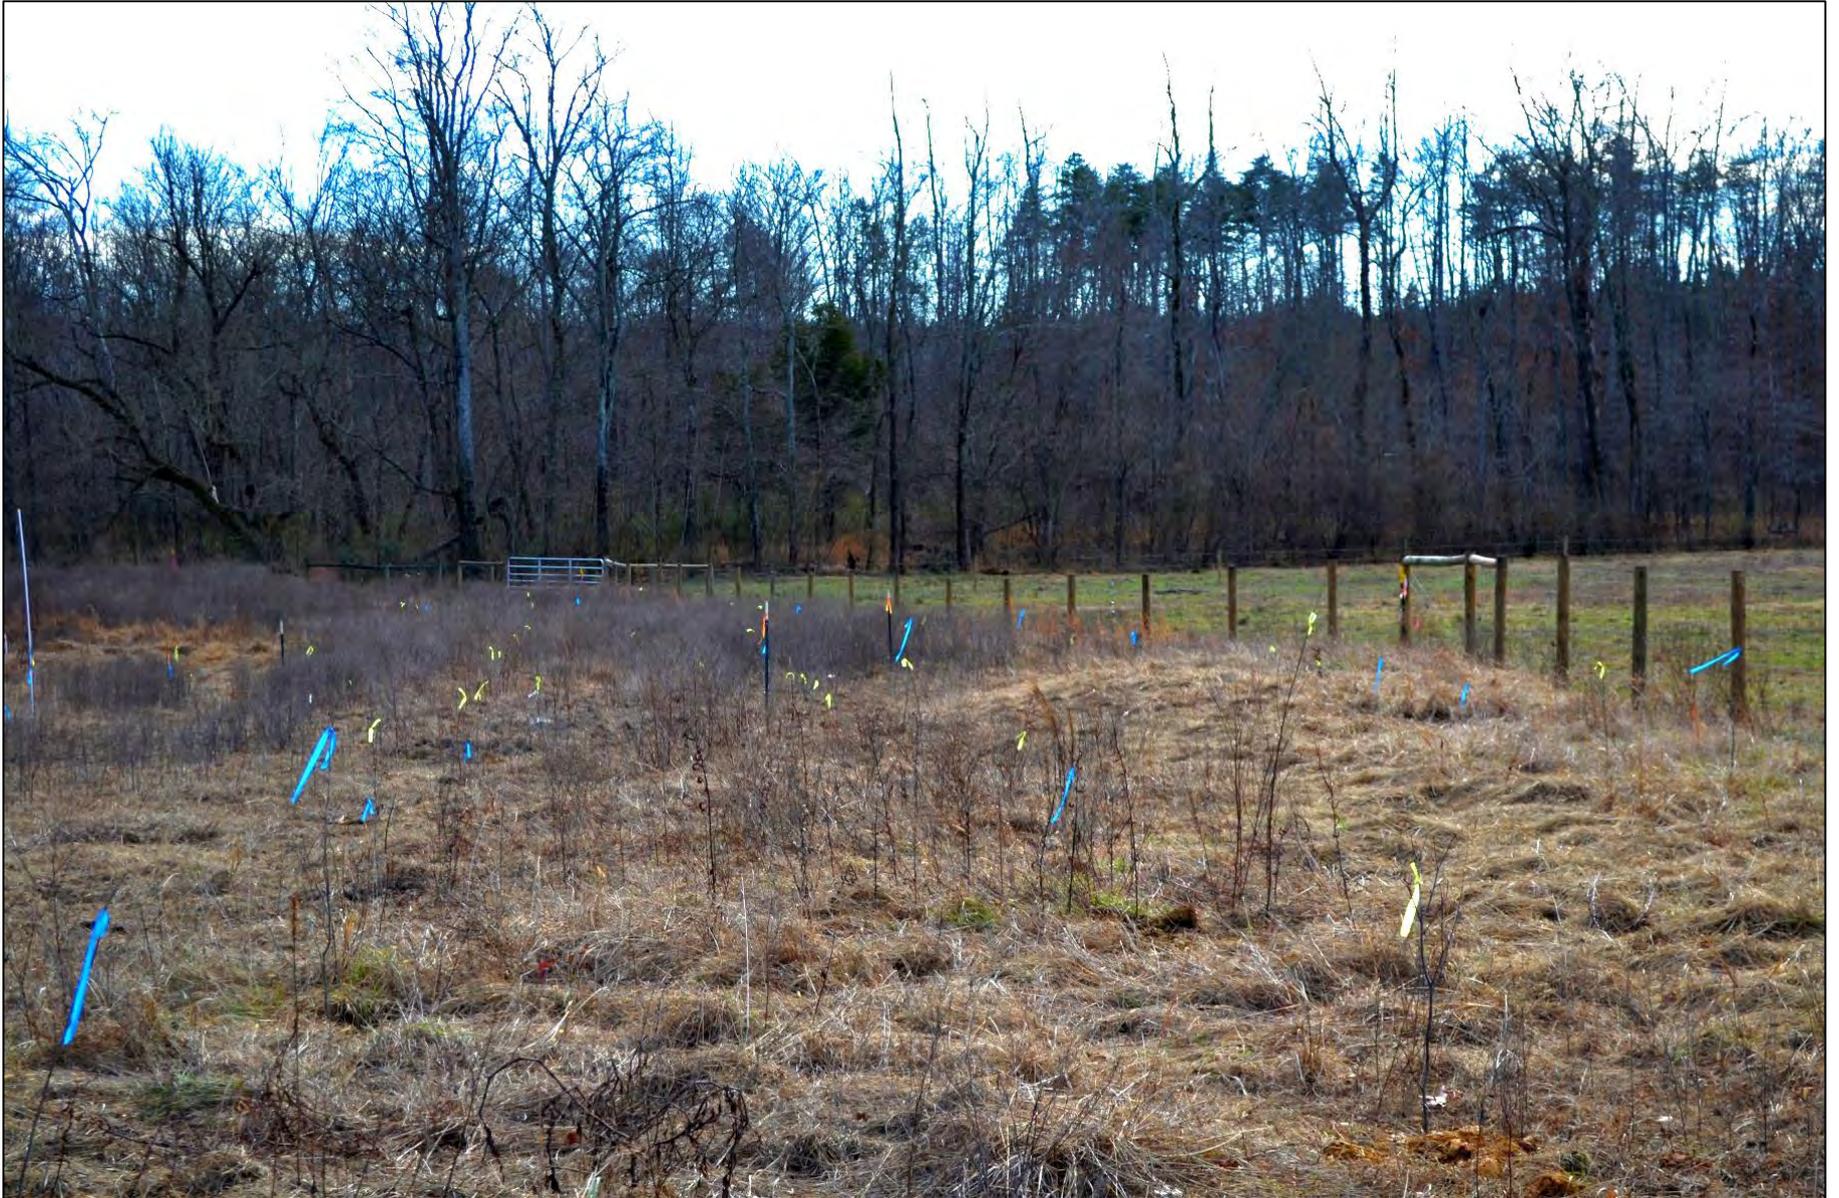
Photo 5: Looking S. in Replant Area 5, N. of veg. plot 5

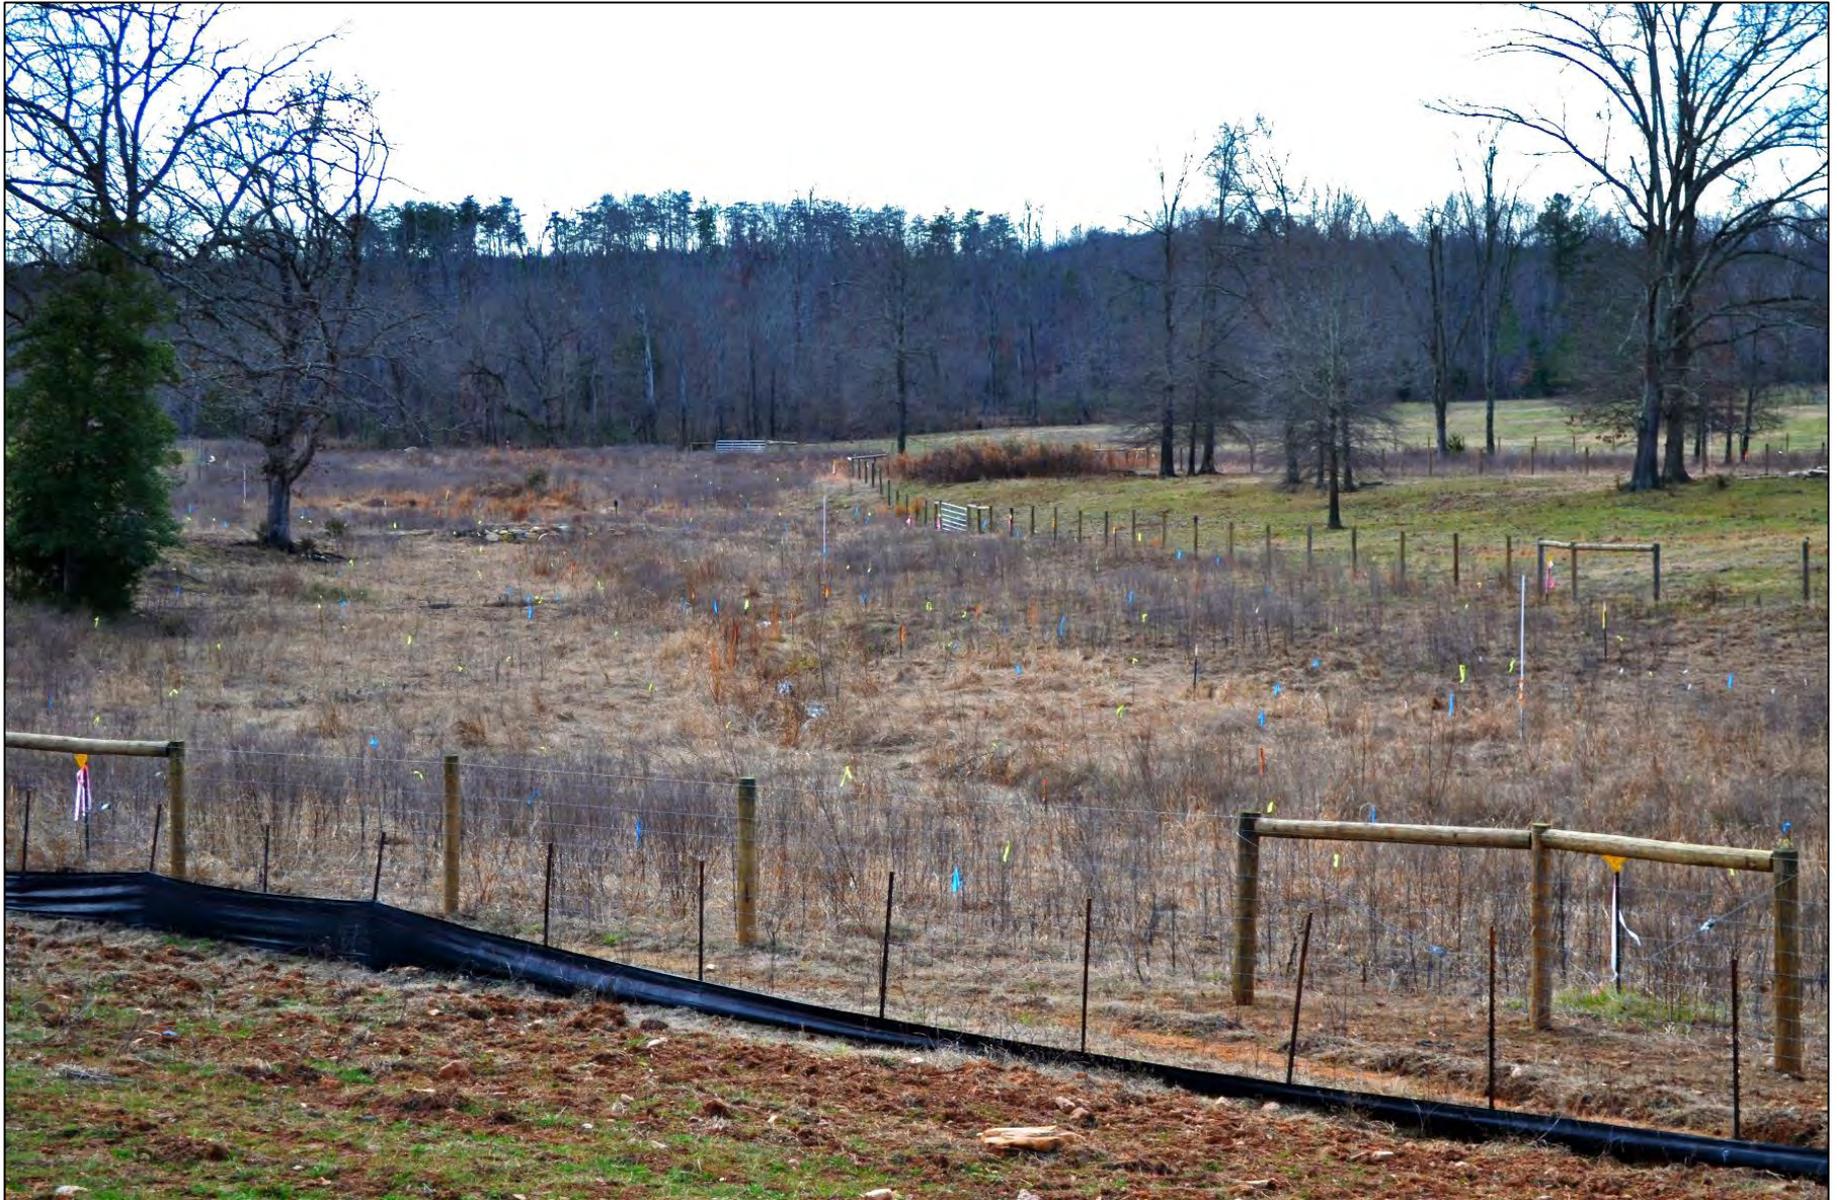
Photo 4: Looking S. in Replant Area 6, from outside of the easement

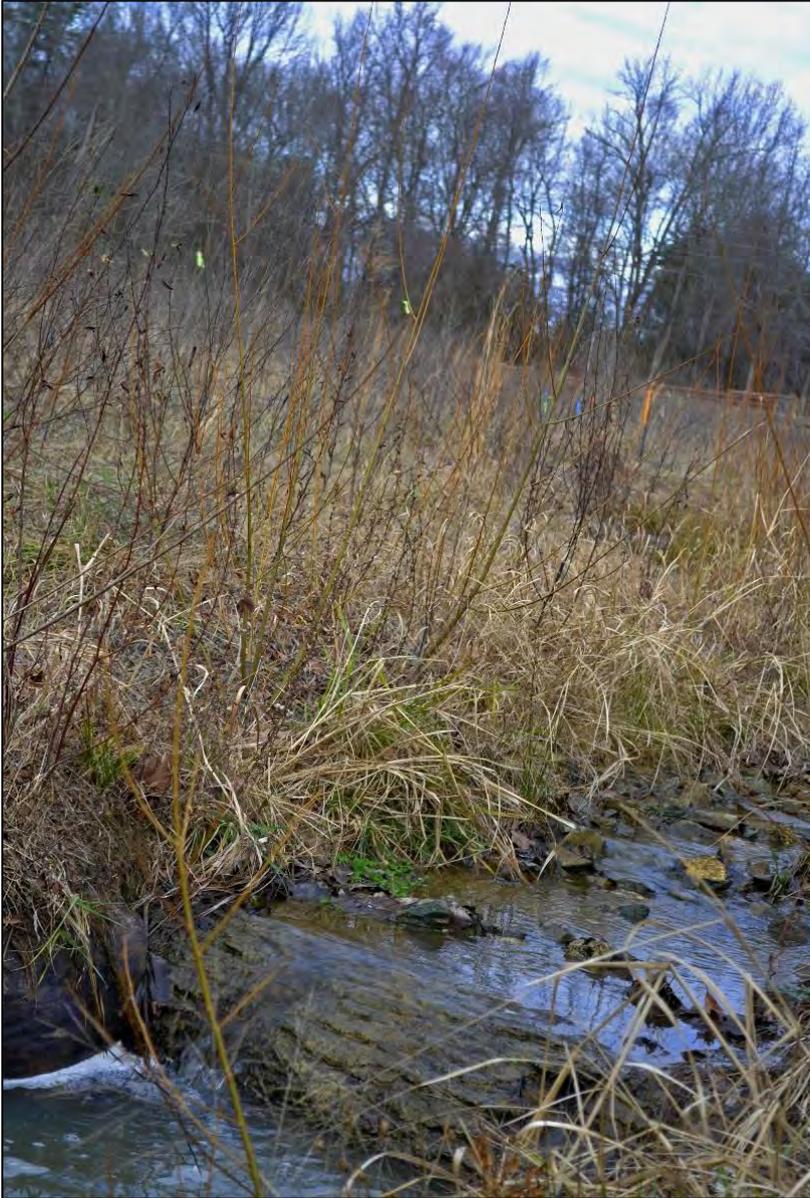
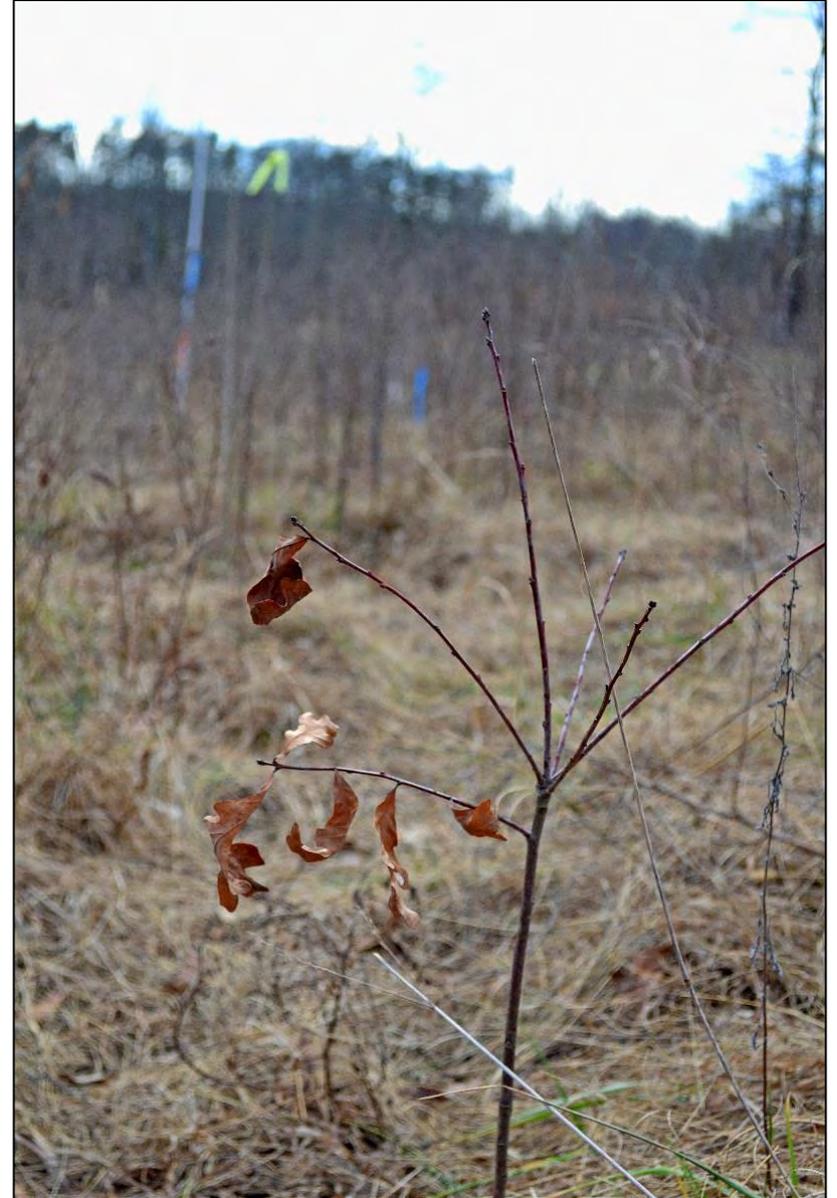
Photo 6 / 7: Live stake establishment on bank in Replant area 6

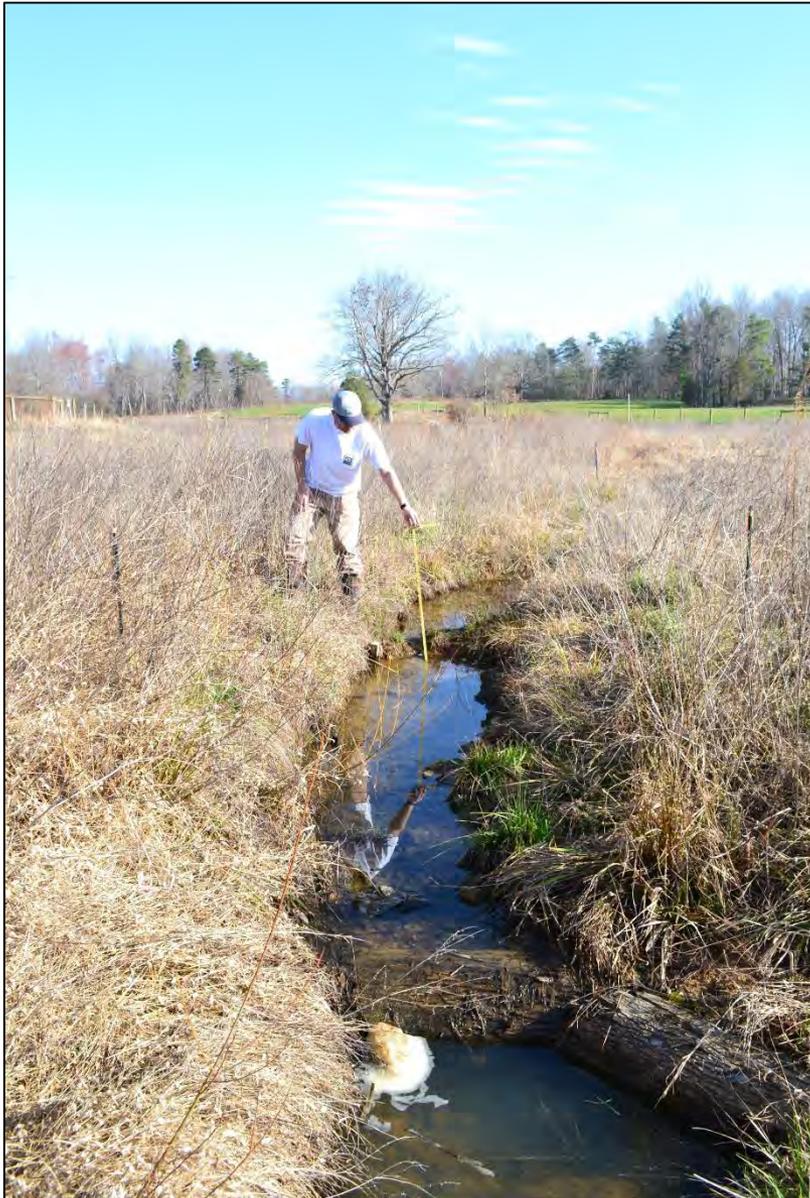
The degradation observed during Year 1 (2016) in and adjacent to cross-sections 9 and 10 on UT-1 encompasses approximately 12 linear feet and 15 linear feet of stream, respectively (<1 percent of the project length). As noted above, the bed material placed during construction was too fine. All of UT-1 used bed material harvested onsite. The material used along this stream reach was too fine and washed from the riffles during heavy rainfall events, resulting in minor bed scour and a small, less than 6-inch head cut, began to develop at the top of the riffle. Suitable sized channel bed material was installed on February 23, 2017, at the proper elevation in the two riffles within UT-1. Bed material was installed such that bank toe protection is provided, and planting with willow stakes occurred. Bank toe protection designates that channel bed material will extend up the lower one-third of the bank. This will be monitored by existing established cross-sections 9 and 10.

Photo 1: Substrate loss, 6" head-cut at UT 1, XC 9

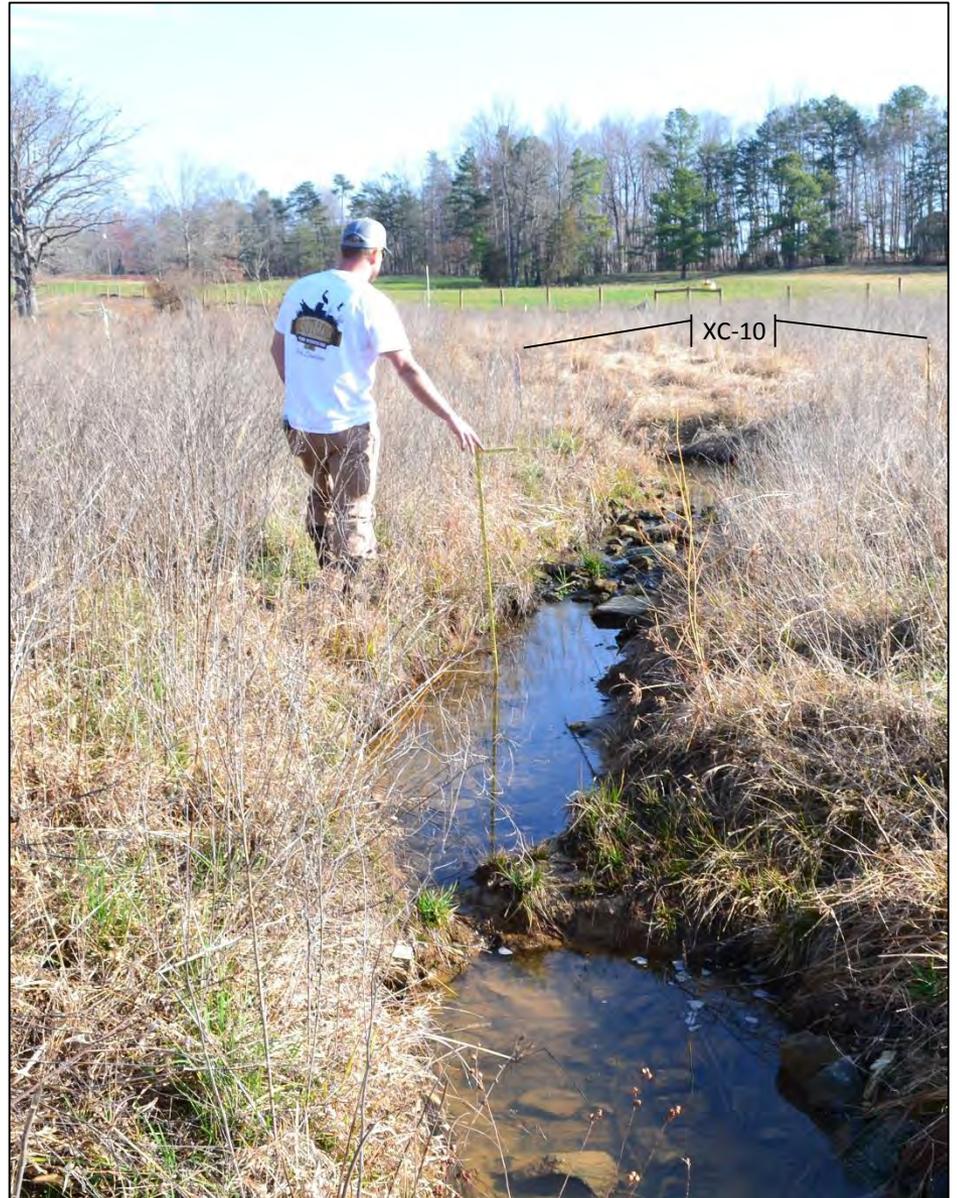
Photo 2: Pool, upstream of 6" head-cut at UT 1, XC 9 (XC 10 in background)

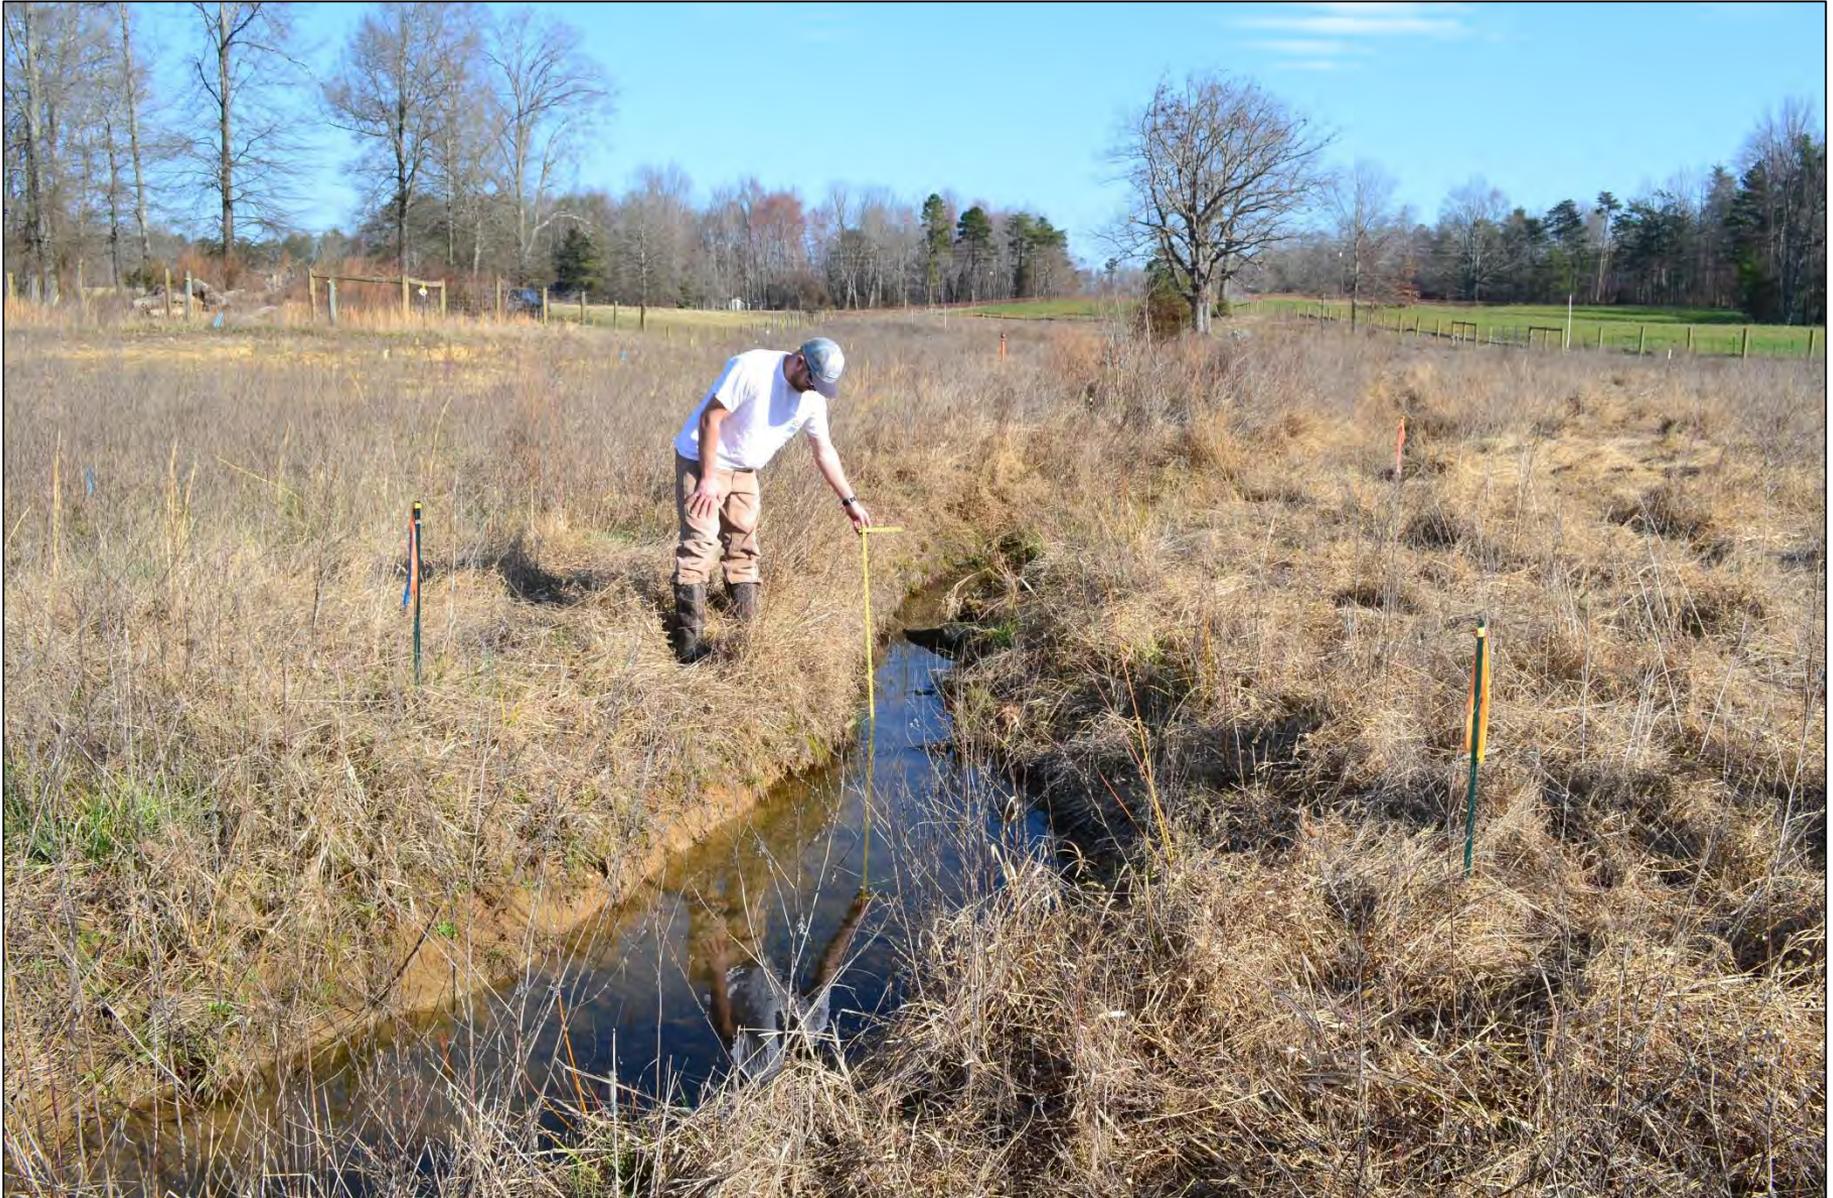
Photo 3: Substrate loss, upstream riffle of XC 10 (pool)
