YEAR 6 (2021) MONITORING REPORT
AYCOCK SPRINGS
STREAM AND WETLAND MITIGATION SITE

ALAMANCE COUNTY, NORTH CAROLINA
DMS PROJECT No. 96312
FULL DELIVERY CONTRACT No. 5791
NCDWR PROJECT No. 20140335
USACE ACTION ID No. SAW-2014-01711

Data Collection – January-October 2021

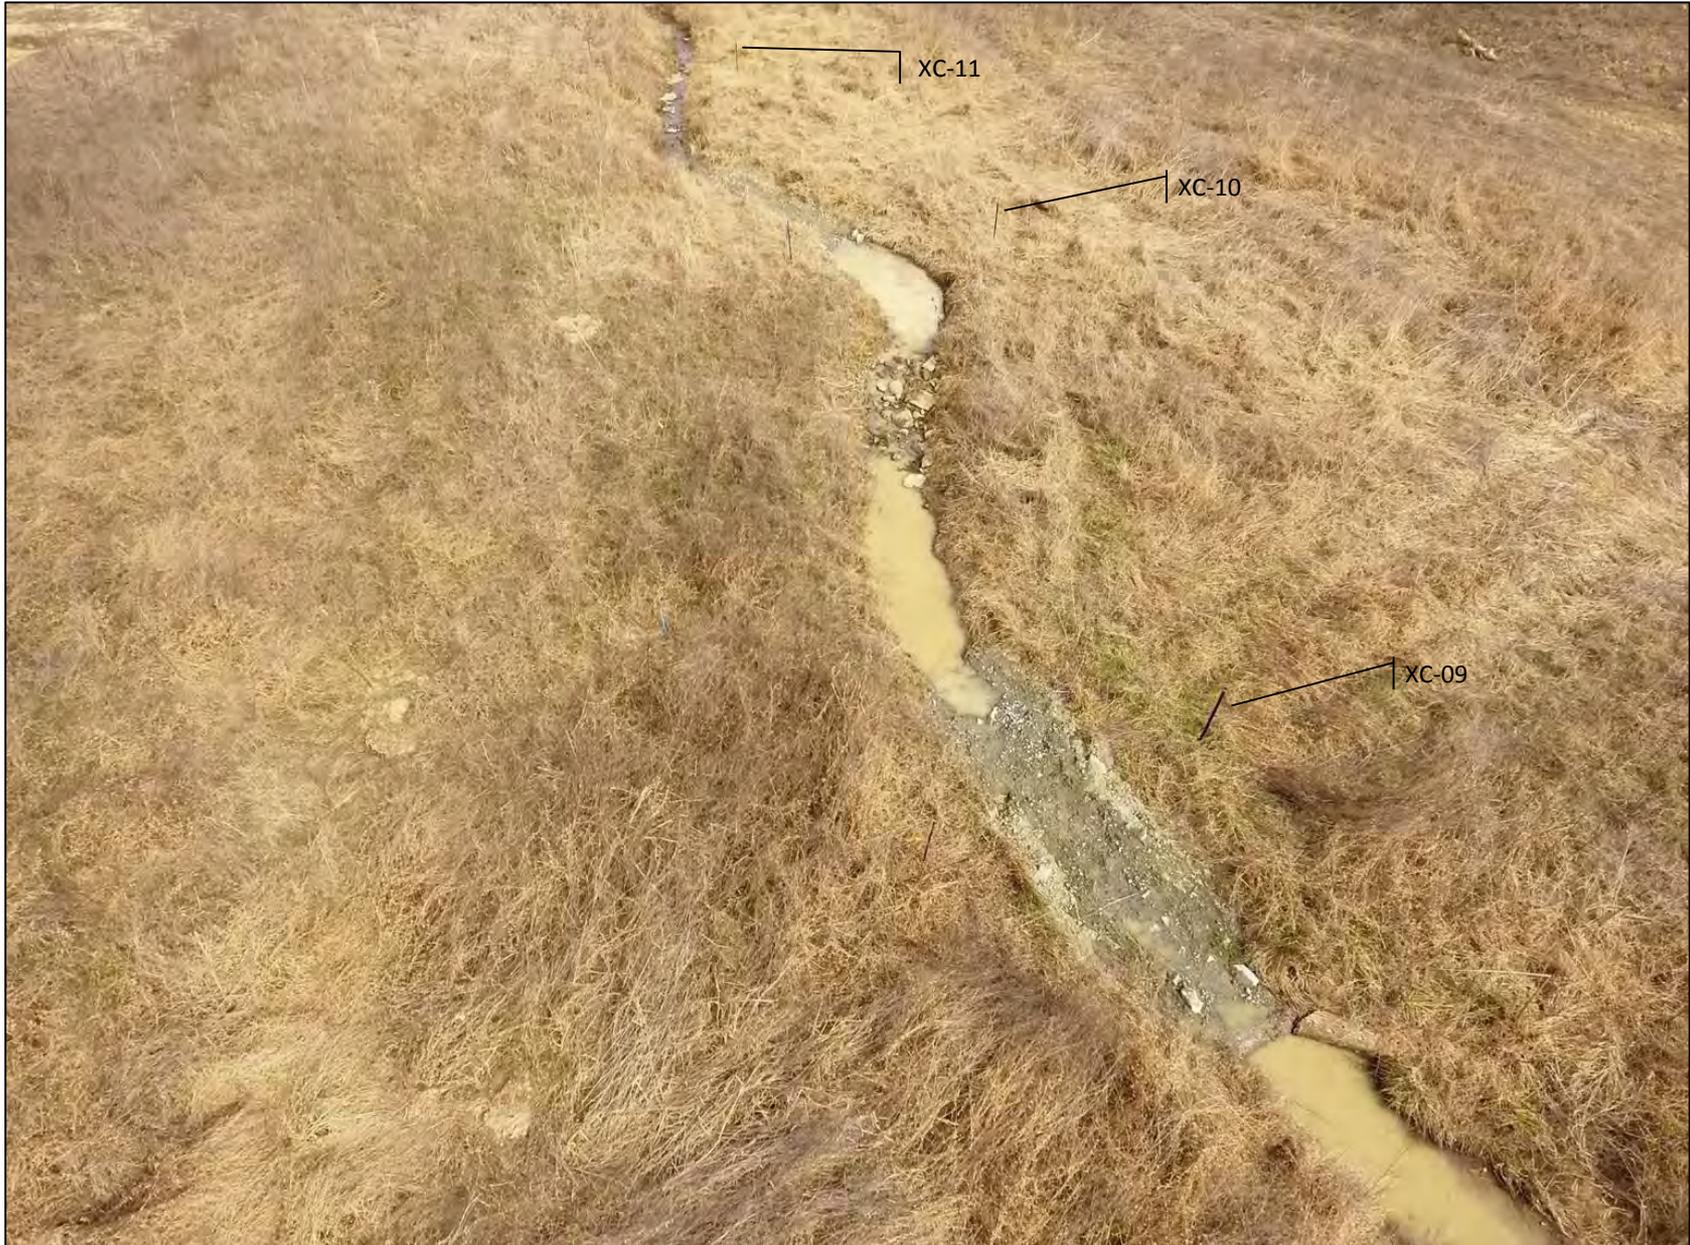
Photo 5: post replacement overview

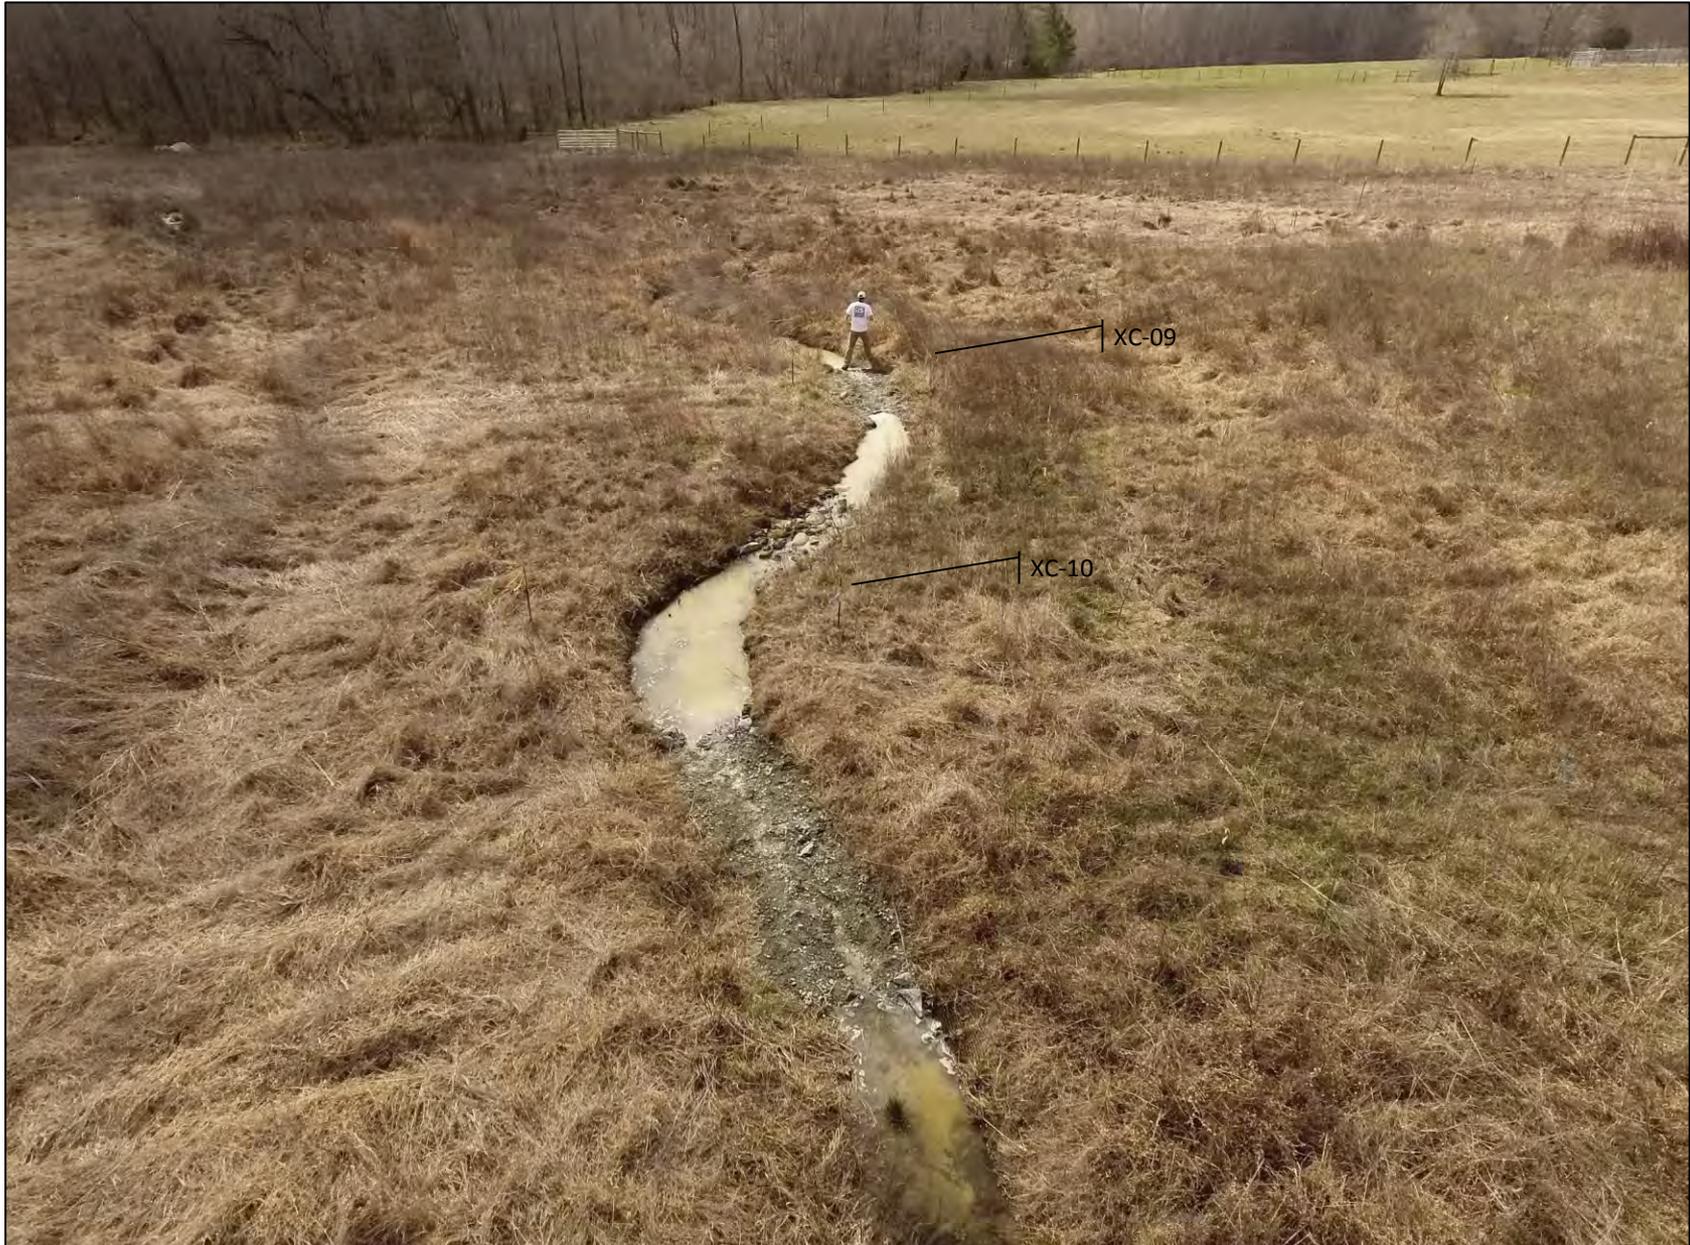
Photo 6: UT-1 looking downstream from XC-11

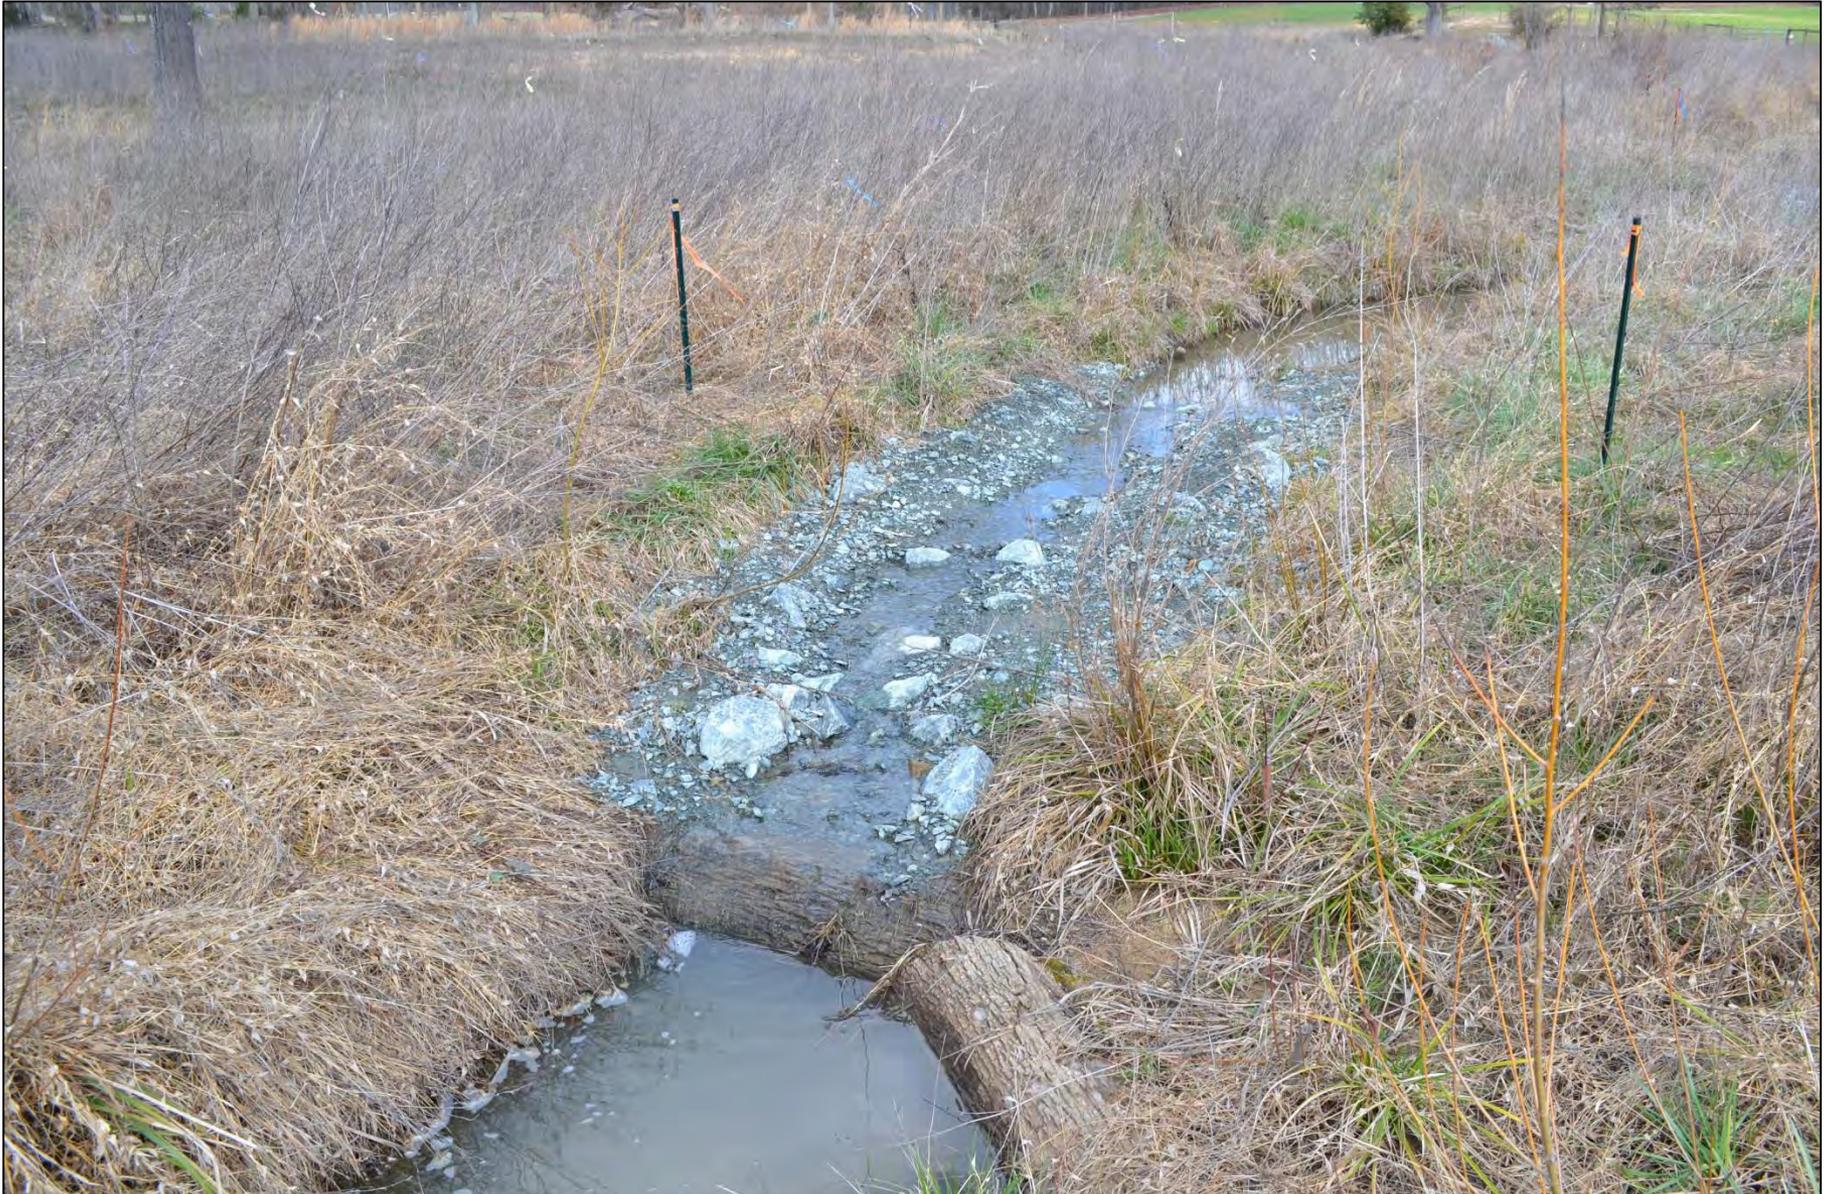
Photo 7: XC-9 – Post 3-1-2017 0.92 inch rain event (Per USGS Guage at BUFFALO CREEK (SR2819 NR MCLEANSVILLE, NC) ~ 7 miles from Site
