MY1 FINAL MONITORING REPORT
Banner Branch Mitigation Project
Stokes County
Roanoke River Basin
CU 03010103

DMS Project # 100080
DMS Contract # 7610 and 7701
DMS RFP # 16-007405
USACE Action ID Number SAW-2018-01760
DWR Project # 18-1154
Calendar Year of Data Collection: 2021

December 29, 2021

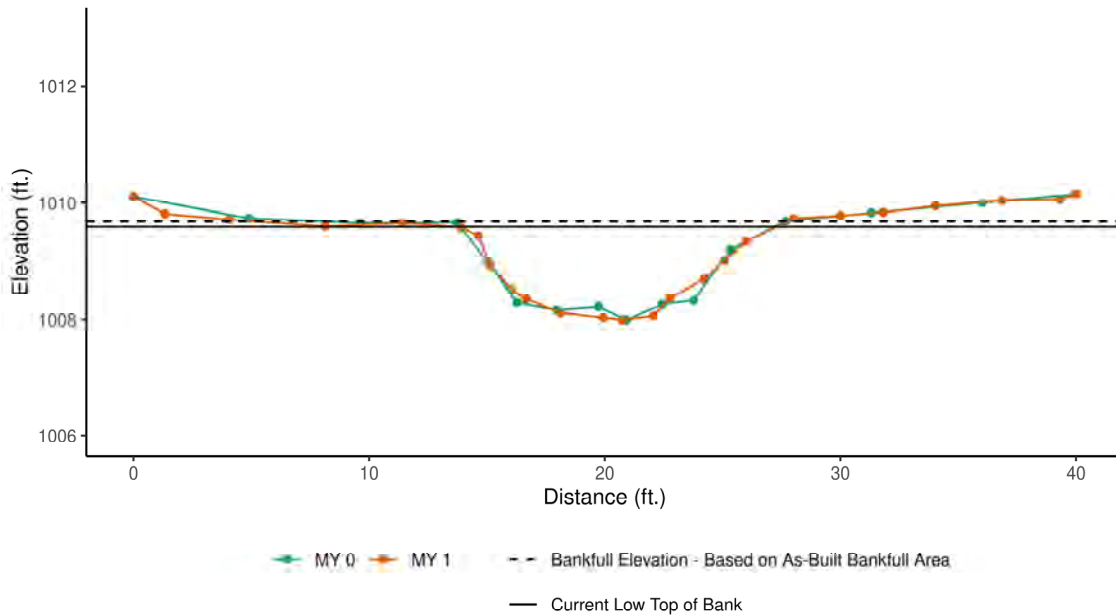
Cross-Section 1 (BB-R1 - Riffle) MY1

MY0	MY1	MY2	MY3	MY4	MY5	MY6	MY7
Bankfull Elevation - Based on As-Built Bankfull Area	1009.67	1009.68						
Bank Height Ratio - Based on As-Built Bankfull Area	1.00	0.94						
Thalweg Elevation	1008.00	1008.00						
LTOB Elevation	1009.67	1009.59						
LTOB Max Depth	1.675	1.594						
LTOB Cross Sectional Area	14.77	13.52

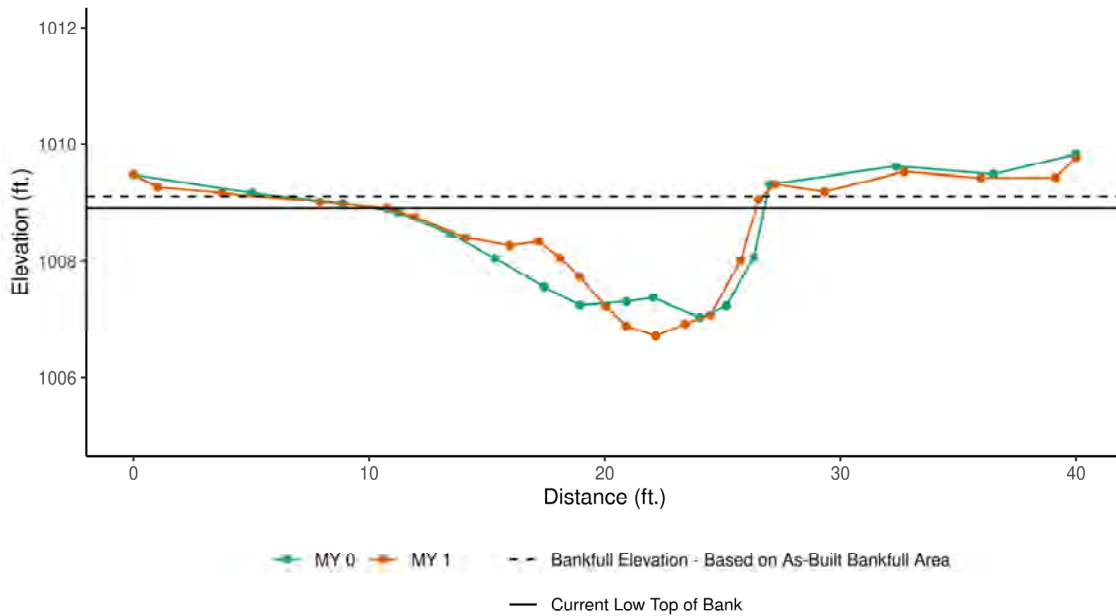
Cross-Section 2 (BB-R1 - Pool) MY1

MY0	MY1	MY2	MY3	MY4	MY5	MY6	MY7
Bankfull Elevation - Based on As-Built Bankfull Area	1008.99	1009.12						
Bank Height Ratio - Based on As-Built Bankfull Area	1.00	0.91						
Thalweg Elevation	1007.03	1006.72						
LTOB Elevation	1008.99	1008.91						
LTOB Max Depth	1.961	2.192						
LTOB Cross Sectional Area	19.91	16.61

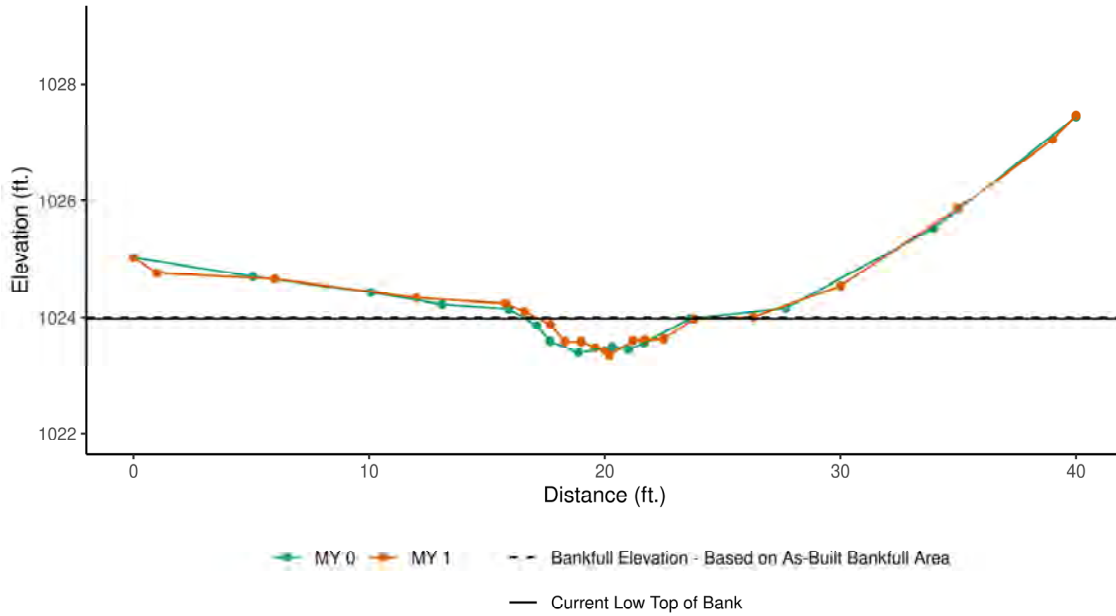
Cross-Section 3 (UT2 - Riffle) MY1

MY0	MY1	MY2	MY3	MY4	MY5	MY6	MY7
Bankfull Elevation - Based on As-Built Bankfull Area	1023.98	1024.00						
Bank Height Ratio - Based on As-Built Bankfull Area	1.00	0.96						
Thalweg Elevation	1023.45	1023.36						
LTOB Elevation	1023.98	1023.98						
LTOB Max Depth	0.527	0.62						
LTOB Cross Sectional Area	2.36	2.21

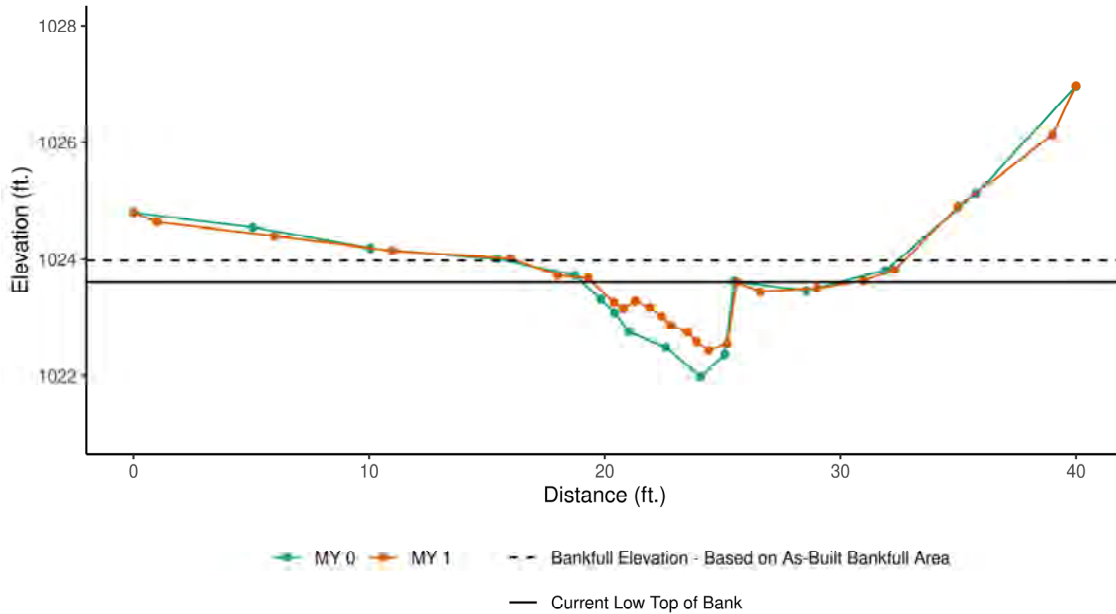
Cross-Section 4 (UT2 - Pool) MY1

MY0	MY1	MY2	MY3	MY4	MY5	MY6	MY7
Bankfull Elevation - Based on As-Built Bankfull Area	1023.62	1023.98						
Bank Height Ratio - Based on As-Built Bankfull Area	1.00	0.75						
Thalweg Elevation	1021.98	1022.44						
LTOB Elevation	1023.62	1023.60						
LTOB Max Depth	1.635	1.16						
LTOB Cross Sectional Area	6.12	3.82

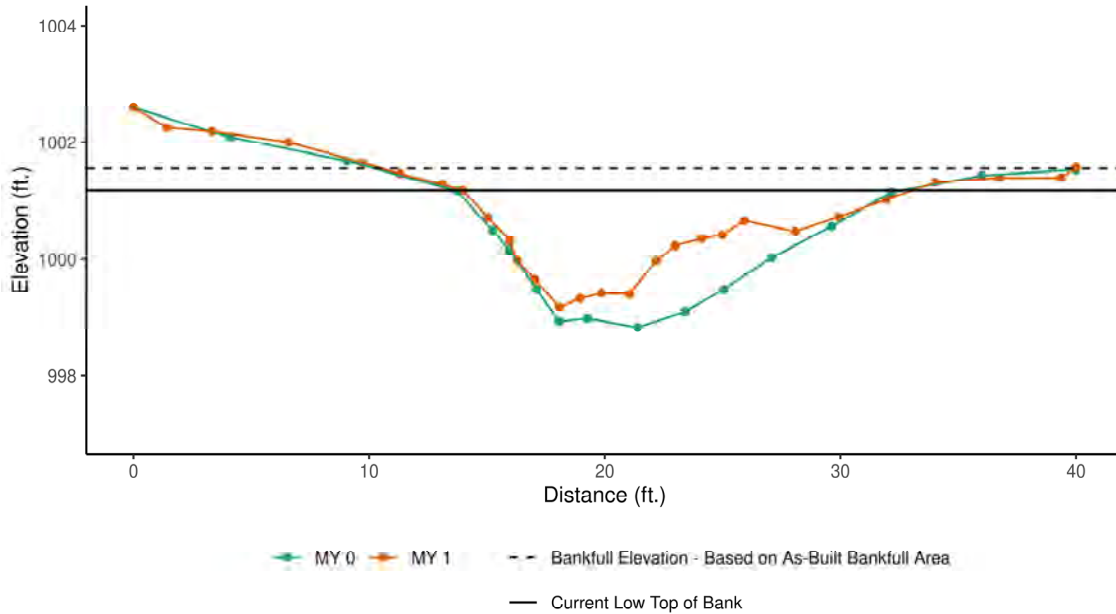
Cross-Section 5 (BB-R2 - Pool) MY1

MY0	MY1	MY2	MY3	MY4	MY5	MY6	MY7
Bankfull Elevation - Based on As-Built Bankfull Area	1001.15	1001.56						
Bank Height Ratio - Based on As-Built Bankfull Area	1.00	0.84						
Thalweg Elevation	998.94	999.18						
LTOB Elevation	1001.15	1001.18						
LTOB Max Depth	2.217	2.005						
LTOB Cross Sectional Area	24.67	17.50

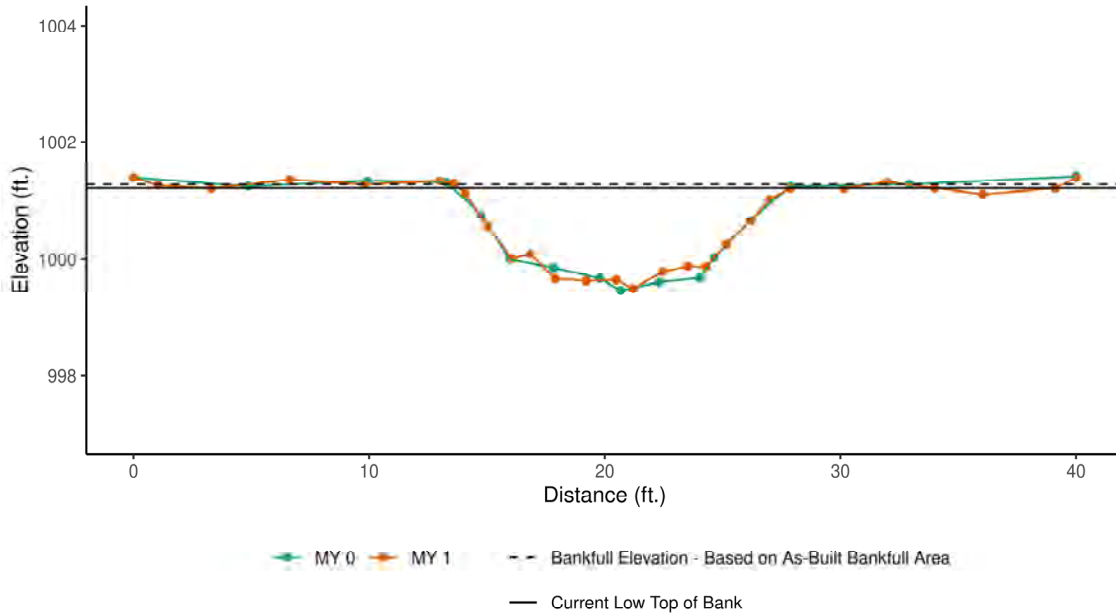
Cross-Section 6 (BB-R2 - Riffle) MY1

MY0	MY1	MY2	MY3	MY4	MY5	MY6	MY7
Bankfull Elevation - Based on As-Built Bankfull Area	1001.25	1001.29						
Bank Height Ratio - Based on As-Built Bankfull Area	1.00	0.96						
Thalweg Elevation	999.46	999.49						
LTOB Elevation	1001.25	1001.22						
LTOB Max Depth	1.792	1.729						
LTOB Cross Sectional Area	16.63	15.67

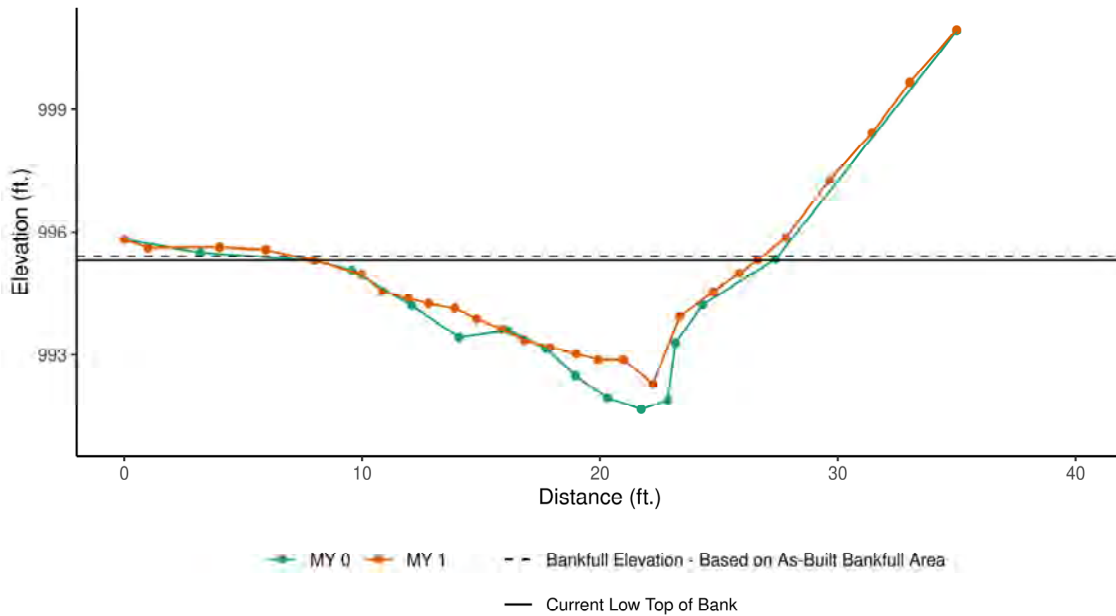
Cross-Section 19 (UT4-R2 - Pool) MY1

MY0	MY1	MY2	MY3	MY4	MY5	MY6	MY7
Bankfull Elevation - Based on As-Built Bankfull Area	995.05	995.40						
Bank Height Ratio - Based on As-Built Bankfull Area	1.00	0.97						
Thalweg Elevation	991.65	992.28						
LTOB Elevation	995.05	995.31						
LTOB Max Depth	3.406	3.031						
LTOB Cross Sectional Area	27.60	25.94

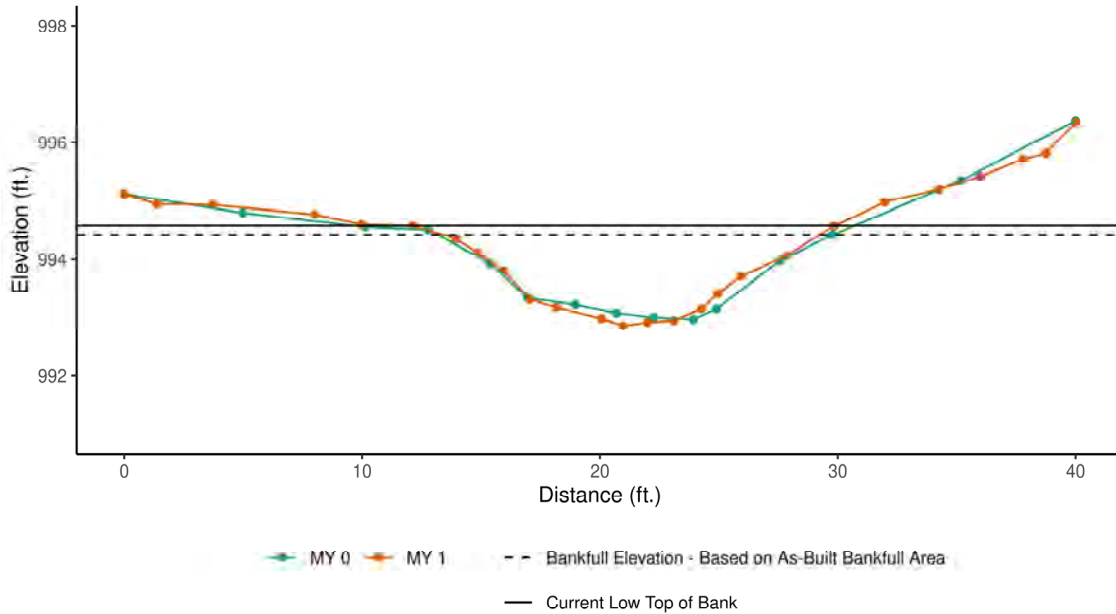
Cross-Section 20 (UT4-R2 - Riffle) MY1

MY0	MY1	MY2	MY3	MY4	MY5	MY6	MY7
Bankfull Elevation - Based on As-Built Bankfull Area	994.42	994.41						
Bank Height Ratio - Based on As-Built Bankfull Area	1.00	1.10						
Thalweg Elevation	993.07	992.86						
LTOB Elevation	994.42	994.58						
LTOB Max Depth	1.342	1.718						
LTOB Cross Sectional Area	14.51	17.20

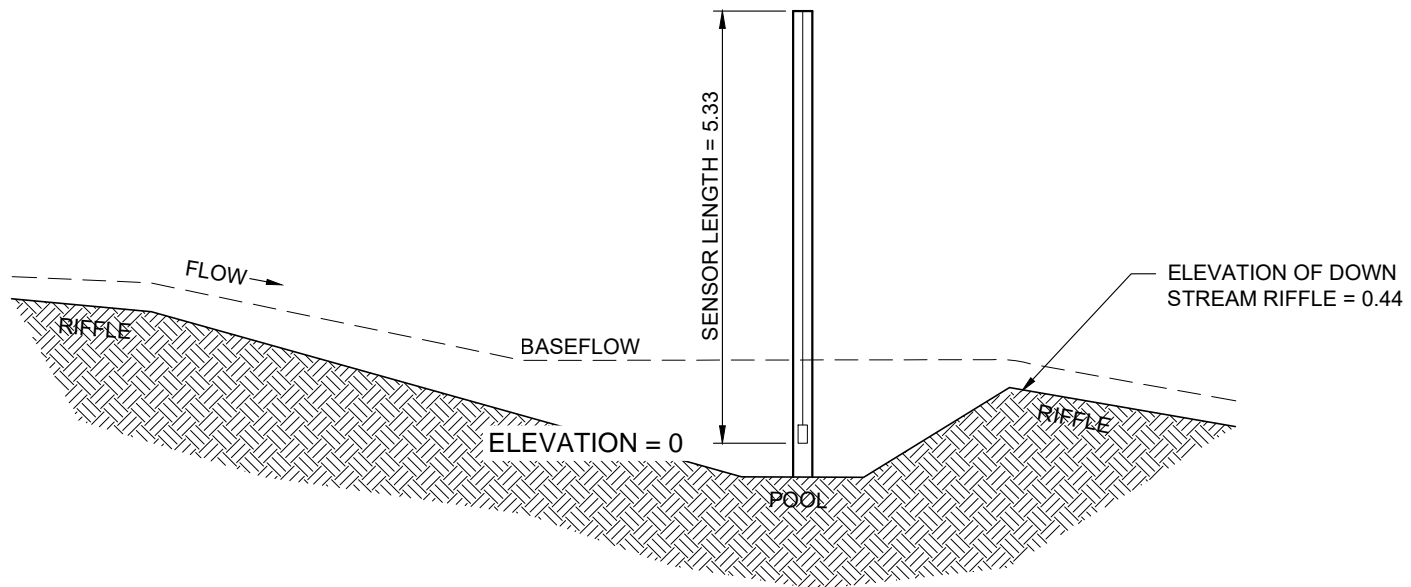
FLOW GAUGE FG-1 (UT1A)

Flow Depth = 0.44 feet

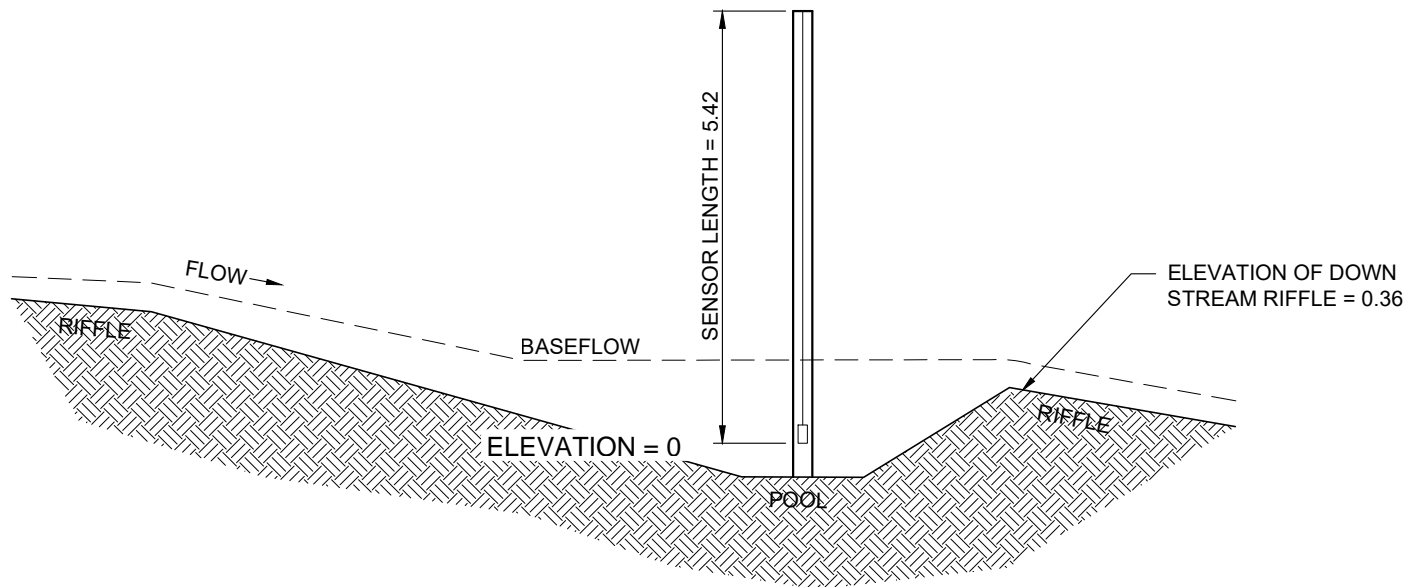
FLOW GAUGE FG-2 (UT1C)

Flow Depth = 0.36 feet

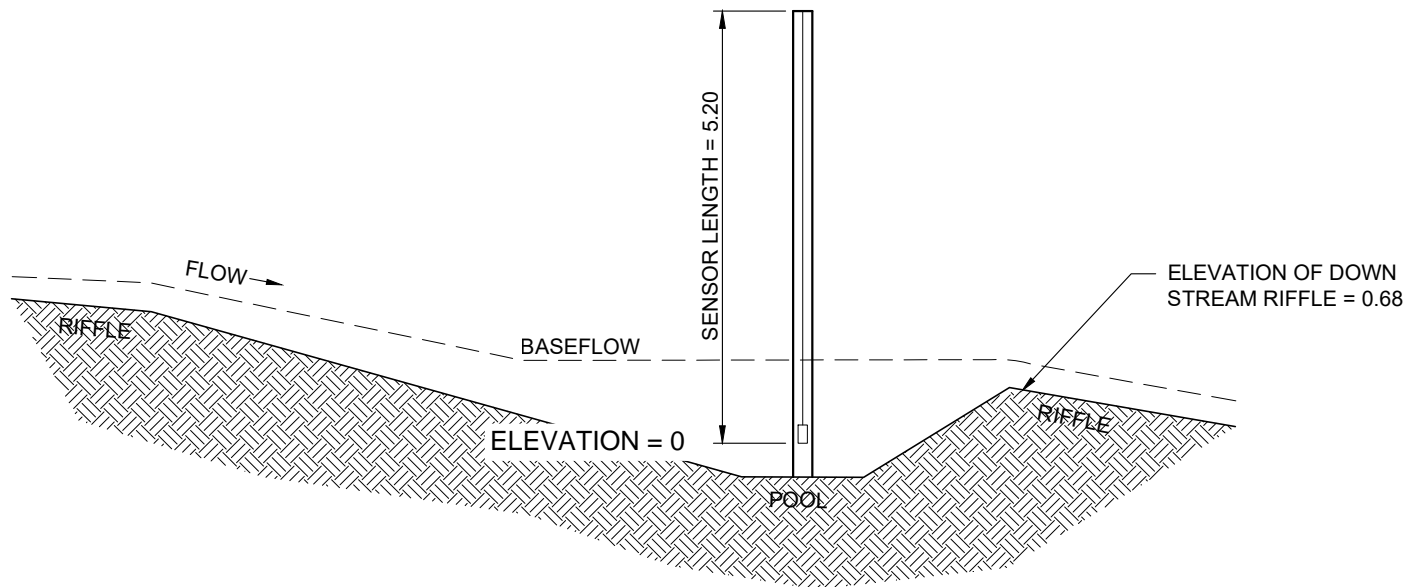
FLOW GAUGE FG-3 (UT2)

Flow Depth = 0.68 feet

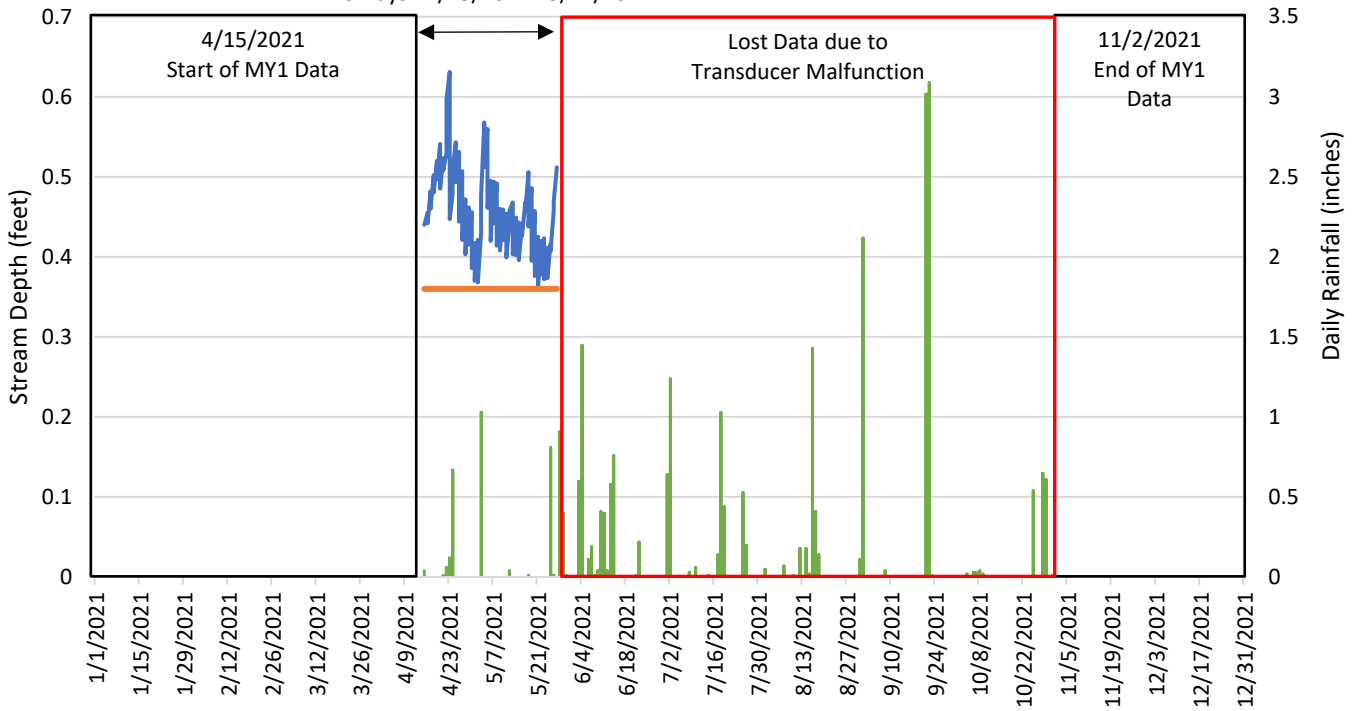
Maximum Days of Consecutive Flow
43 Days - 4/15/2021 - 5/27/2021

*43 days of cumulative flow
