# **MONITORING YEAR 3 ANNUAL REPORT**

## **BUCKWATER MITIGATION SITE**

Orange County, NC  
NCDEQ Contract No. 006829  
DMS Project Number 97084  
USACE Action ID Number 2016-00873  
NCDWR Project Number 2016-0406

Data Collection Period: January – November 2021  
Draft Submission Date: November 29, 2021  
Final Submission Date: December 13, 2021

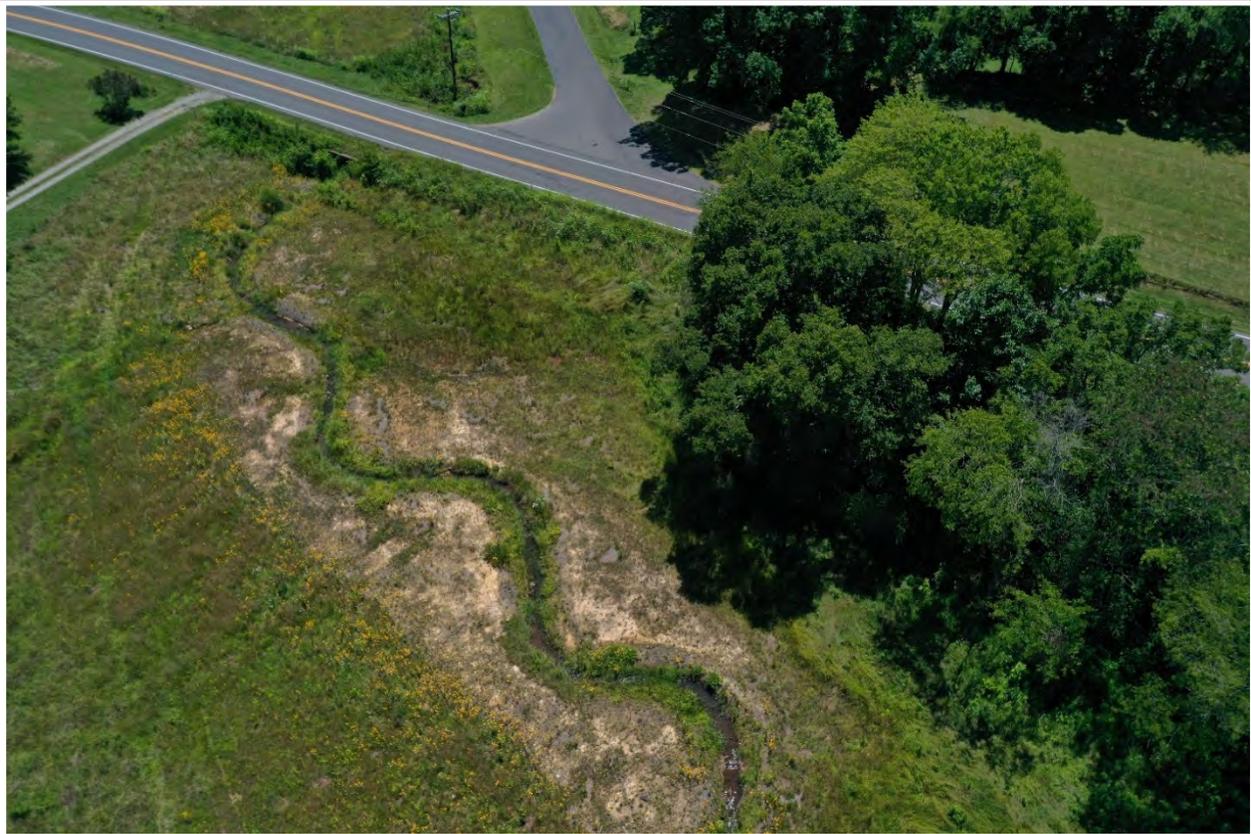
**Vegetation Area of Concern Photographs**  
**Bare Area Along T5**

**Before – Bare Area Along T5 (6/23/2020)**

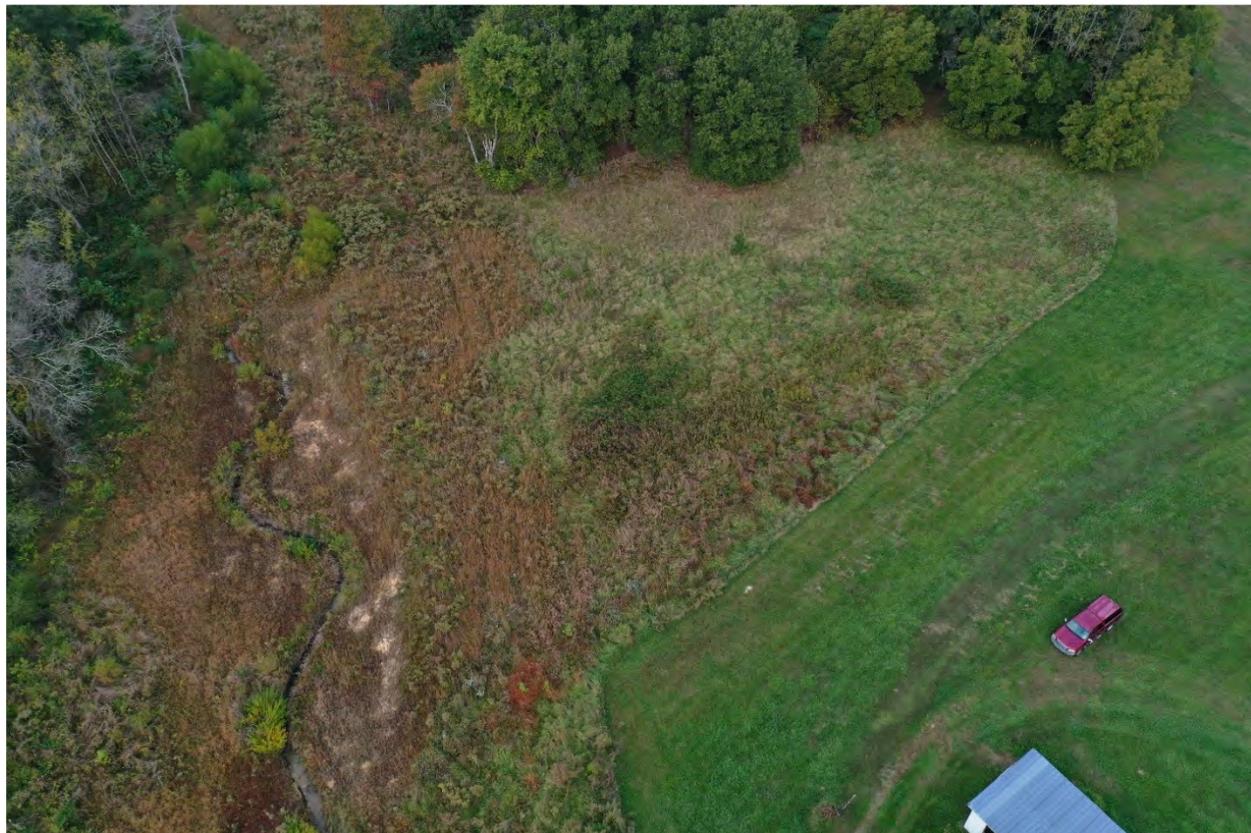
**After – Bare Area Along T5 with Soil Amendments (10/21/2021)**
