Year 2 Monitoring Report

Bucky's Branch Mitigation Project

DMS Project #: 100109 | Contract #: 7861 | DWR # 2019-1404 | RFP: 16-007703

Randolph County, North Carolina
Cape Fear River Basin
Randleman Lake Watershed
HUC 03030003

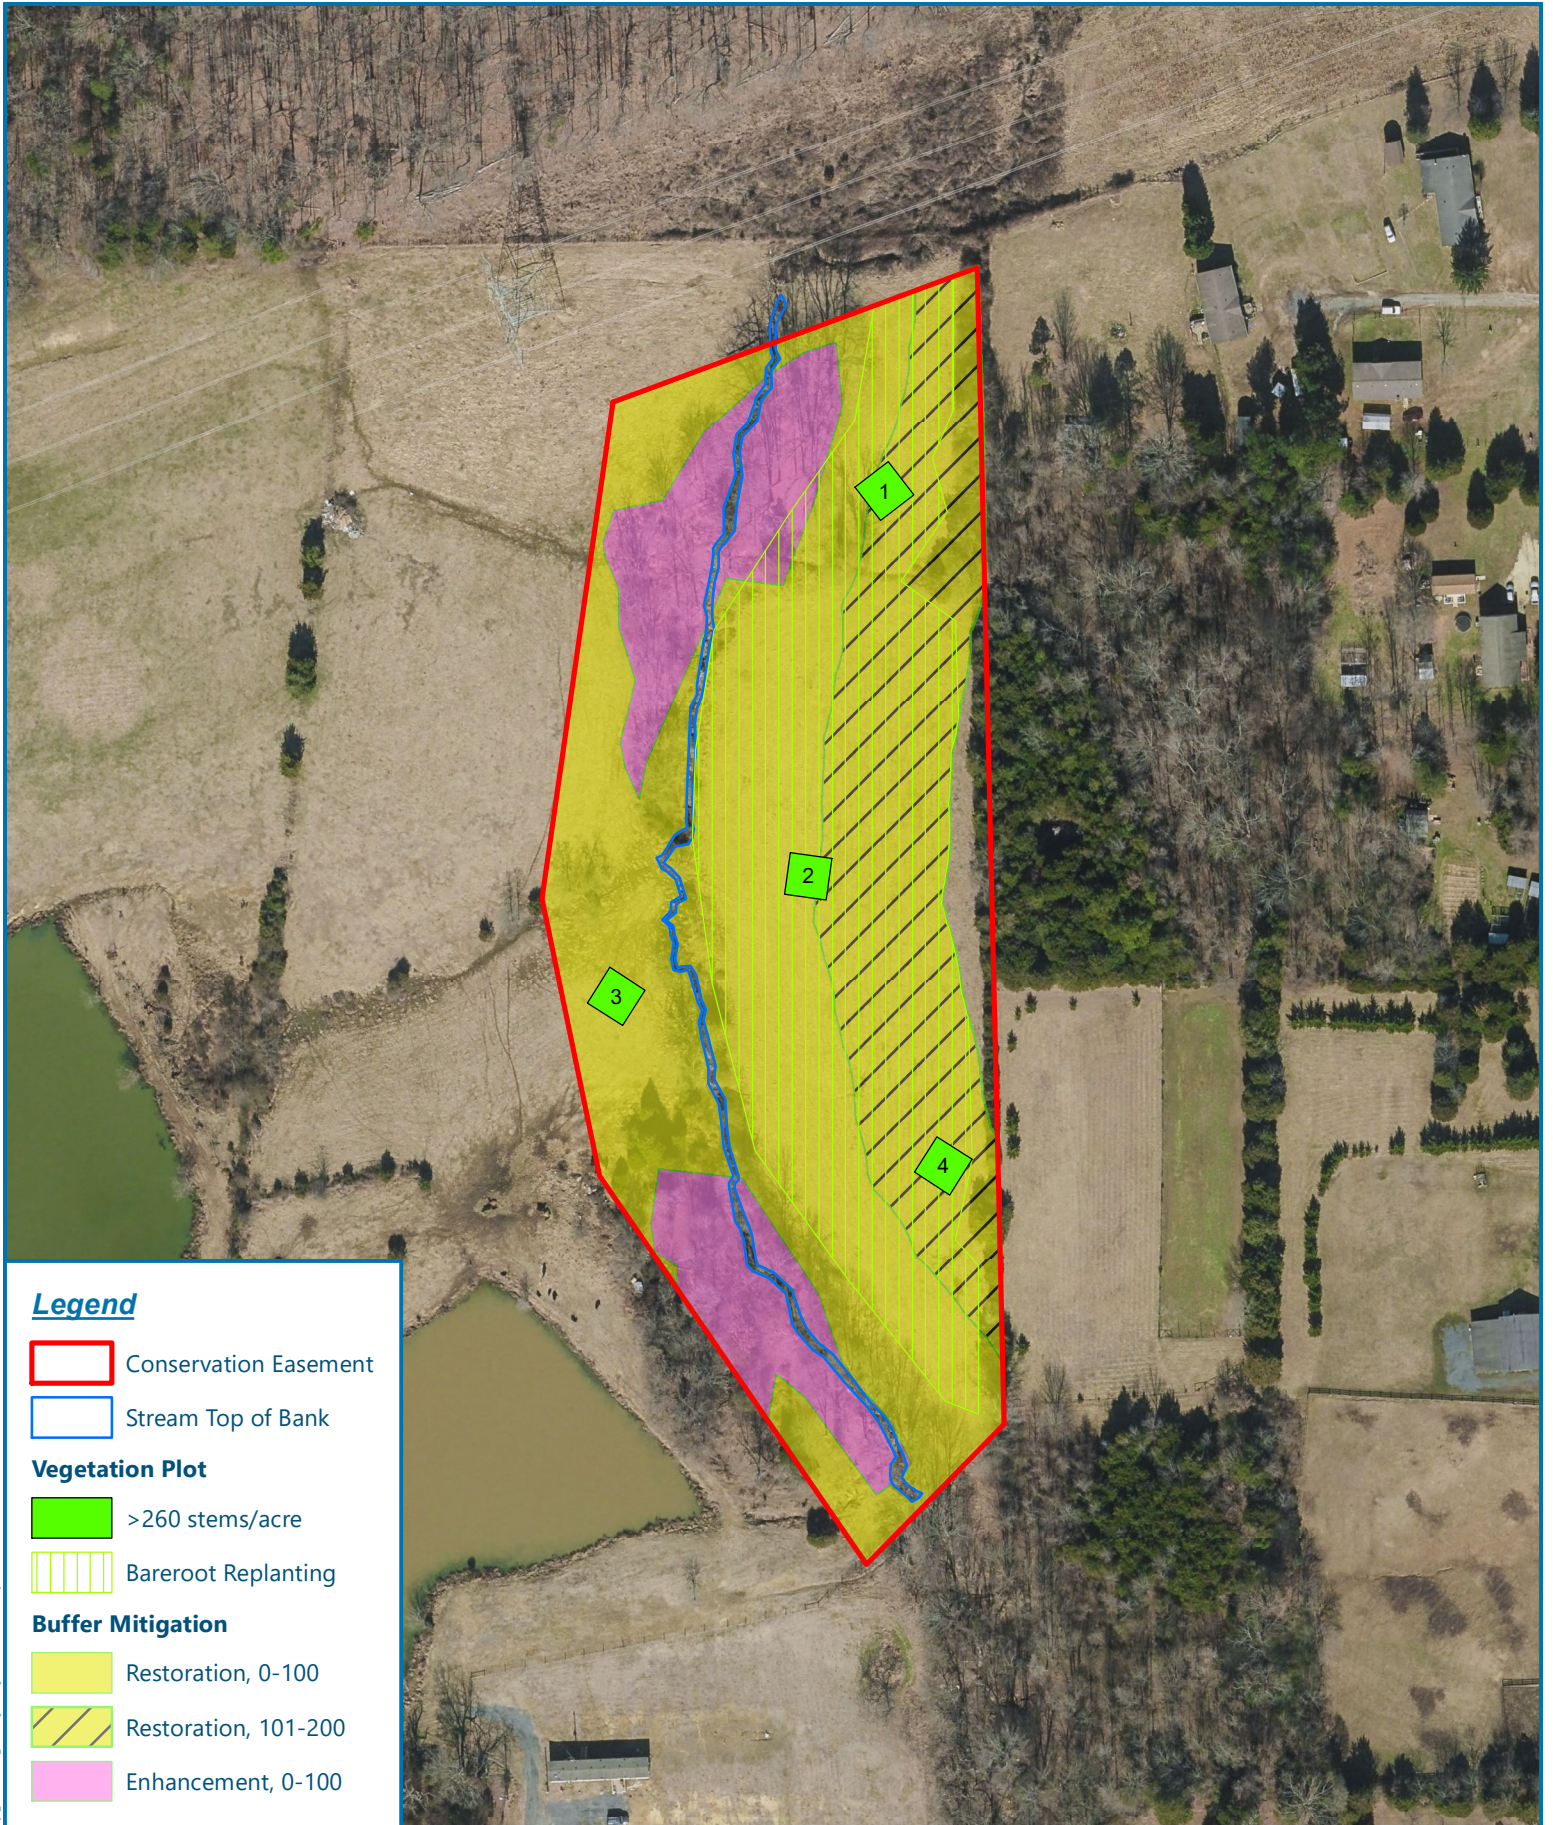
Figure 2 - Current Conditions Plan View

1. Please show the supplemental planting area on the CCPV (Figure 2) and submit the associated shapefile.
The replanted area has been included on the CCPV (Figure 2) and the shapefile has been added to the support files.

Visual assessment of vegetation outside of the monitoring plots indicates that the herbaceous vegetation is becoming well established throughout the project and no invasive species were observed. The fence has been installed, is in good condition, and is maintaining cattle exclusion. Additionally, there were no signs of encroachment or concentrated flow in the easement area.

Supplemental bareroot planting of willow oak, white oak, overcup oak, persimmon, sugarberry, and buttonbush occurred throughout the eastern portion of the easement in January 2021 to account for the lower stems counts during Year 1 monitoring.
