MY1 FINAL MONITORING REPORT  
Buffalo Creek Tributaries Mitigation Project  
Johnston County  
Neuse River Basin  
CU 03020201

DMS Project # 100042  
DMS Contract # 7422  
DMS RFP # 16-007279  
USACE Action ID Number: SAW-2018-00425  
DWR Project # 2018-0199 V2  
Calendar Year of Data Collection: 2021

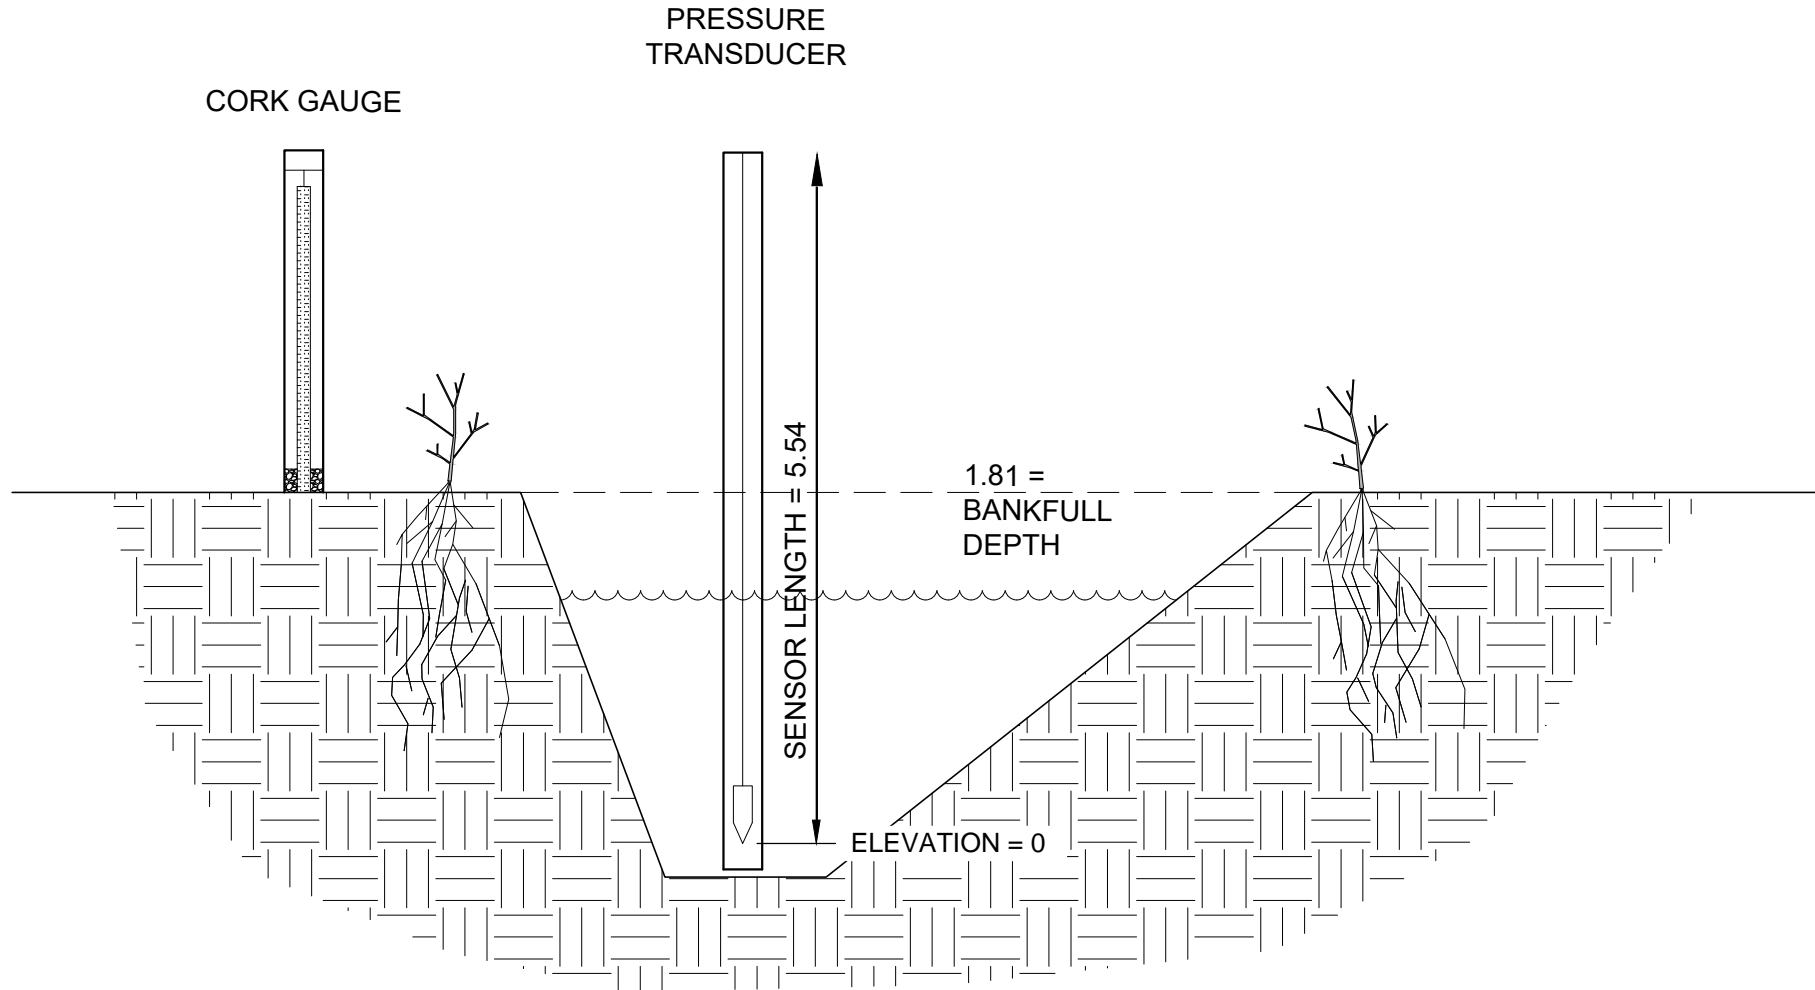
## Crest Gauge CG-1 (MS-R2)

Bankfull Event Depth = 1.81

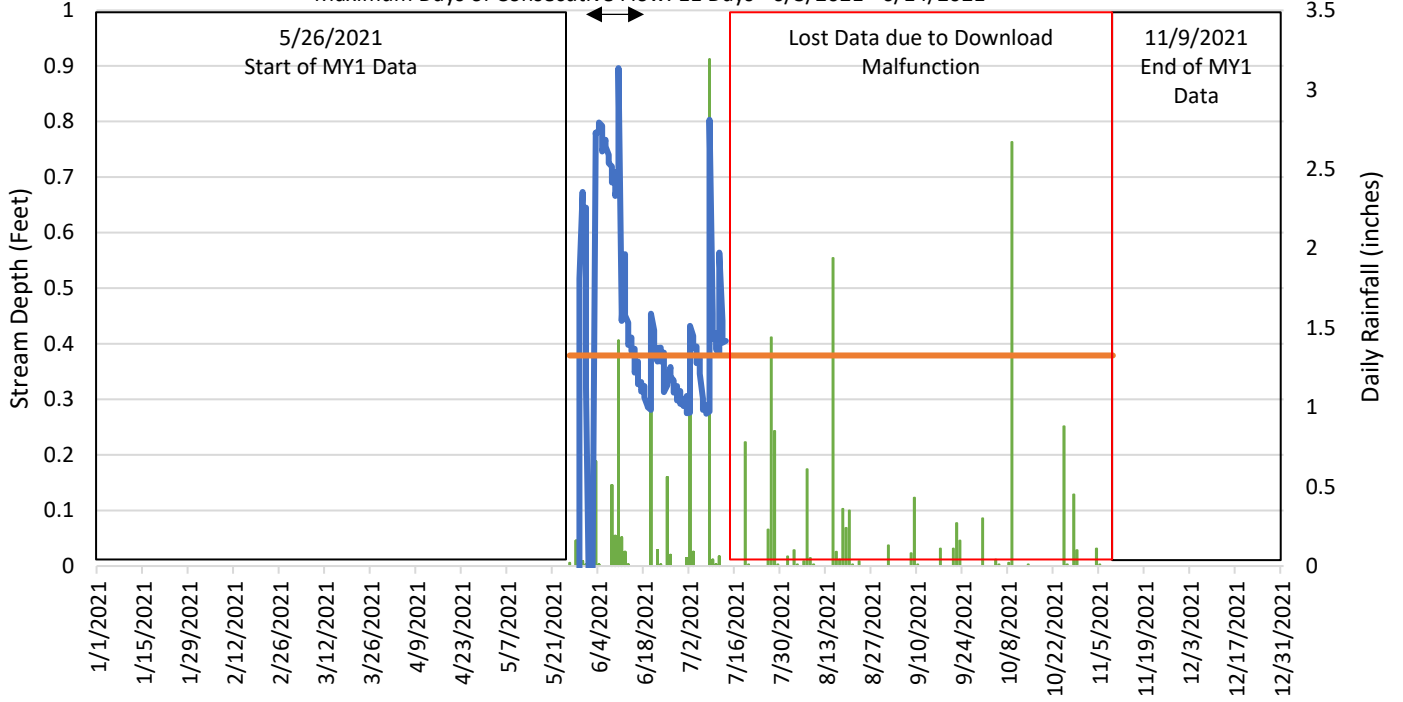
### Buffalo Creek Tributaries FG-1 (R4)

Maximum Days of Consecutive Flow: 11 Days - 6/3/2021 - 6/14/2021

\*FG-1: 20 days of cumulative flow

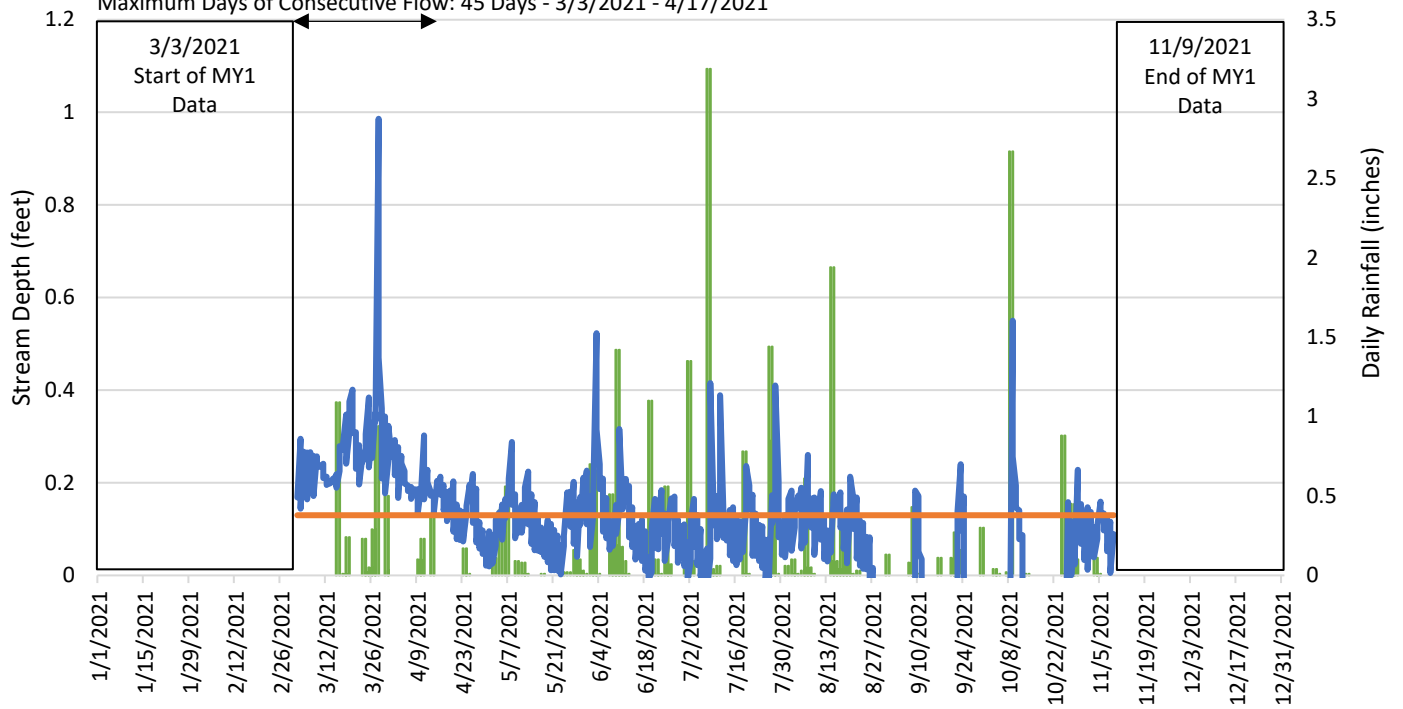
### Buffalo Creek Tributaries FG-2 (R6)

Maximum Days of Consecutive Flow: 45 Days - 3/3/2021 - 4/17/2021

\*FG-2: 69 days of cumulative flow

\*\*FG-2: 182 days of no flow
