**BEST STREAM AND WETLAND RESTORATION PROJECT
MONITORING REPORT
MONITORING YEAR 7
FINAL**

DUPLIN COUNTY, NORTH CAROLINA
CONTRACT No. 004631 - PROJECT No. 95353
USACE Action ID No. 2012-01384 -NCDWR Project No. 13-0865

RE: Best Stream and Wetland Restoration Project: MY7 Monitoring Report (NCDMS ID 95353)

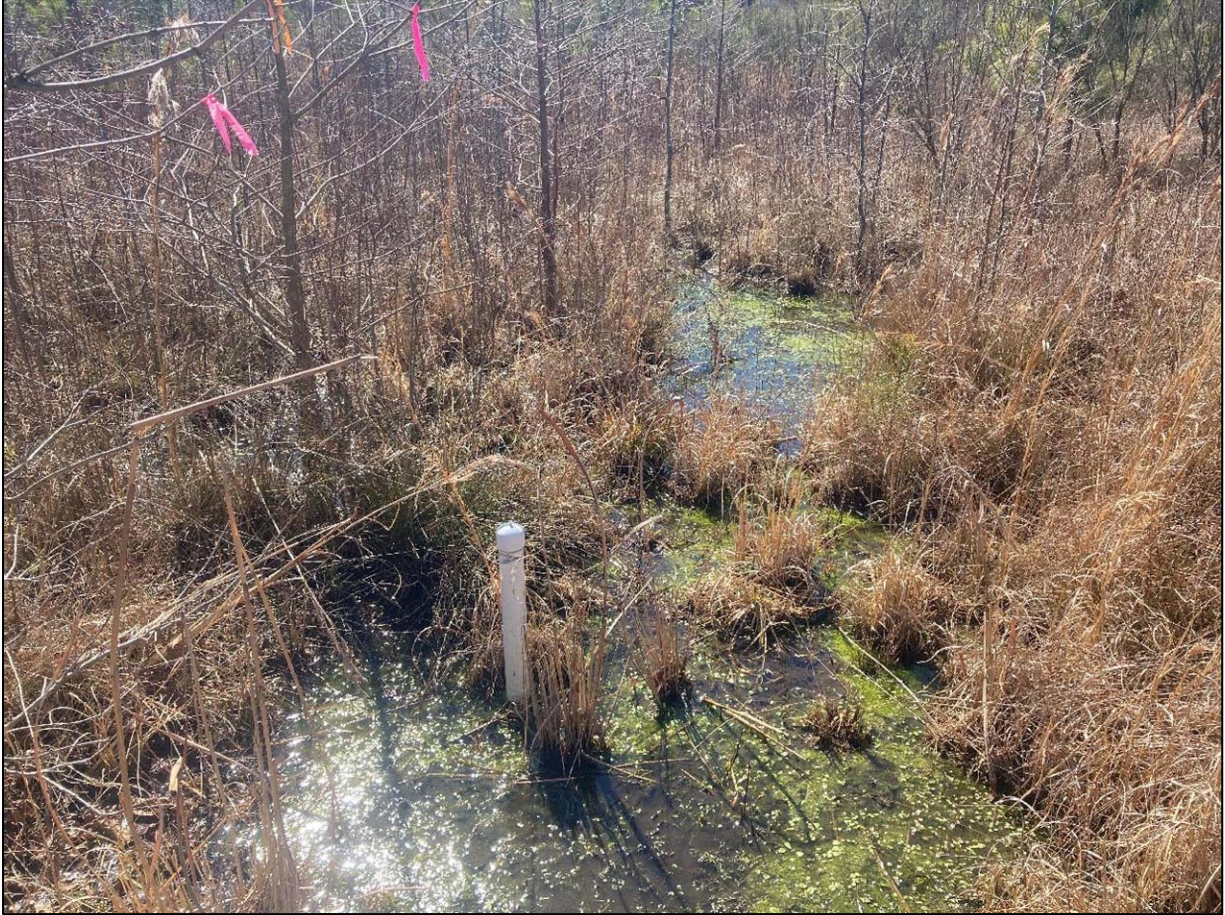
The one wetland problem area that was noted in previous years is no longer a problem area in MY7. AW7 did not meet success in four of the past six years, however this year it met success. RES inspected the “at-risk” area around this well in February 2021 and the area displayed similar soil and vegetation to the other areas in Wetland 3B. A photo of AW7 is included in **Appendix B** which shows standing water and algal mats in this area.

AW7 in Wetland 3B (February 2021)

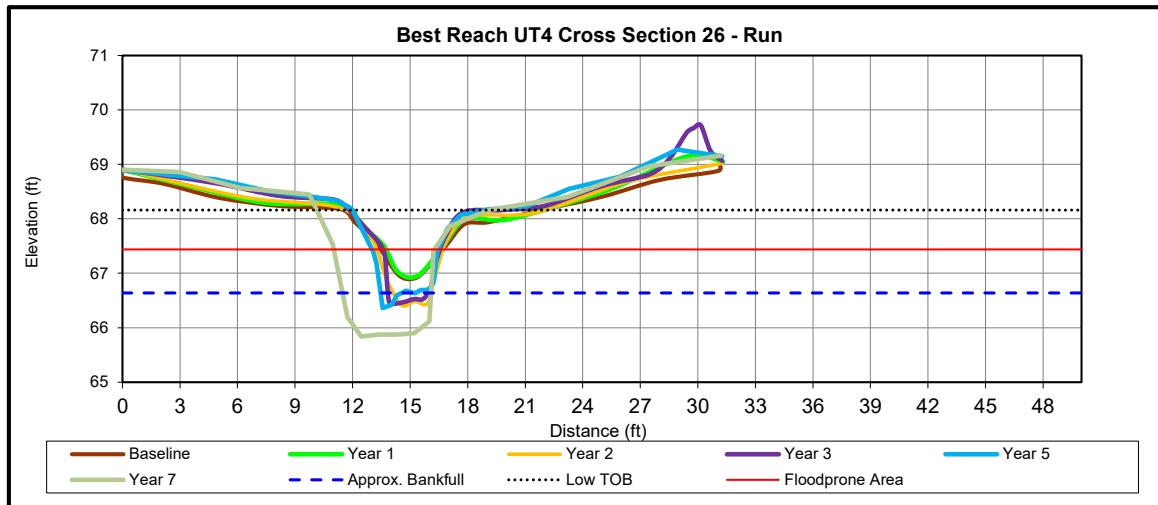
No stream problem areas were noted in Year 7. Cross Section 26 showed a shift in the depth and bank distance from the previous years. RES believes this is not a systematic issue and the rooted banks and rock bed will prevent any further degradation. Additionally, the cross section is contained between two intact log sills that are holding grade.

The Year 7 (MY7) cross sectional dimensions generally match the baseline and MY5 cross section parameters. Minimal changes were noted during Year 7 cross section surveys resulting from stable bed and bank conditions. Cross Section 26 shows a shift in the depth and bank distance from the previous years which was most likely caused by a middle channel bar that formed on the flow gauge directly downstream of this cross section (discussed in **Section 4.1**). All cross-section plots and data tables can be found in **Table 11 and Figure 7**.
