**MONITORING YEAR 1
ANNUAL REPORT**
Final

BUG HEADWATERS MITIGATION SITE

Wilkes County, NC
Yadkin River Basin
HUC 03040101

DMS Project No. 100084
DMS RFP No. 16-007406
NCDEQ Contract No. 7617
USACE Action ID No. 2018-01788
DWR Project No. 2018-1273

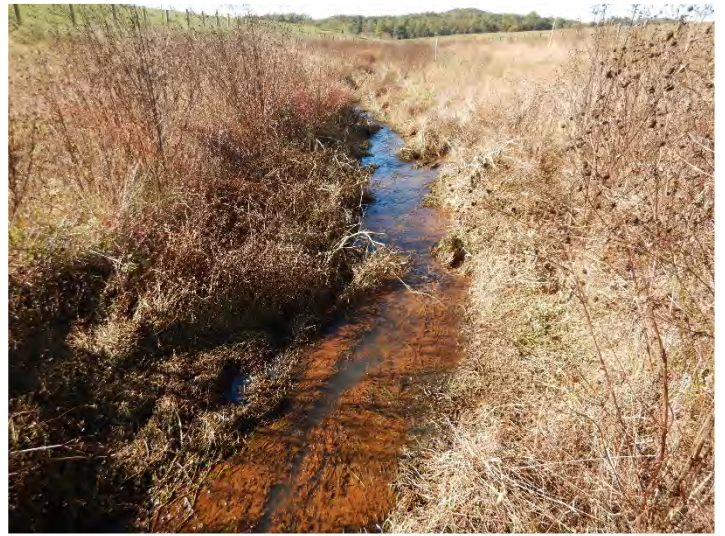
PHOTO POINT 5 Big Bugaboo R2 – upstream (10/27/2021)

PHOTO POINT 5 Big Bugaboo R2 – downstream (10/27/2021)

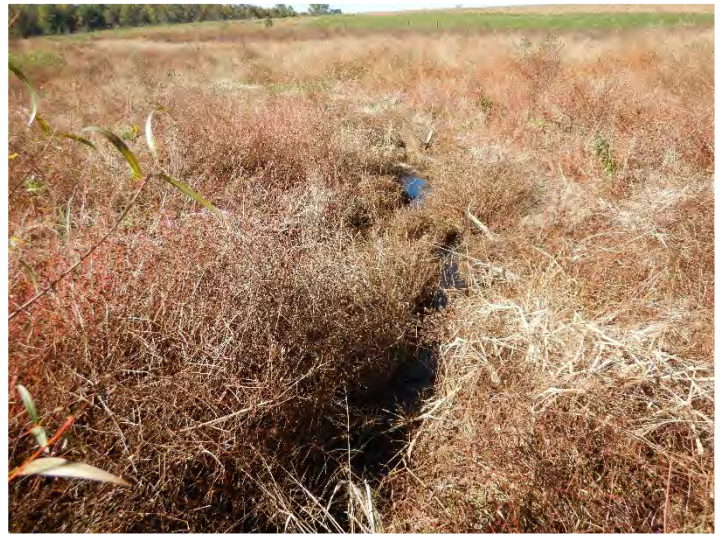
PHOTO POINT 8 Big Bugaboo R3 – upstream (10/27/2021)

PHOTO POINT 8 Big Bugaboo R3 – downstream (10/27/2021)

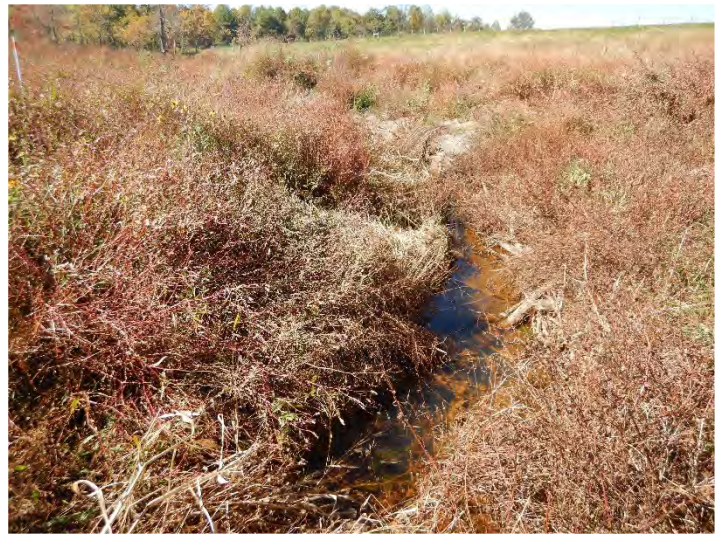
PHOTO POINT 10 Big Bugaboo R3 – upstream (10/27/2021)

PHOTO POINT 10 Big Bugaboo R3 – downstream (10/27/2021)

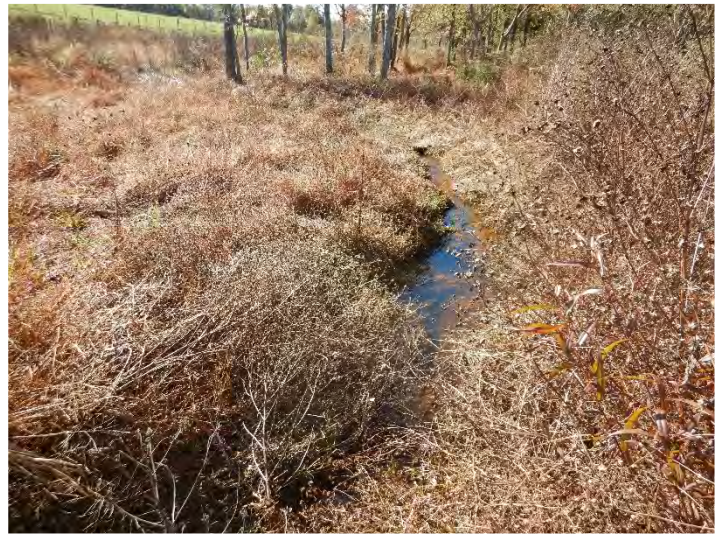
PHOTO POINT 11 Big Bugaboo R3 – upstream (10/27/2021)

PHOTO POINT 11 Big Bugaboo R3 – downstream (10/27/2021)

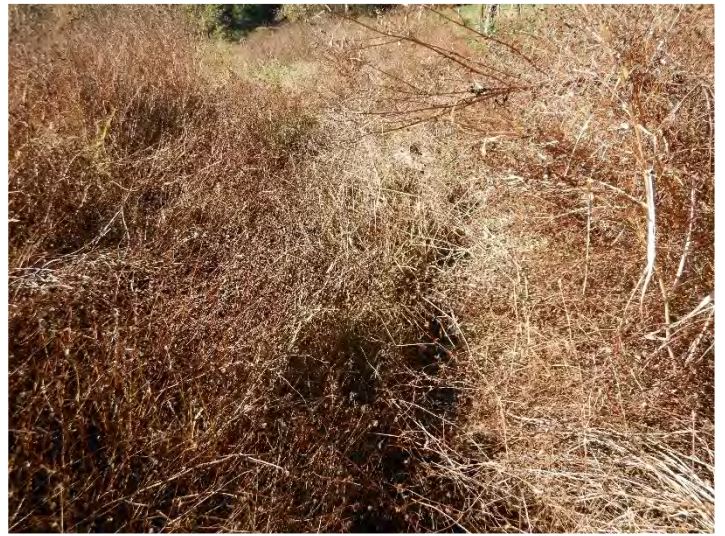
PHOTO POINT 14 Big Bugaboo R3 – upstream (10/27/2021)

PHOTO POINT 14 Big Bugaboo R3 – downstream (10/27/2021)

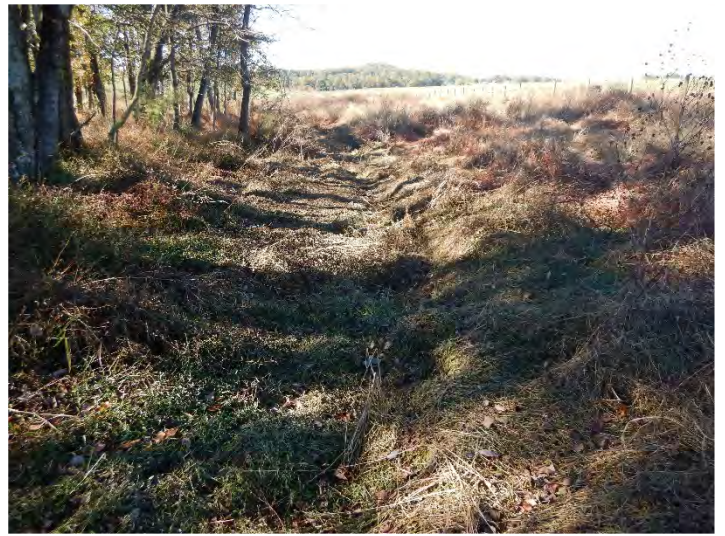
PHOTO POINT 19 UT1 – upstream (10/27/2021)

PHOTO POINT 19 UT1 – downstream (10/27/2021)

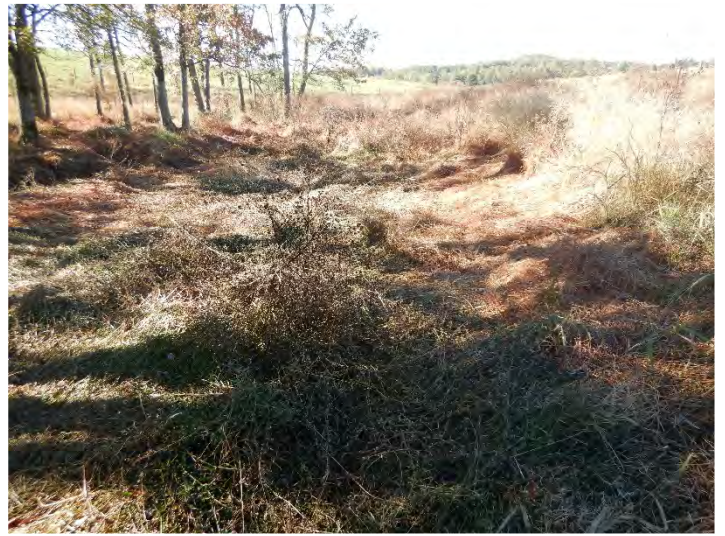
PHOTO POINT 20 UT1 – upstream (10/27/2021)

PHOTO POINT 20 UT1 – downstream (10/27/2021)

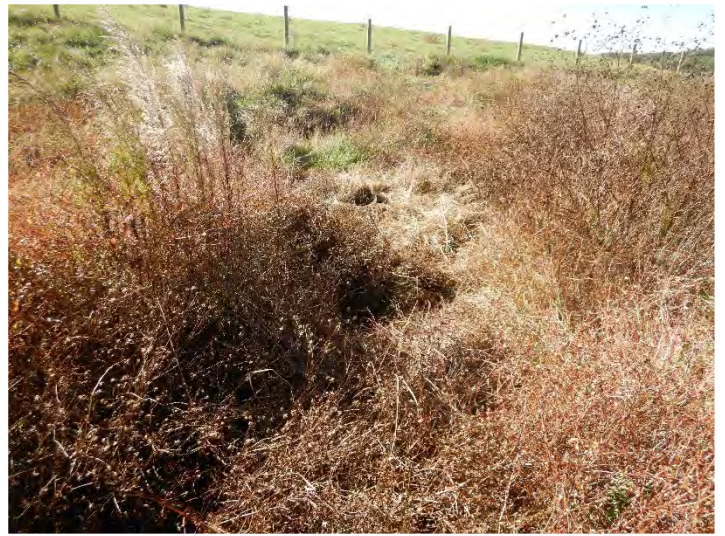
PHOTO POINT 22 UT1 – upstream (10/27/2021)

PHOTO POINT 22 UT1 – downstream (10/27/2021)

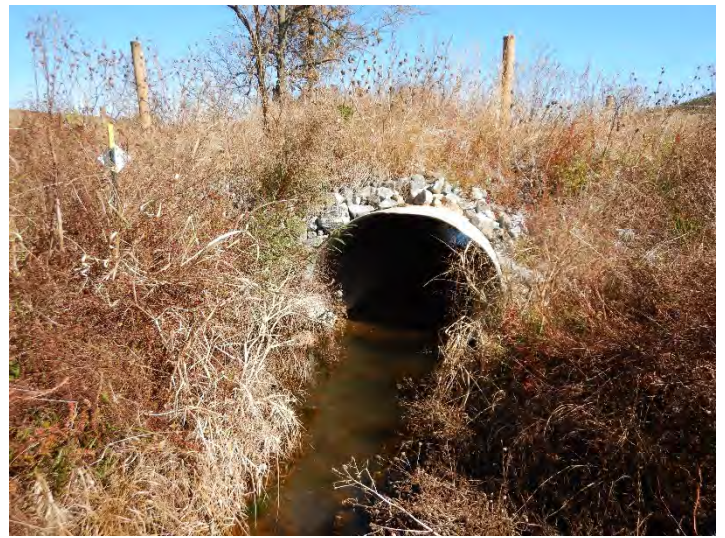
Big Bugaboo Creek R3 - Looking Upstream (10/27/2021)

Big Bugaboo Creek R3 - Looking Downstream (10/27/2021)
