Year 2 Monitoring Report

CATBIRD SITE

NCDMS Project #100022 (Contract #7186)
USACE Action ID: SAW-2017-01506
DWR Project #20171039

RE: Catbird Site: Year 2 Monitoring Report (NCDMS ID 100022)

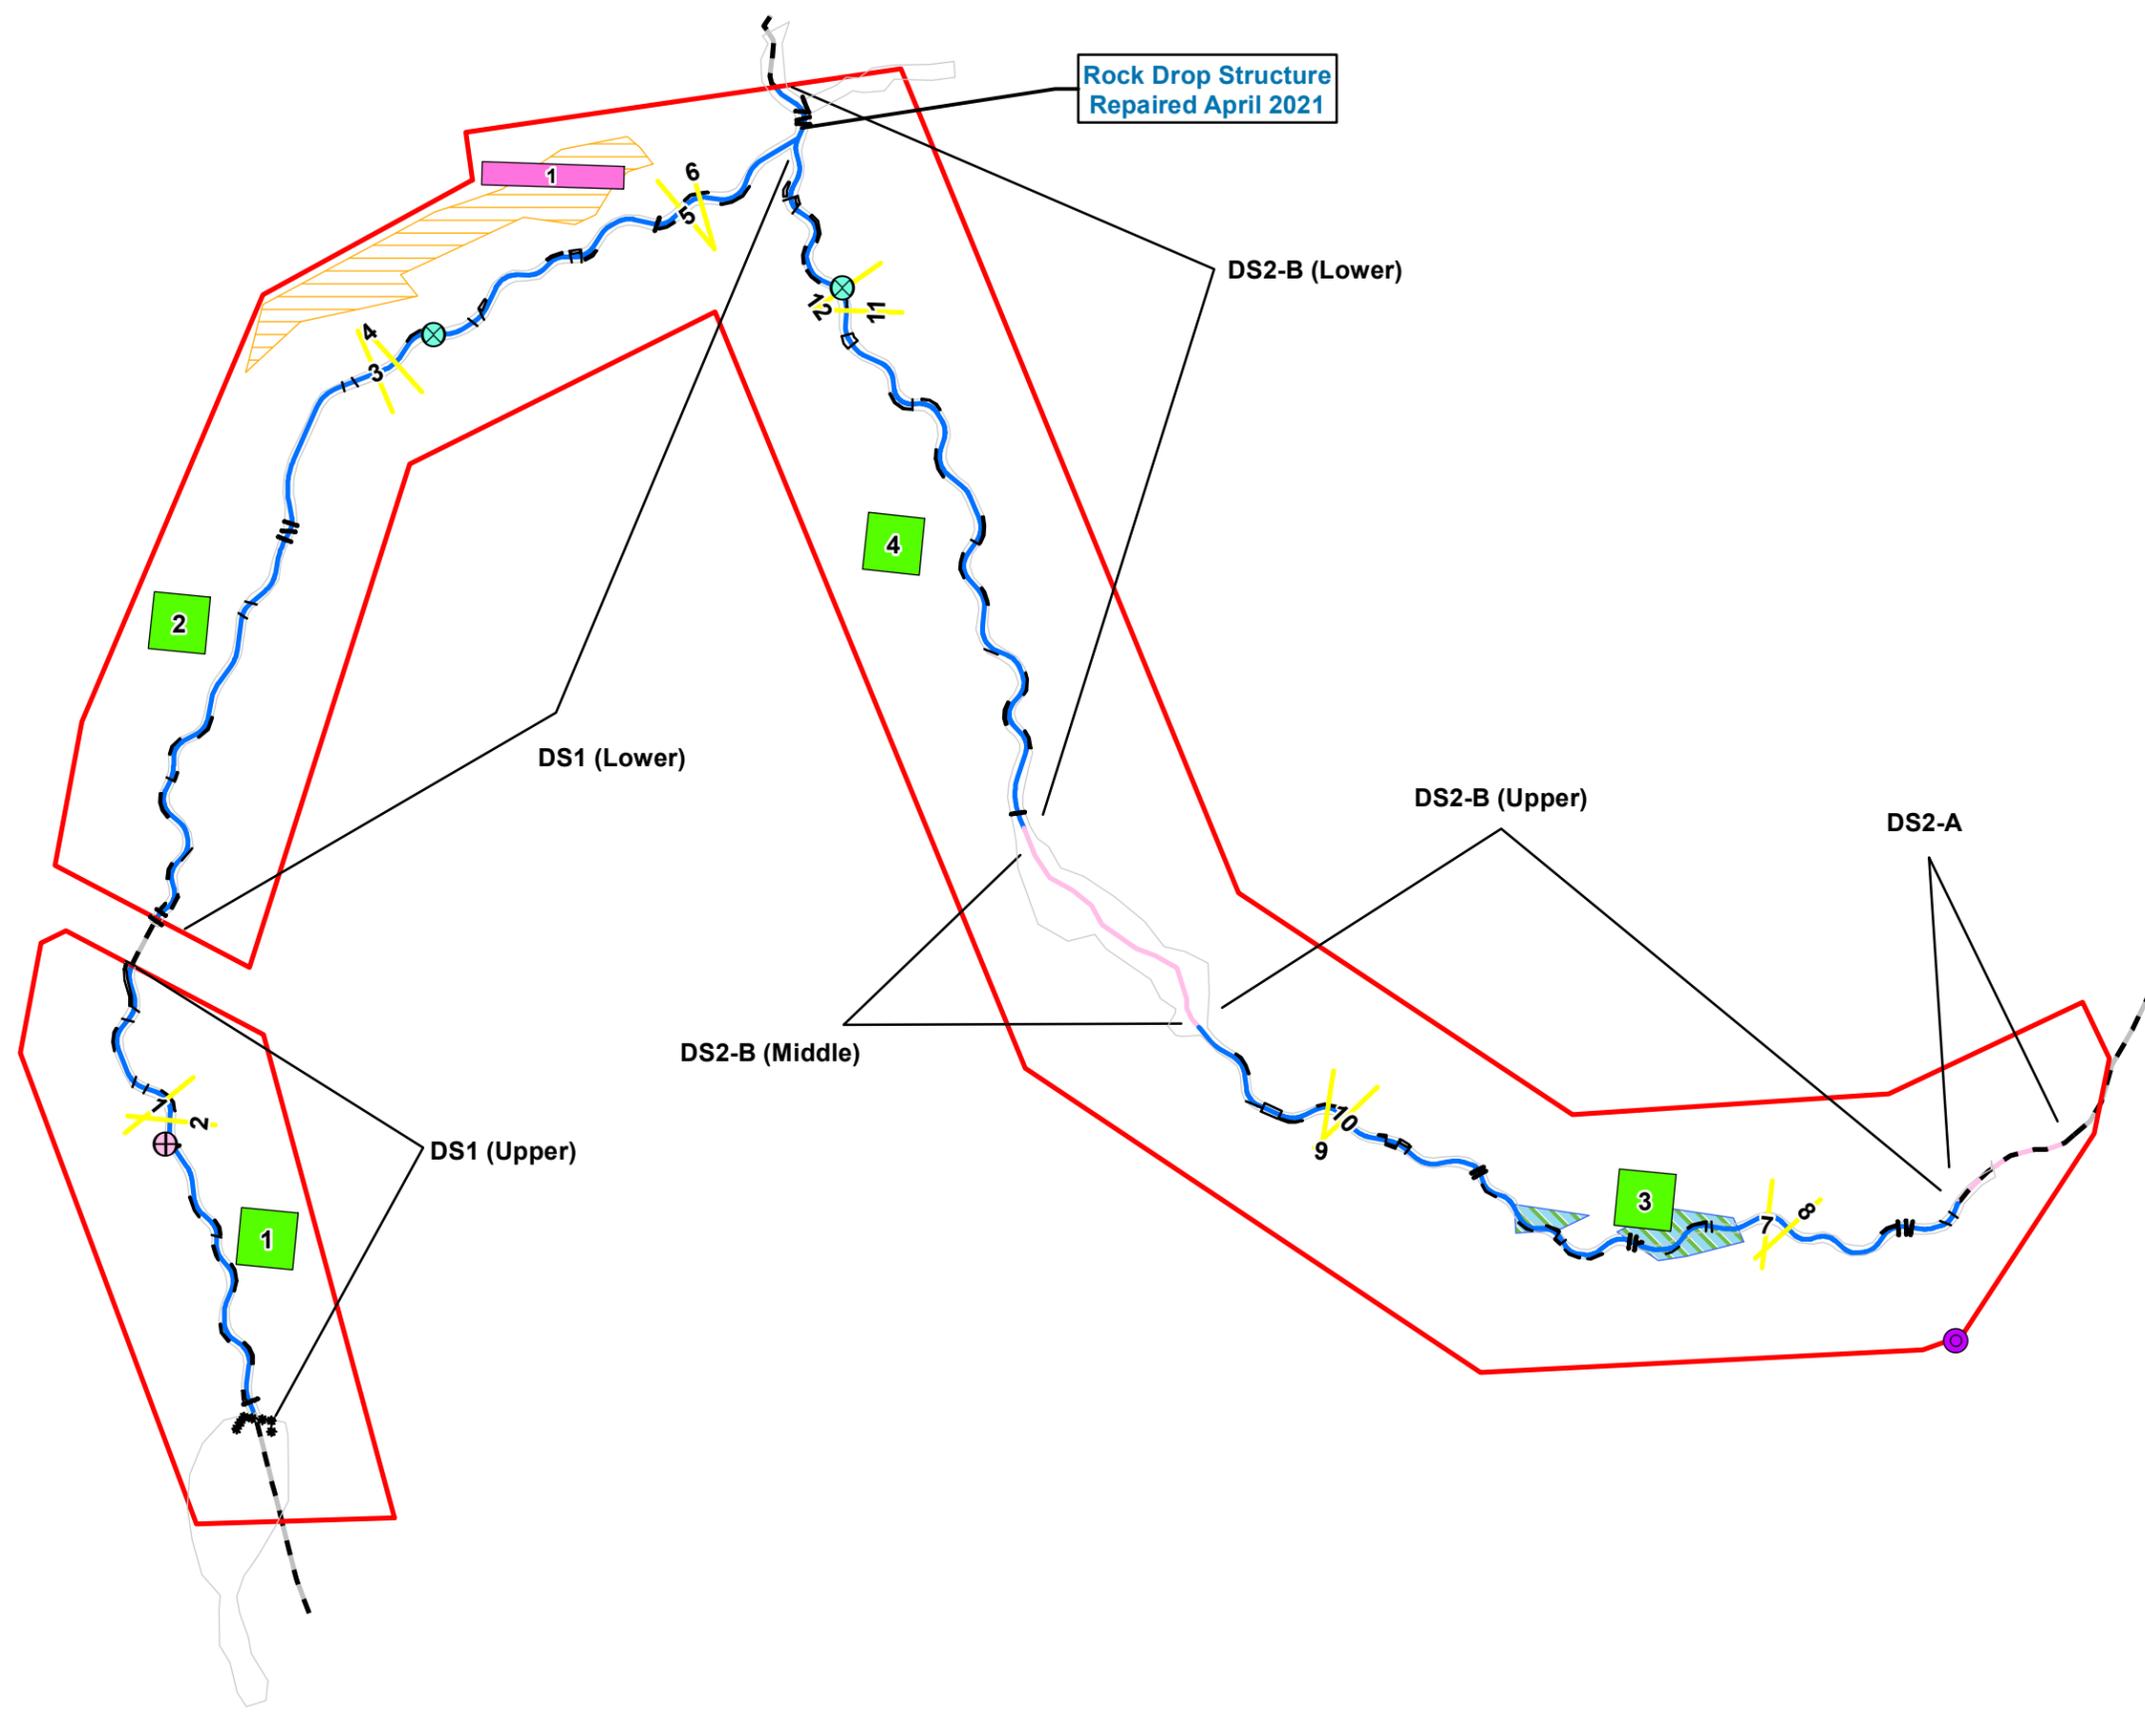
Rock Drop Structure
Repaired April 2021

[We have included a photograph of the repaired structure taken just after repair. More photos will be taken in MY3 for submittal. Photo can be found in support files>visual assessment data.](#)

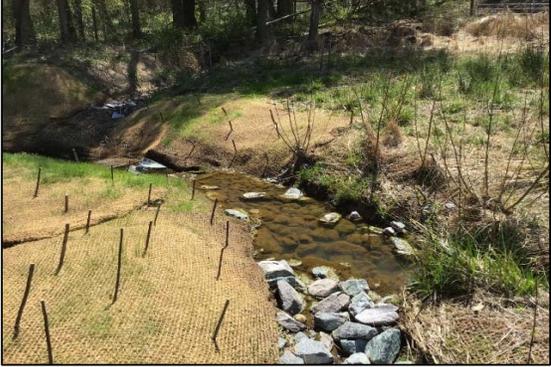
Stream Problem Areas Catbird	
Feature Issue / Location	Photo
Failing Rock Drop Structure / DS2-B (Repaired April 2021)

second was on the bottom of DS2-B (Lower) (below the confluence with DS-1) where a rock drop structure was repaired, and the left bank was graded to alleviate shear stress. The first area was repaired in April 2020 and the second was repaired in June 2020. The as-built survey (including a redlined version) is included in **Appendix E**.

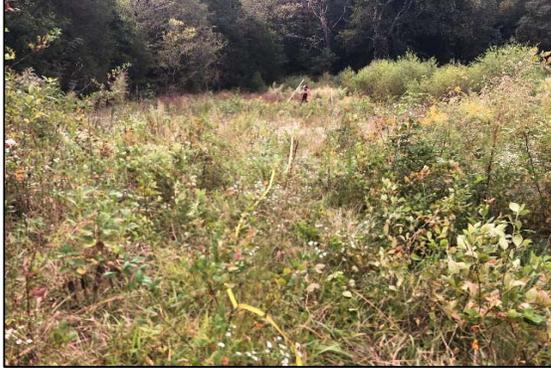
Vegetation Problem Areas Catbird	
Feature Category / Location / Size	Photo
Low Stem Density Area / DS1 RB / 0.15 acres
