**CEDAR CREEK STREAM AND WETLAND RESTORATION  
PROJECT  
MONITORING REPORT  
MONITORING YEAR 7  
FINAL**

SAMPSON COUNTY, NORTH CAROLINA  
CONTRACT No. 005011 - PROJECT No. 95718  
USACE ACTION ID No. 2012-00389 – NCDWR PROJECT No. 2013-0186

January 2022

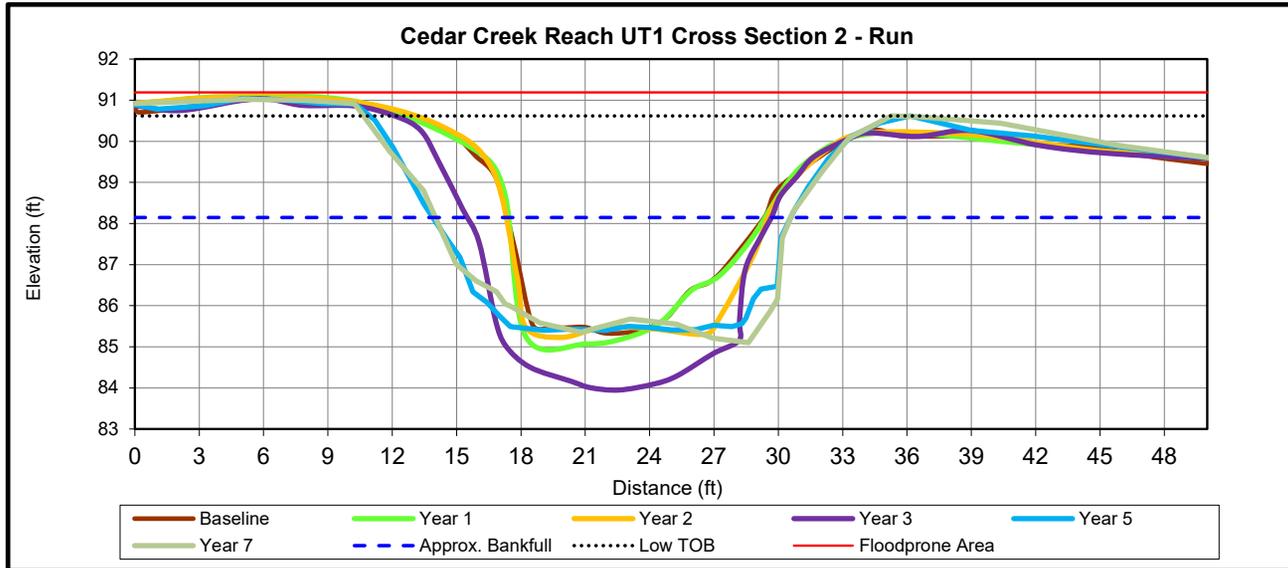
Dimension	Cross Section 2 (Run)						
	Base	MY1	MY2	MY3	MY5	MY7	MY+
<b>Bankfull Elevation (ft) - Based on AB-XSA<sup>1</sup></b>	89.2	89.2	89.2	89.2	88.2	88.1	
Bankfull Width (ft) <sup>1</sup>	14.3	14.2	14.4	16.5	16.7	16.6	
Floodprone Width (ft) <sup>1</sup>	50.0	50.0	50.0	50.0	43.8	50.0	
Bankfull Mean Depth (ft)	2.7	2.8	3.0	3.7	-	-	
Bankfull Max Depth (ft) <sup>2</sup>	3.9	4.1	4.0	5.3	5.1	5.5	
Low Bank Elevation (ft)	-	-	-	-	90.4	90.6	
Bankfull Cross Sectional Area (ft <sup>2</sup> ) <sup>2</sup>	38.0	40.1	43.1	61.3	82.9	87.3	
Bankfull Width/Depth Ratio	5.4	5.1	4.8	44.0	-	-	
Bankfull Entrenchment Ratio <sup>1</sup>	>2.2	>2.2	>2.2	>2.2	>2.2	>3	
Bankfull Bank Height Ratio <sup>1</sup>	1.0	1.0	1.0	1.1	1.8	1.8

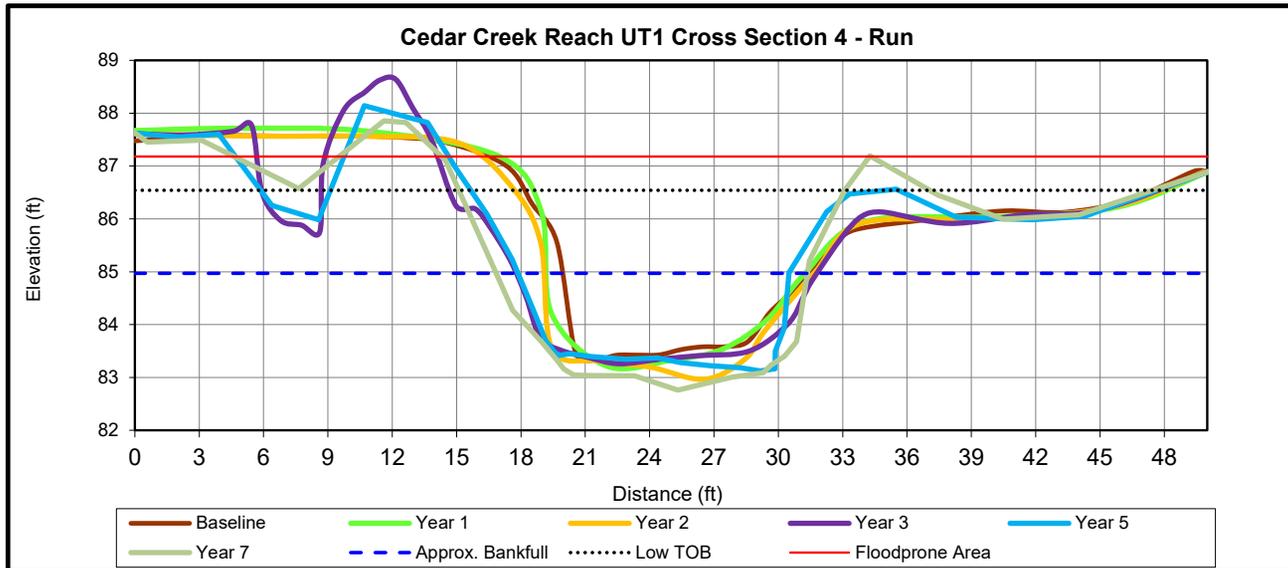
Dimension	Cross Section 4 (Run)						
	Base	MY1	MY2	MY3	MY5	MY7	MY+
Bankfull Elevation (ft) - Based on AB-XSA <sup>1</sup>	85.8	85.8	85.8	85.8	85.4	85.0	
Bankfull Width (ft) <sup>1</sup>	14.4	14.5	15.0	16.7	13.7	14.5	
Floodprone Width (ft) <sup>1</sup>	50.0	50.0	50.0	50.0	46.4	40.7	
Bankfull Mean Depth (ft)	1.7	1.8	2.0	1.9	-	-	
Bankfull Max Depth (ft) <sup>2</sup>	2.5	2.6	2.8	2.5	3.3	3.8	
Low Bank Elevation (ft)	-	-	-	-	86.5	86.5	
Bankfull Cross Sectional Area (ft <sup>2</sup> ) <sup>2</sup>	24.7	26.3	29.8	31.4	41.4	50.1	
Bankfull Width/Depth Ratio	8.4	8.0	7.5	8.9	-	-	
Bankfull Entrenchment Ratio <sup>1</sup>	>2.2	>2.2	>2.2	>2.2	>2.2	>2.8	
Bankfull Bank Height Ratio <sup>1</sup>	1.0	1.0	1.0	1.1	1.5	1.7

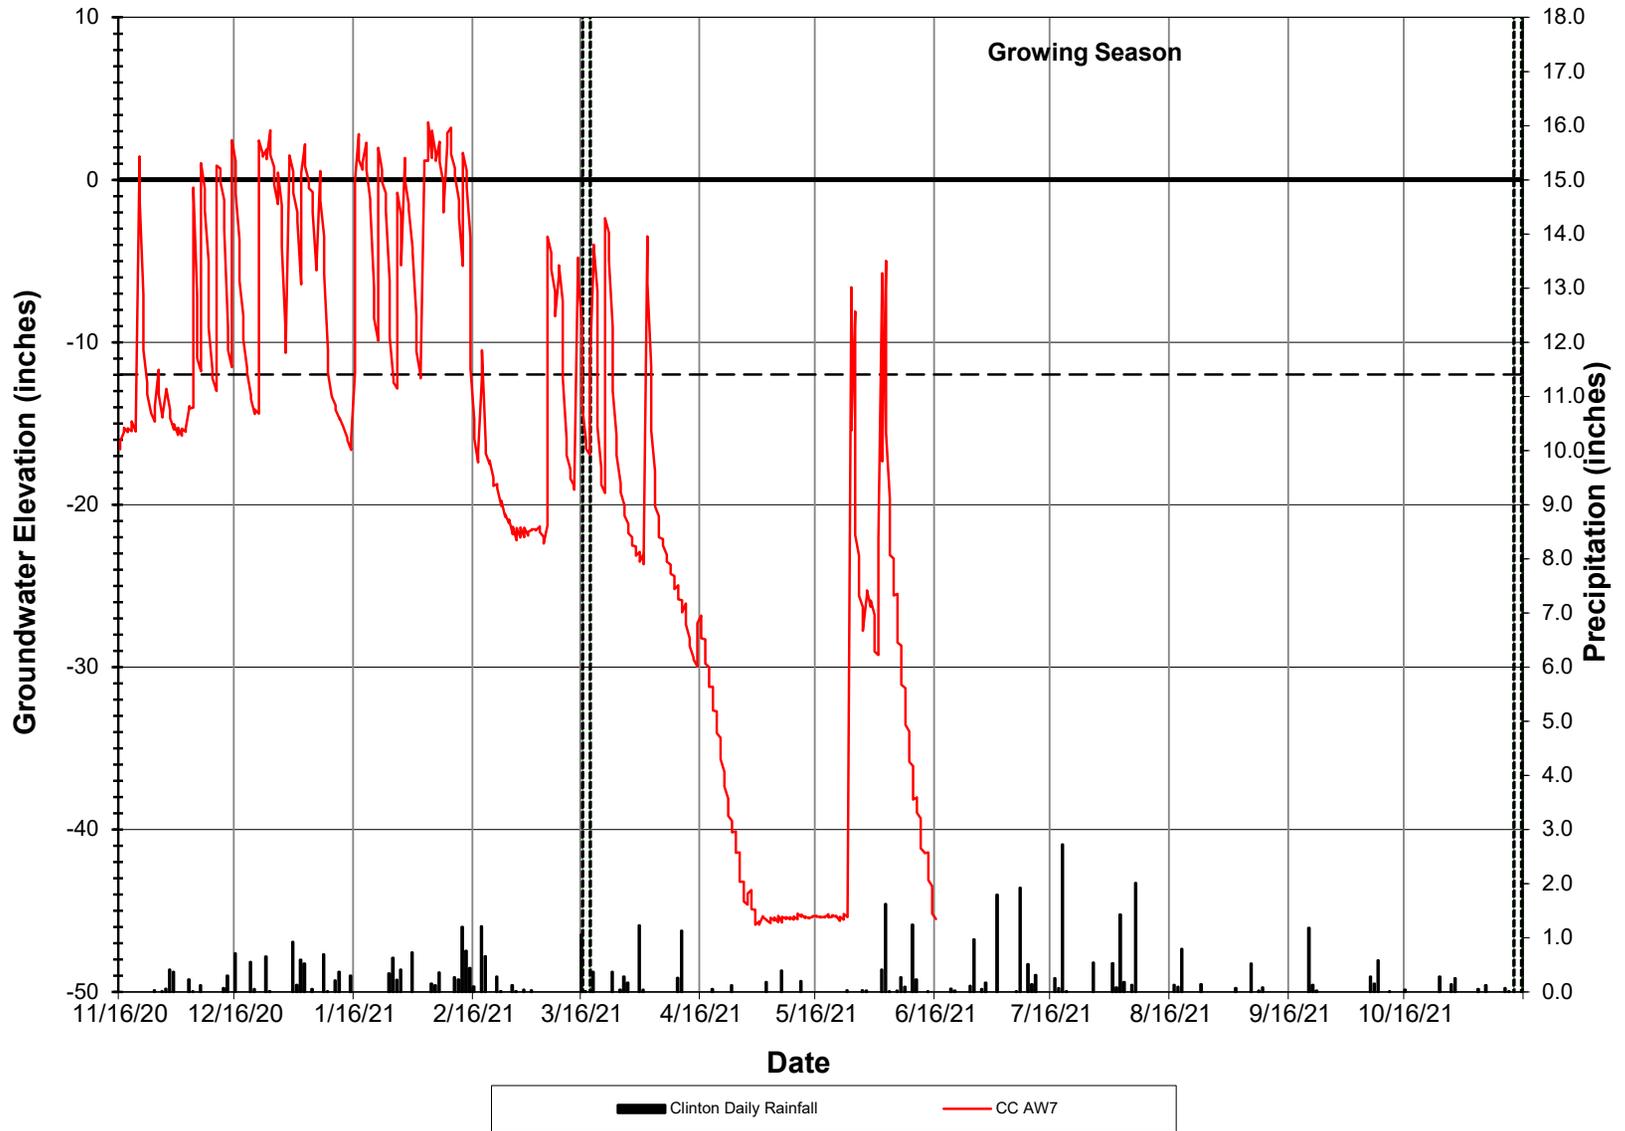
# 2021 Cedar Creek Groundwater Gauge AW7

One wetland problem area was noted during the Year 7 monitoring period. AW7 did not meet success criteria for the seventh year in a row. In January 2022, RES visited the site with DMS and delineated the unsuccessful wetland area. The area immediately surrounding AW7 had hydric soil, however, was slightly higher in elevation. RES used LIDAR to delineate out the area directly around AW7 and included the filled in swale from 2018 to determine the unsuccessful wetland area (0.33 acres; **Figure 3**).
