MONITORING YEAR 1 ANNUAL REPORT FINAL

MCLENNY ACRES MITIGATION SITE

Wayne County, NC
Neuse River Basin
HUC 03020201

DMS Project No. 100038
NCDEQ Contract No. 7423
DWR Project No. 2018-0197
USACE Action ID No. 2018-02042

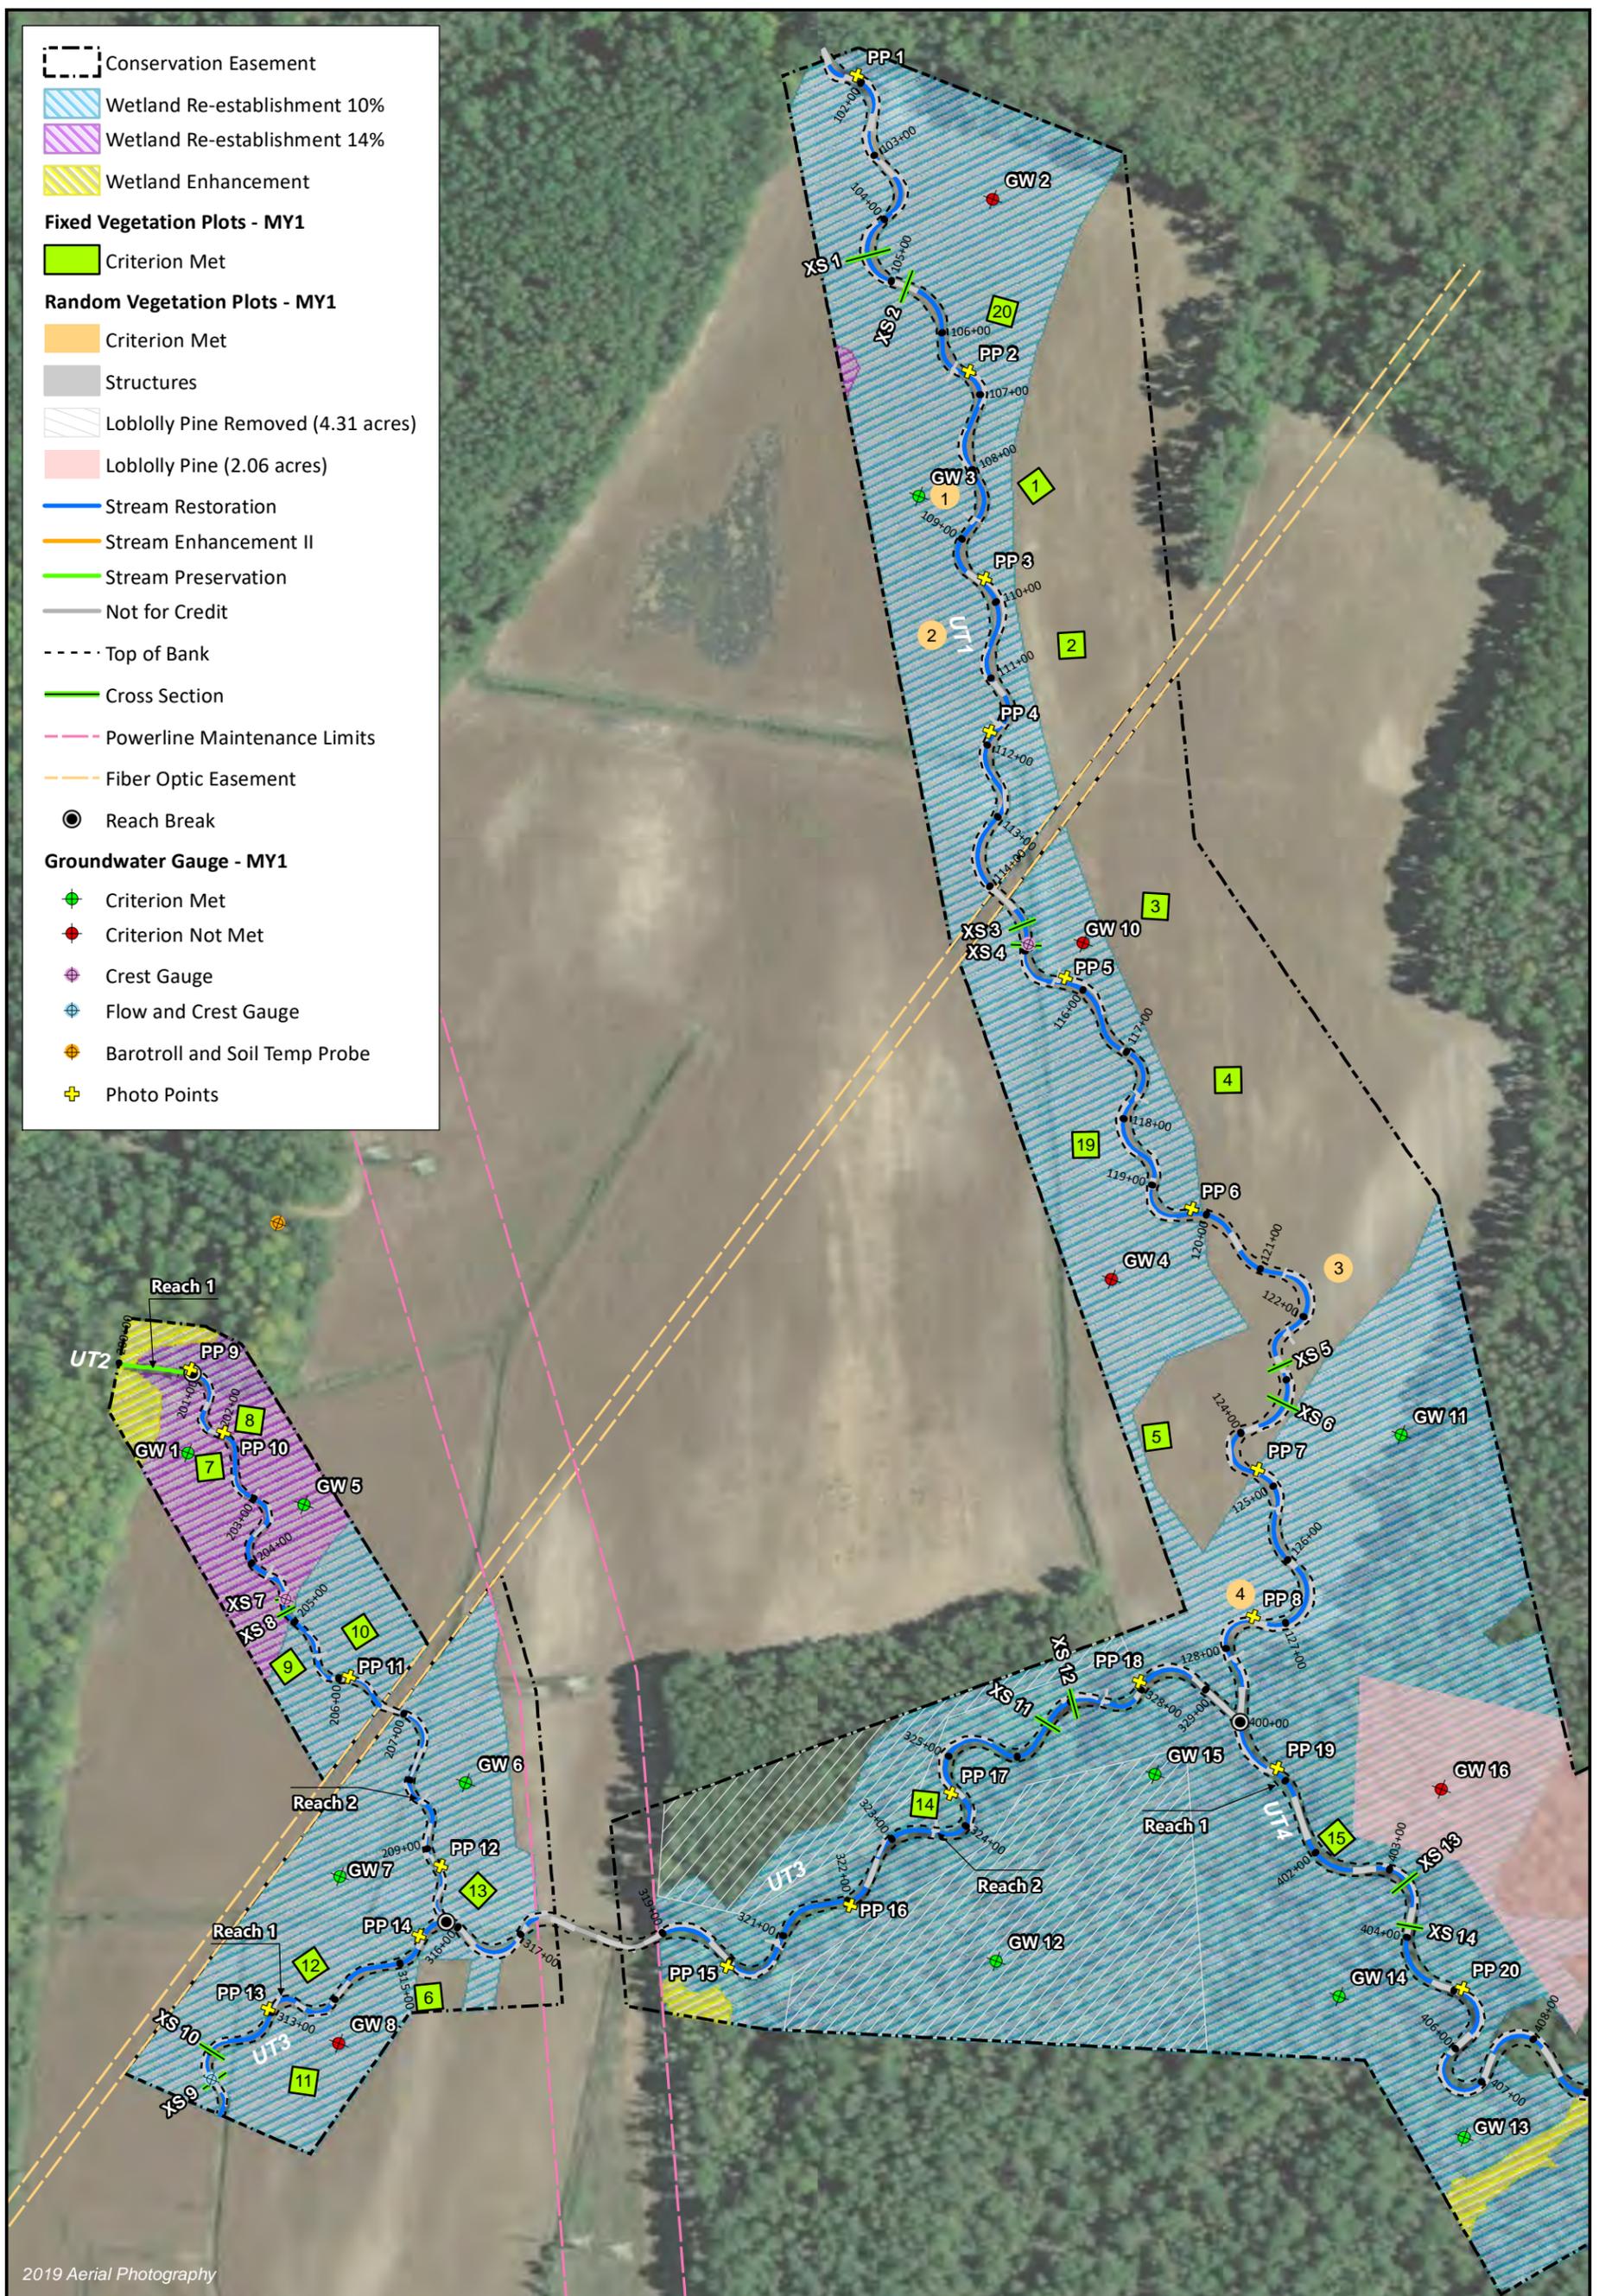
Figure 1a - Current Condition Plan View
 McClenny Acres Mitigation Site
 DMS Project No. 100038
 Monitoring Year 1 - 2021

Mature pine (*Pinus taeda*) trees were harvested and removed from a 4.31 acre area within the conservation easement surrounding UT3 during December of 2021. Additional mature pines remain within a 2.06 acre area along the east side of upper UT4. Girdling this area of pine trees will be considered to reduce the seed source within the conservation easement, although it is Wildlands' understanding that pine removal is not required as a condition of the mitigation plan or subsequent correspondence in this area (Figure 1a, 1b). No other vegetation areas of concern were identified during MY1.

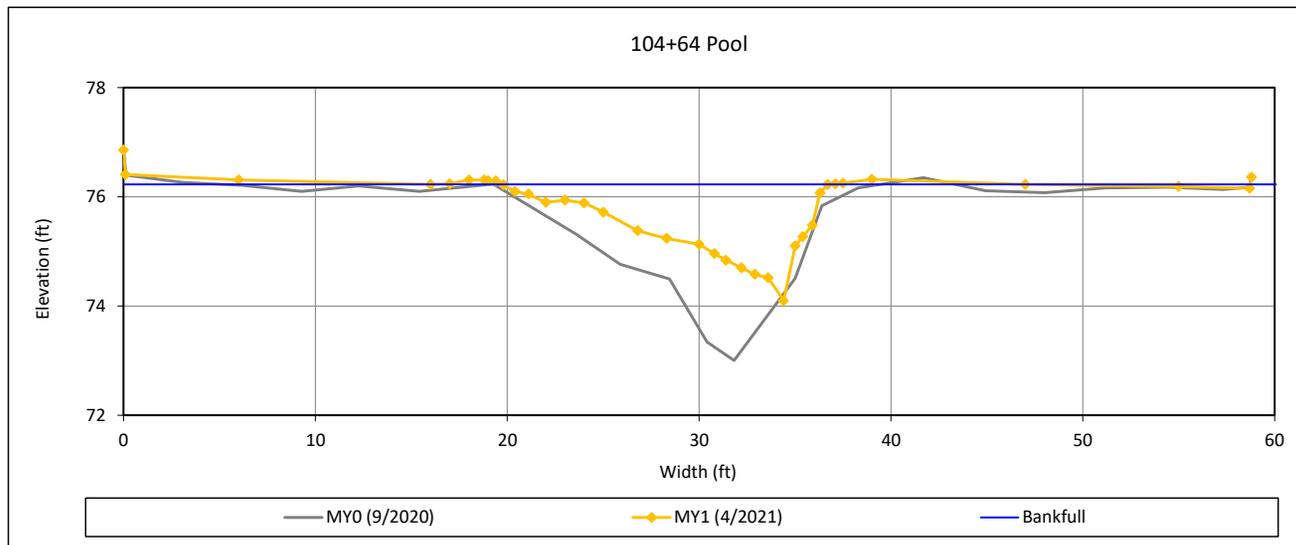
Cross-Section 1-UT1

Morphological surveys for MY1 were conducted in April 2021. All streams within the Site are stable and functioning as designed. Some sediment has accumulated in the cross-section (XS) 1 pool of UT1. This is possibly related to the sudden energy relief provided by the restored channel relative to the off-project, steeper, and more incised condition of UT1. Additionally, some variation in pool depth is characteristic of sediment dynamics in sand bed streams. The max depth and water surface slope observed in XS 1 indicate this pool is still functioning as designed. All remaining cross-sections at the Site show little to no change in the bankfull area and width-to-depth ratio and bank height ratios are less than 1.2. Refer to Appendix A for the Visual Stream Morphology Stability Assessment Table and Stream Photographs. Refer to Appendix C for Stream Geomorphology Data.

14.6	x-section area (ft.sq.)
17.0	width (ft)
0.9	mean depth (ft)
2.1	max depth (ft)
18.2	wetted perimeter (ft)
0.8	hydraulic radius (ft)
19.7	width-depth ratio
