**Year 1 Monitoring Report**

**MOCKINGBIRD SITE**

NCDMS Project # 100021 (Contract # 7185)

Davie County, North Carolina

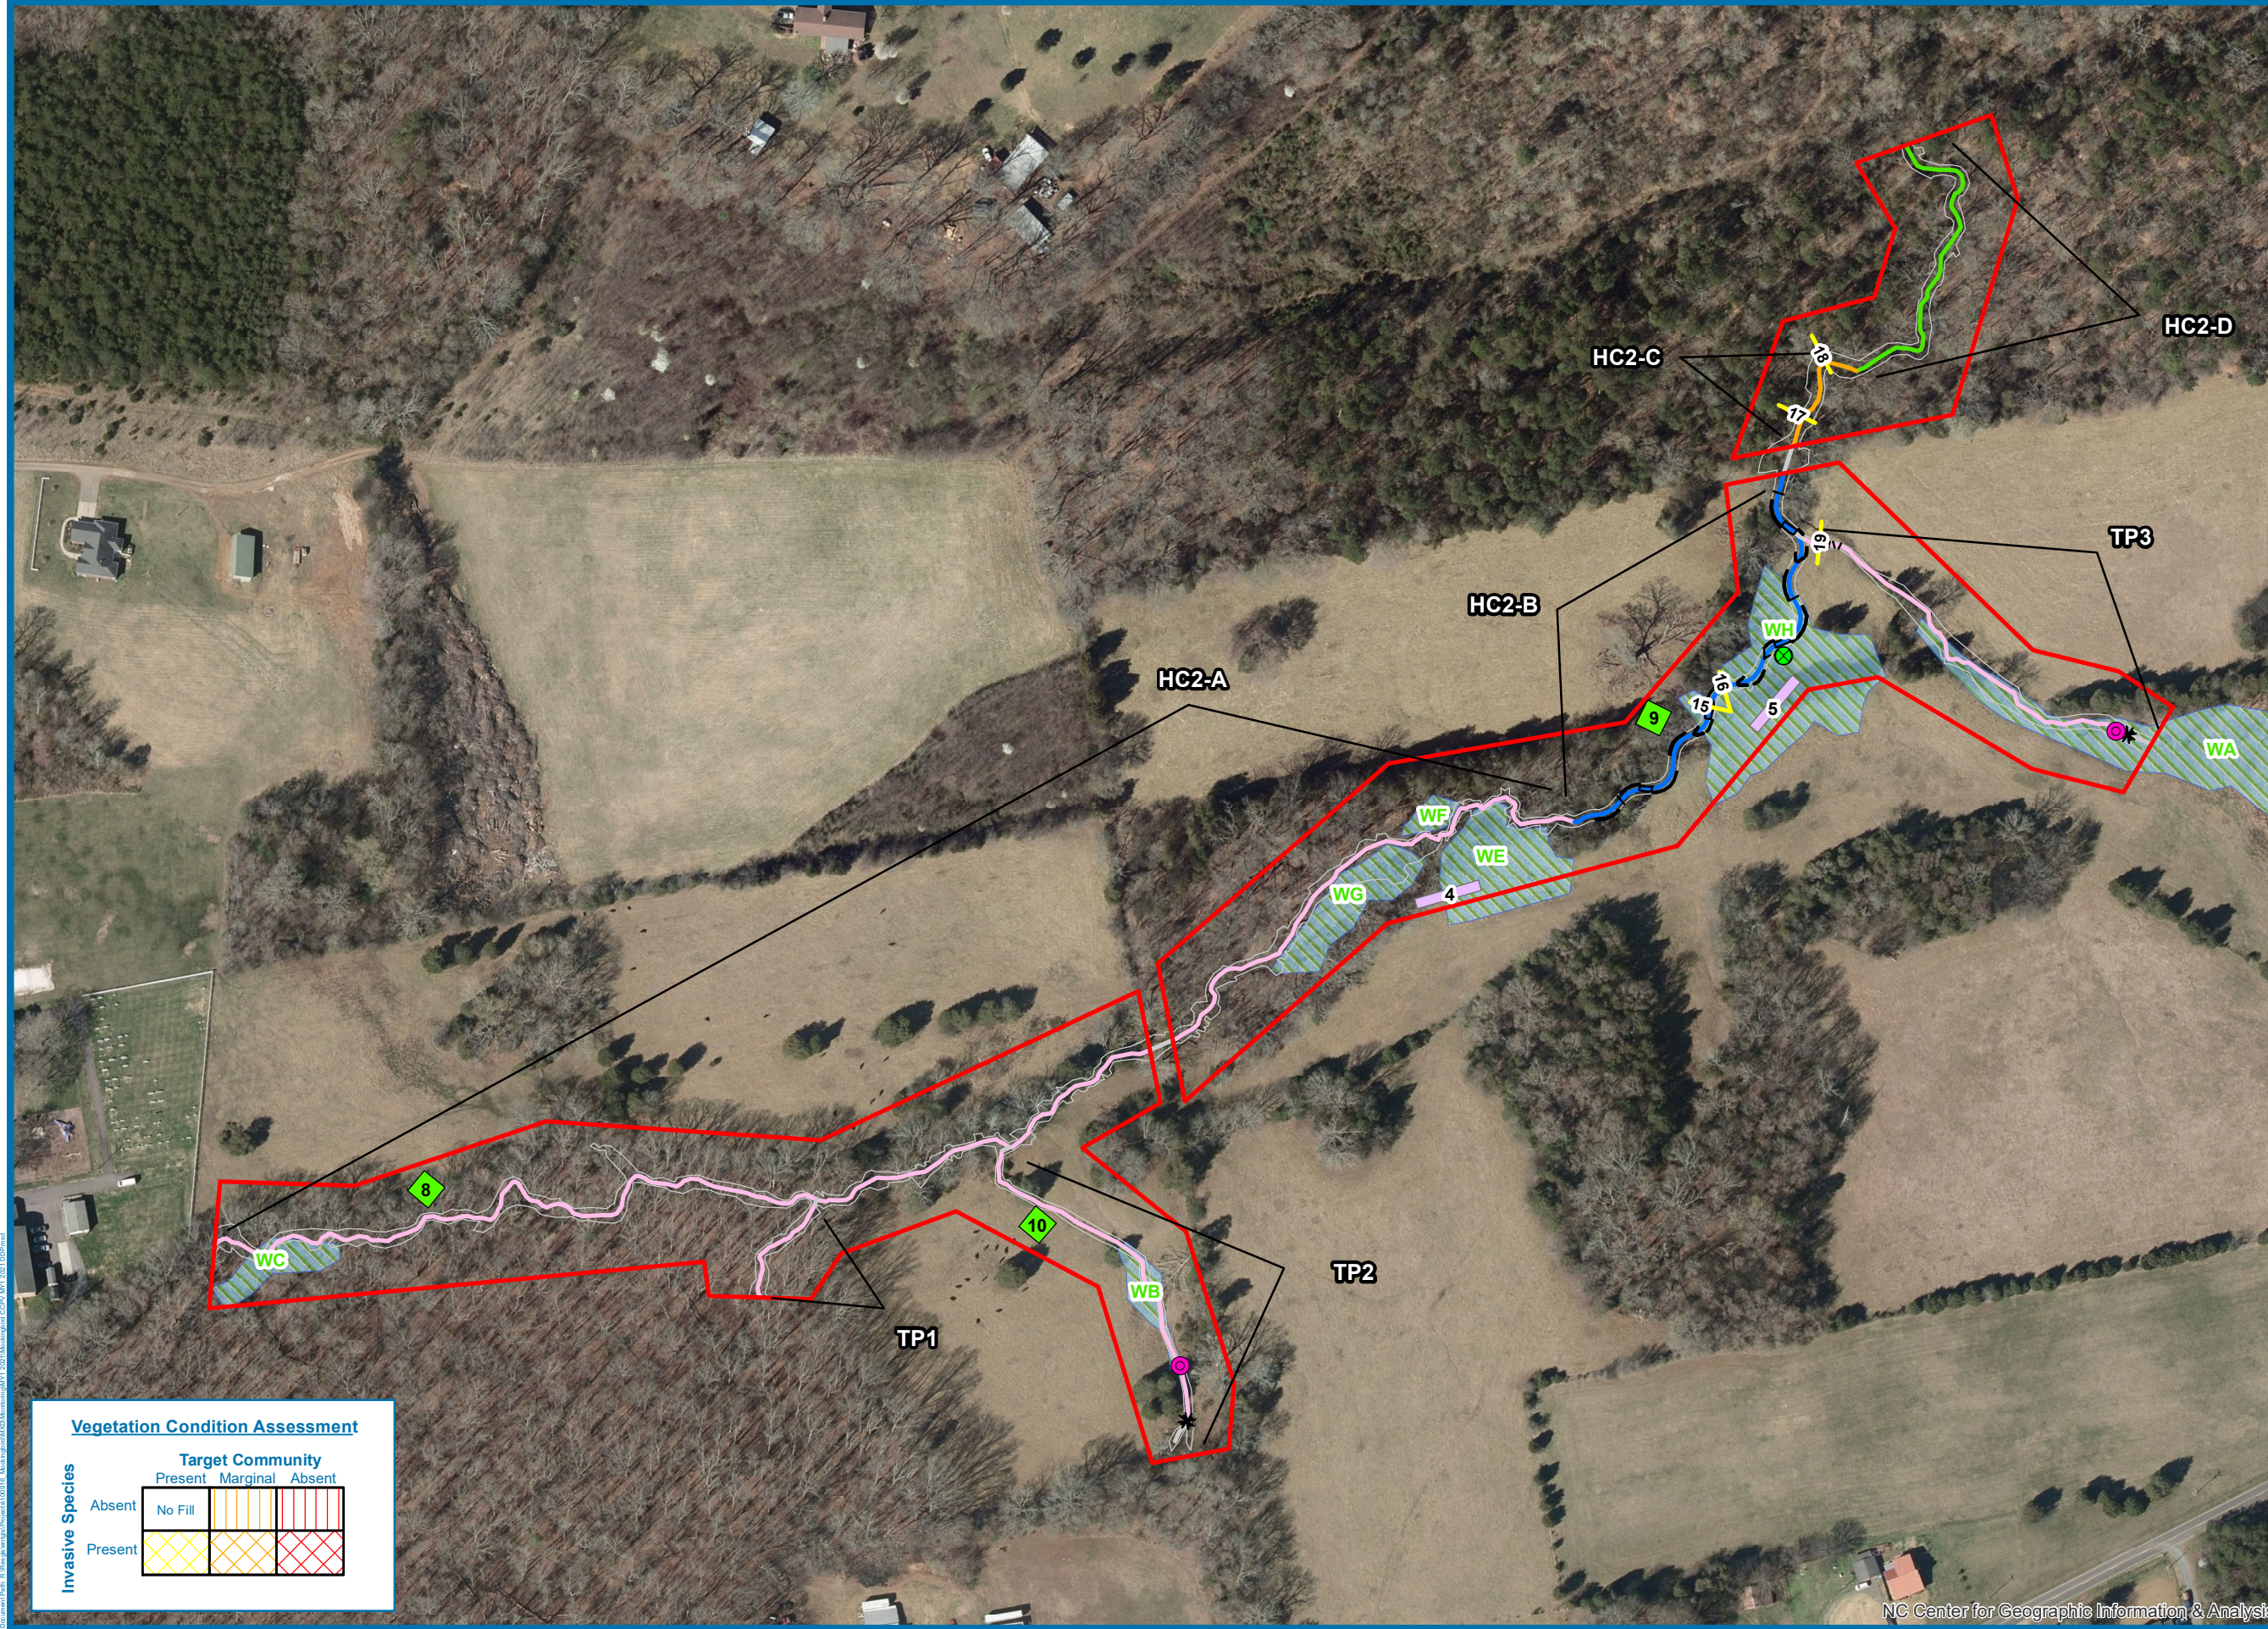
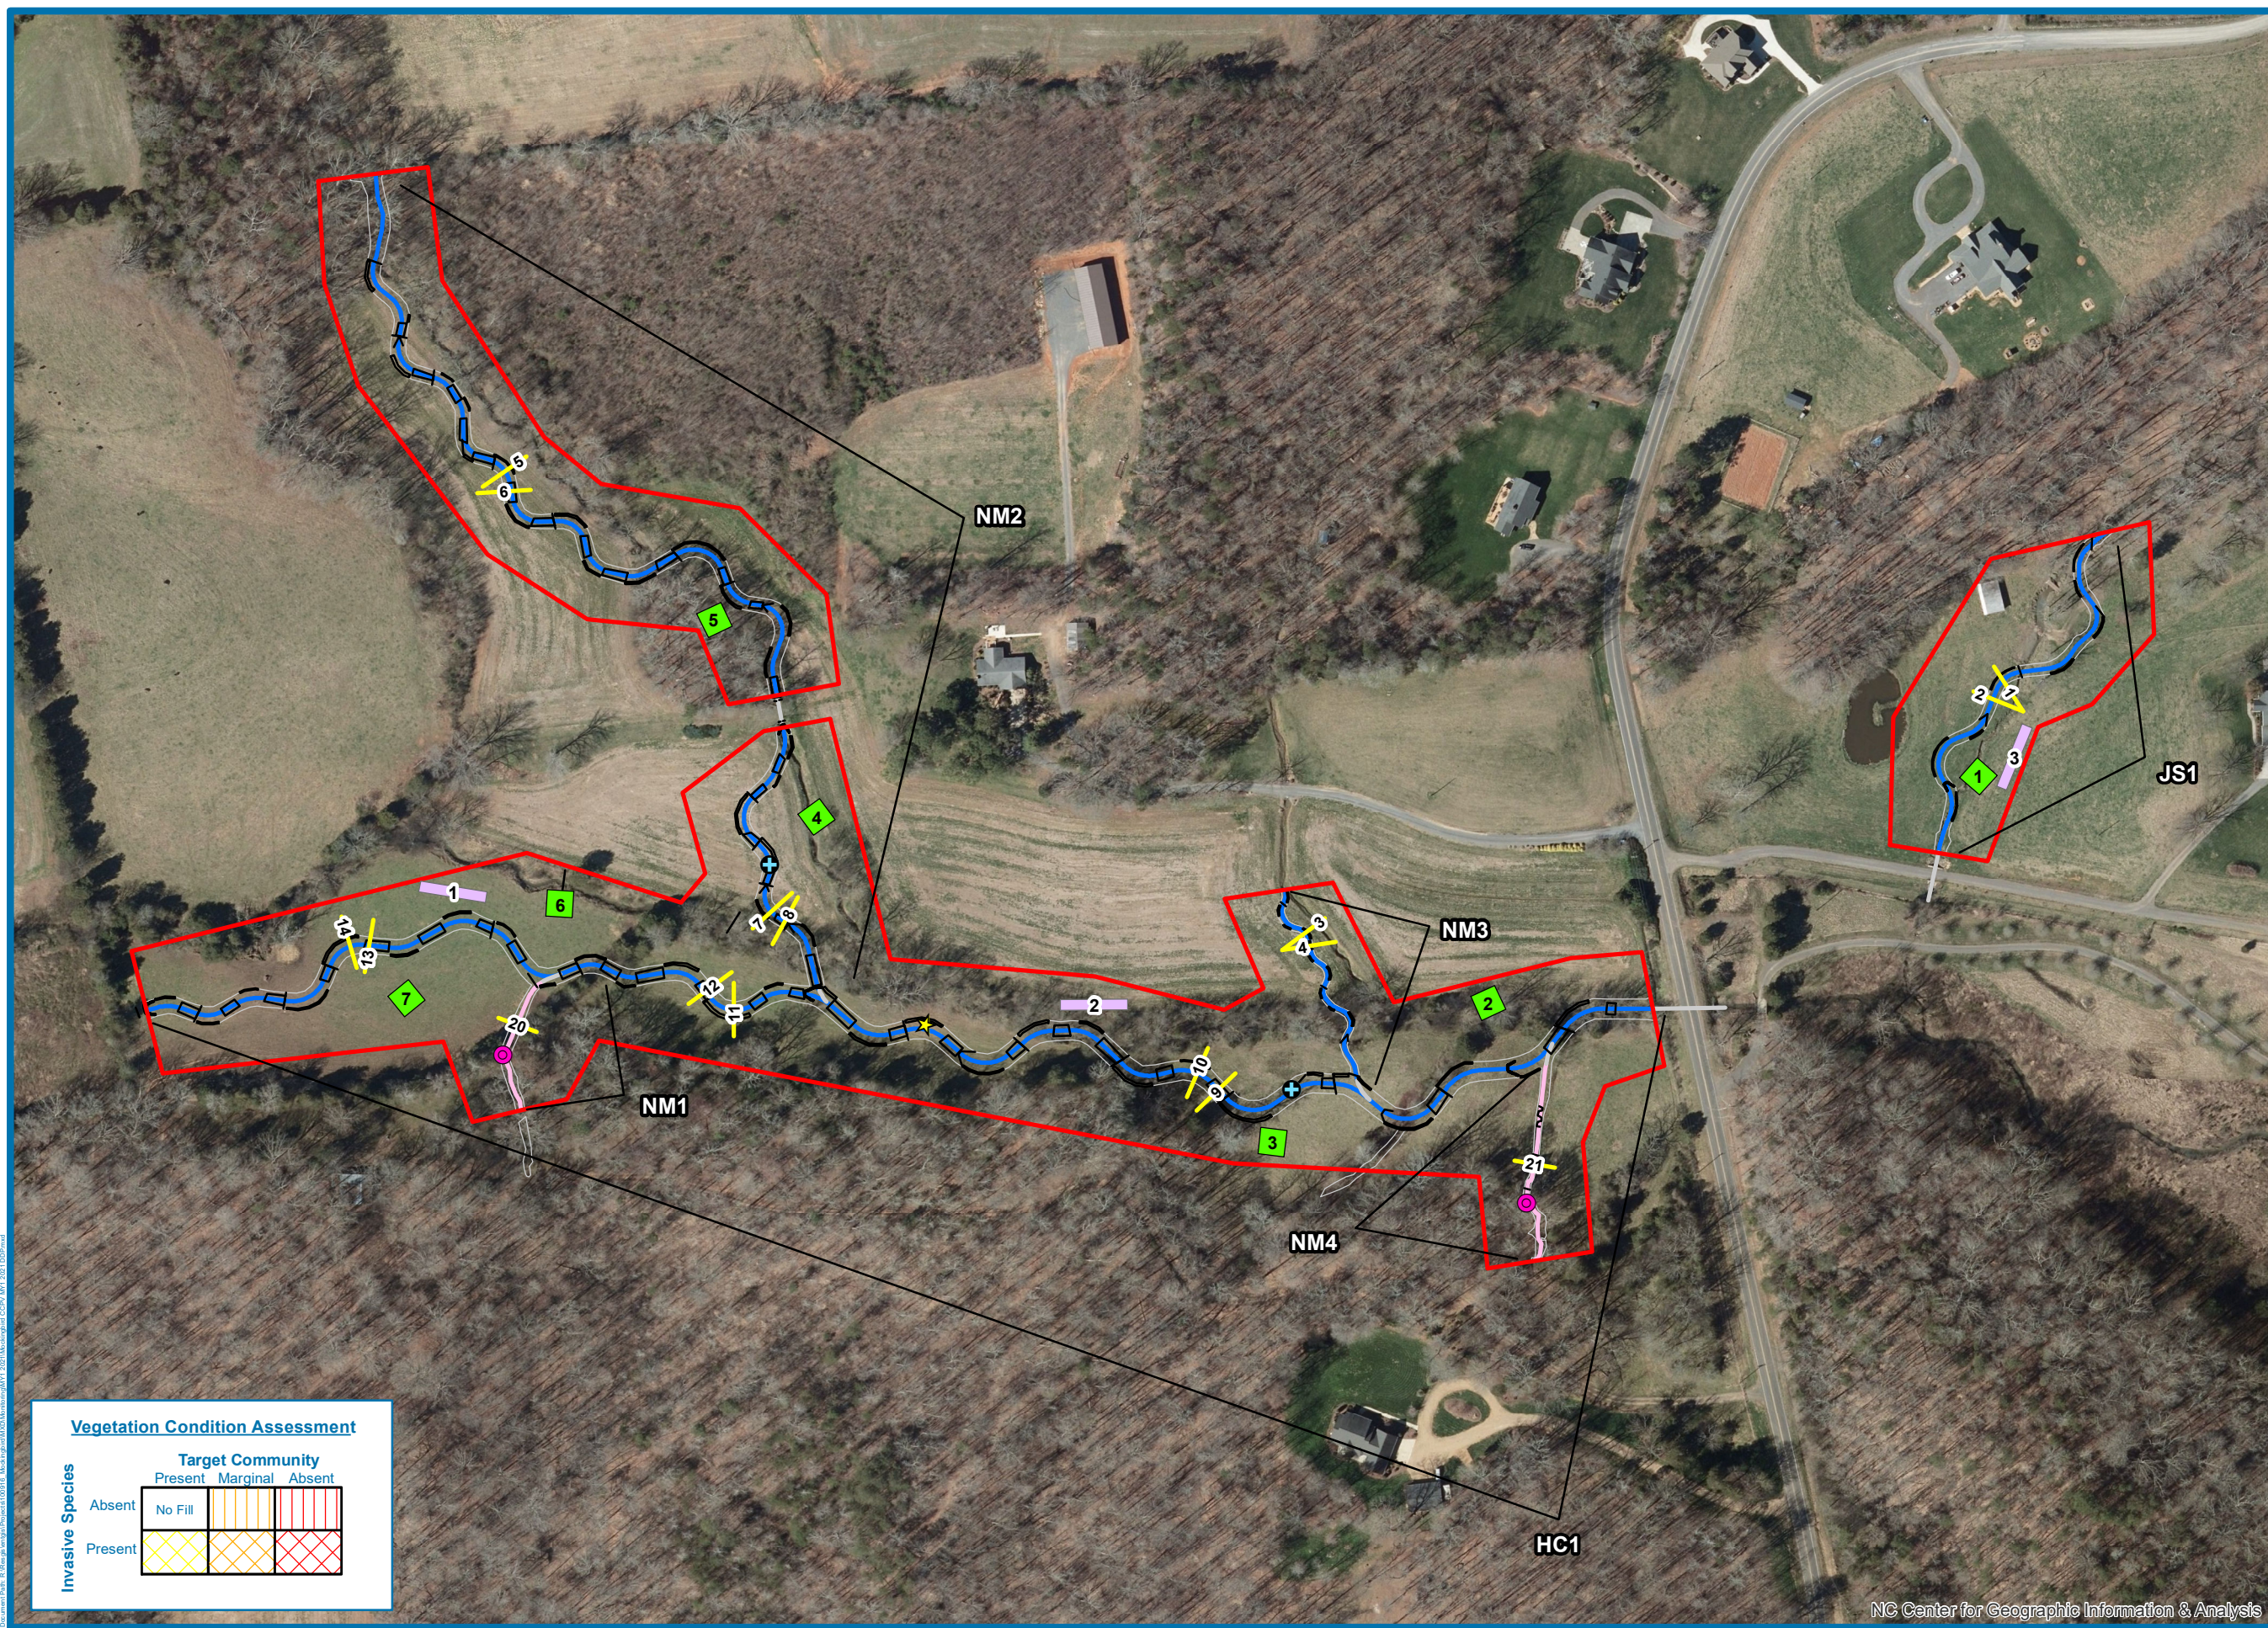
Current Conditions  
Plan View

Please map the location of the minor hand grading / repair on HC1  
[Now included on the MY1 CCPV Figure](#)

and will continue to be monitored for aggradation and degradation. One minor area of bank erosion was hand repaired on the right bank of HC1 in January 2021. This repair included grading the bank back and installing coir logs and livestakes.
