FINAL
MONITORING REPORT
YEAR 4 (2021)
MUD LICK CREEK MITIGATION SITE

Chatham County, North Carolina

NCDMS Project No. 93482

Submission: January 2022

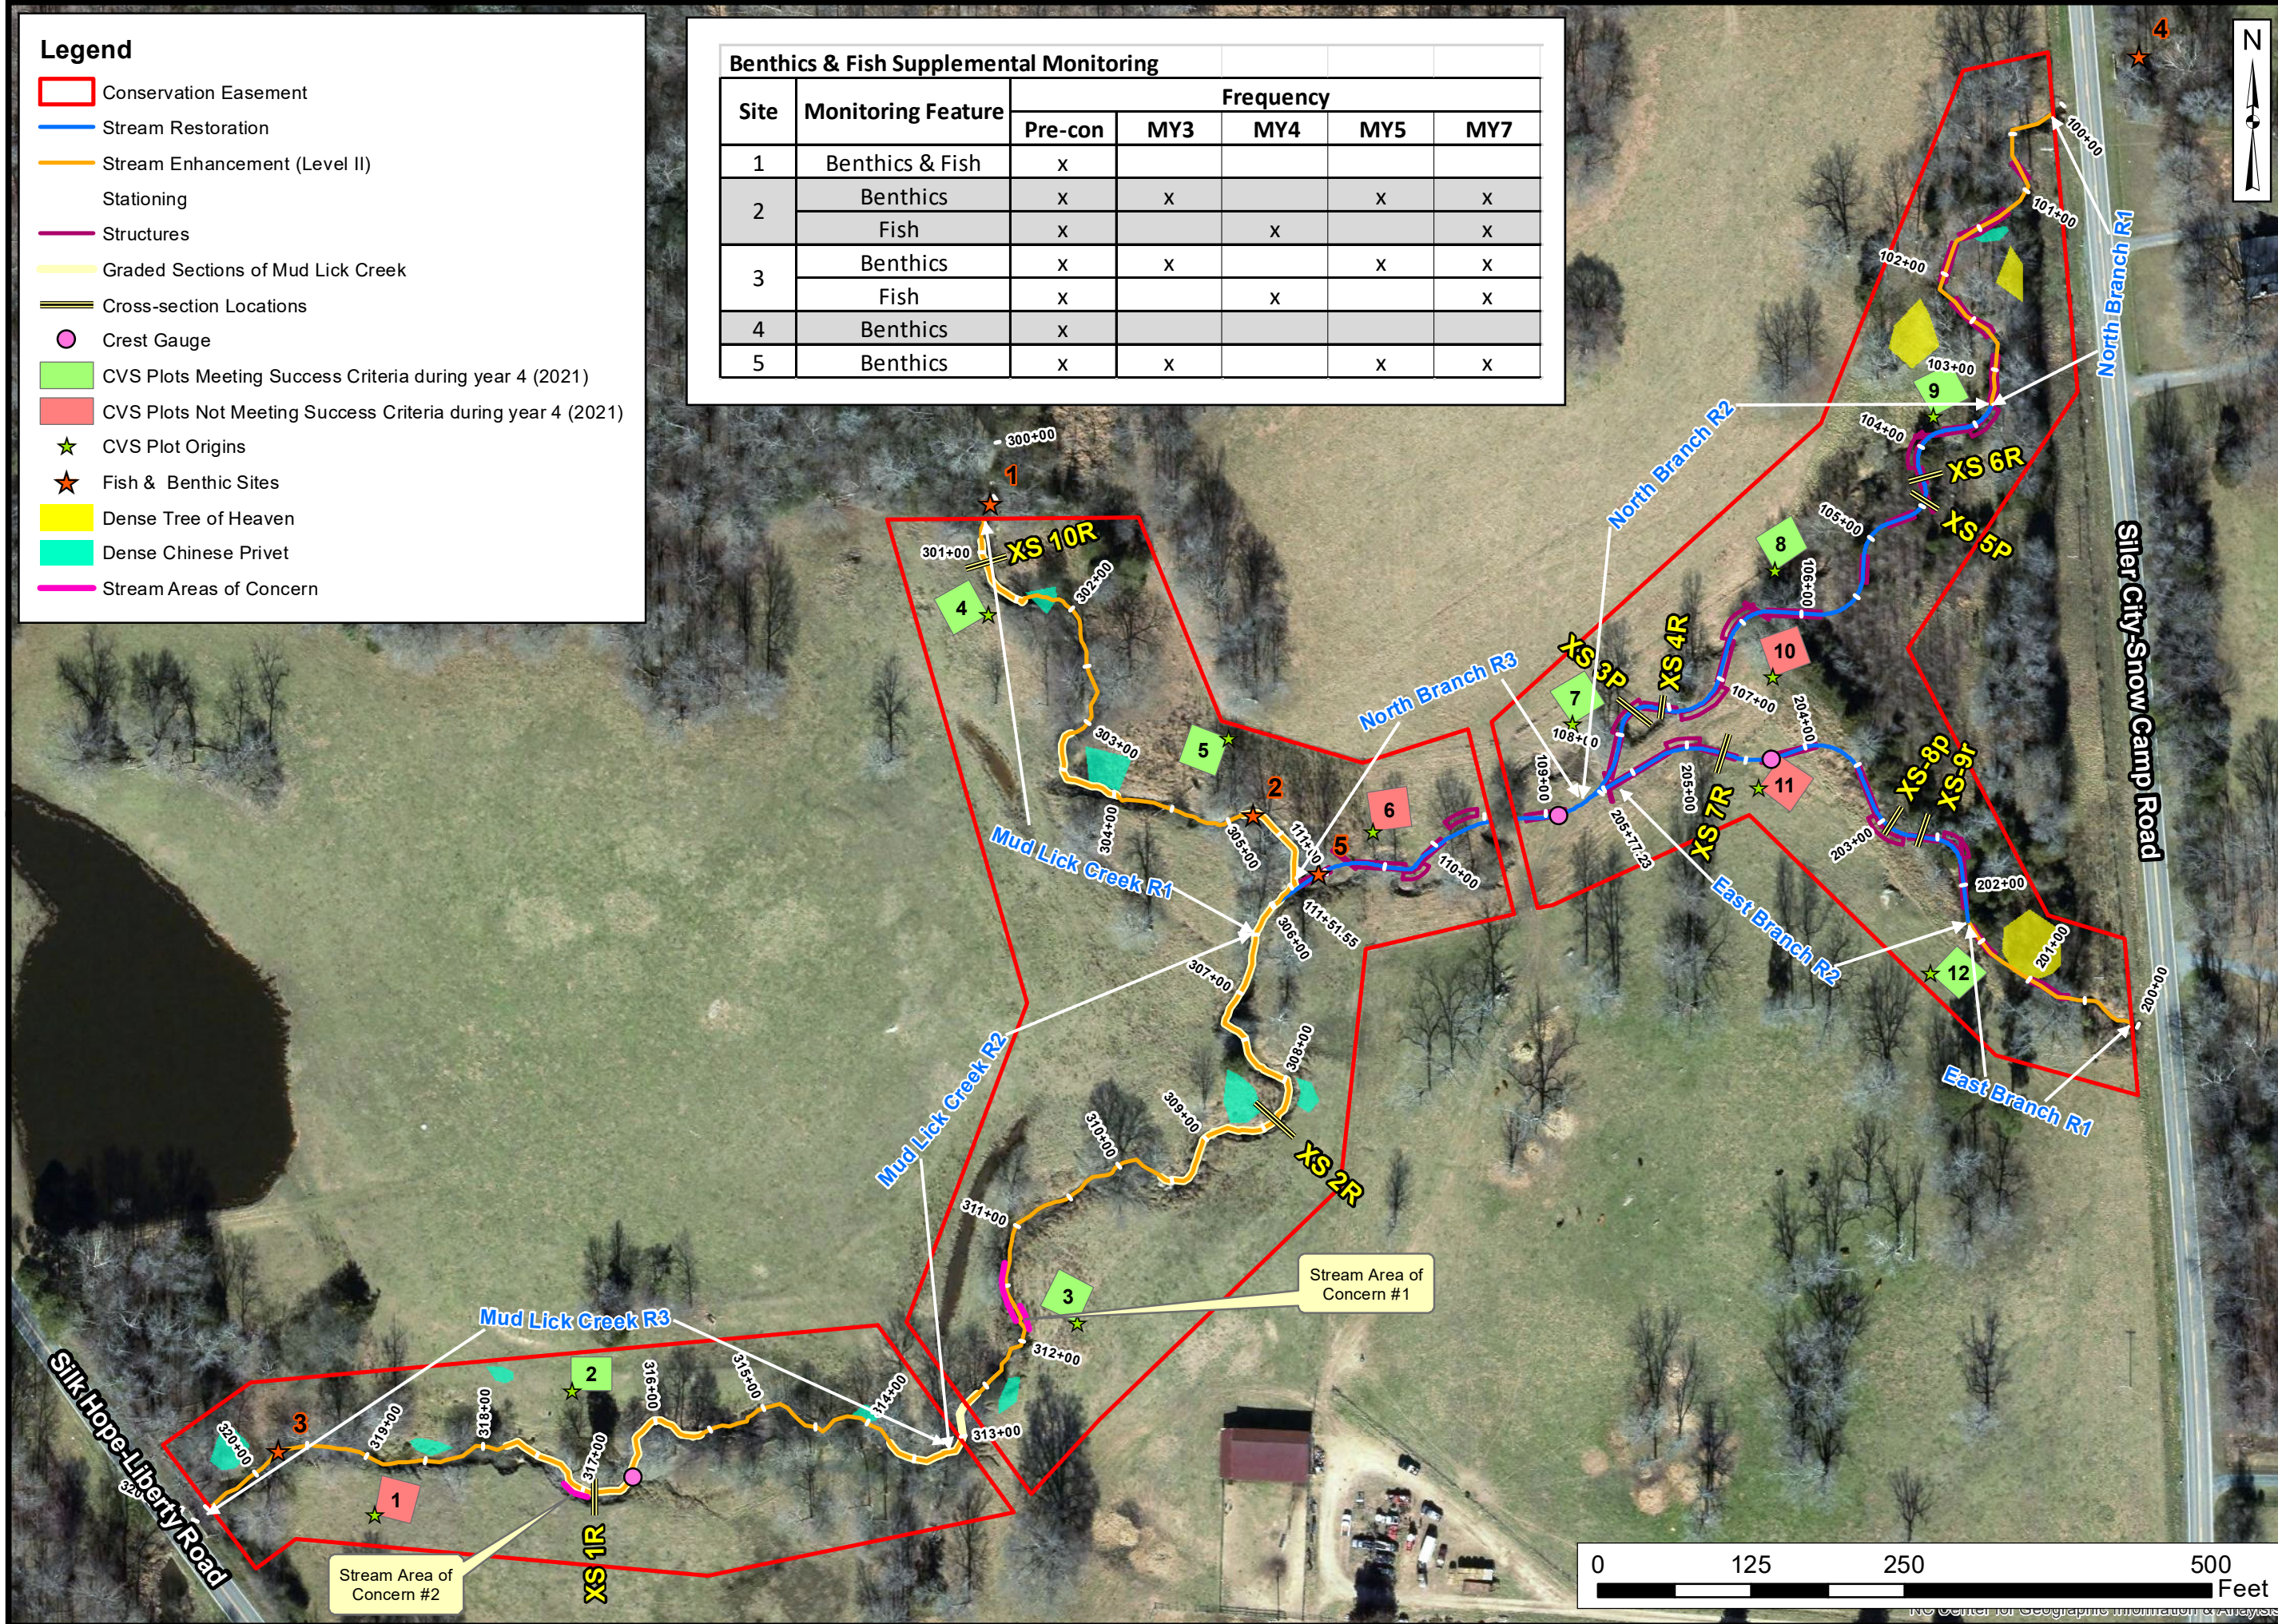
Title:
**CURRENT
 CONDITIONS
 PLAN
 VIEW**

Two stream areas of concern were observed during monitoring year 4 (2021); both were documented during previous monitoring years. Stream Area of Concern #1 is located along Mud Lick Creek R2 where approximately 50 feet of the right bank and 20 feet of the left bank have eroded to the point of bank sloughing. This area remains relatively unchanged from year 1 (2018); the establishment of dense herbaceous vegetation and lack of high discharge events have allowed this area to continue to stabilize. Stream Area of Concern #2 consists of scour and sloughing along an outer bend along Mud Lick Creek R3, immediately downstream from cross-section 1. It was noted during year 4 (2021) that the material that had sloughed from the bank was generally stable and herbaceous vegetation was vigorous. Both stream areas of concern are located within enhancement II stream reaches; all stream reaches generating restoration credit are stable throughout and functioning as designed. Stream areas of concern are depicted on Figure 2 in Appendix B.

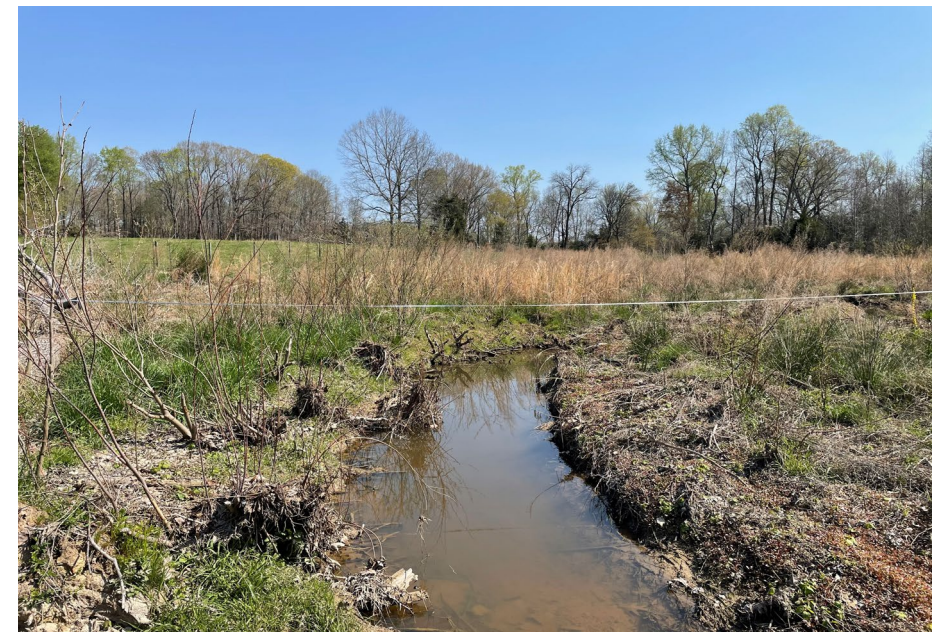
River Basin:	Cape Fear
Site Name	Mud Lick Creek
XS ID	XS - 3, Pool (North Branch)
Drainage Area (sq mi):	0.65
Date:	4/6/2021
Field Crew:	Adams, Lawson

SUMMARY DATA	
Bankfull Elevation:	98.2
Bankfull Cross-Sectional Area:	15.5
Area at Low Bank:	19.9
Bankfull Width:	12.0
Flood Prone Area Elevation:	NA
Flood Prone Width:	NA
Max Depth at Bankfull:	2.4
Low Bank Height:	2.7
Mean Depth at Bankfull:	1.3
W / D Ratio:	NA
Entrenchment Ratio:	NA
Bank Height Ratio:	NA

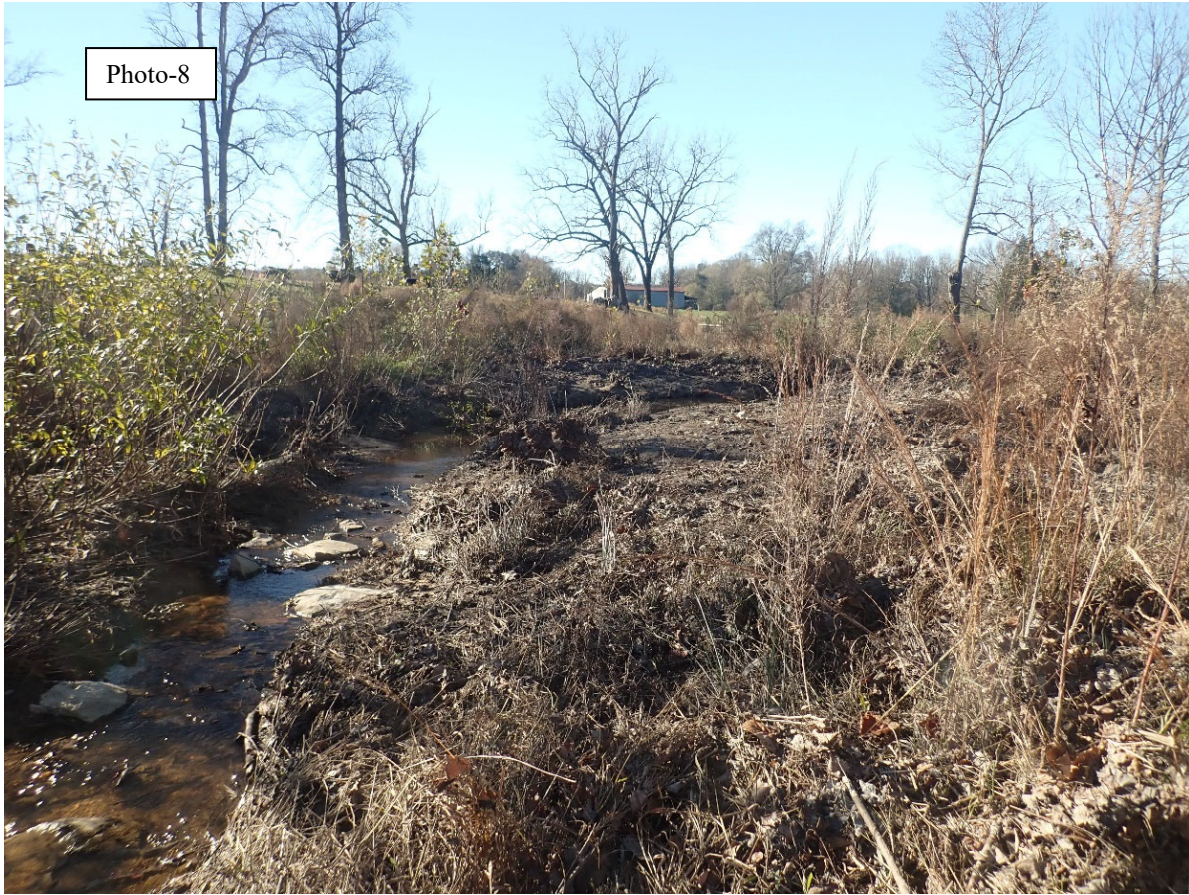
Photo-8

Date of Data Collection	Date of Occurrence	Method	Photo (if available)
December 6, 2018	October 16-17, 2018	Observations throughout floodplain and crest gauge indicate a bankfull event after 4.61 inches of rain fell over 48 hours.	1, 2
May 8, 2019	February 24, 2019	Observation of wrack in floodplain along North Branch R2 and crest gauge data from all site crest gauges indicate a bankfull event after 2.27 inches of rain fell over 48 hours.	3
September 18, 2019	July 24, 2019	Observation of wrack on Mud Lick Creek R2 floodplain fences and crest gauge data from all site crest gauges indicate a bankfull event after 3.02 inches of rain fell over 48 hours.	4
May 29, 2020	February 7, 2020	Observations of wrack throughout site along all stream reaches, and crest gauge data from all site crest gauges indicate a bankfull event after approximately 3.59 inches of rain fell over 24-hour period.	5, 6, 7
November 16, 2020	November 12, 2020	Observations of wrack throughout site along all stream reaches, and crest gauge data from all site crest gauges indicate a bankfull event after approximately 4.60 inches of rain fell over 48-hour period.	8, 9
