Year 7 Monitoring Report

UT Millers Creek
Duplin County, NC

DMS Project ID No. 95719 Contract No. 5000

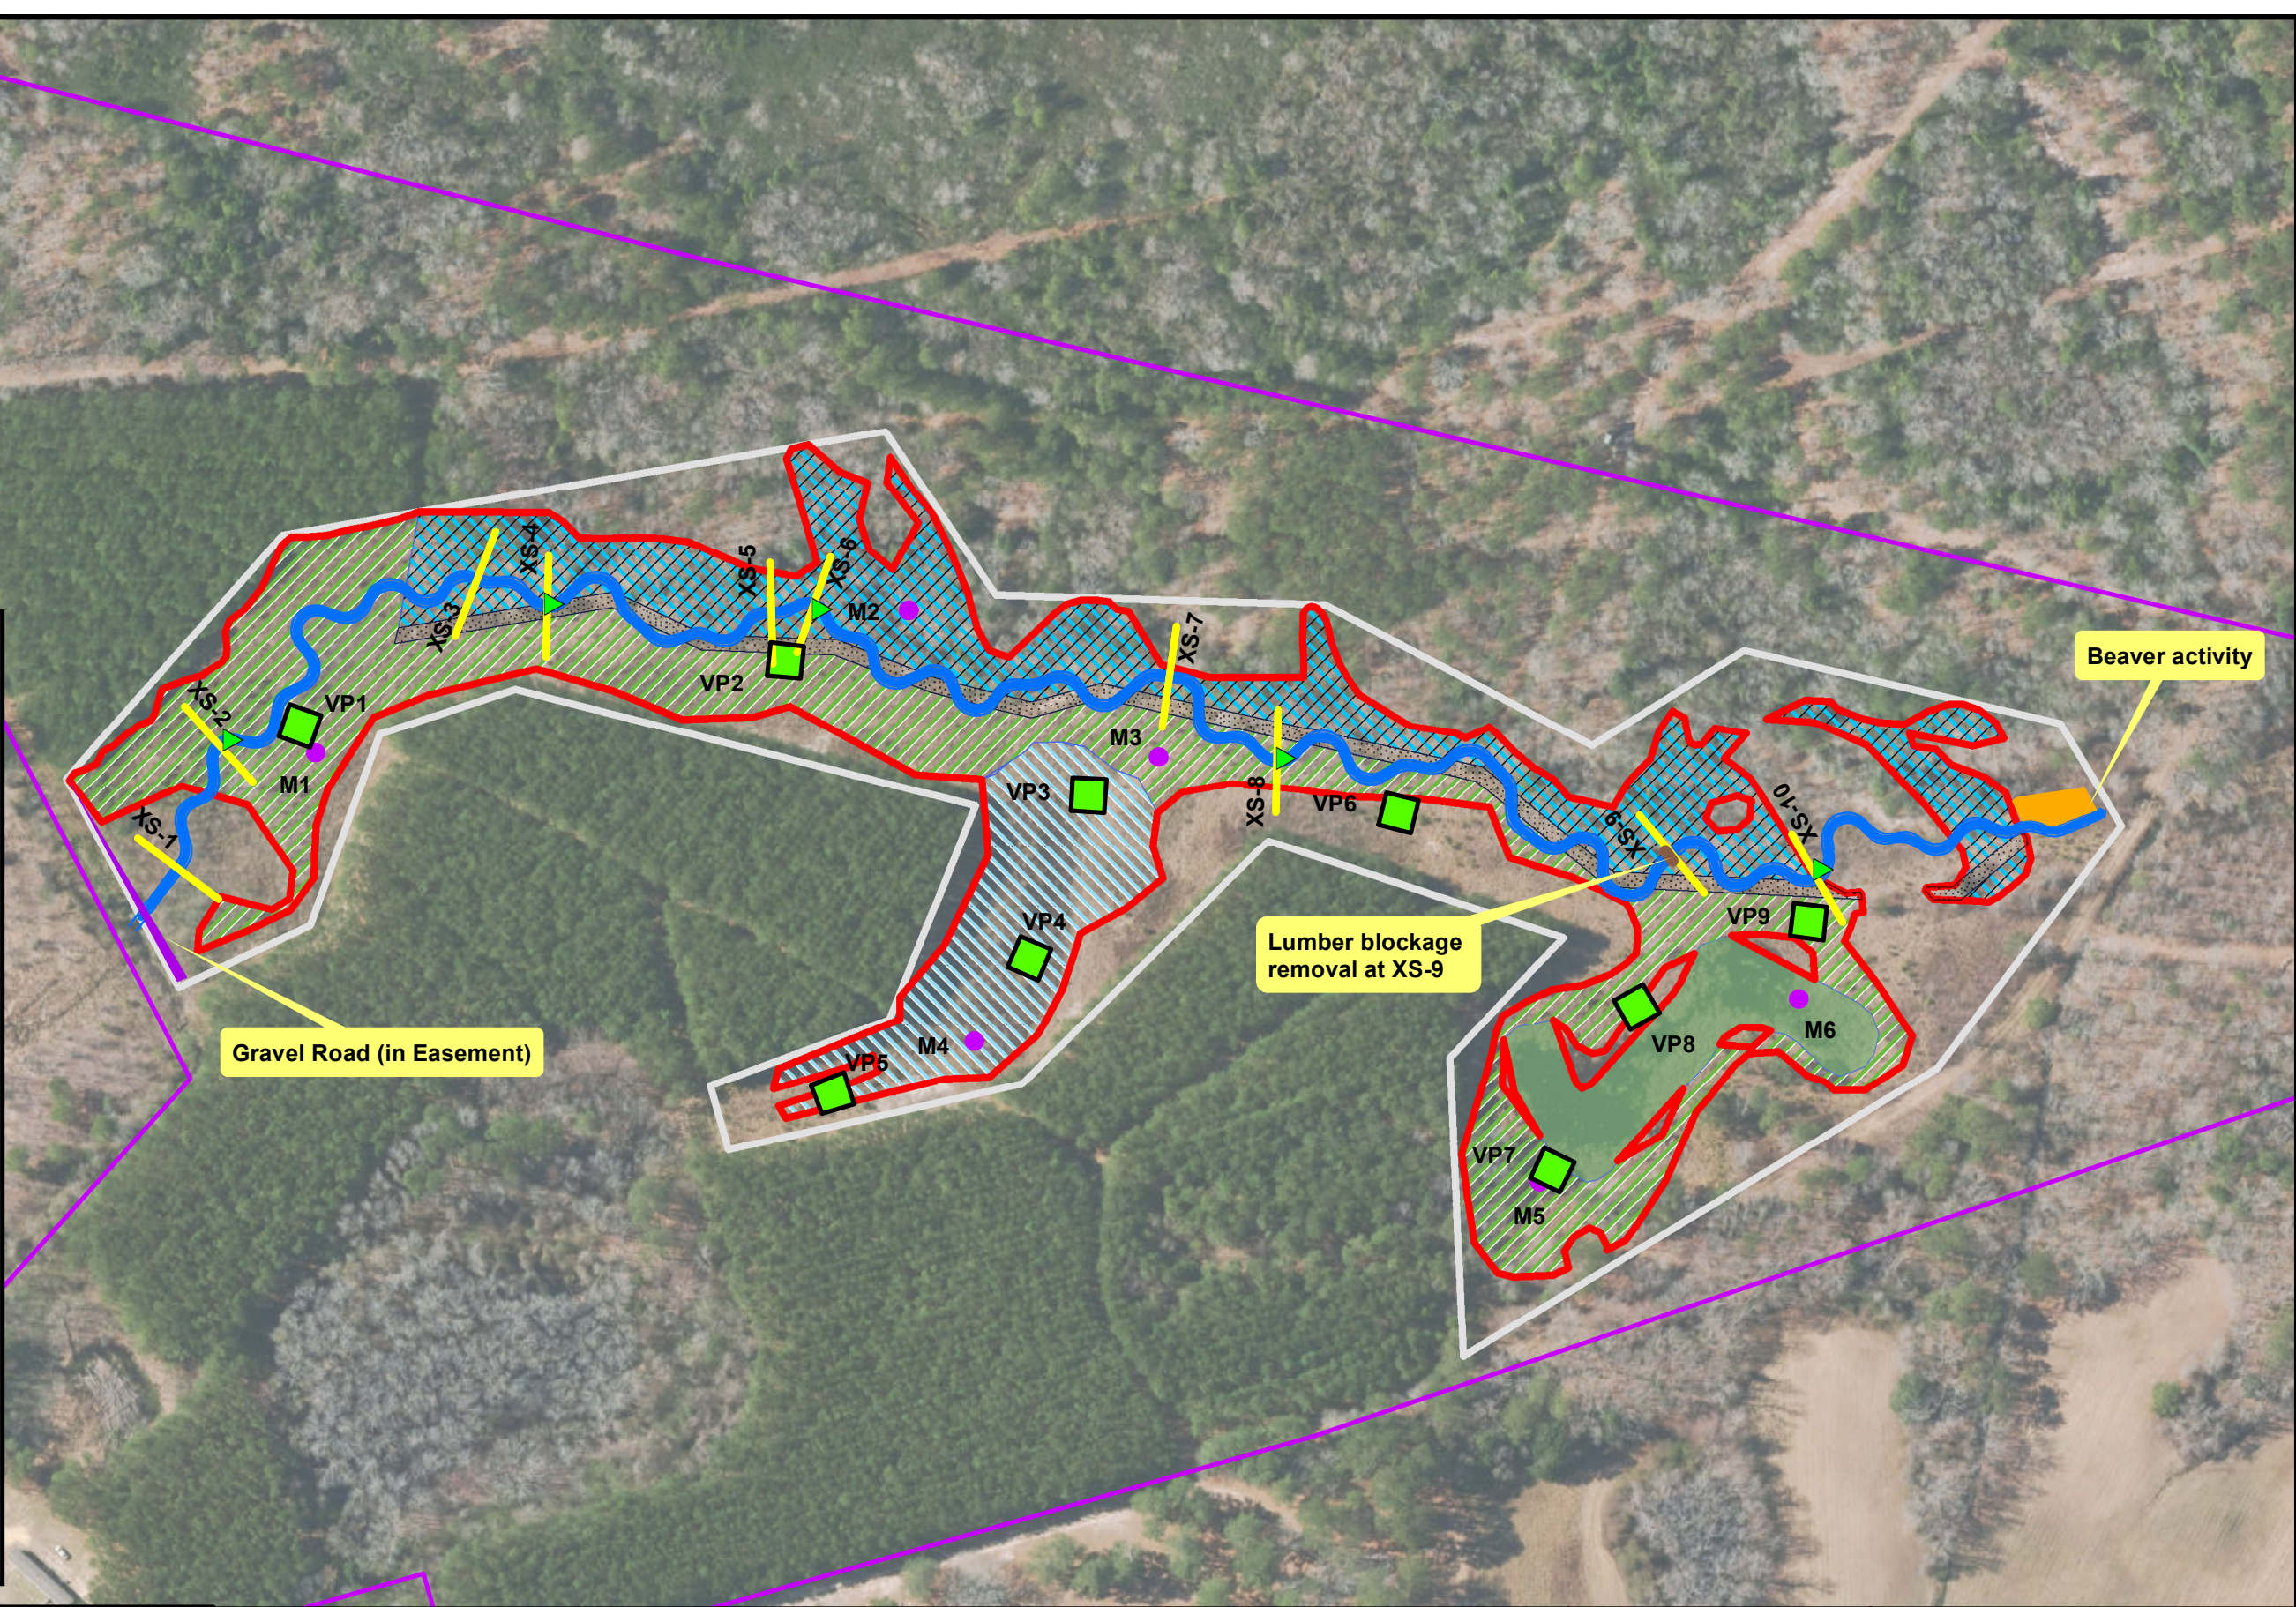
Current Condition Plan View - Year 7
 UT Millers Creek, Duplin County, North Carolina

Beaver Activity

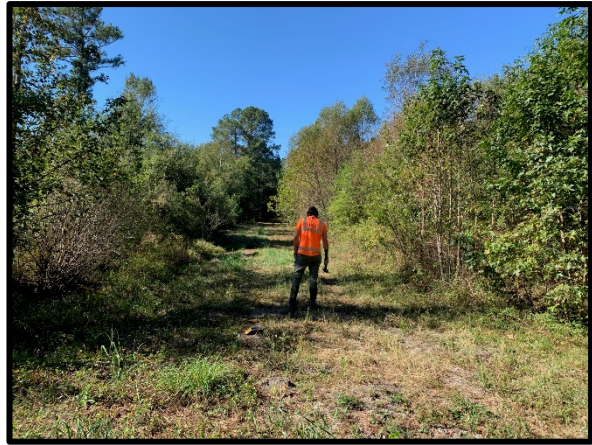
During the stewardship site visit in October 2021 by DMS staff, it was discovered that a small portion of the gravel road was installed during project construction, impacting the southeastern property corner. This went unnoticed during monitoring. DMS property staff added this road to the infrastructure layer to ensure it does not expand or migrate as the project moves into the stewardship phase. The southeastern easement boundary (witness post #14) was removed from its original location. Table 6 notes the acreage of the gravel road encroachment, Figure 2.1 illustrates the area and Figure 3.10 shows a photo of the area.

3.10 Gravel road at southeastern boundary (facing west)

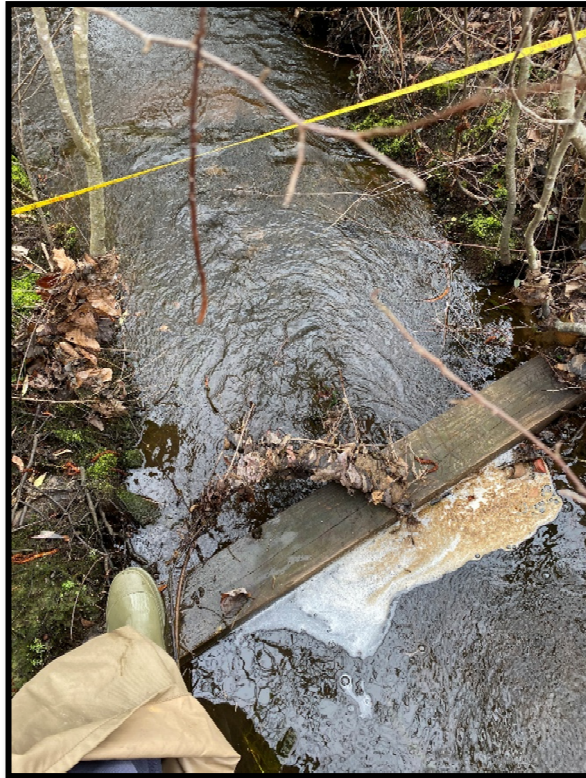
Two locations were noted as problem areas. The first location, approximately 5 ft upstream of cross section 9, was a stream block caused by a length of lumber. The lumber was approximately 4 inches by 6 inches in cross section and between 4 and 5 feet in length. It was lodged perpendicular to stream flow. There were no apparent adverse effects to channel banks or stream channel due to the blockage. The monitoring crew removed the piece of lumber while on Site.

3.11 Large lumber debris at XS 9

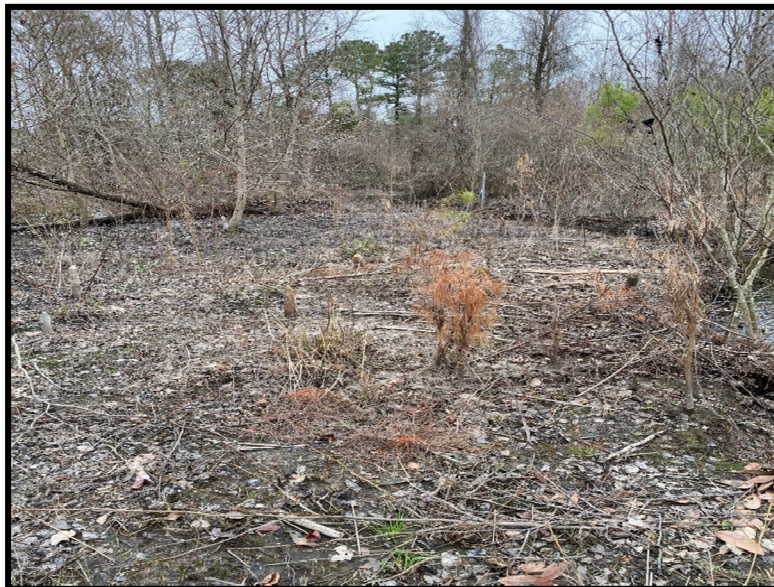
The second location noted as a problem area was at Sta. 36+75 on the left overbank area. Large woody vegetation on the floodplain had been removed by beaver activity. Although it was apparent that beavers removed the vegetation, no beaver activity was noted within any part of the stream channel.

3.12 Beaver activity at STA 36+75

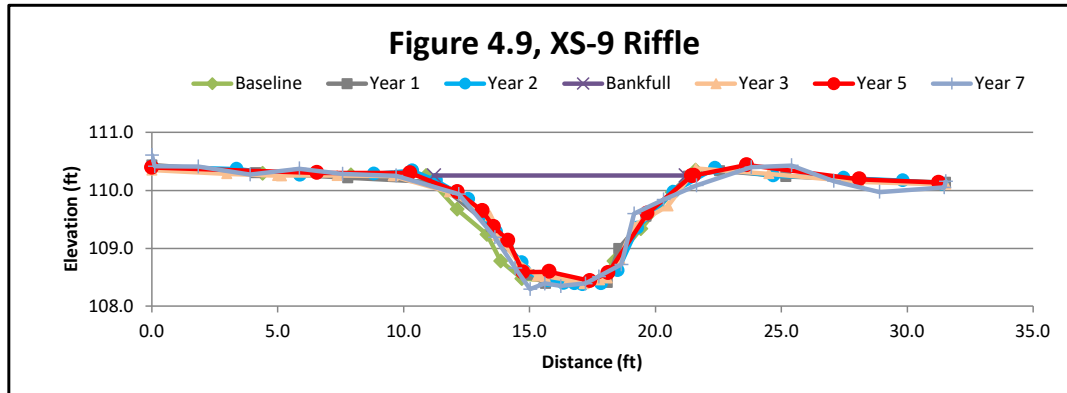
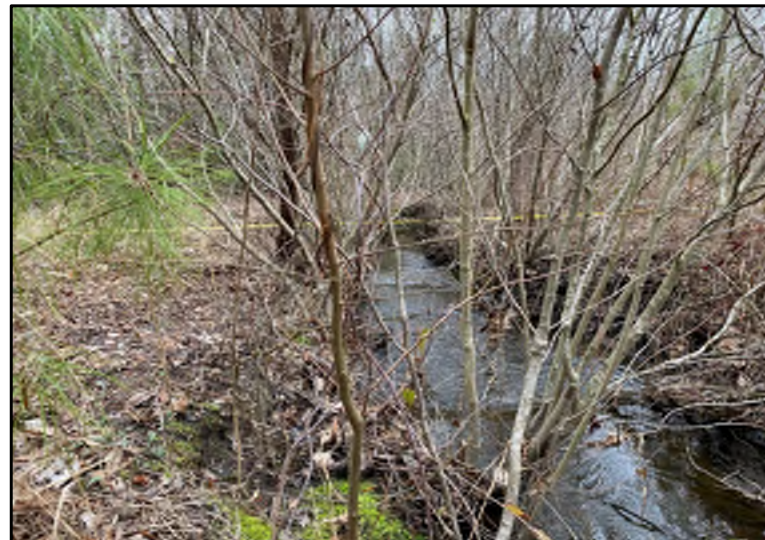
All riffle cross sections retained similar parameters when compared to previous years. The one minor exception was to cross section 9 where a slight uptick in bankfull width and bankfull maximum depth were documented. Subsequently, values for cross sectional area and bankfull width/depth ratio were slightly elevated. The presence of the stream block immediately upstream, as noted above, likely is the cause for these minor variations. No notable changes were seen in pool cross section locations.

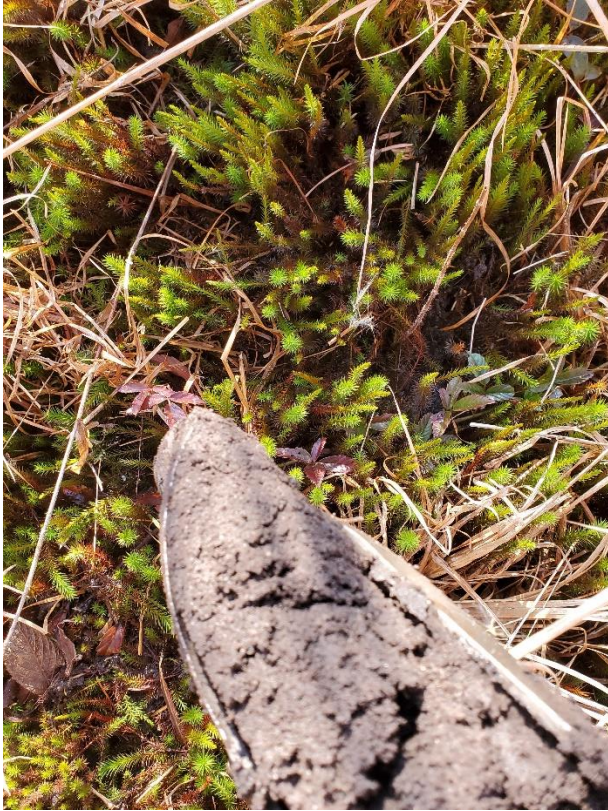
Spagnum moss common on-site in the inundated, and hydric soil areas.

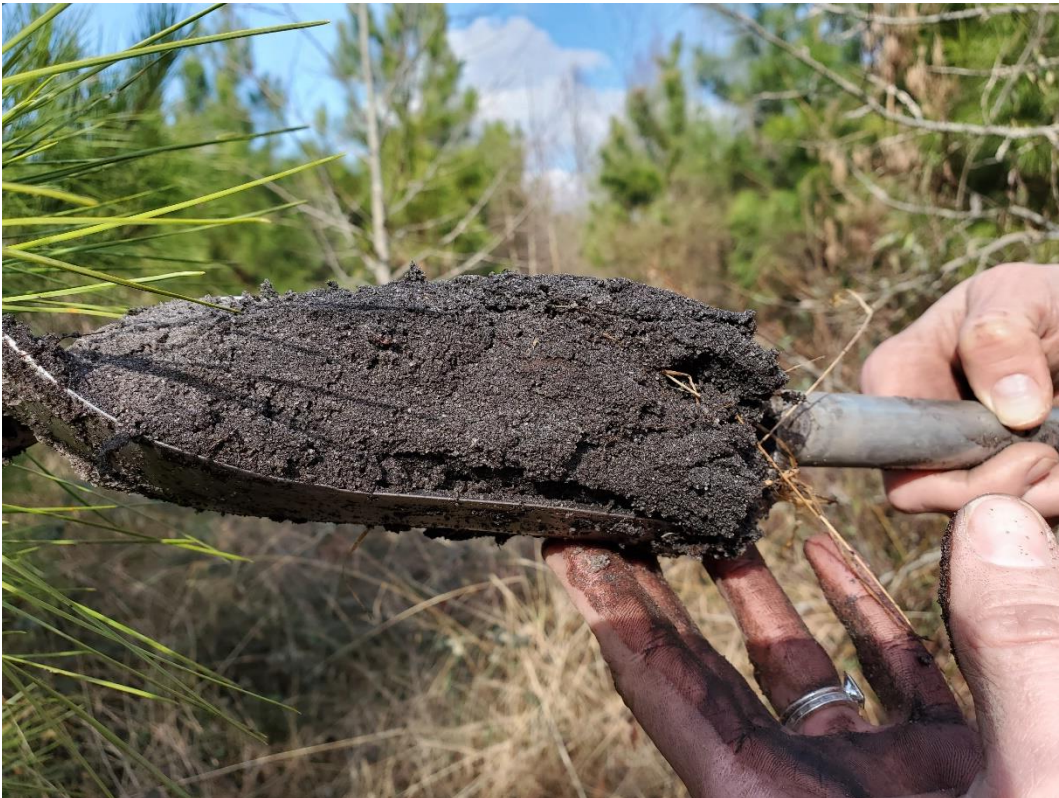
Typical example of dark surface; observe organic coating on hands.

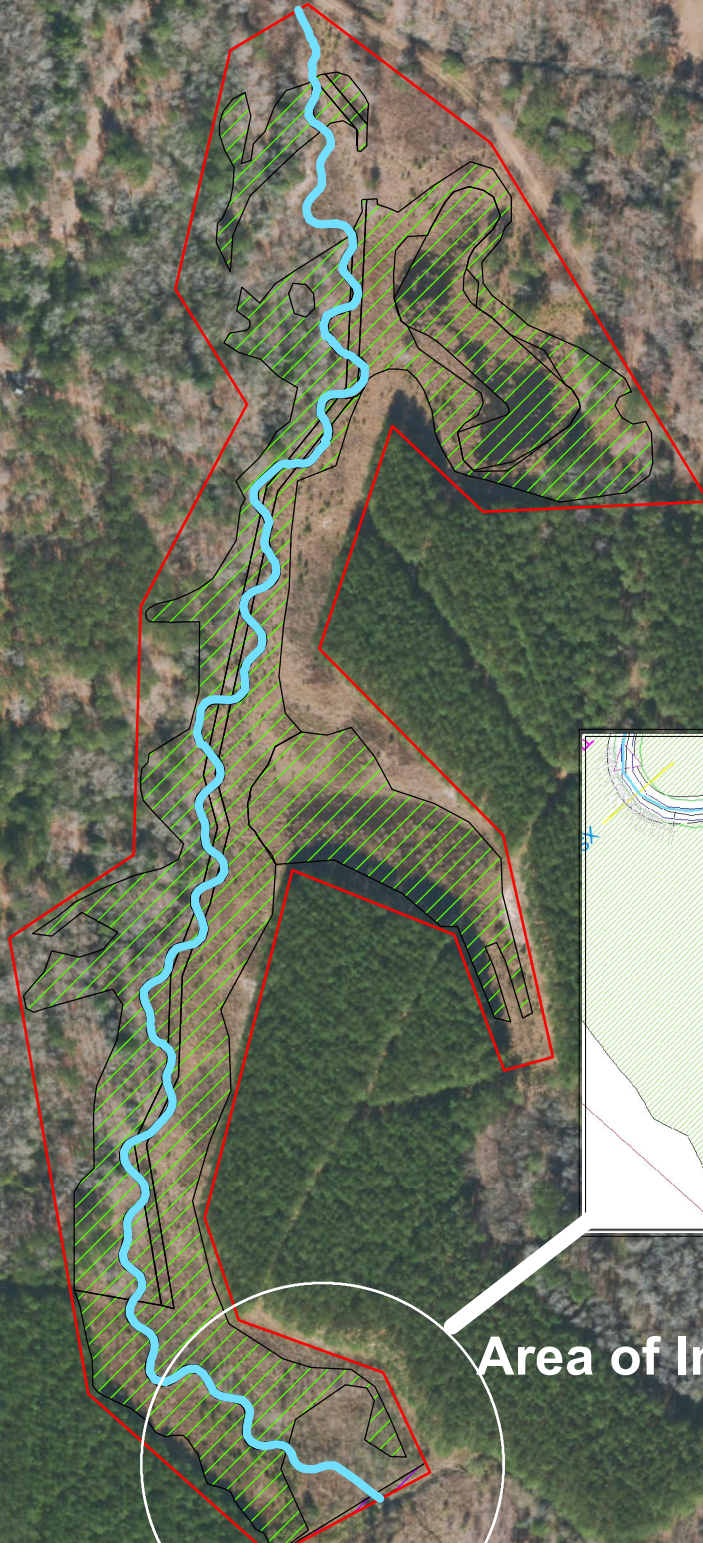
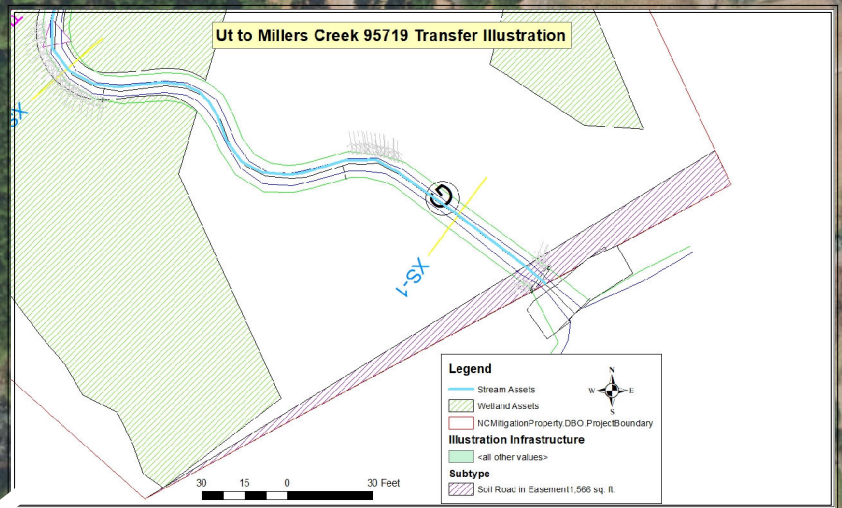
Area of Infrastructure Encroachment

- Soil Road in Easement 1,566 sq. ft.
