Year 1 Monitoring Report

APPLE VALLEY PROJECT

NCDMS Project #100063 (Contract #7531)

Henderson County, North Carolina

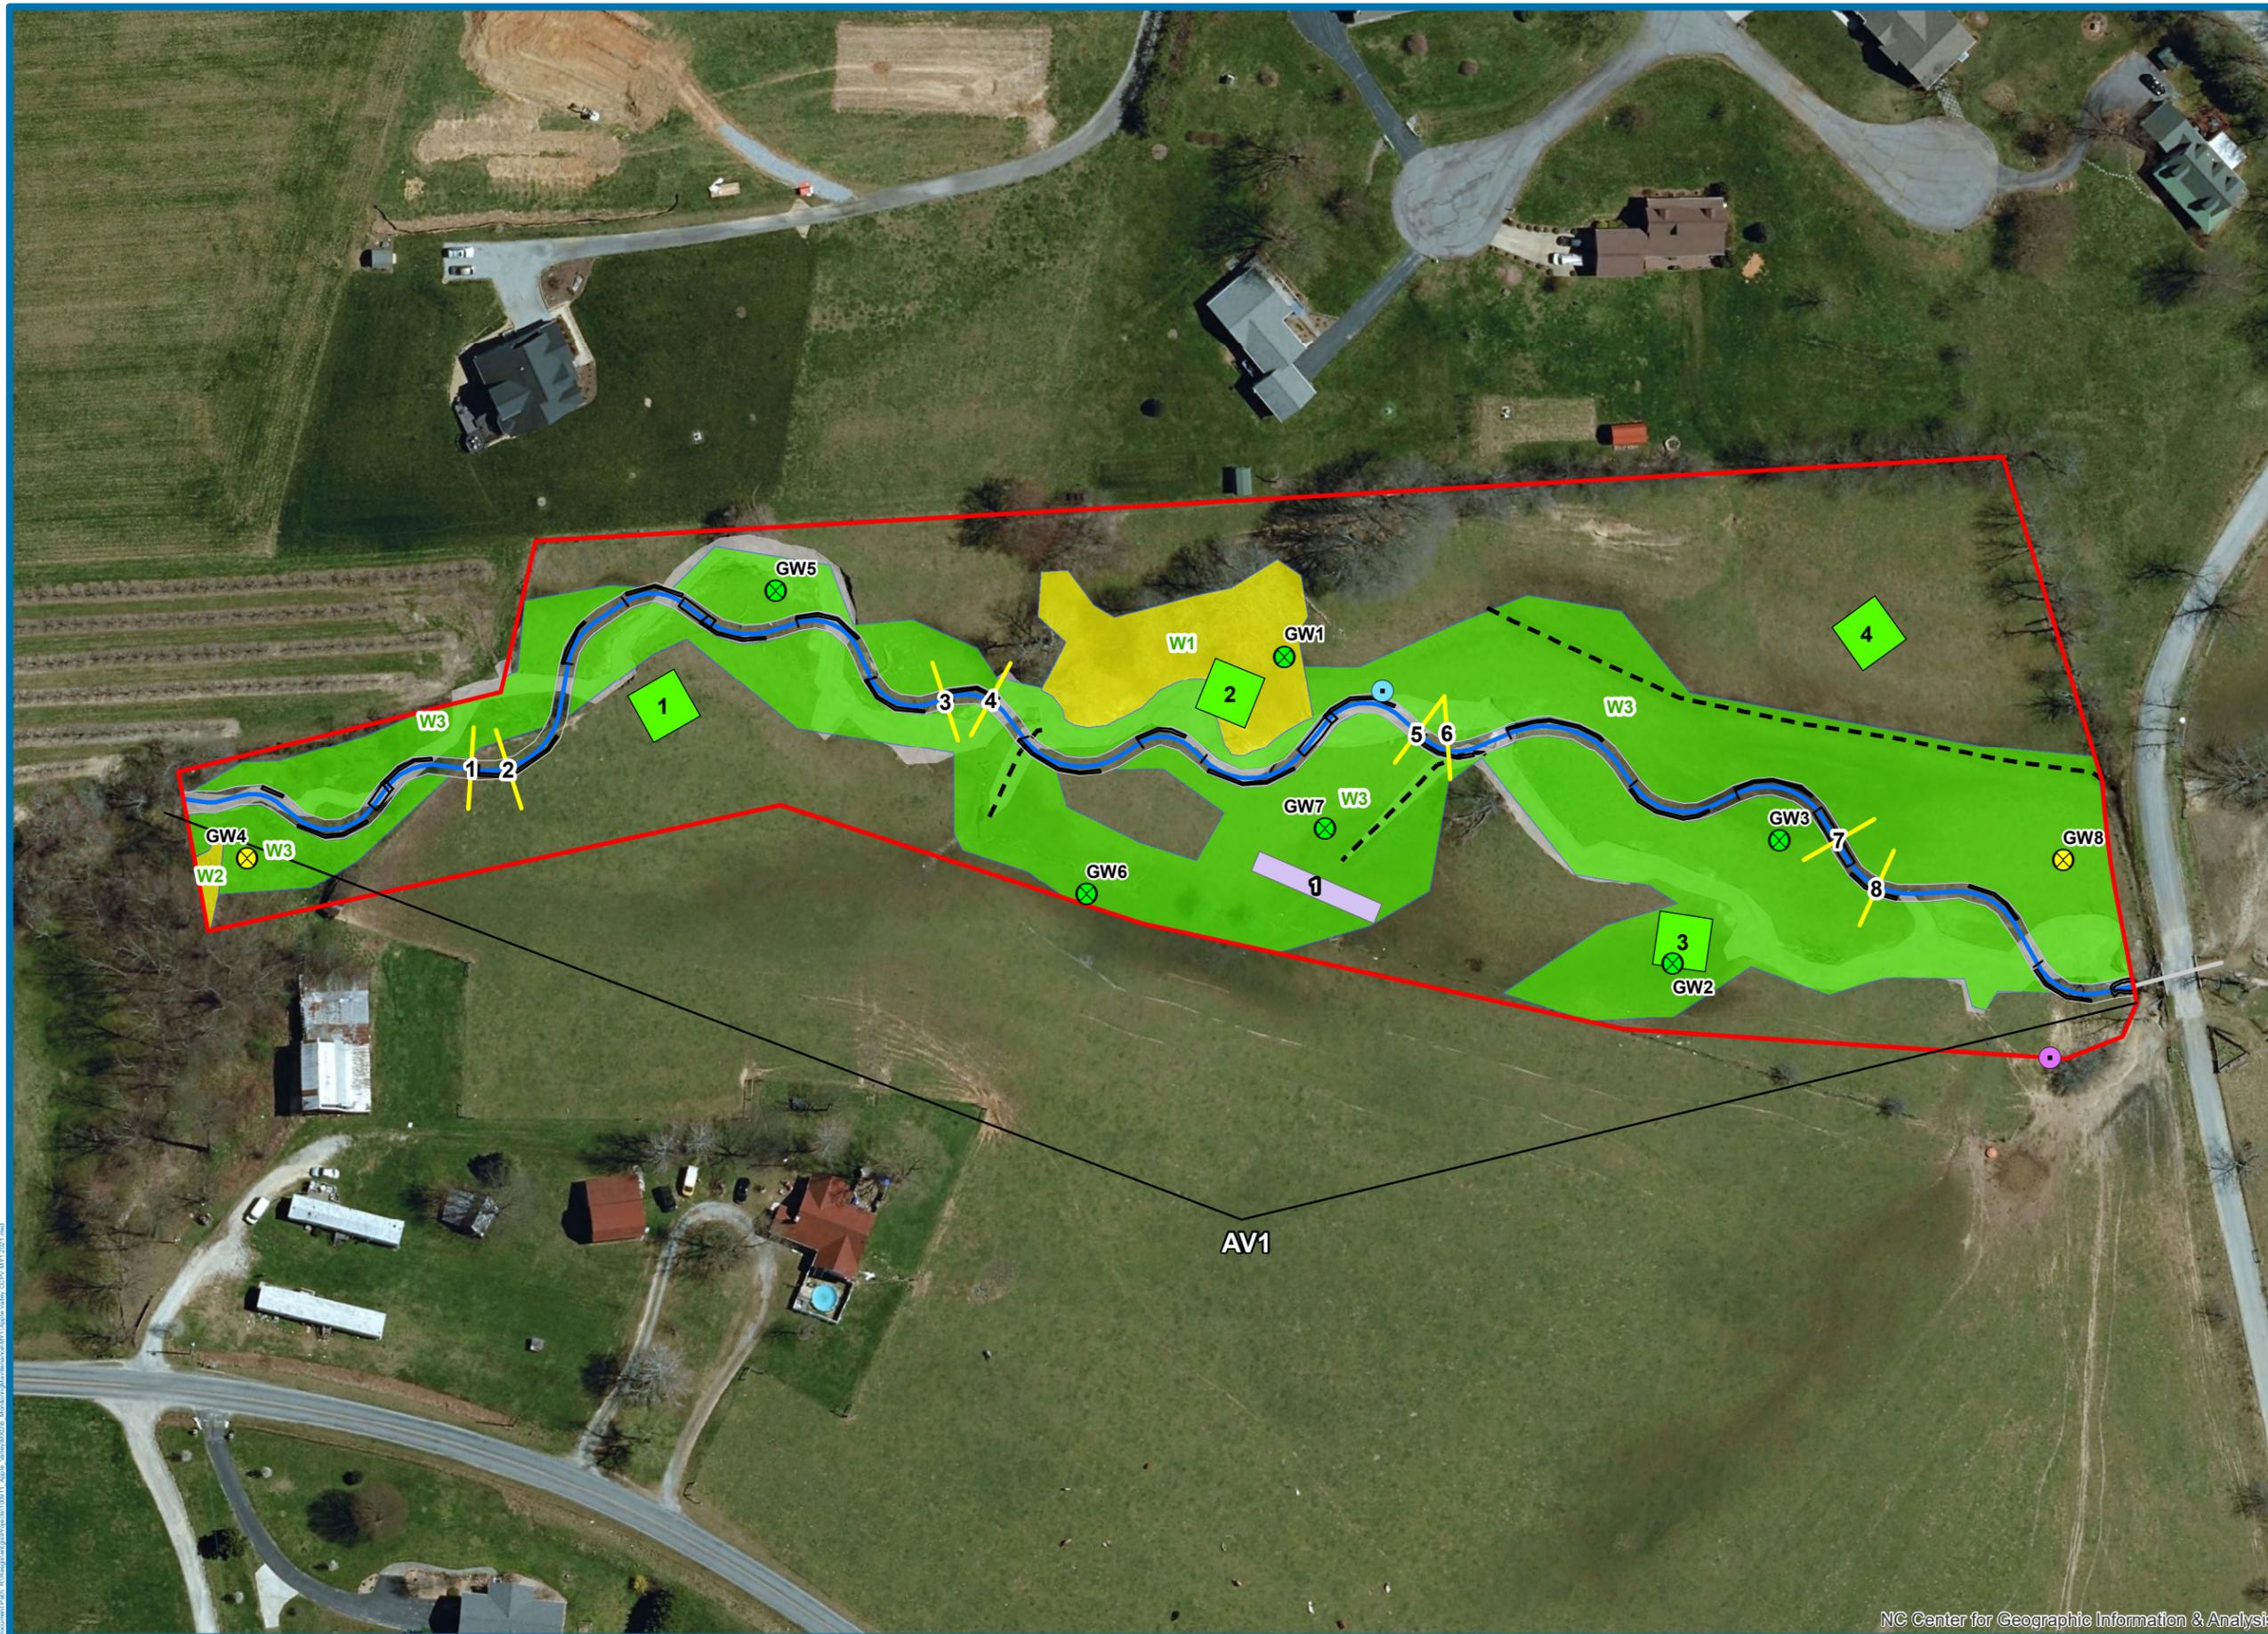
Current Conditions
Plan View

Visual assessment of the stream channel was performed to document signs of instability, such as eroding banks, structural instability, or excessive sedimentation. The channel is transporting sediment as designed and will continue to be monitored for aggradation and degradation.

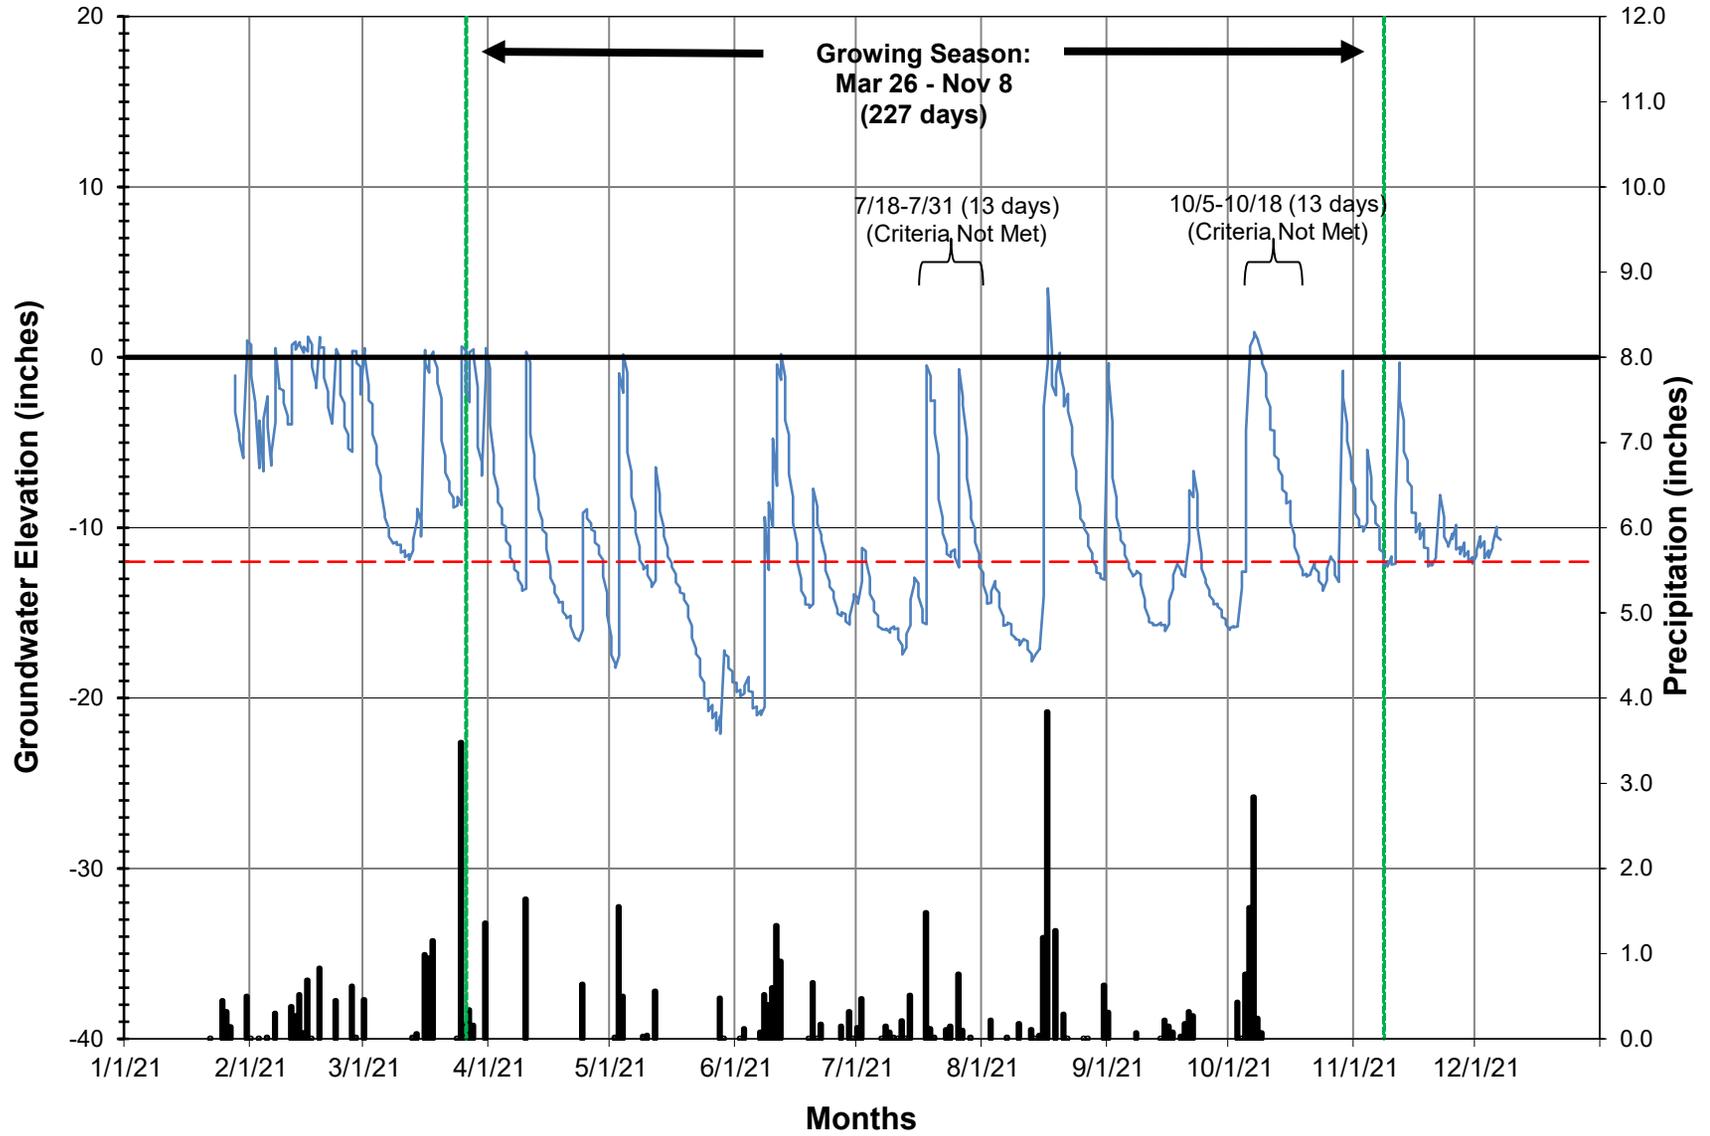
2021 Apple Valley GW4

the well was not dug deep enough. However, photo documentation of GW4 does not suggest that the well was installed improperly; in fact, the photo of GW4 shows the well surrounded with wetland vegetation (*Juncus* sp.) (**Appendix B**). GW8 at the bottom of the Project, also fell short of the success criteria. This failure could be attributed to its proximity to a ditch, south of the easement, running parallel to the road, possibly diverting water from the wetland. However, photo documentation of this well also shows it surrounded by wetland vegetation (*Juncus* sp. and *Ludwigia alternifolia*) (**Appendix B**). RES expects the hydroperiods to increase in subsequent years as the wetlands continue to establish and the surrounding vegetation matures. Groundwater well locations can be found on **Figure 2** and the data is in **Appendix E**.
