# **Monitoring Report MY04**

**Cedar Branch Restoration Site  
Monitoring Year 04  
DMS Contract 6598  
DMS Project Number 97009**

**DWR #: 20150904  
USACE Action ID: 2003-21395  
Randolph County, North Carolina**

**Monitoring Data Collected: 2021  
Date Submitted: January 2022**

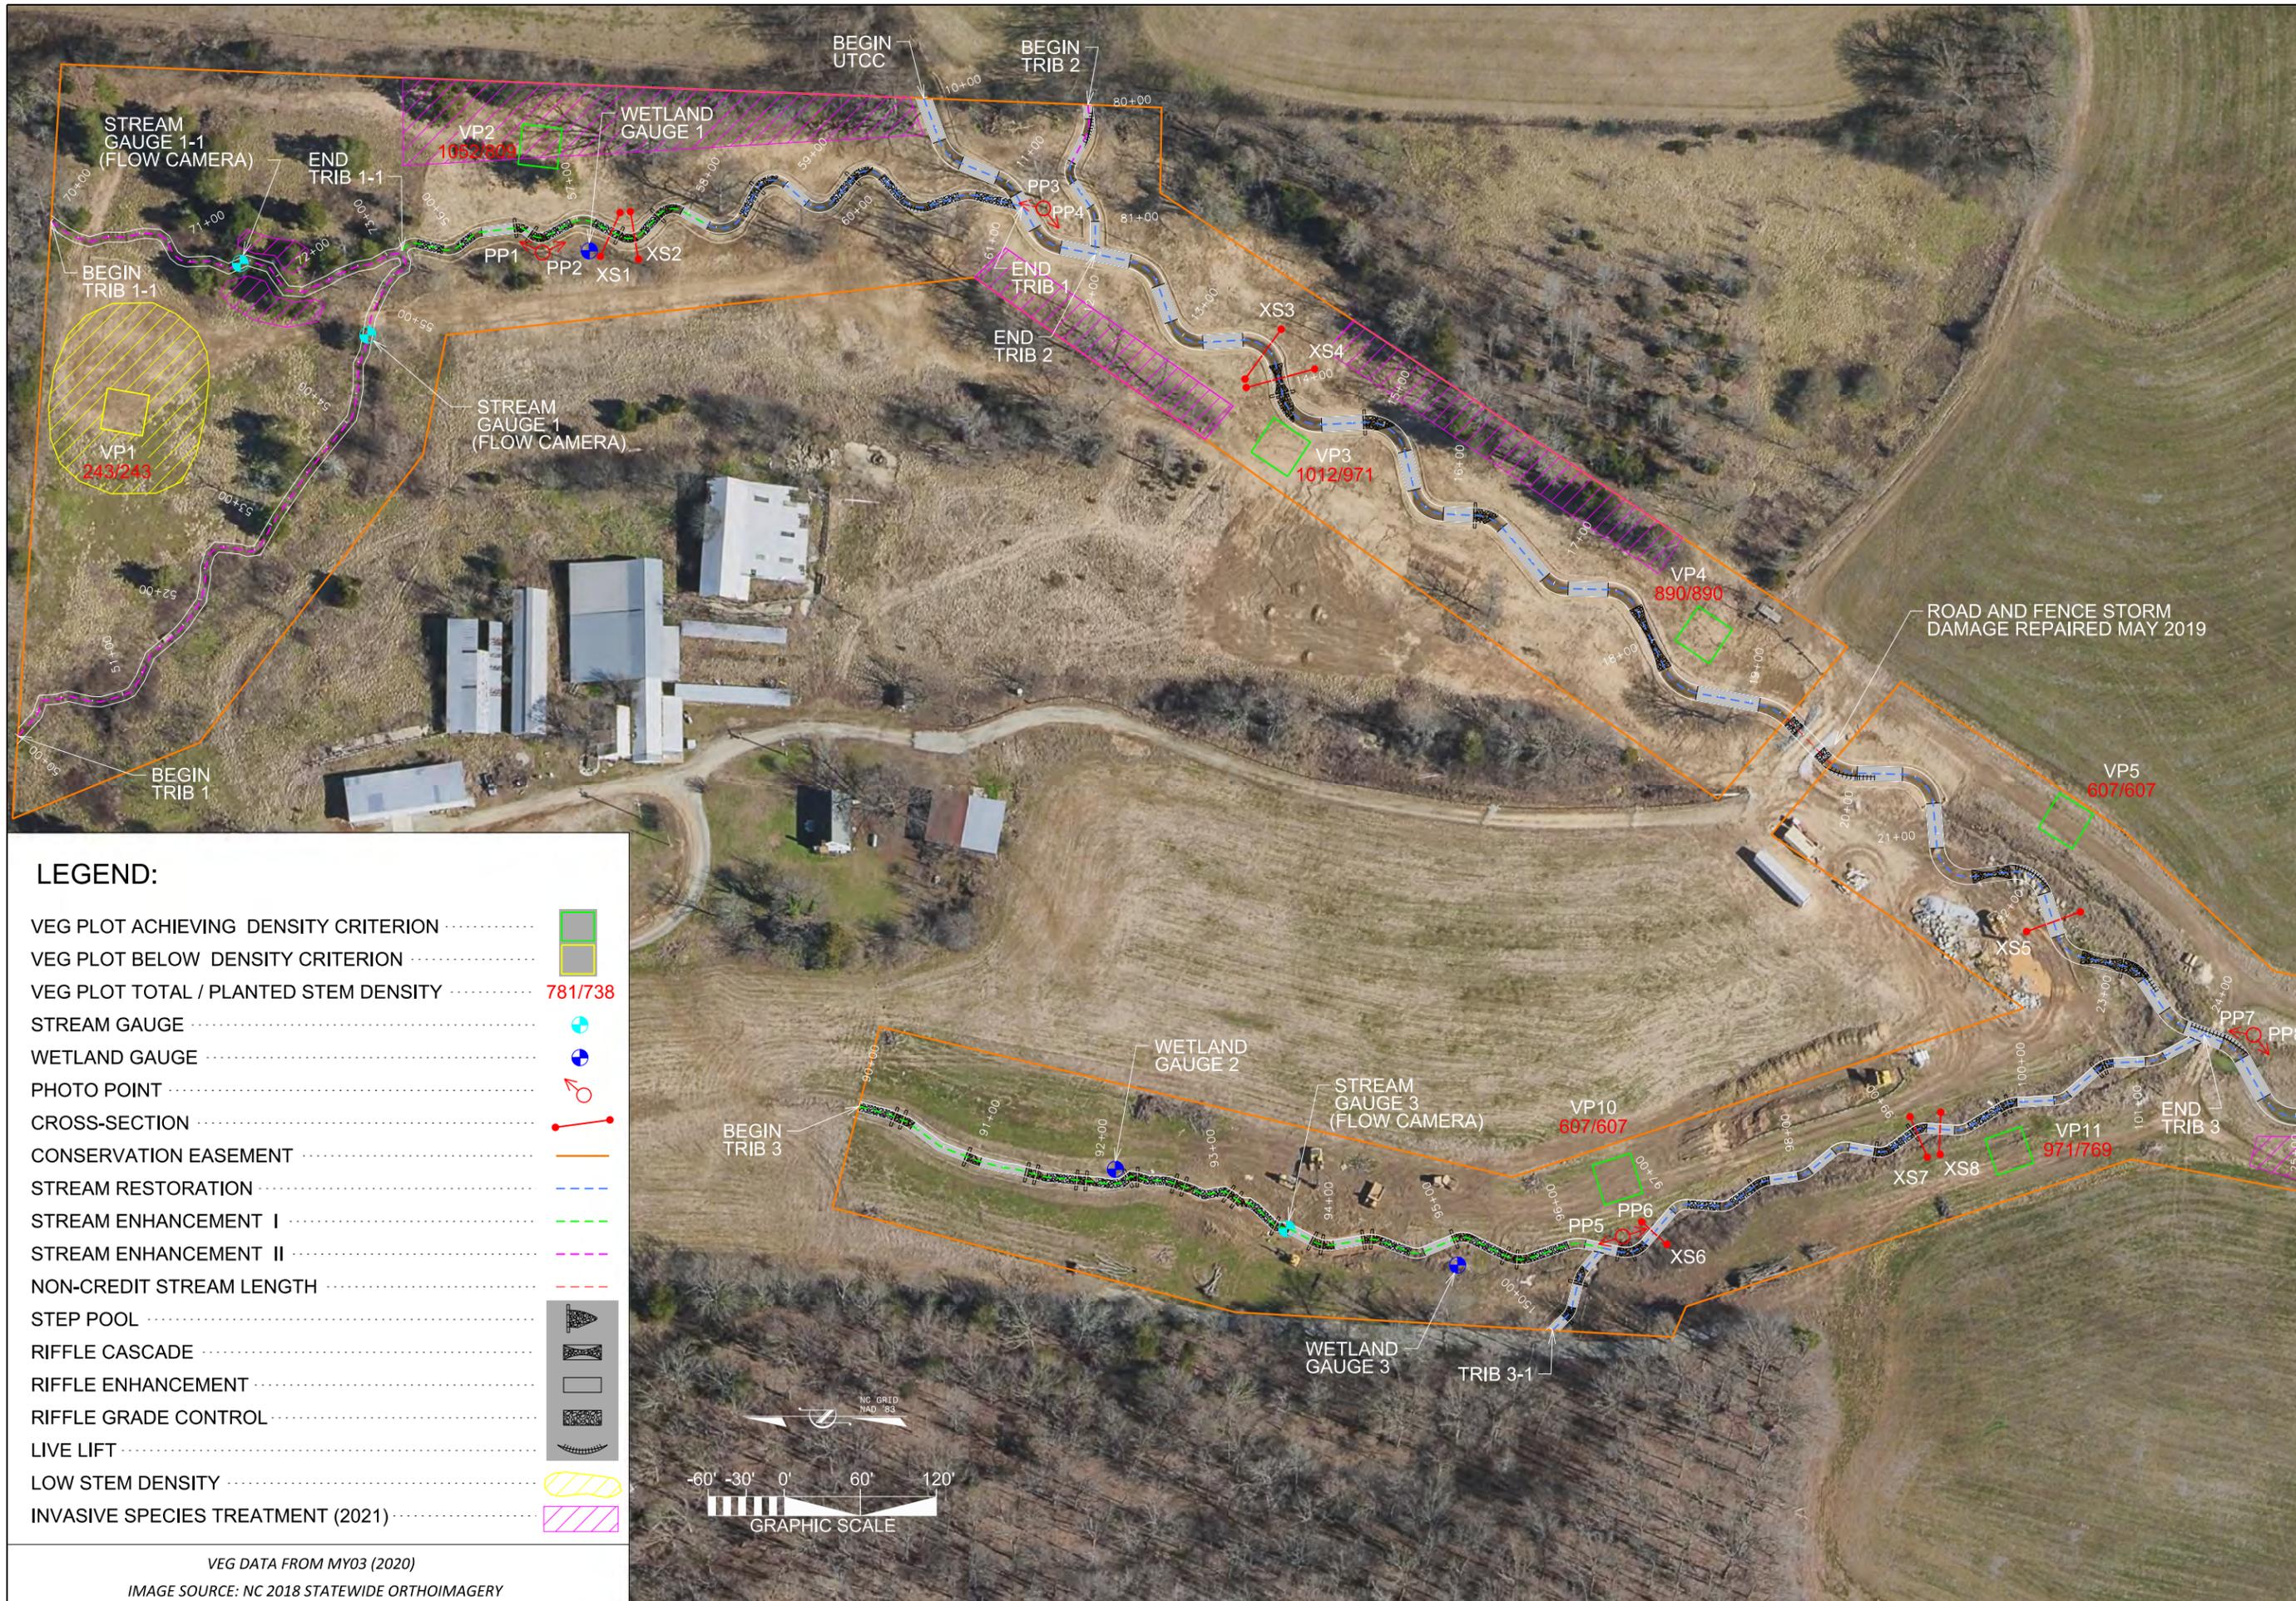
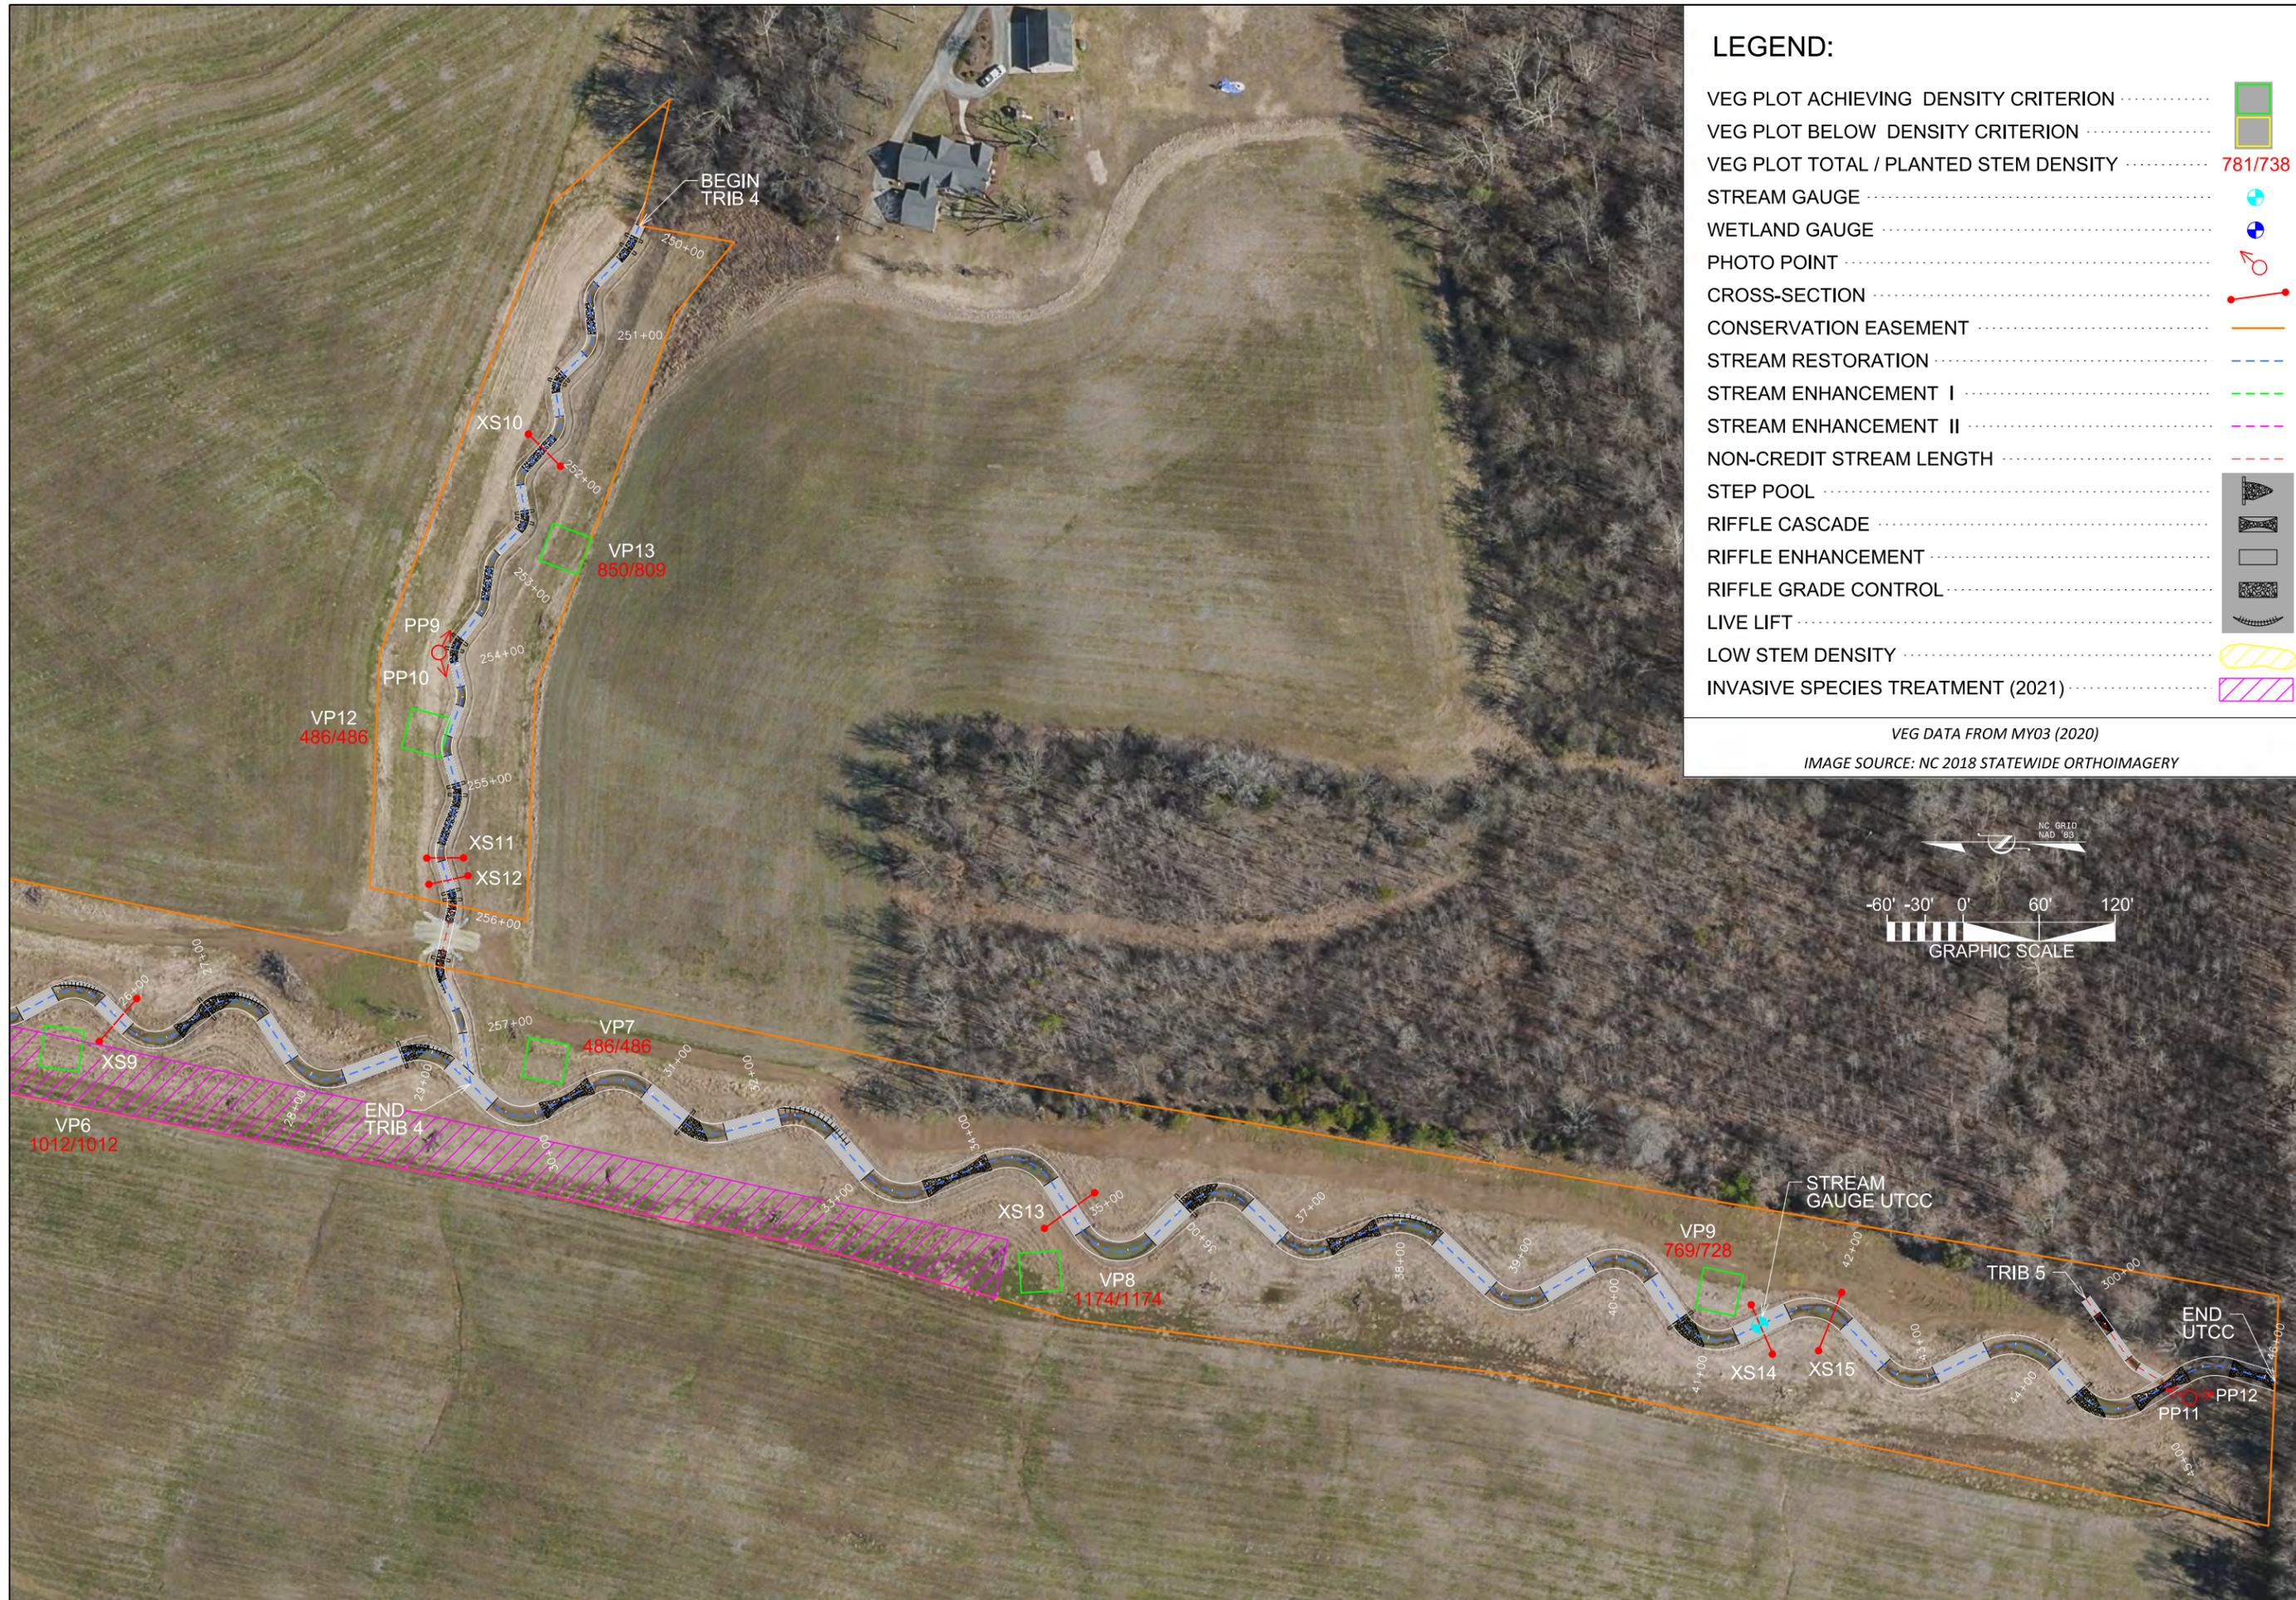
**CURRENT  
 CONDITION  
 PLAN VIEW**

Vegetation monitoring was not conducted in year four, per the mitigation plan, but will resume in year five. Privet growing along T1 and UTCC was treated by cutting and spraying of stumps between July 13 and 16, 2021. Johnson grass that was growing within the easement along UTCC was also treated by spraying at this time. A supplemental planting of the area between T1 and T1-1 is planned for the coming winter.

➤ *Supplemental planting was done for the 0.4-acre area between T1 and T1-1 on January 4, 2022. There were 200 bare root trees planted, making the planting density 500 stems/acre. The proposed species (*Liriodendron tulipifera*, *Quercus palustris*, *Quercus alba*, *Quercus falcata*, and *Diospyros virginiana*) that were planted were all from the approved mitigation plan.*

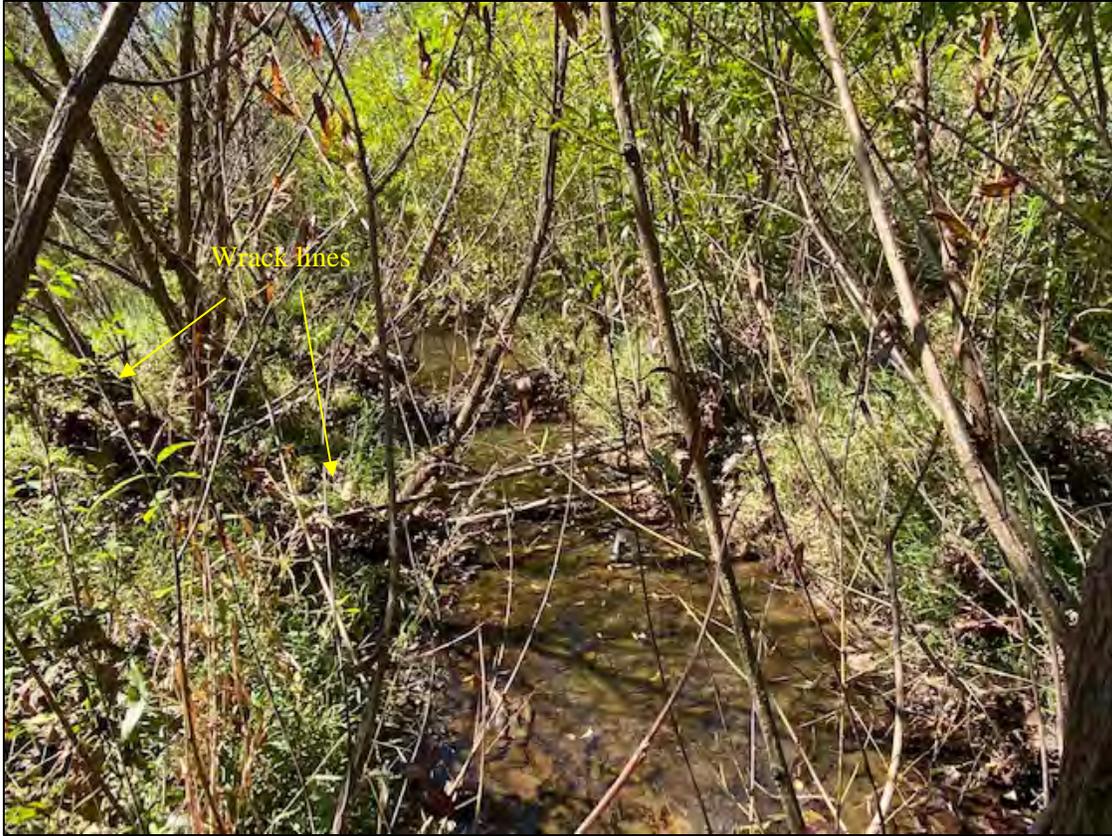
Photo 1. Wrack lines above bankfull, 9/27/21
