MONITORING YEAR 2 ANNUAL REPORT

KEY MILL MITIGATION SITE

Surry County, NC
NCDEQ Contract No. 7180
DMS Project No. 100025
USACE Action ID No. SAW-2017-01504
NCDEQ DWR Certification No. 17-1045
RFP #: 16-006993

Data Collection Period: January 2021 – November 2021
Final Submission Date: February 1, 2022

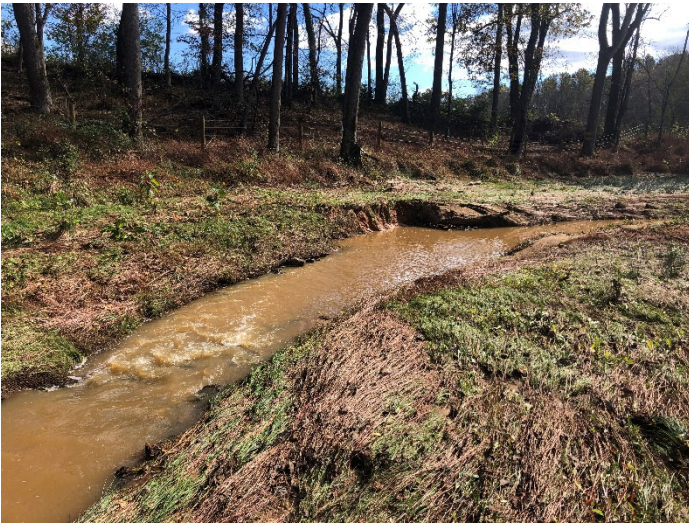
Pre-Repair – STA 102+00 Downstream; Erosion Along Left Bank and Brush Toe (11/02/2020)

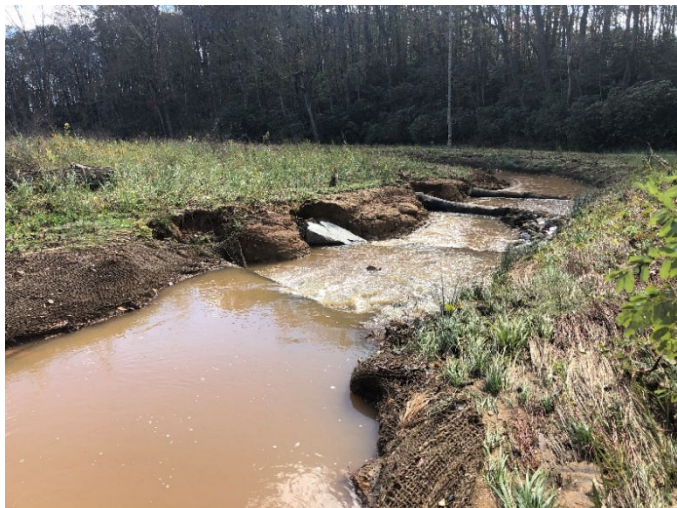
Pre-Repair – STA 105+85 Downstream; Erosion Along Left Bank at Structure Tie-ins and Loss of Riffle Material (11/02/2020)

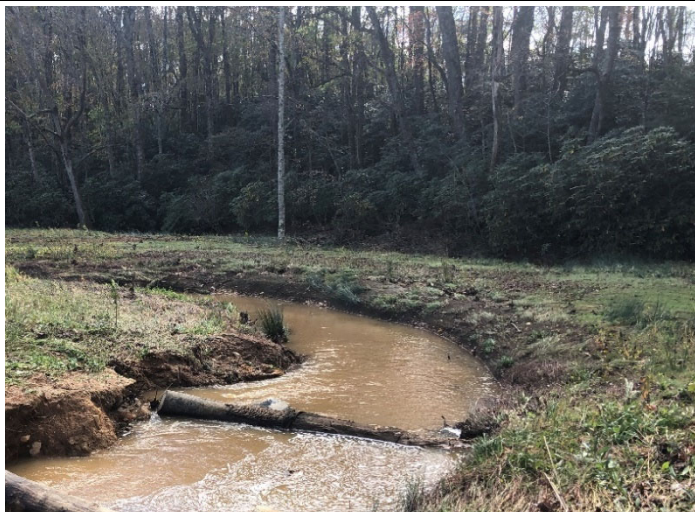
Pre-Repair – STA 106+35 Downstream; Erosion Along Right Bank Underneath Matting Possible Brush Toe Failure (11/02/2020)

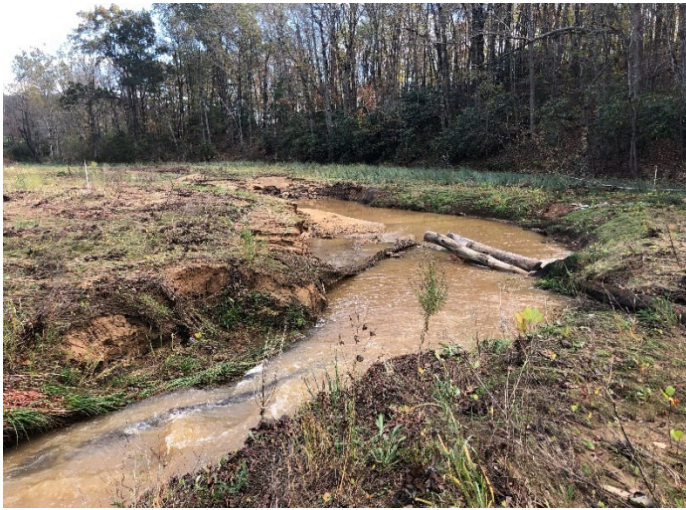
Pre-Repair – STA 109+80 Downstream; Riffle Failure, Dislodged Log Sill, and Erosion Along Point Bar (11/02/2020)

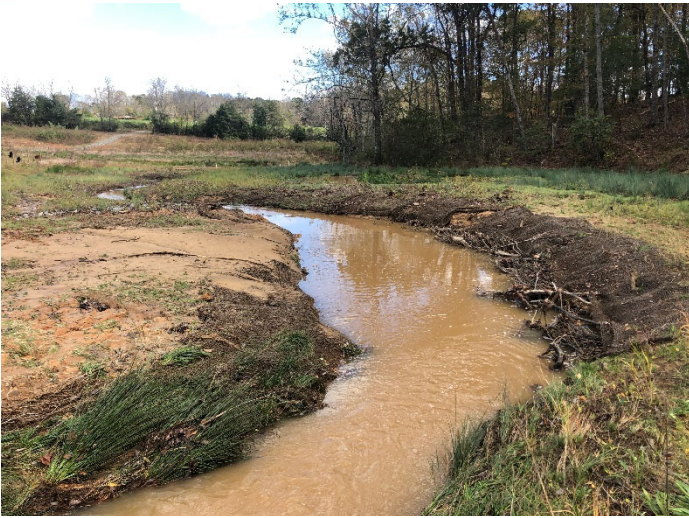
Pre-Repair – STA 112+00 Downstream; Erosion Along Right Bank Above and Within Brush Toe (11/02/2020)

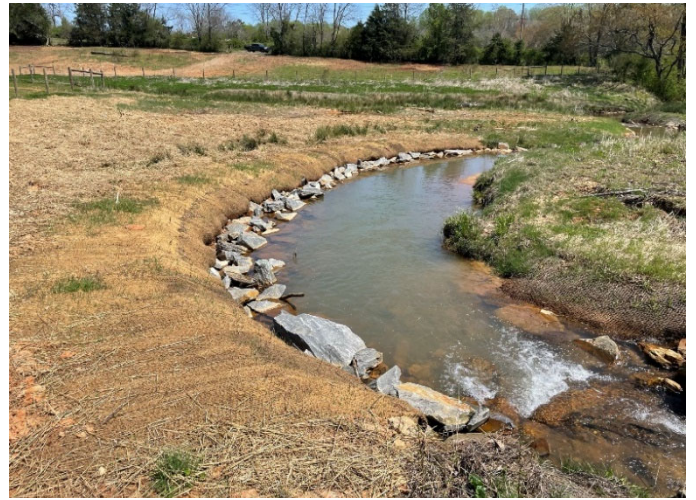
Pre-Repair – STA 114+65 Downstream; Erosion Along Left Bank and Brush Toe (11/02/2020)

Post-Repair – STA 114+50 Downstream; Replaced Brush Toe with Geo-Lift and Boulder Toe (04/07/2021)

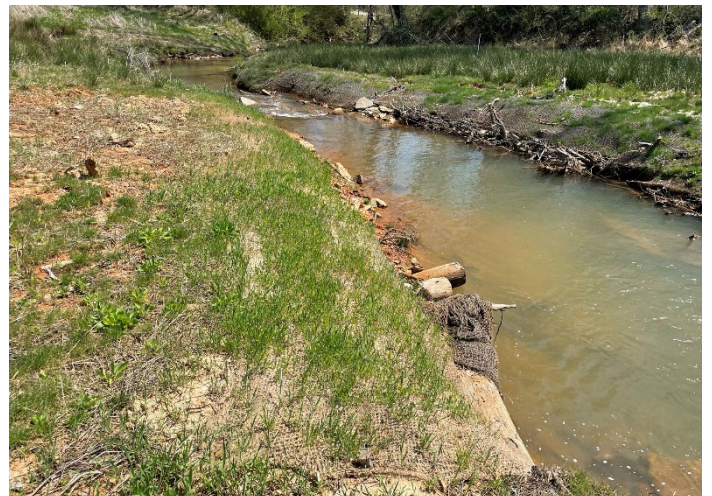
Pre-Repair – STA 115+35 Downstream; Erosion Along Right Bank (11/02/2020)

Post-Repair – STA 115+35 Downstream; Regraded and Installed Brush Toe along Right Bank (04/07/2021)

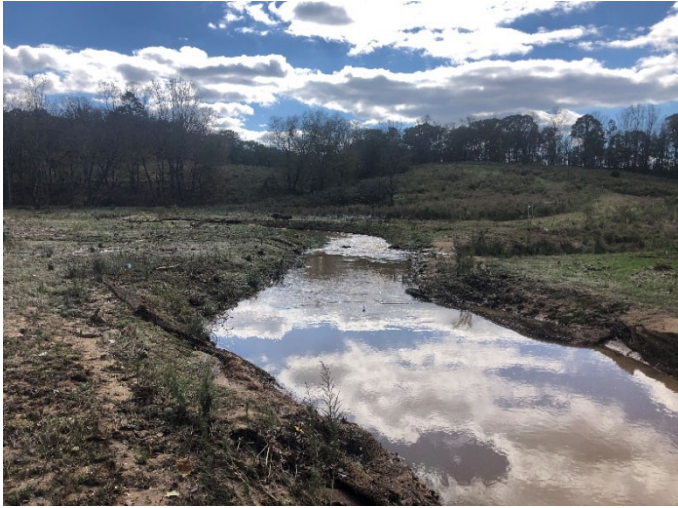
Pre-Repair – STA 150+30 Downstream; Erosion along Right and Left Banks (11/02/2020)

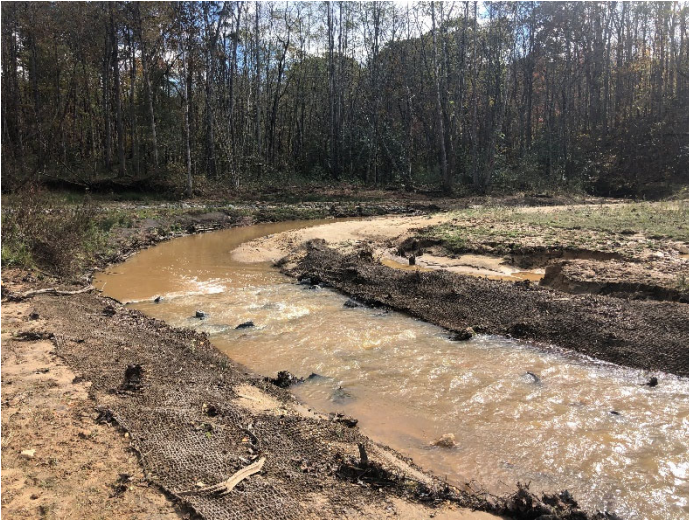
Pre-Repair – STA 165+30 Downstream; Erosion Along Right Bank
(11/02/2020)

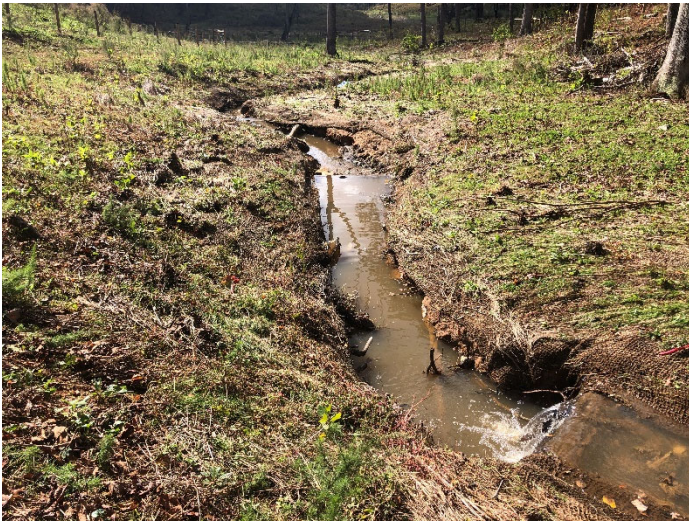
Pre-Repair – STA 404+90 – 405+30 Downstream; Riffle Scour
(11/02/2020)

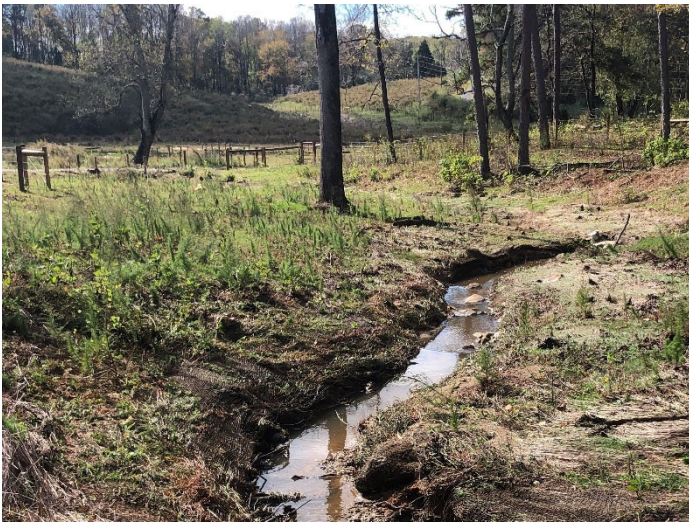
Pre-Repair – STA 405+40 – 405+65 Downstream; Riffle Scour
(11/02/2020)
