**Year 1 Monitoring Report**

**MATTHEW SITE**

NCDMS Project #100043 (Contract #7419)  
USACE Action ID: SAW-2017-00055  
DWR Project #2017-0624

Johnston County, North Carolina  
Neuse River Basin  
HUC 03020201

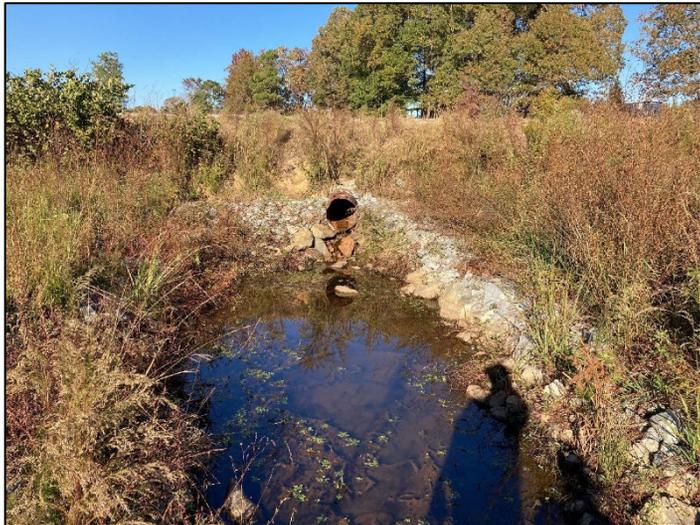
Plunge pool at the top of RL2 (11/9/2021)

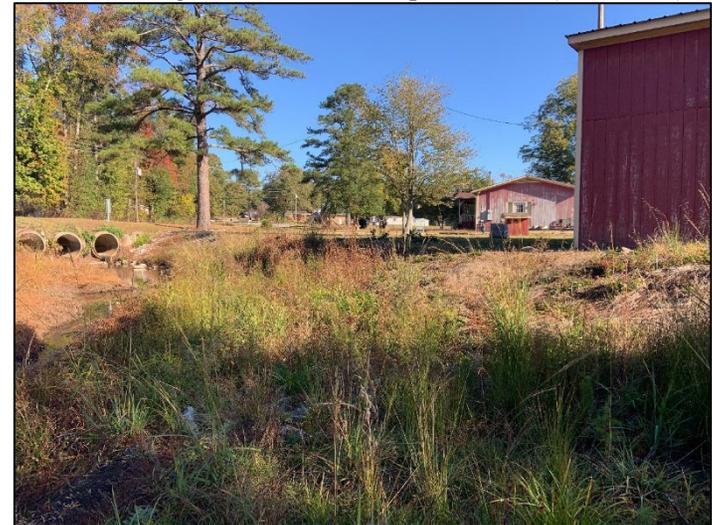
Plunge pool and boulder toe protection below NC-96 culvert on RL1-A (11/9/2021)

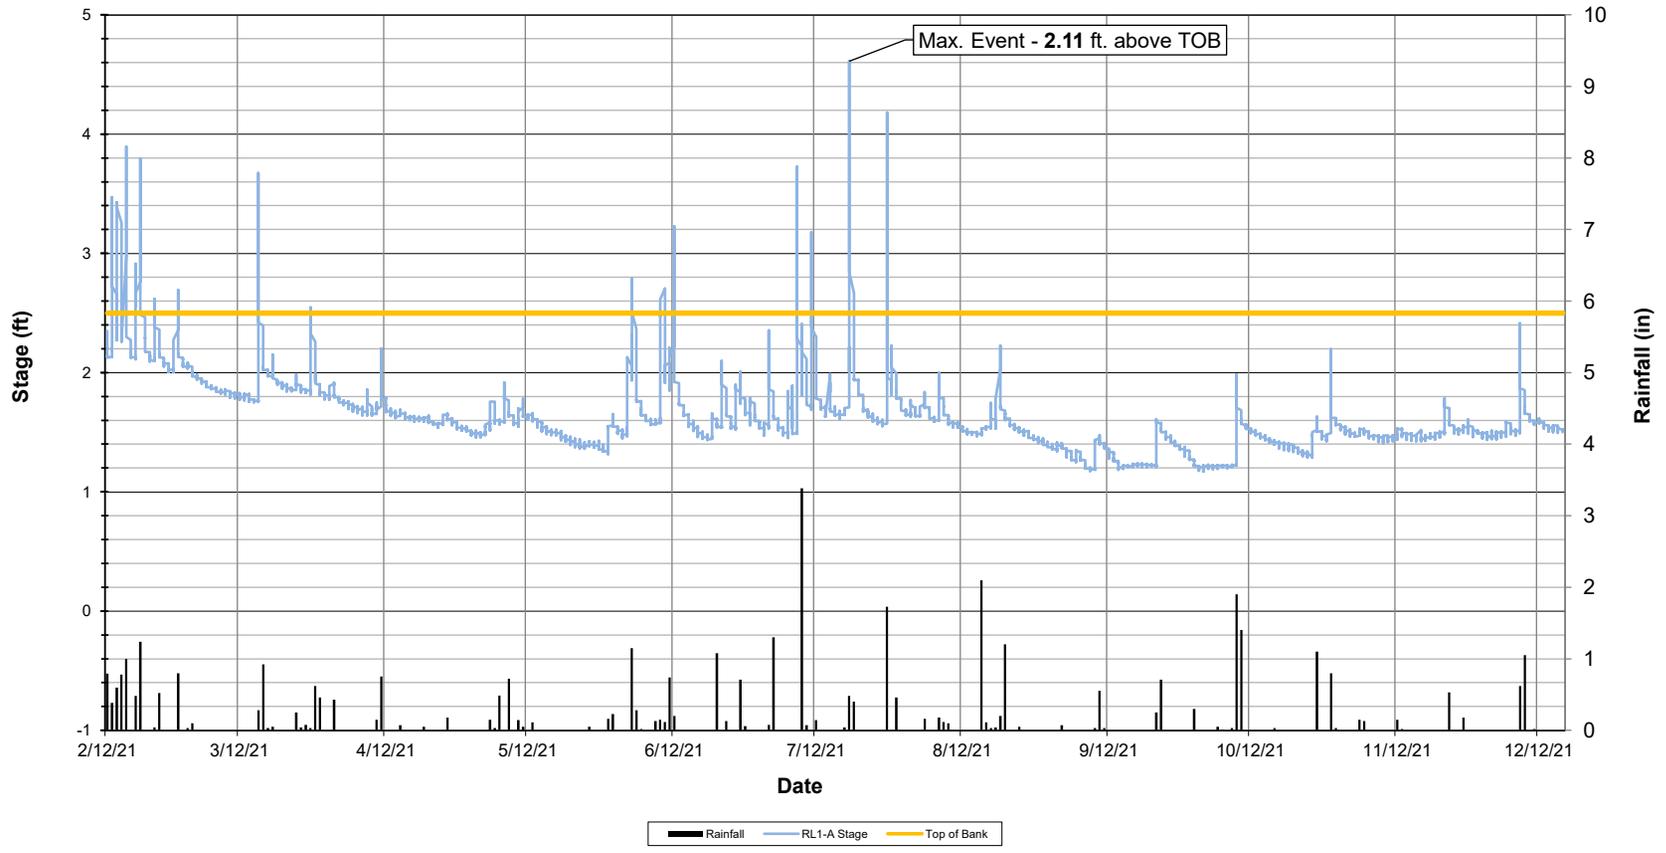
MY1 Matthew RL1-A Stage Recorder Hydrograph

Two stage recorders are currently recording bankfull events on reaches RL1-A and RL2. The stage recorder on RL1-A recorded 15 bankfull events in MY1 with the highest reading being 2.11 feet above the top of bank. The stage recorder on RL2 recorded 11 bankfull events in MY1 with the highest reading being 2.78 feet above the top of bank. Stage recorder locations can be found on **Figure 2**, photos are in **Appendix B**, and hydrology data are in **Appendix E**.

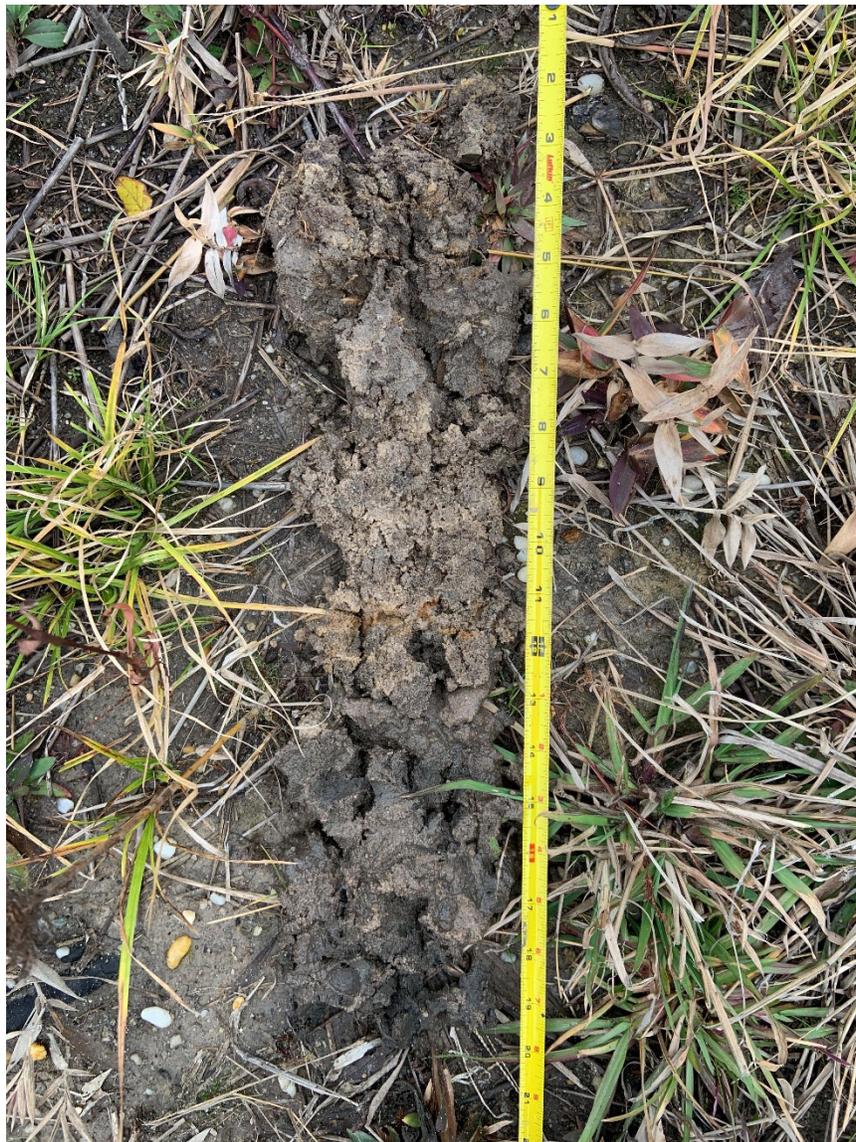
GW1						
Horizon Depths (in.)	Texture	Matrix Color	Redox Features		Induration	Roots
			Color	Abundance		
0-6	Loamy sand	10YR 4/1	2.5YR 4/6	15%	None	Common
6-13	Sand	10YR 6/1	2.5YR 4/6	10%	None	Few
13-18	Loamy sand	10YR 4/1	-	-	None	None
18-24	Sandy loam	10YR 3/1	-	-	None	None
<b>Comments:</b> Old pond bed

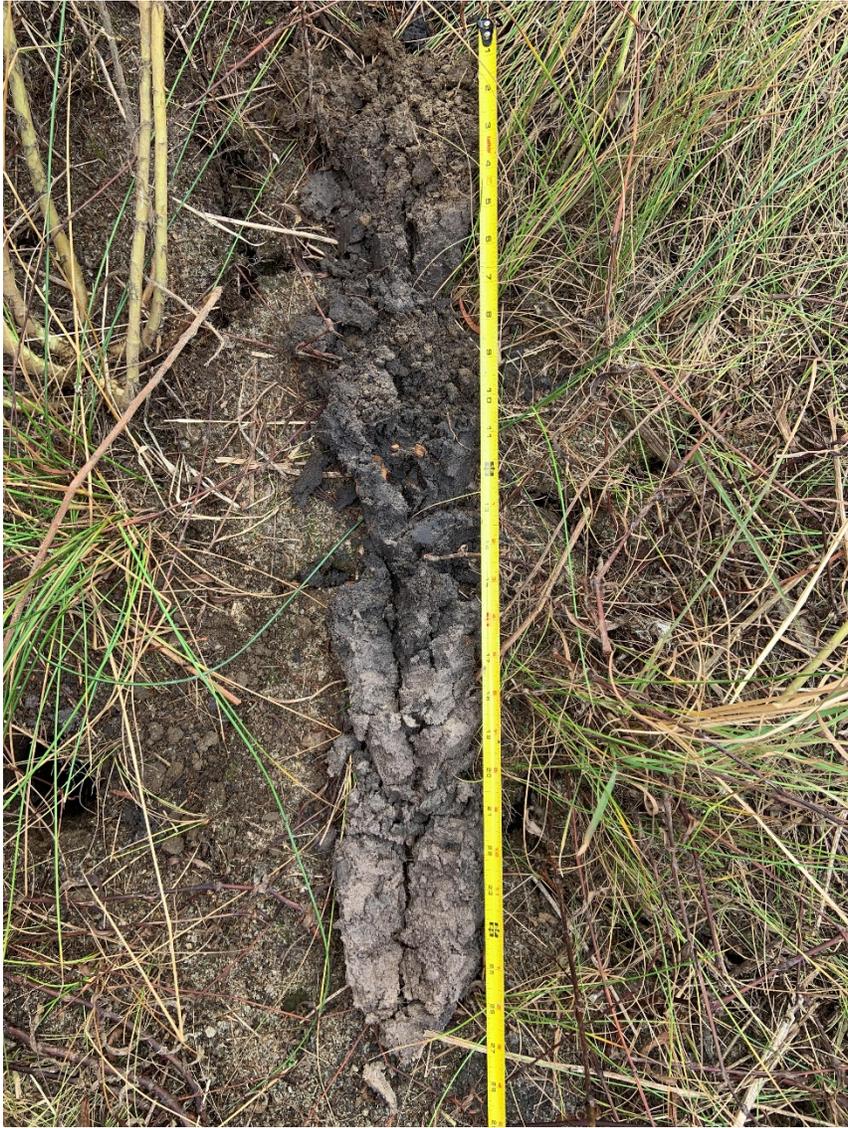
GW4						
Horizon Depths (in.)	Texture	Matrix Color	Redox Features		Induration	Roots
			Color	Abundance		
0-3	Silt loam	10YR 4/2	10YR 4/6	5%	Weak	Common
3-10	Silt loam	10YR 4/1	10YR 4/6	5%	Weak	Few
10-16	Sandy loam	Gley 1 4/N	10YR 4/6	3%	None	None
16-27	Loamy sand	10YR 6/1	-	-	None	None
<b>Comments:</b> Old pond bed, micro-high, large surface soil cracks

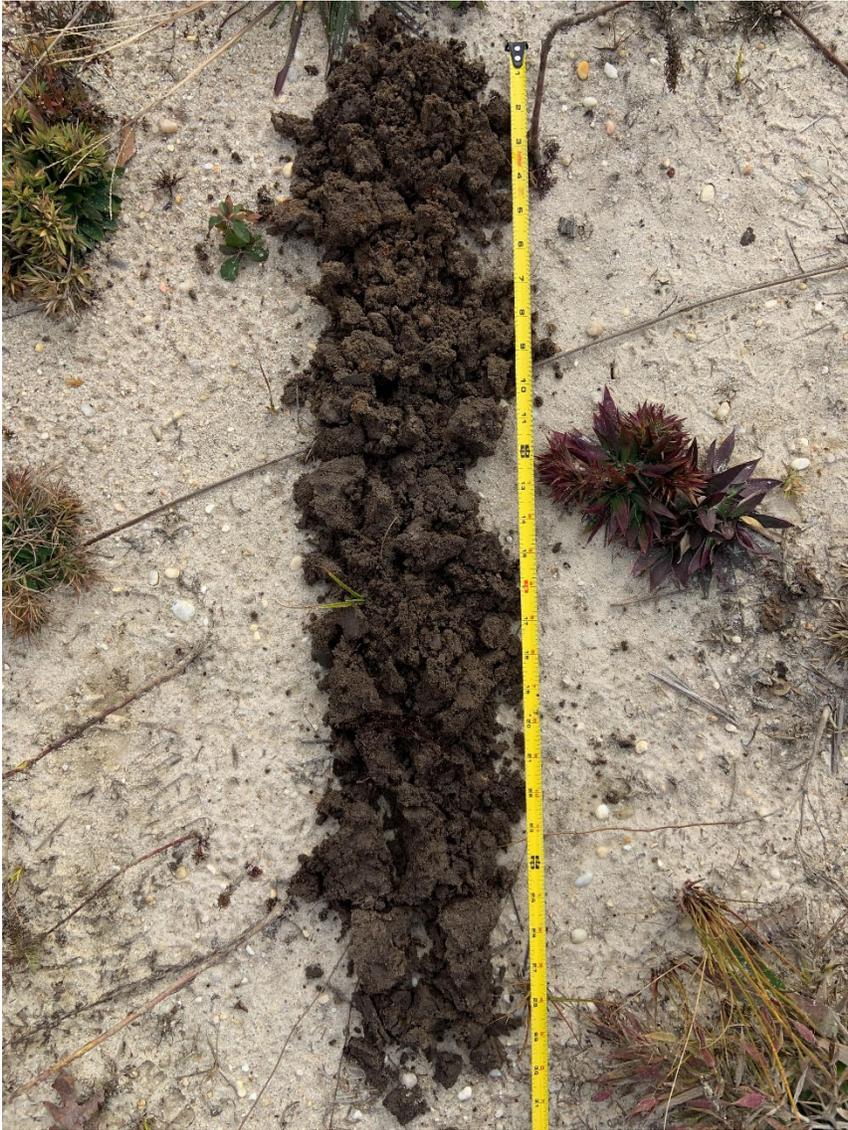
GW7						
Horizon Depths (in.)	Texture	Matrix Color	Redox Features		Induration	Roots
			Color	Abundance		
0-18	Loamy sand	10YR 4/1	5YR 5/8	15%	None	None
18-30	Loamy sand	10YR 4/2	10YR4/6	5%	None	None
<b>Comments:</b> Old damn footprint, likely historic compacted fill

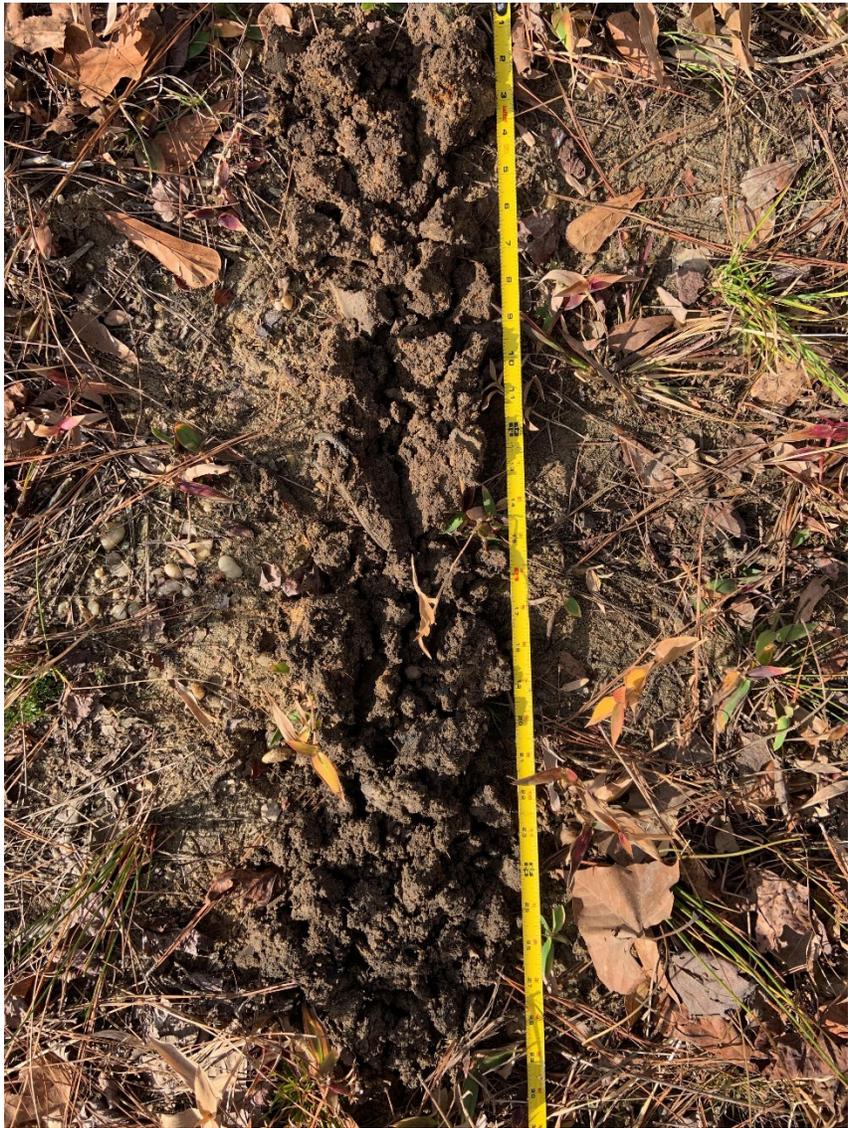
GW8						
Horizon Depths (in.)	Texture	Matrix Color	Redox Features		Induration	Roots
			Color	Abundance		
0-16	Sandy loam	10YR 5/1	5YR 5/8	15%	None	Few
16-28	Sandy loam	10YR 4/1	10 YR 4/6	5%	None	None
<b>Comments:</b> Newly compacted fill material (used to fill old stream channel)
