# **Annual Monitoring Report**

**Mill Dam Creek Restoration Site  
Yadkin River Basin - 03040101  
Monitoring Year 02  
DEQ Contract 6898  
DMS Project Number 97136**

**DWR #: 18-1349  
USACE Action ID: 2016-01335  
Yadkin County, North Carolina**

**Data Collected: July 2021  
Date Submitted: December 2021**

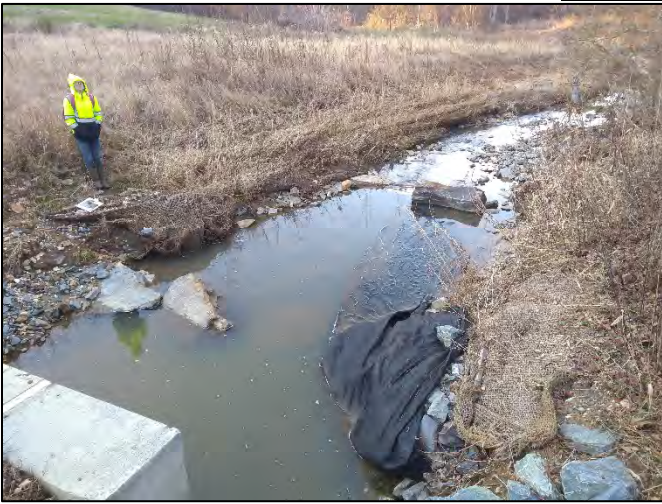
Damaged boulder sill – 12/18/20
