**MONITORING YEAR 1
ANNUAL REPORT**
Final

PERRY HILL MITIGATION SITE

Orange County, NC
Neuse River Basin
HUC 03020201

DMS Project No. 100093
DMS Contract No. 7744
DMS RFP No. 16-007576
USACE Action ID No. 2019-00125
DWR Project No. 2019-0157

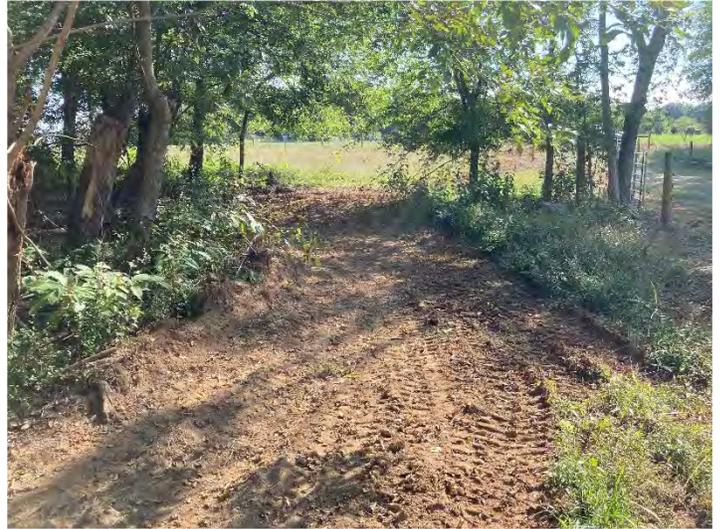
Perry Branch R2 – CE Encroachment (10/04/2021)

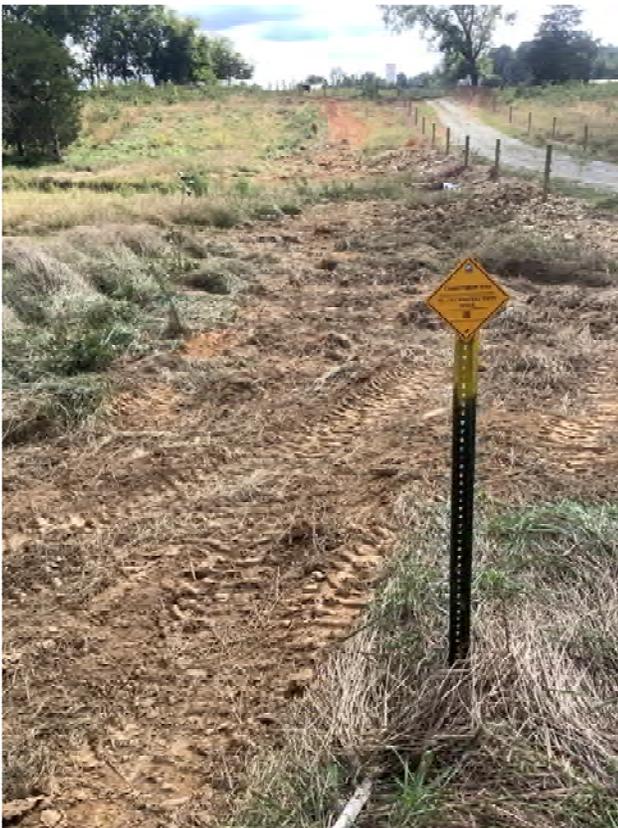
Perry Branch R4 – CE Encroachment (10/04/2021)

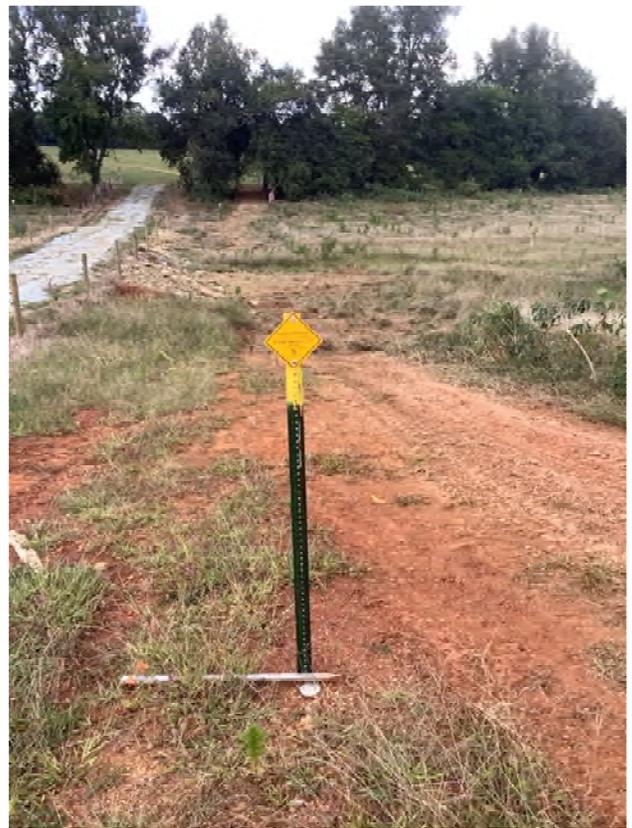
Perry Branch R4 – CE Encroachment (10/04/2021)

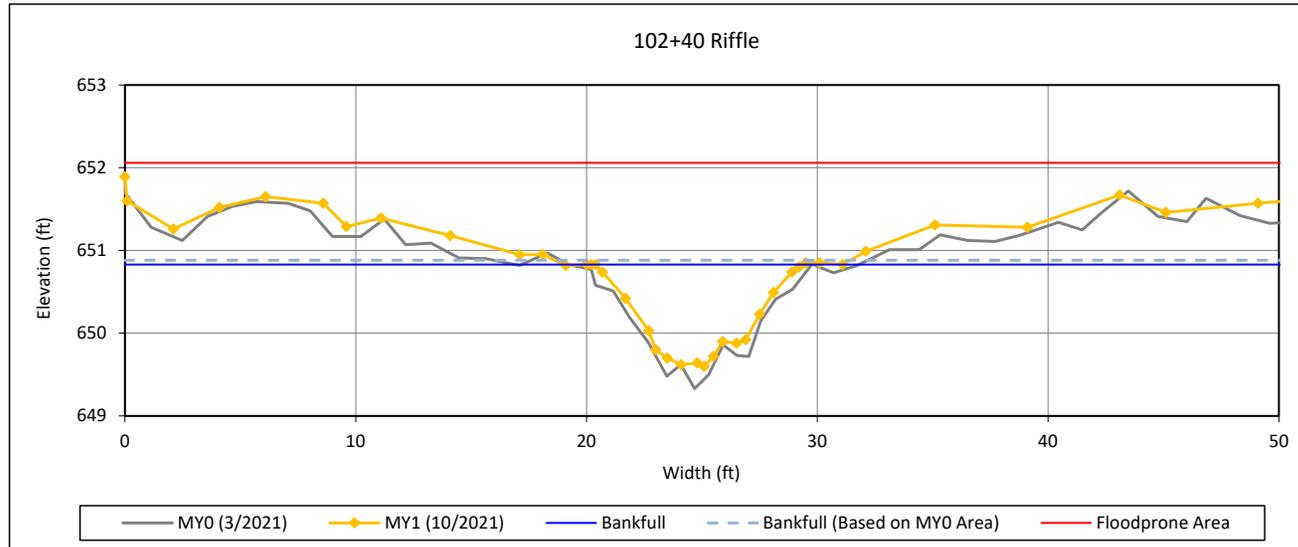
Cross-Section 1 - Perry Branch Reach 1

Bankfull Dimensions

6.3	x-section area (ft.sq.)
9.0	width (ft)
0.7	mean depth (ft)
1.2	max depth (ft)
9.4	wetted perimeter (ft)
0.7	hydraulic radius (ft)
12.7	width-depth ratio
80.0	W flood prone area (ft)
8.9	entrenchment ratio
1.0	low bank height ratio

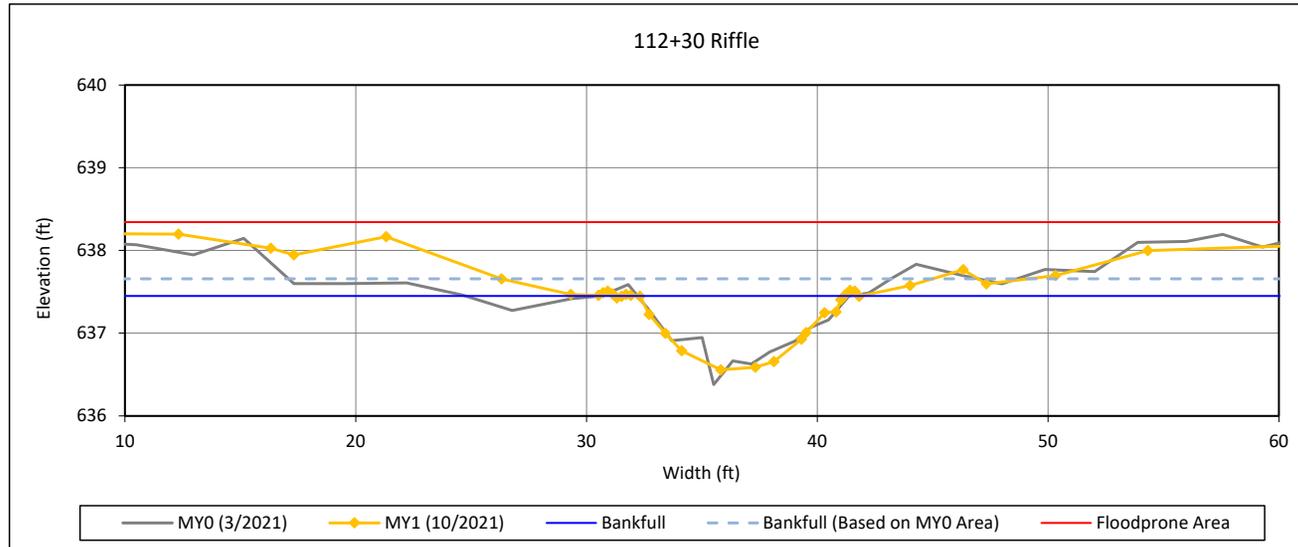
Cross-Section 2 - Perry Branch Reach 3

Bankfull Dimensions

5.2	x-section area (ft.sq.)
8.8	width (ft)
0.6	mean depth (ft)
0.9	max depth (ft)
9.1	wetted perimeter (ft)
0.6	hydraulic radius (ft)
14.9	width-depth ratio
100.0	W flood prone area (ft)
11.3	entrenchment ratio
< 1.0	low bank height ratio

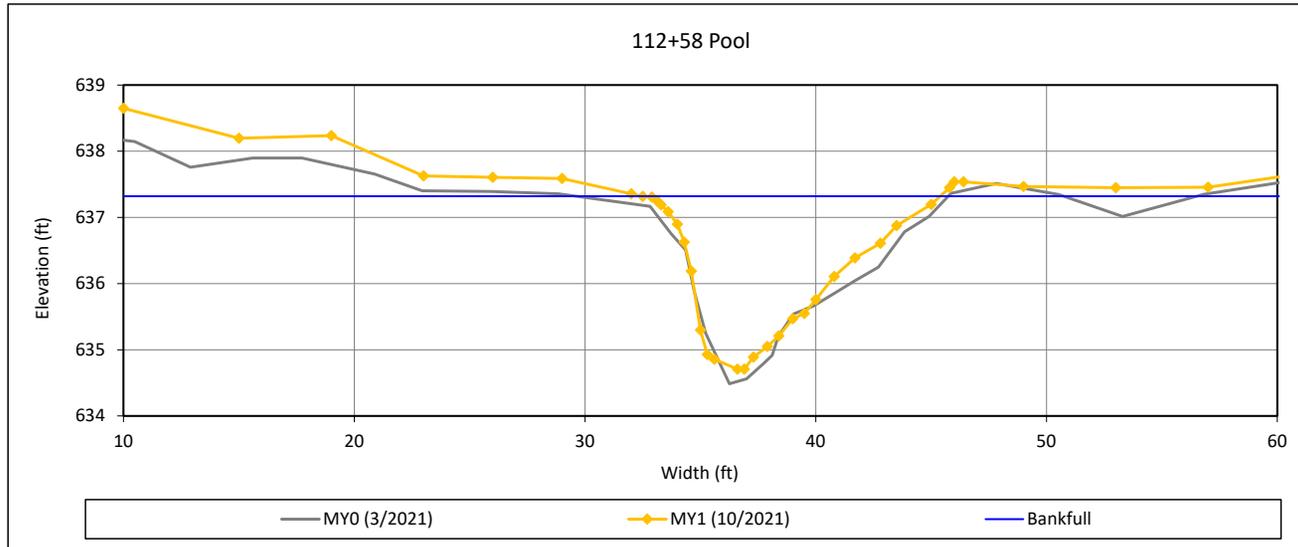
Cross-Section 3 - Perry Branch Reach 3

Bankfull Dimensions

16.3	x-section area (ft.sq.)
12.9	width (ft)
1.3	mean depth (ft)
2.6	max depth (ft)
14.5	wetted perimeter (ft)
1.1	hydraulic radius (ft)
10.2	width-depth ratio

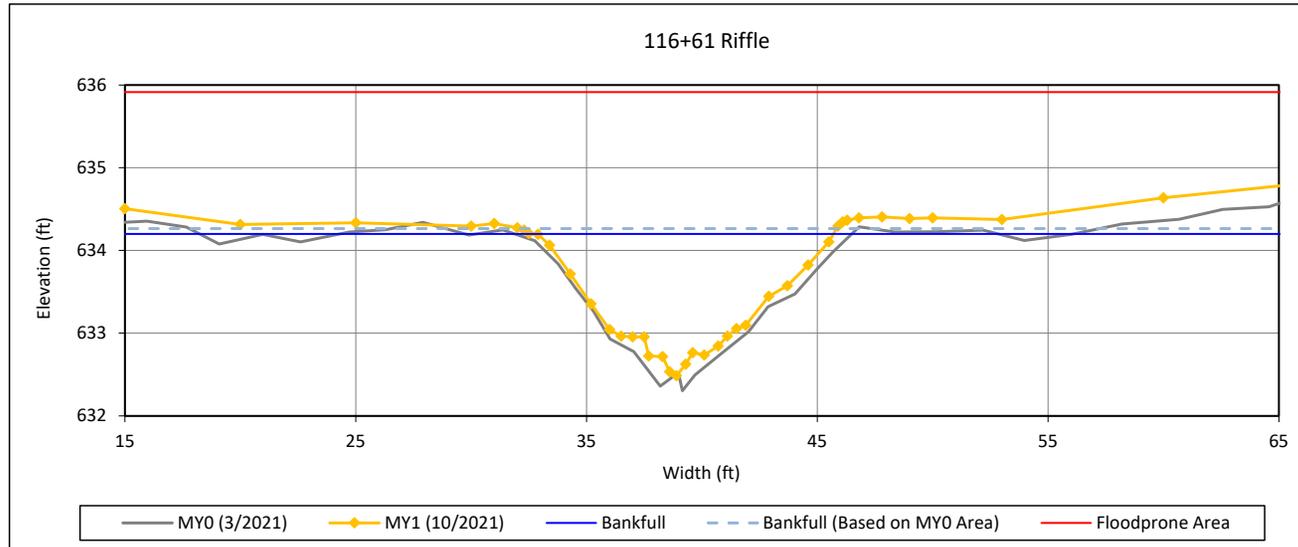
Cross-Section 4 - Perry Branch Reach 4

Bankfull Dimensions

12.0	x-section area (ft.sq.)
12.8	width (ft)
0.9	mean depth (ft)
1.7	max depth (ft)
13.4	wetted perimeter (ft)
0.9	hydraulic radius (ft)
13.7	width-depth ratio
175.0	W flood prone area (ft)
13.7	entrenchment ratio
1.0	low bank height ratio

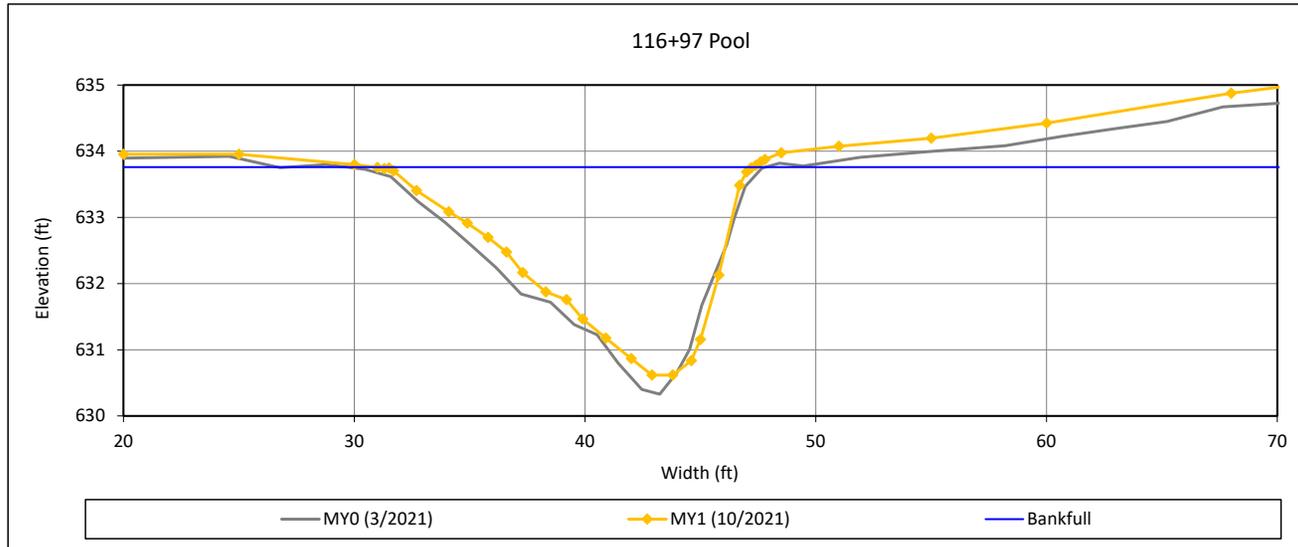
Cross-Section 5 - Perry Branch Reach 4

Bankfull Dimensions

26.5	x-section area (ft.sq.)
15.6	width (ft)
1.7	mean depth (ft)
3.1	max depth (ft)
17.4	wetted perimeter (ft)
1.5	hydraulic radius (ft)
9.2	width-depth ratio

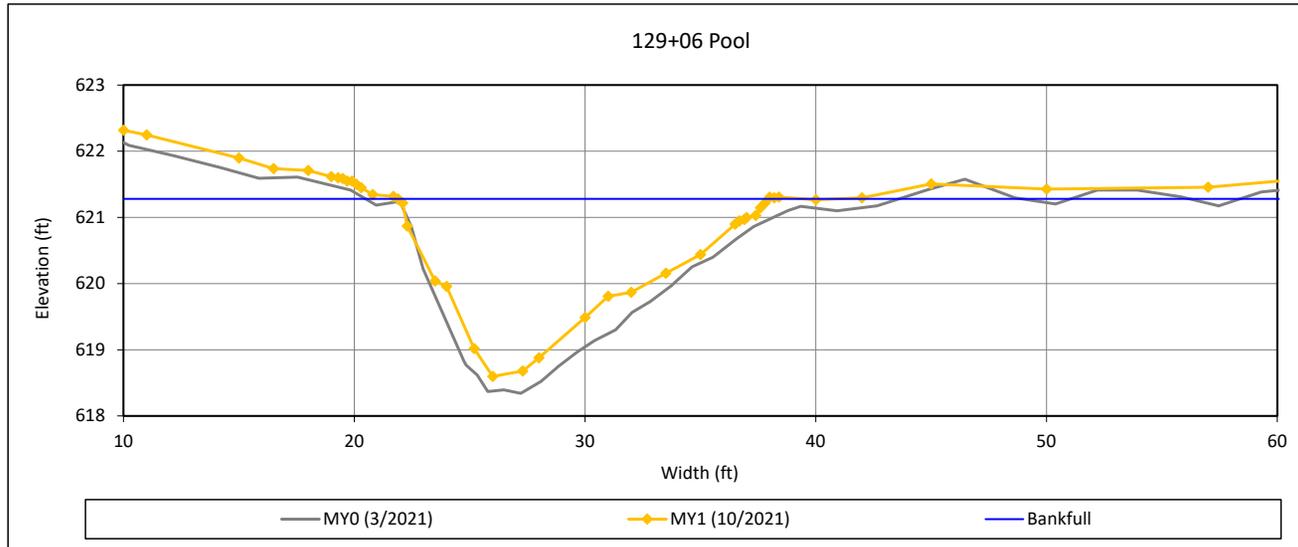
Cross-Section 6 - Perry Branch Reach 4

Bankfull Dimensions

22.9	x-section area (ft.sq.)
16.0	width (ft)
1.4	mean depth (ft)
2.7	max depth (ft)
17.3	wetted perimeter (ft)
1.3	hydraulic radius (ft)
11.2	width-depth ratio

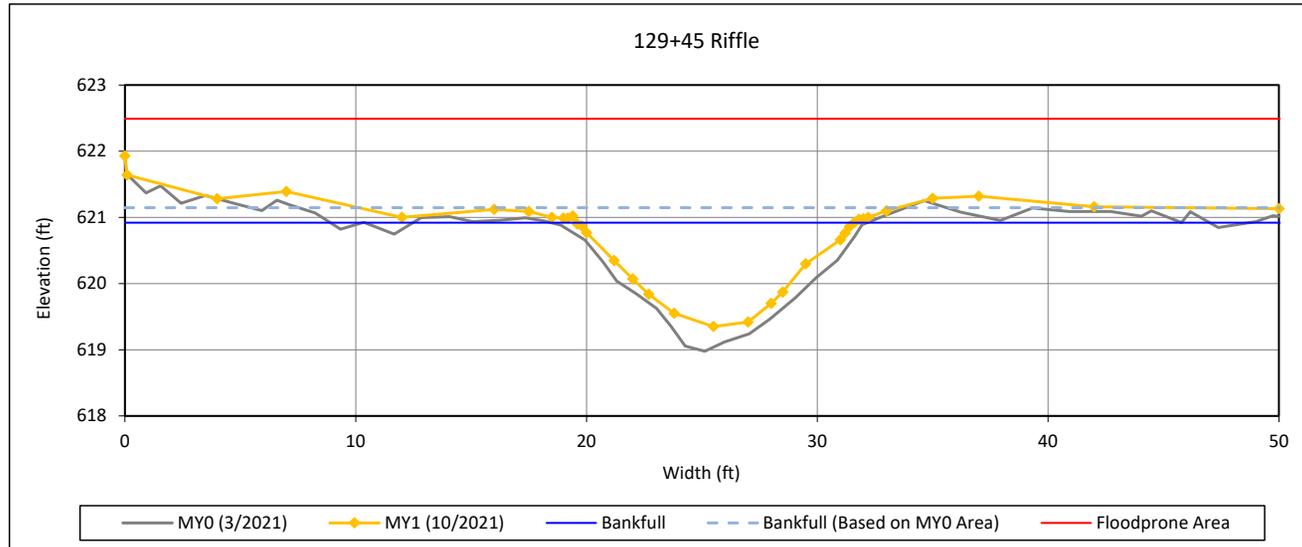
Cross-Section 7 - Perry Branch Reach 4

Bankfull Dimensions

11.3	x-section area (ft.sq.)
12.0	width (ft)
0.9	mean depth (ft)
1.6	max depth (ft)
12.5	wetted perimeter (ft)
0.9	hydraulic radius (ft)
12.8	width-depth ratio
125.0	W flood prone area (ft)
10.4	entrenchment ratio
< 1.0	low bank height ratio

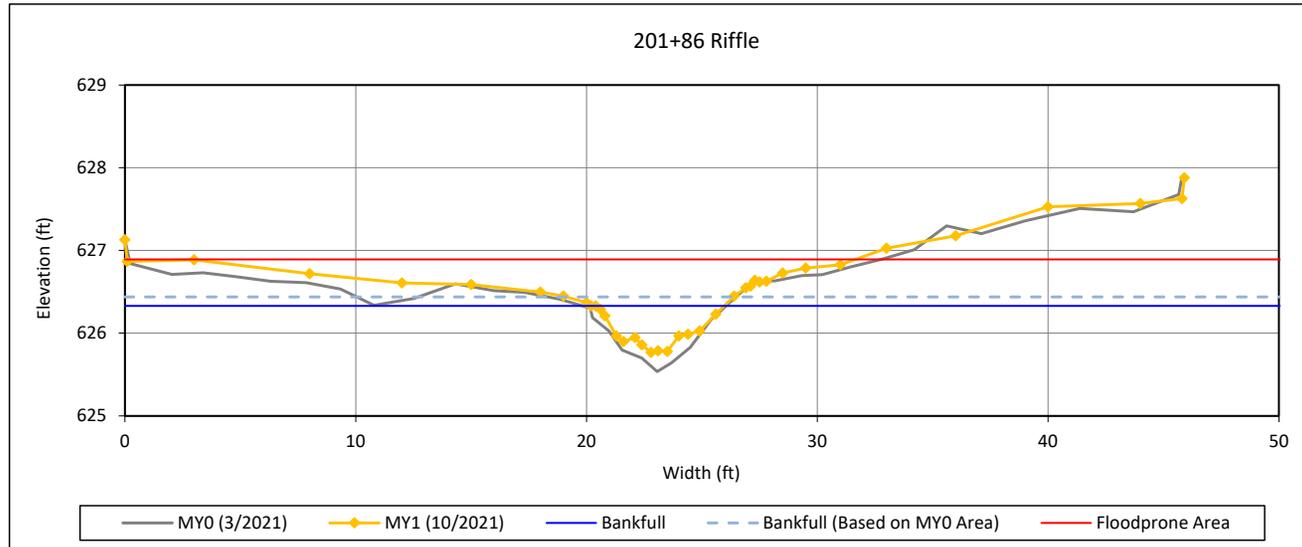
Cross-Section 8 - UT1 Reach 1

Bankfull Dimensions

1.9	x-section area (ft.sq.)
5.6	width (ft)
0.3	mean depth (ft)
0.6	max depth (ft)
5.8	wetted perimeter (ft)
0.3	hydraulic radius (ft)
16.6	width-depth ratio
50.0	W flood prone area (ft)
9.0	entrenchment ratio
< 1.0	low bank height ratio

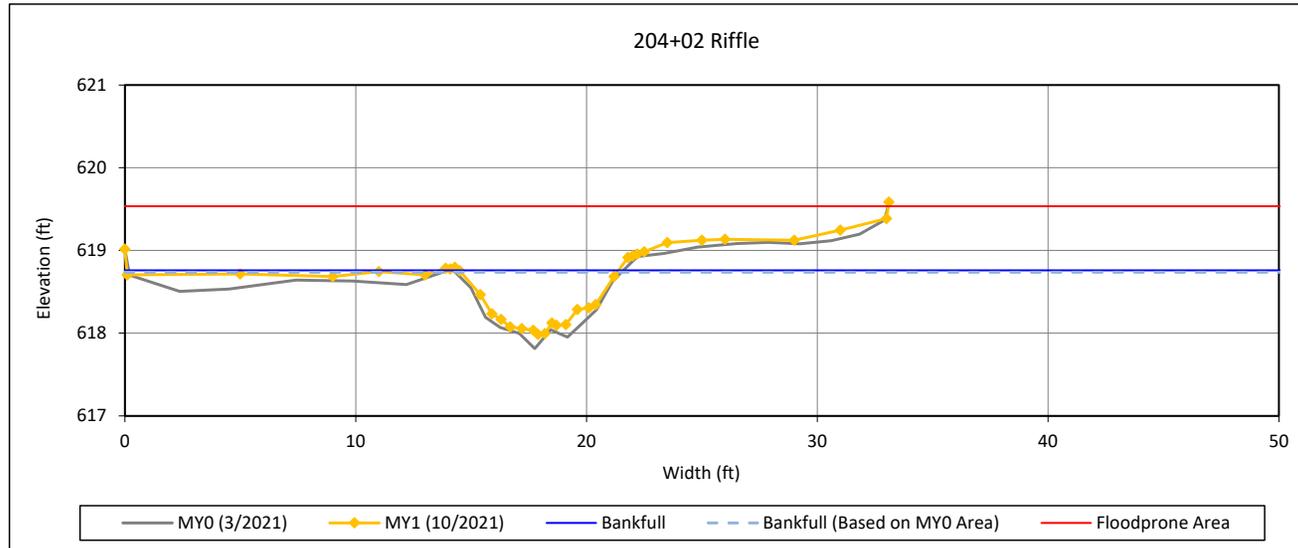
Cross-Section 9 - UT1 Reach 2

Bankfull Dimensions

3.4	x-section area (ft.sq.)
6.9	width (ft)
0.5	mean depth (ft)
0.8	max depth (ft)
7.2	wetted perimeter (ft)
0.5	hydraulic radius (ft)
14.2	width-depth ratio
175.0	W flood prone area (ft)
25.4	entrenchment ratio
1.0	low bank height ratio

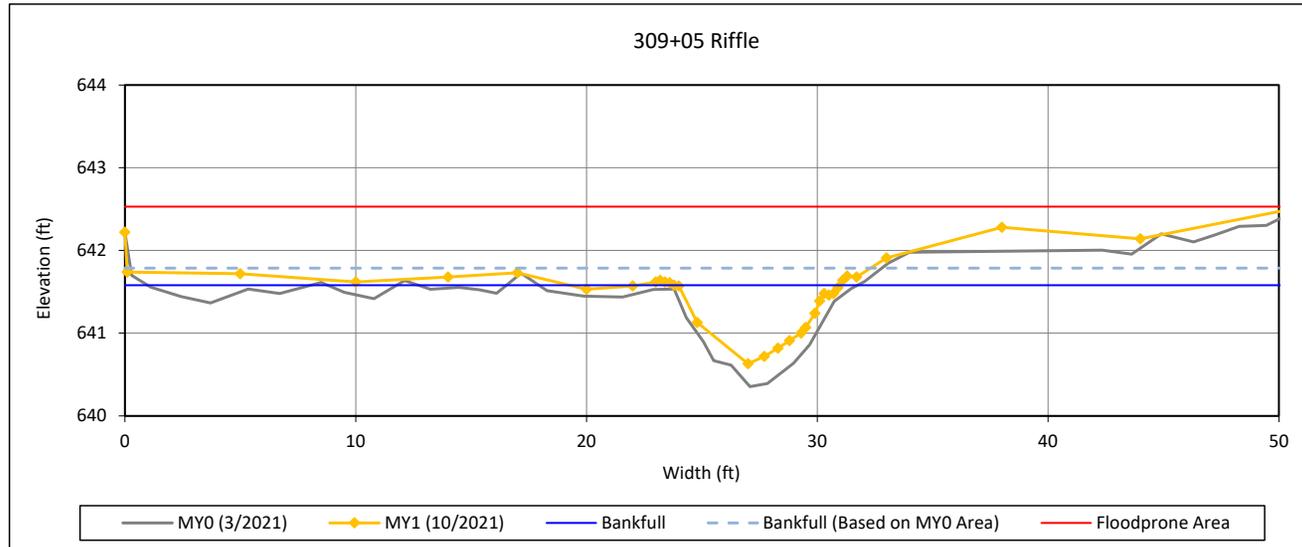
Cross-Section 10 - UT2 Reach 2

Bankfull Dimensions

3.9	x-section area (ft.sq.)
7.1	width (ft)
0.6	mean depth (ft)
1.0	max depth (ft)
7.4	wetted perimeter (ft)
0.5	hydraulic radius (ft)
12.8	width-depth ratio
100.0	W flood prone area (ft)
14.1	entrenchment ratio
< 1.0	low bank height ratio

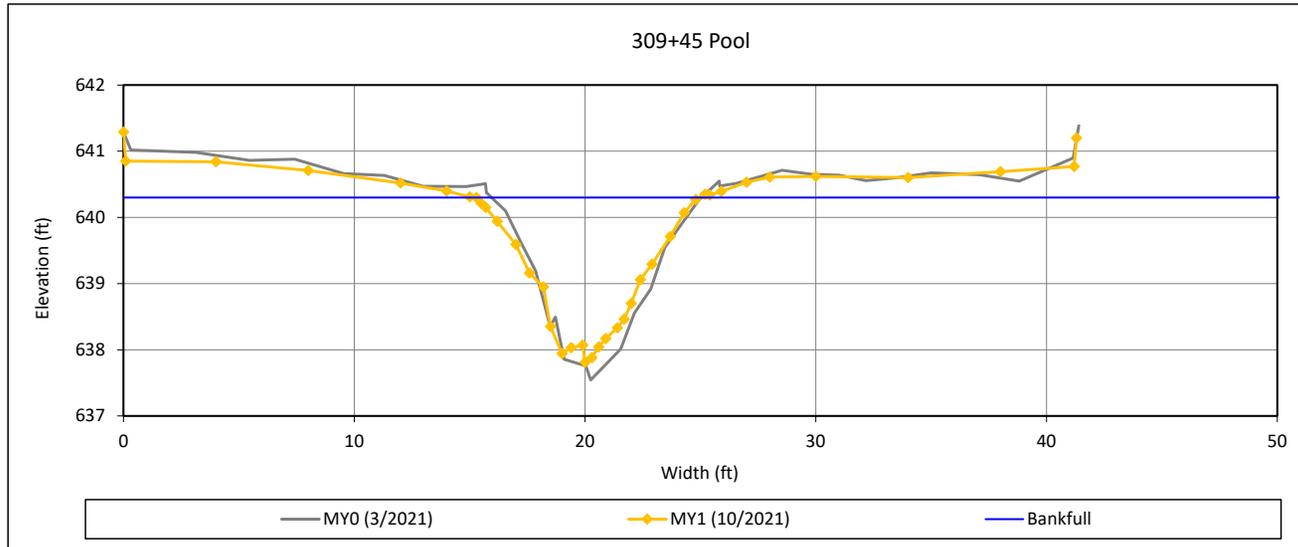
Cross-Section 11 - UT2 Reach 2

Bankfull Dimensions

12.0	x-section area (ft.sq.)
9.7	width (ft)
1.2	mean depth (ft)
2.5	max depth (ft)
11.3	wetted perimeter (ft)
1.1	hydraulic radius (ft)
7.7	width-depth ratio
