# Year 6 Monitoring Report

Roses Creek

Burke County, NC

DMS Project ID No. 96309

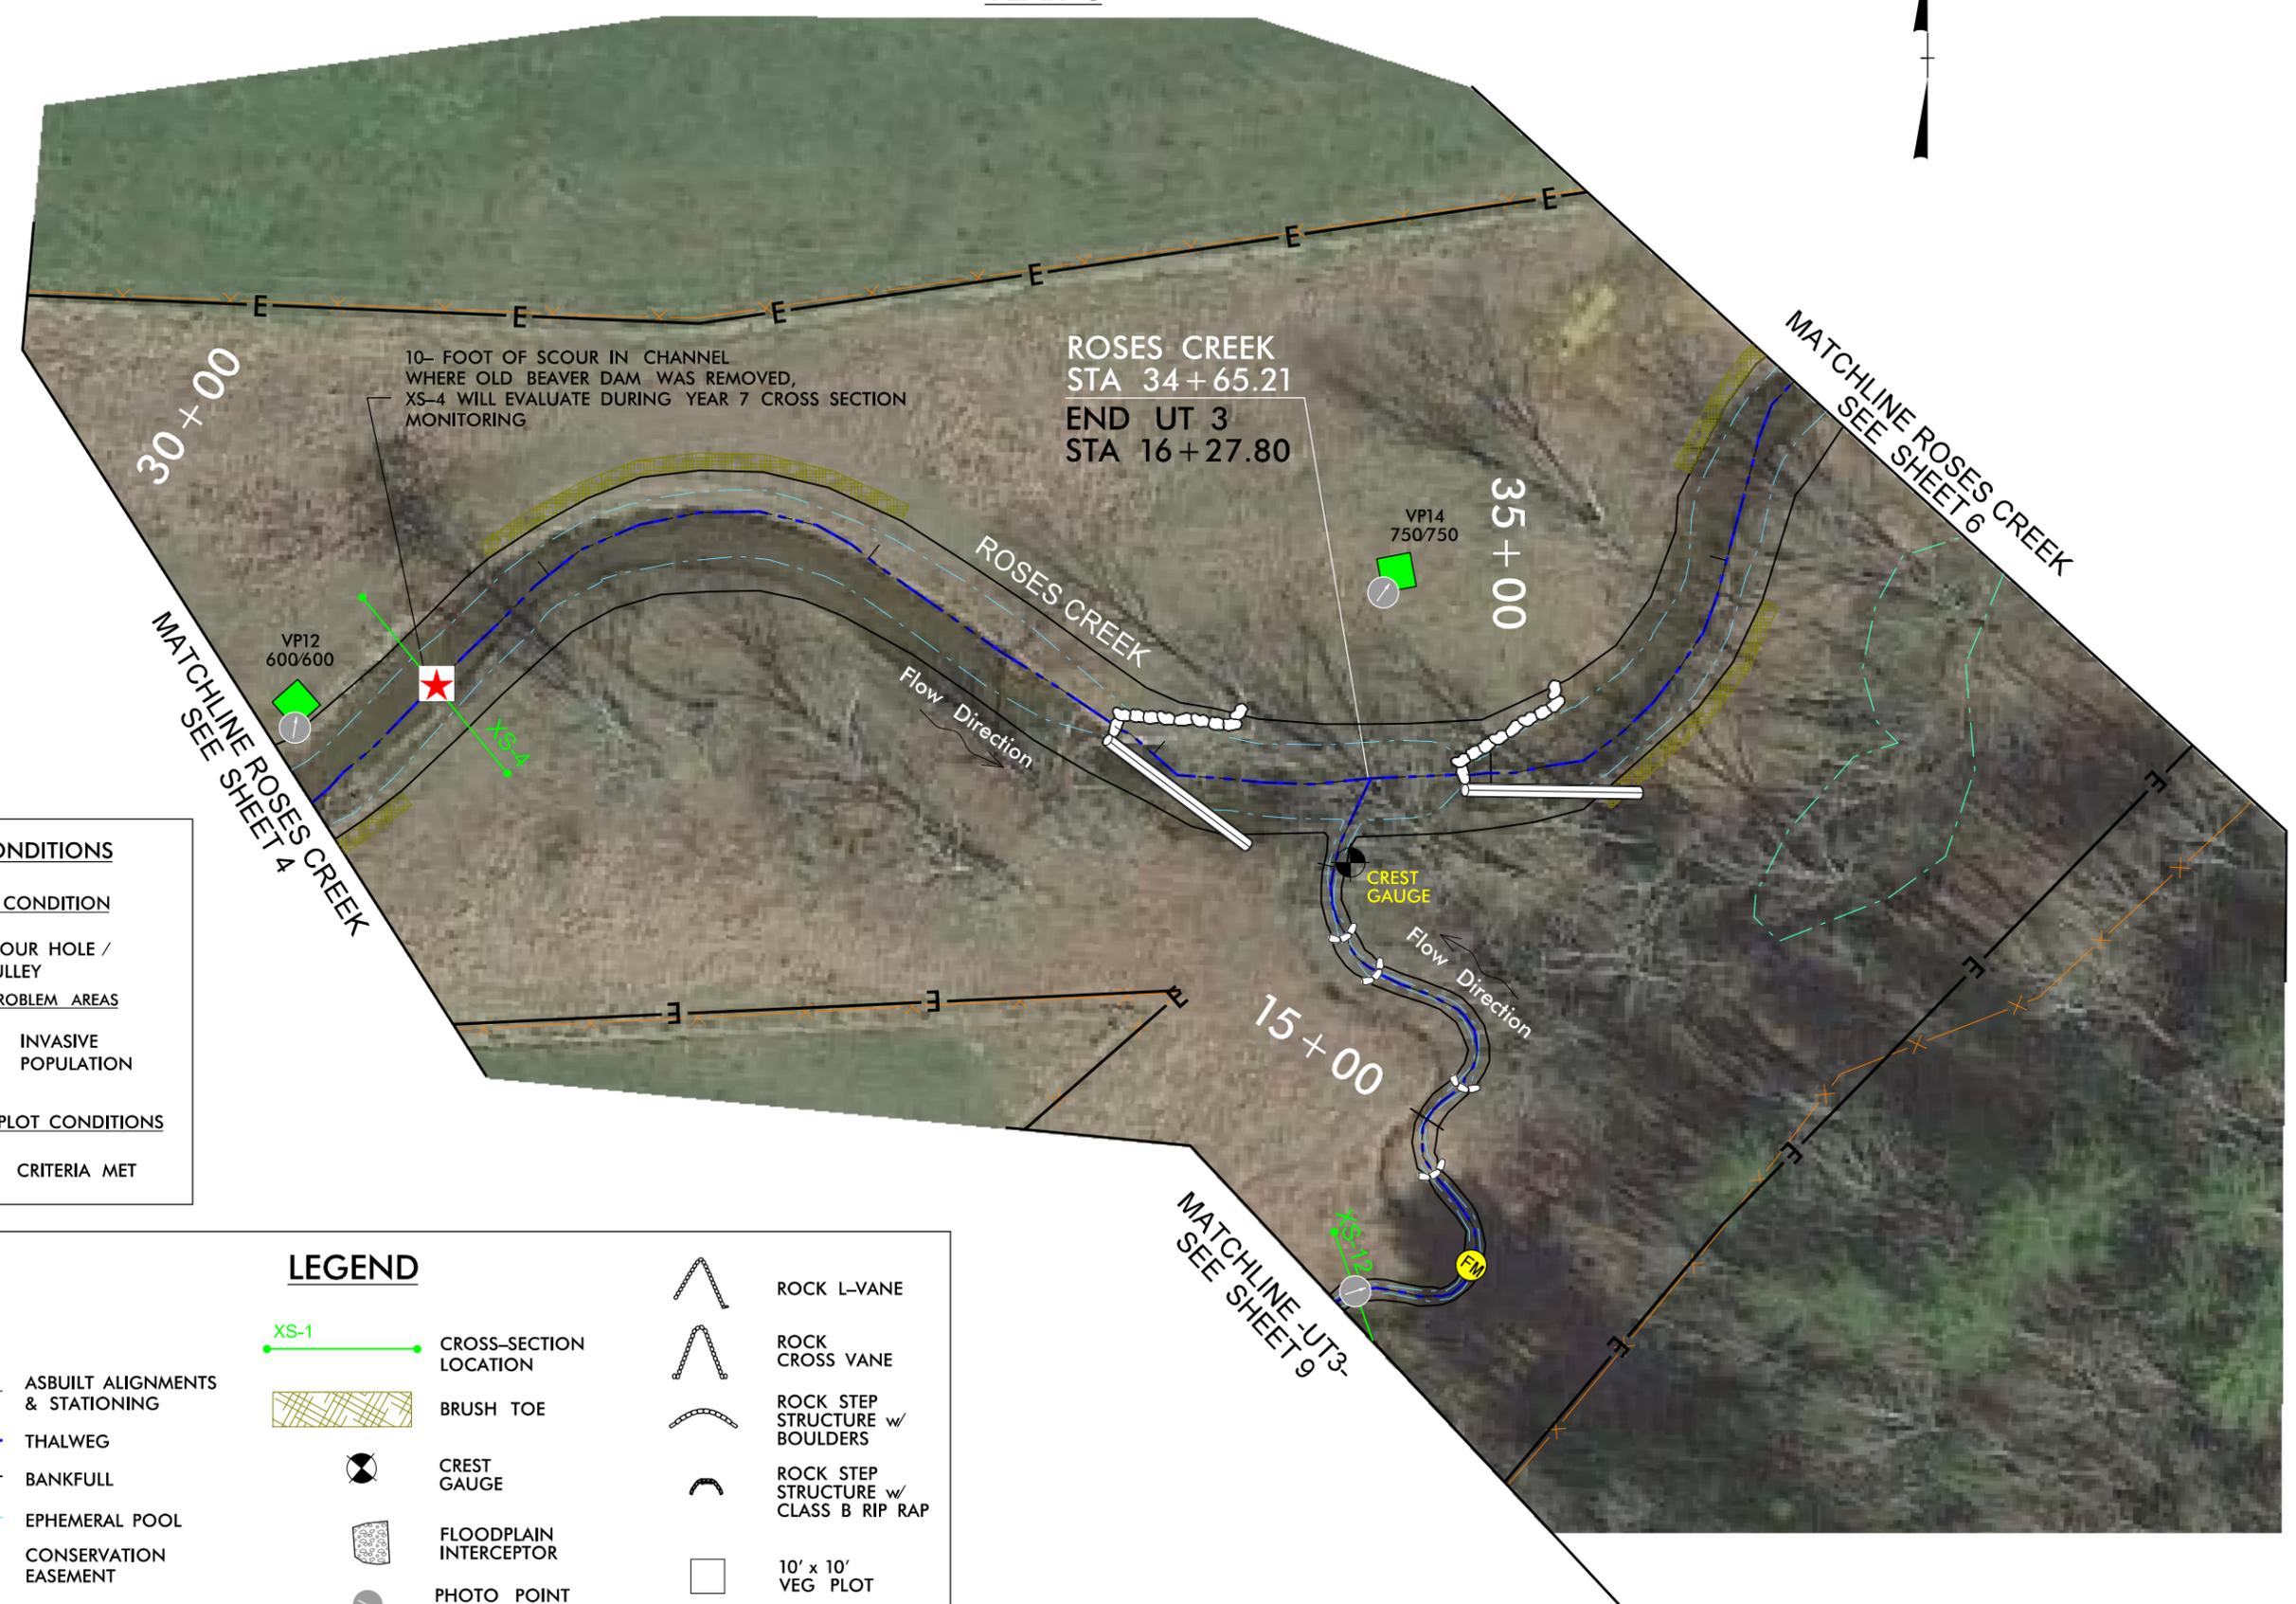
*During the credit release meeting in 2020, Cross Section 4 was noted to have down cut approximately 1 foot. Cross Section 4 is in the vicinity of a previous dam removal from 2019 and appears to be redistributing sediment throughout the reach. HDR will carry out cross section monitoring in Year 7 to determine if it has stabilized.*

10- FOOT OF SCOUR IN CHANNEL  
WHERE OLD BEAVER DAM WAS REMOVED,  
XS-4 WILL EVALUATE DURING YEAR 7 CROSS SECTION  
MONITORING

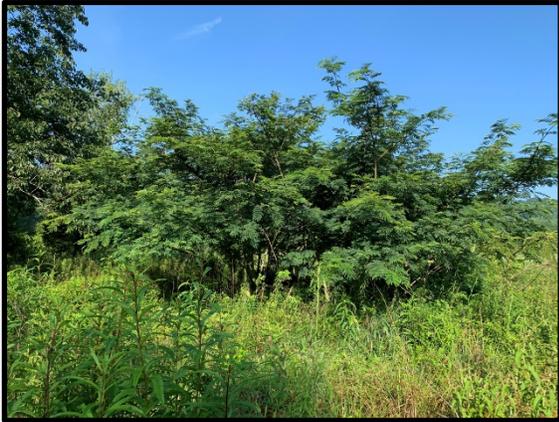
Mimosa (*Albizia julibrissin*), Chinese privet (*Ligustrum sinense*), multiflora rose (*Rosa multiflora*) and Japanese honeysuckle (*Lonicera japonica*) were the invasive species noted along UT 1. A large mimosa shrub is located at STA 12+00 on the downstream right bank about 35 feet from the stream. Chinese privet, multiflora rose and Japanese honeysuckle were noted around STA 12+50, STA 18+50 and sporadically in between these two areas along UT 1. Removal treatments to these species occurred along UT 1 in 2019 (mechanical and chemical) and in 2020 (chemical only). HDR plans to do additional mechanical and chemical treatments in early 2022 before the growing season and a final treatment as suggested by DMS in early 2023. Sparse patches of cattails (*Typha latifolia*) are located at the top of UT 2 around STA 11+00 through STA 12+00 on the downstream left area. Figures 3.1 – 3.3 and CCPV illustrates the current conditions and location of these invasive species.

**3.1 UT 1 Invasive Mimosa (7/27/21)**

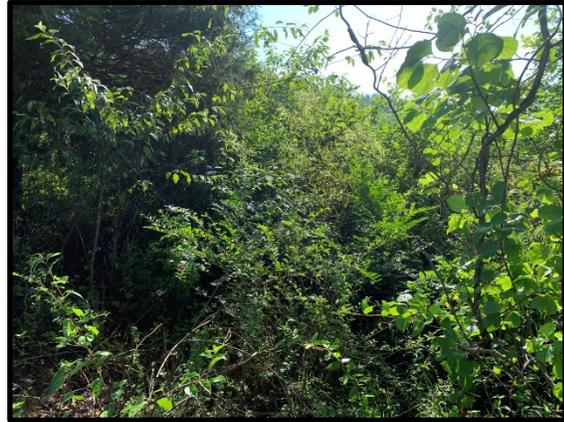
**3.2 UT 1 Invasive Chinese privet (7/27/21)**

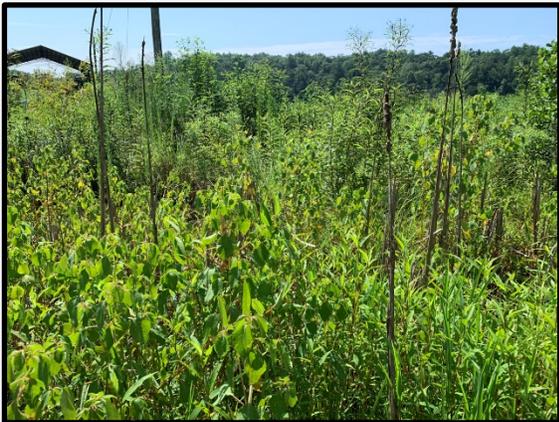
**3.3 UT 2 Invasive cattails (7/27/21)**

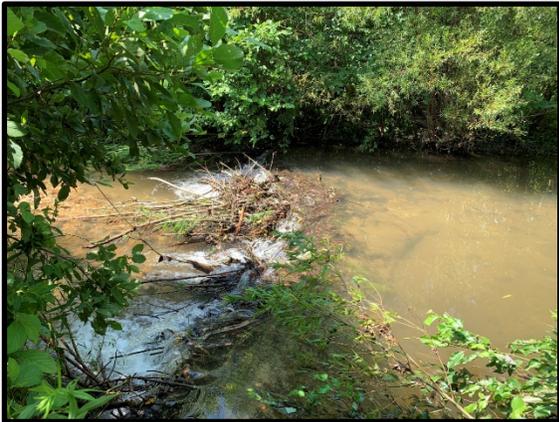
Roses Creek remains stable and functioning as designed. During Year 6 visual monitoring no areas of erosion were noted along the channel toes and banks. Bank repairs from 2018 appear stable and vegetation growth along the stream banks is maturing as expected. During the credit release meeting in 2020, Cross Section 4 was noted to have down cut approximately 1 foot. Cross Section 4 is in the vicinity of a previous dam removal from 2019 and appears to be redistributing sediment throughout the reach. HDR will carry out cross section monitoring in Year 7 and will determine if it has stabilized. A beaver dam was discovered at STA 24+50 in July 2021 creating minimal backwater effects upstream to STA 24+00. The dam was removed in August 2021, and two beavers were trapped and removed by APHIS. The stream is currently stable in the vicinity of the old beaver dam location (Figures 3.9 – 3.11). HDR will continue to monitor stream bank stability through Year 7.

**3.9 Roses Creek beaver dam (7/27/21)**

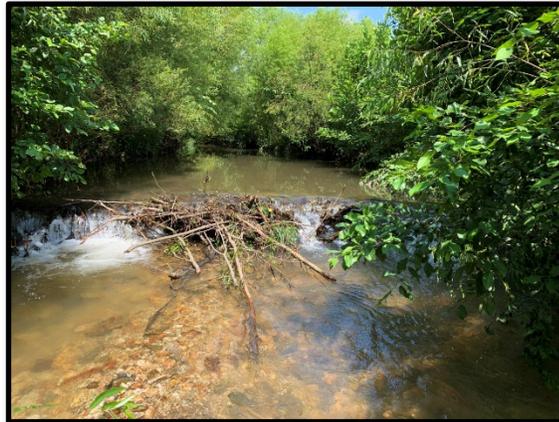
**3.10 Roses Creek beaver dam (7/27/21)**

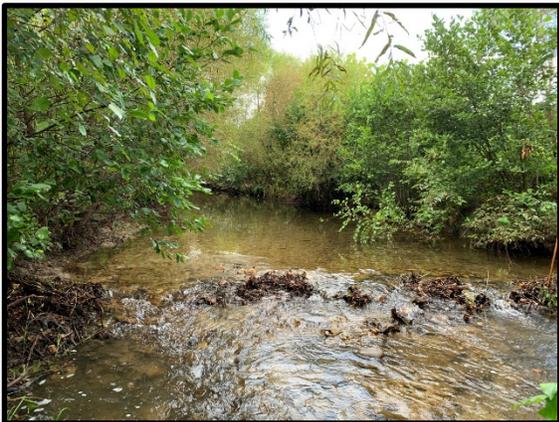
**3.11 Beaver dam after removal (9/8/21)**

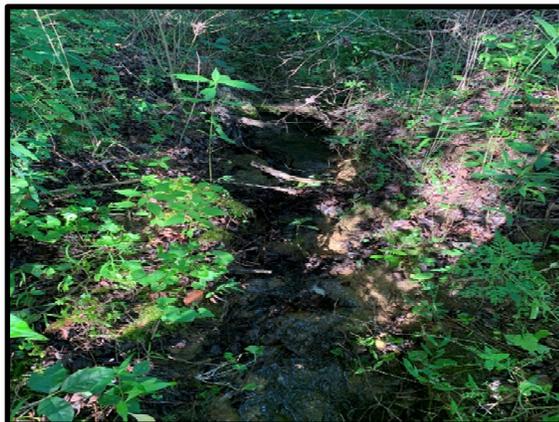
Generally, UT 1, UT 2 and UT 3 have remained stable over the Year 6 monitoring period. The IRT has raised concerns about the flow in the tributaries in the past on-site meetings. (Appendix D) However, two small areas of minor channel erosion were noted on UT 1 and UT 2. At STA 18+50 along UT 1 an area of in-channel downcutting is occurring (Figure 3.12). During the November field visit, it was noted there was a lack of channel flow at the top of UT 1. The upstream road culvert (18" CPP) above UT 1 connecting to the pond is most likely blocked/damaged and needs to be adjusted and/or cleaned out to allow for stream flow. In early 2022, HDR plans to investigate and remediate with the landowner a potential blockage at the culvert crossing above UT1. On UT 2 at STA 16+50, adjacent to vegetation plot 8, there was minor channel erosion/downcutting within the channel and, despite this, the stream banks appear stable. (Figure 3.13). HDR does not feel any repair actions are necessary for the minor downcutting along UT1 and UT2. At the bottom of Roses Creek at STA 41+25 there is a cow wasting area adjacent to the easement fencing on the downstream left (Figure 3.14 - 15). The herbaceous/forested buffer between this area and the stream is approximately 50 feet wide and is helping to filter this manure by soil absorption and plant nutrient uptake. In 2022, HDR will continue to monitor this area and will work with the landowner to see if fencing out an additional area in the vicinity is achievable.

**3.12 UT 1 channel erosion (7/27/21)**

*HDR added the following clarifying statements on page 4. “In early 2022, HDR plans to investigate and remediate with the landowner any potential blockage at the culvert crossing above UT1.” For the minor channel downcutting - “HDR does not feel any repair actions are necessary for the minor downcutting along UT1 and UT2.” For the lagoon area - “In 2022, HDR will continue to monitor this area and will work with the landowner to see if fencing out an additional area in the vicinity is achievable”.*

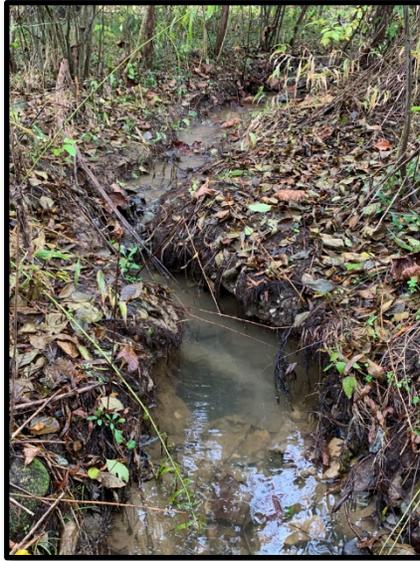
**3.13 UT 2 channel erosion (11/4/21)**

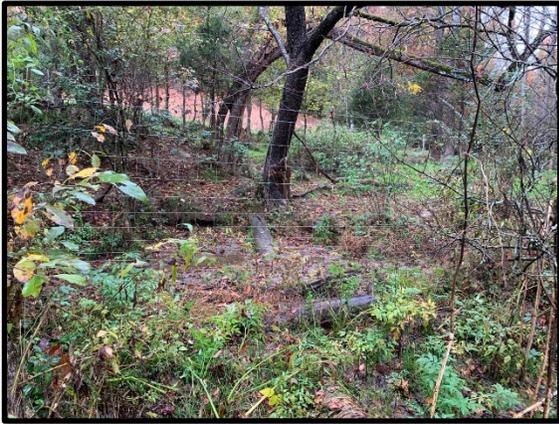
*HDR has not addressed any encroachment issues (two cow wasting areas at the bottom of Roses Creek) in 2021 and these will be addressed in 2022.*

**3.14 Cow wasting area (11/4/21)**

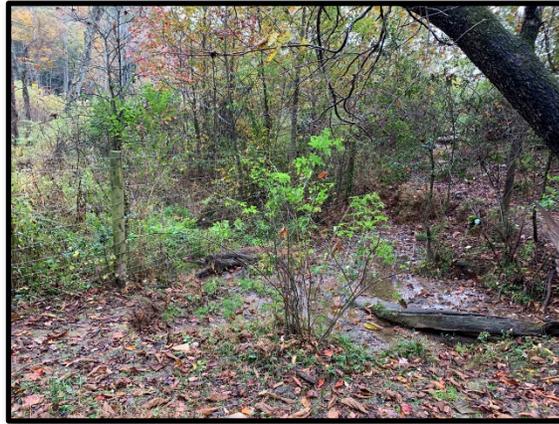
**3.15 Wasting area (outside easement)**
