Monitoring Report MY05

**Sandy Bridge Restoration Site
DMS Contract 6400
DMS Project Number 96920**

**DWR #: 15-0414
USACE Action ID: 201500827
Rutherford County, North Carolina**

**Monitoring Data Collected: 2021
Date Submitted: December 2021**

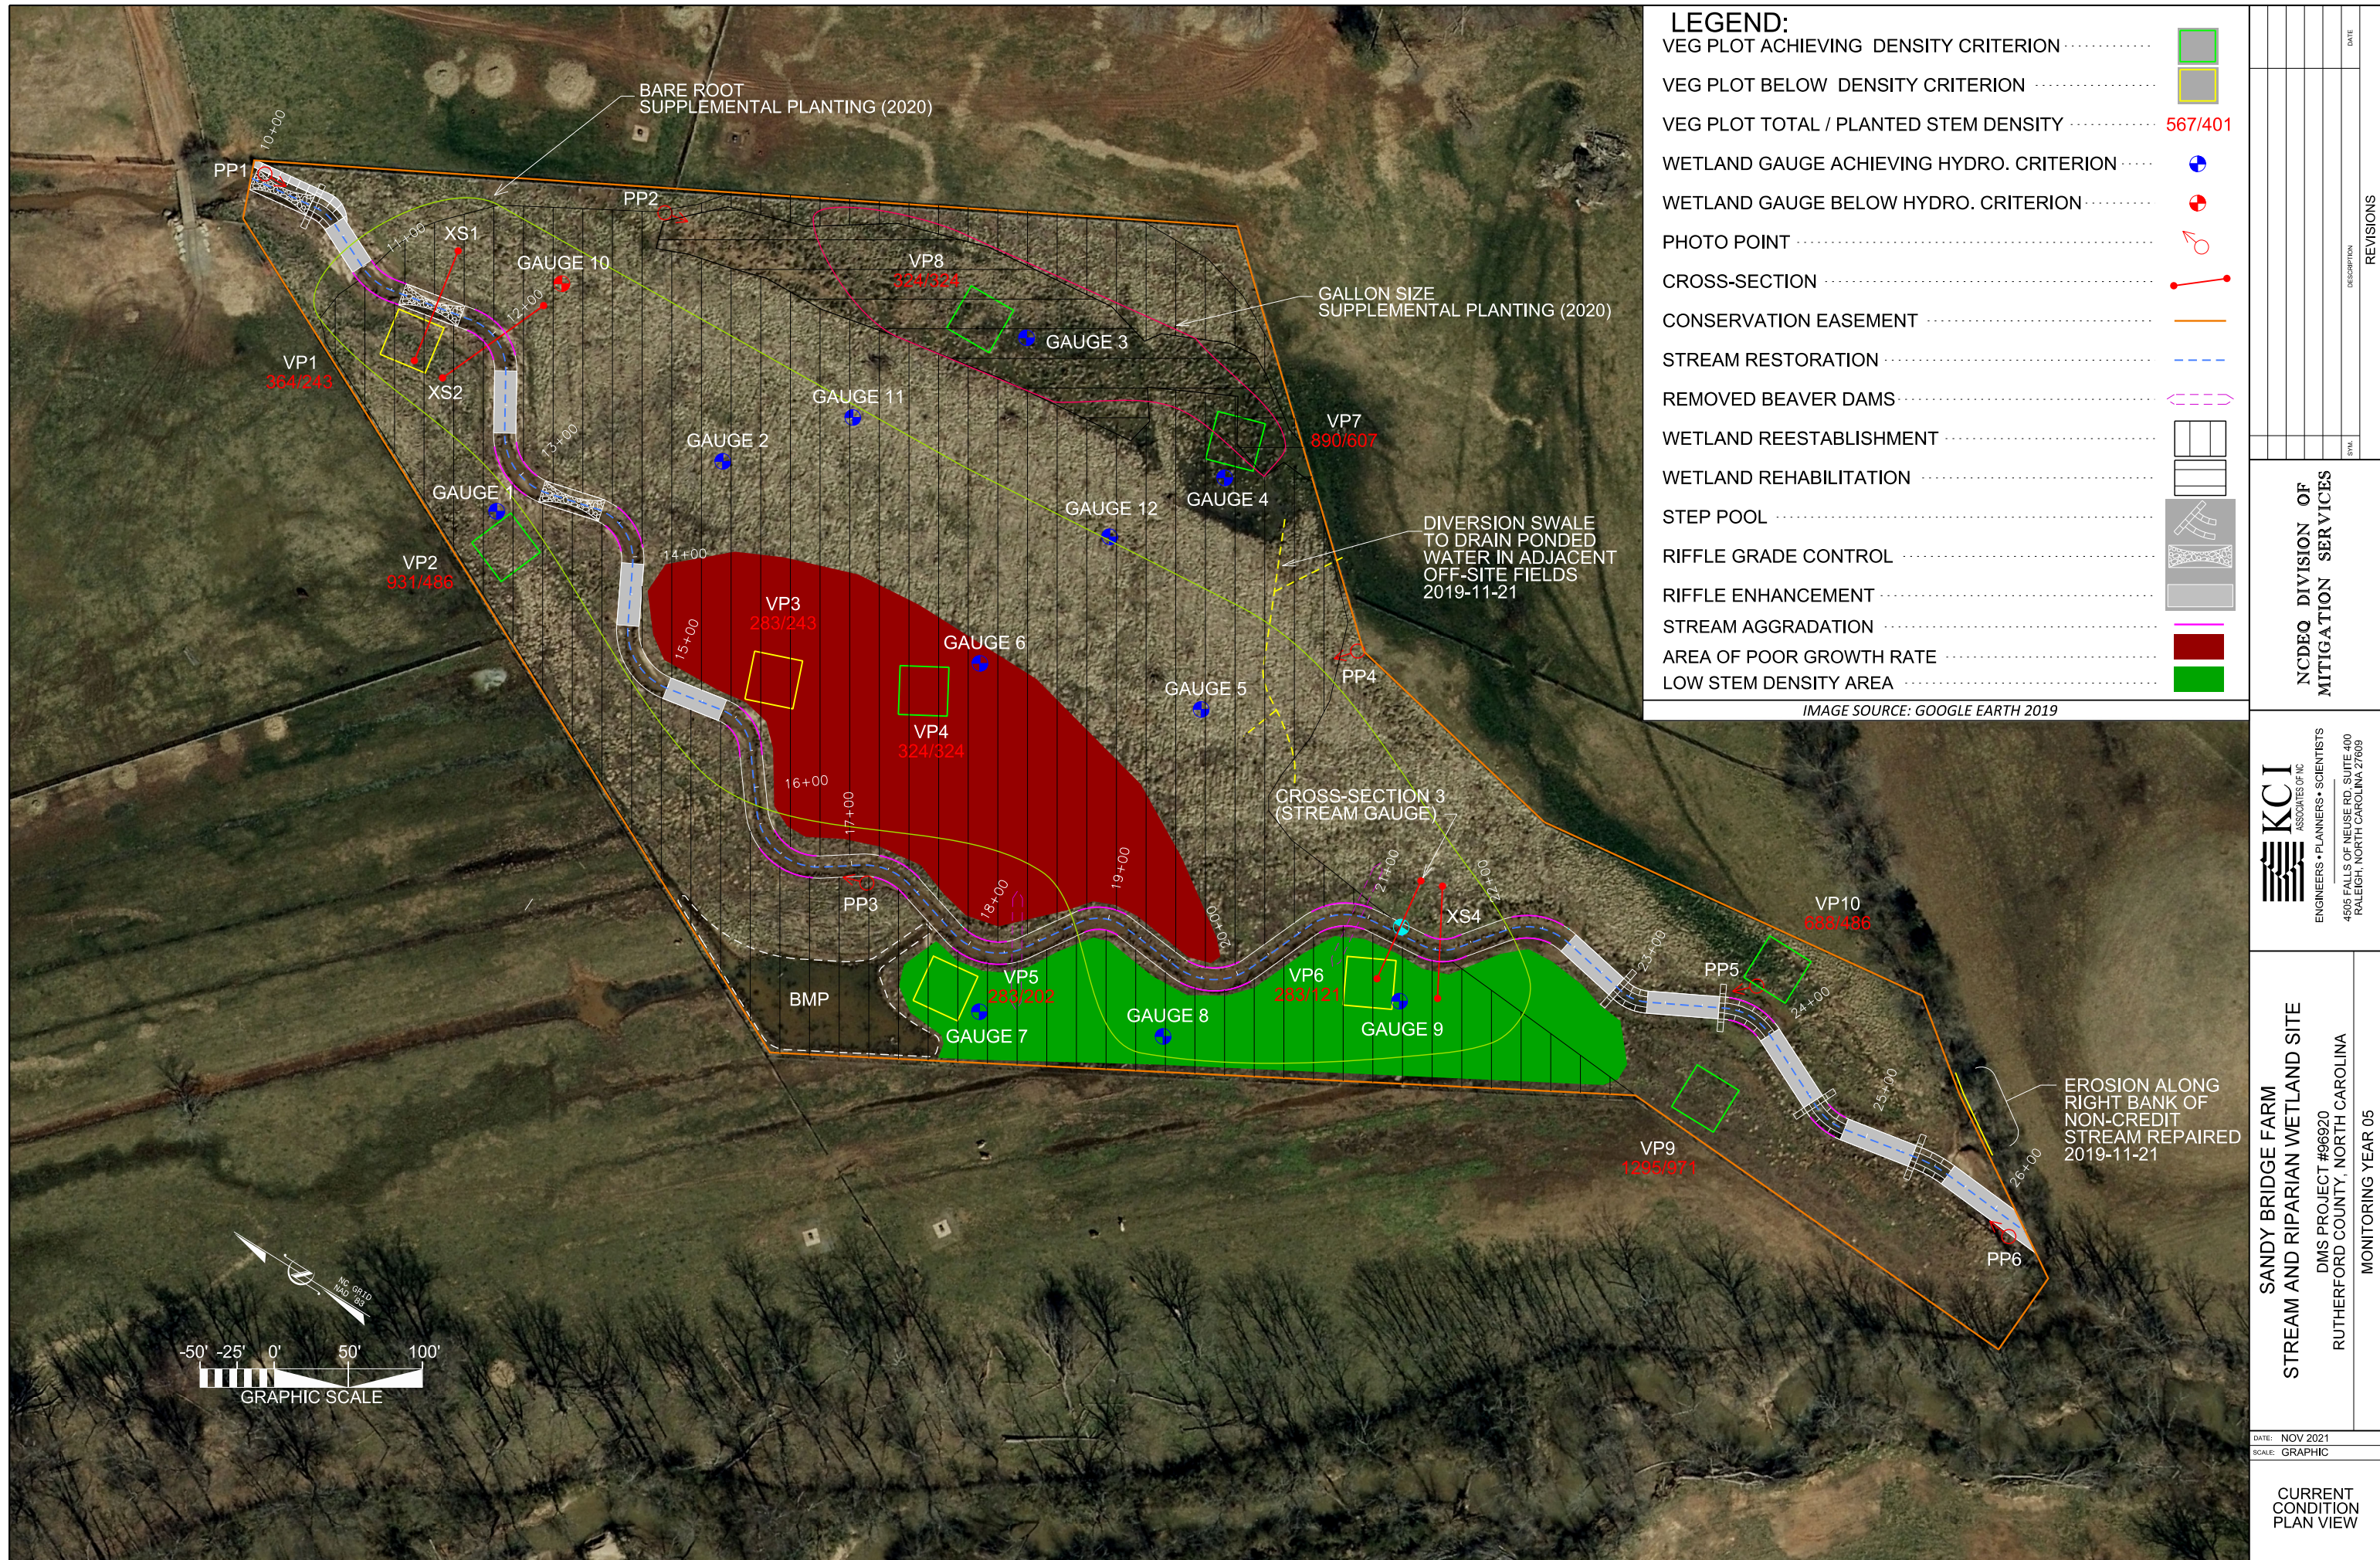
DATE: NOV 2021
 SCALE: GRAPHIC
 CURRENT CONDITION PLAN VIEW

Due to the presence of beavers on-site, there has been more aggradation in the stream channel than has been anticipated. KCI has been removing the beavers routinely, but when the dams are built, sediment has deposited in the channel. The fifth-year cross-section survey showed bed aggradation in all four cross-sections as well as aggradation on the banks of Cross-sections 1 and 2. When the beaver dams are removed for an extended period of time, there is evidence of the accumulated sediment washing out of the stream. An example of this can be seen when comparing the MY02 and MY03 surveys of XS2. During MY02, a mid-channel bar had formed within this cross-section but after the removal of the beaver dams and a period of several months without them being rebuilt, this bar was completely absent from the MY03 survey. Comparing the MY04 and MY05 surveys of XS4 also shows this pattern. Starting in MY03, a large beaver dam was located at the head of the riffle just downstream of XS4. This dam was removed multiple times during 2019 and 2020. After being removed in September 2020, this dam was not rebuilt, but a new dam was constructed upstream of XS4. Comparing the MY04 survey to the MY05 survey shows that the thalweg elevation in this cross-section has dropped approximately half a foot. KCI believes that if given enough time without backwater conditions, this trend will hold true for the entire site. It is also important to note that even with the rebuilding of the dams, the stream flow has stayed within the restored channel and no evidence of other channels forming in this system has been noted.

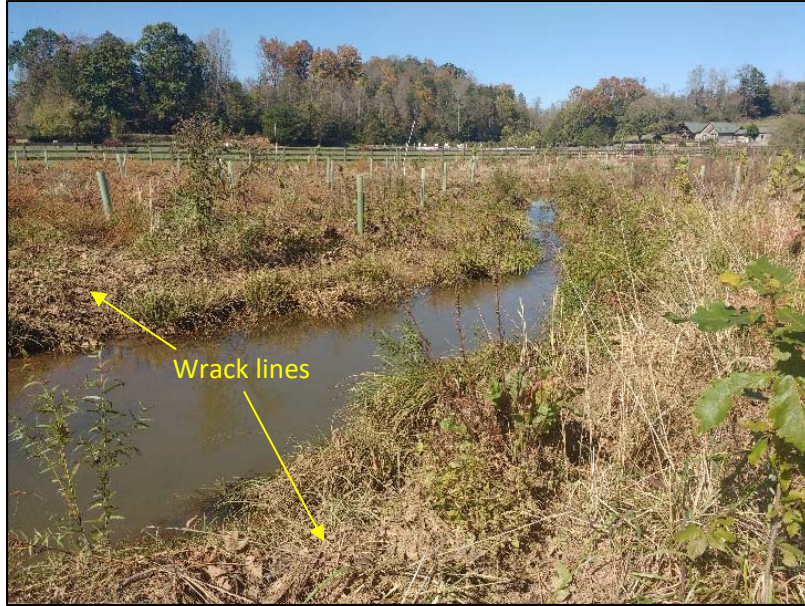
Photo 1. Sediment on plants and wrack lines above bankfull, 10/26/2017

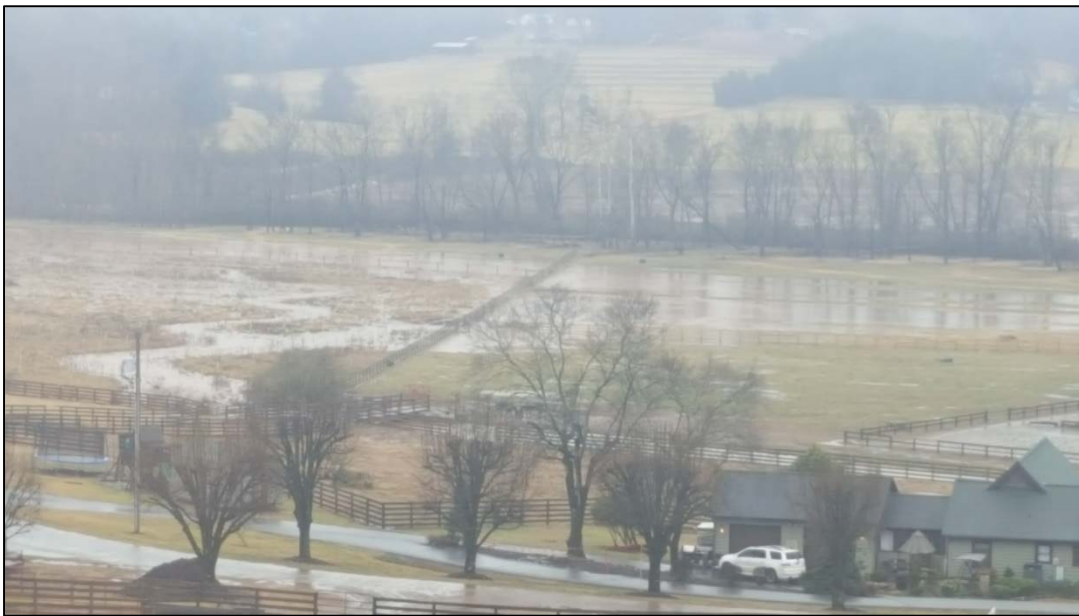
Photo 2. Bankfull event on site, 2/7/2018

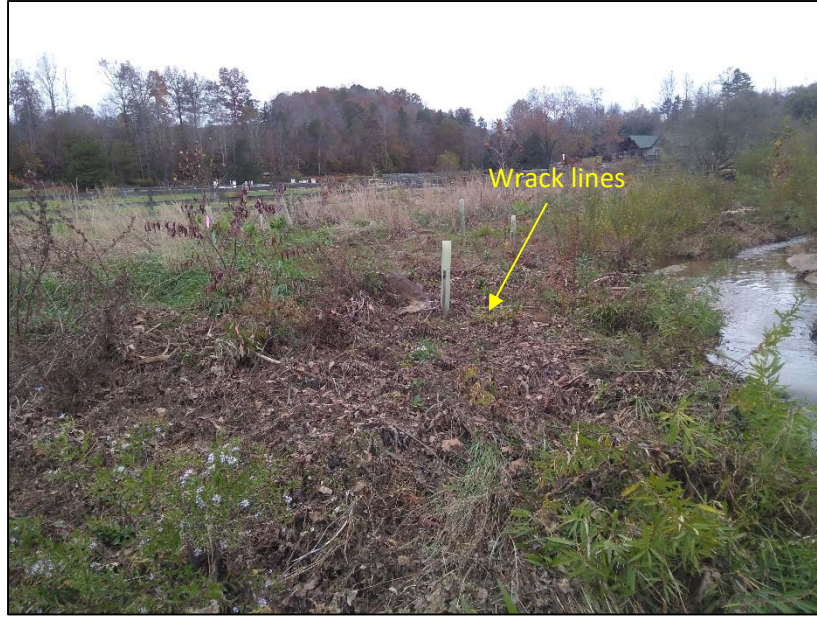
Photo 3. Wrack lines above bankfull, 11/7/2018

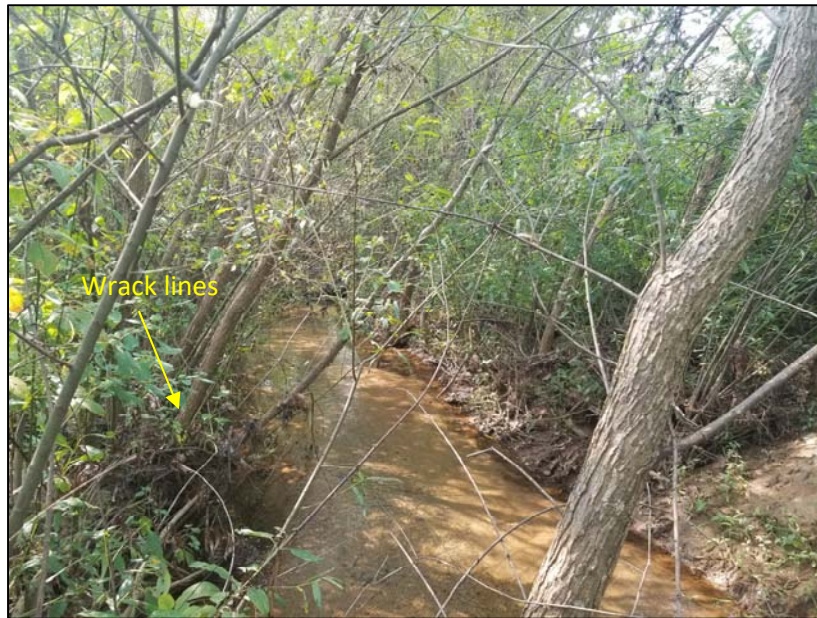
Photo 4. Wrack lines above bankfull, 9/13/2021
