**Bowl Basin Restoration Site  
Monitoring Report MY07  
DMS Project # 95721  
DMS Contract # 005012**

**Onslow County, NC  
CU# 03020106  
DWR# 2013-0864  
SAW# 2013-00393**

**Construction Completed: February 2015  
Data Collection: 2021  
Submitted: February 2022**

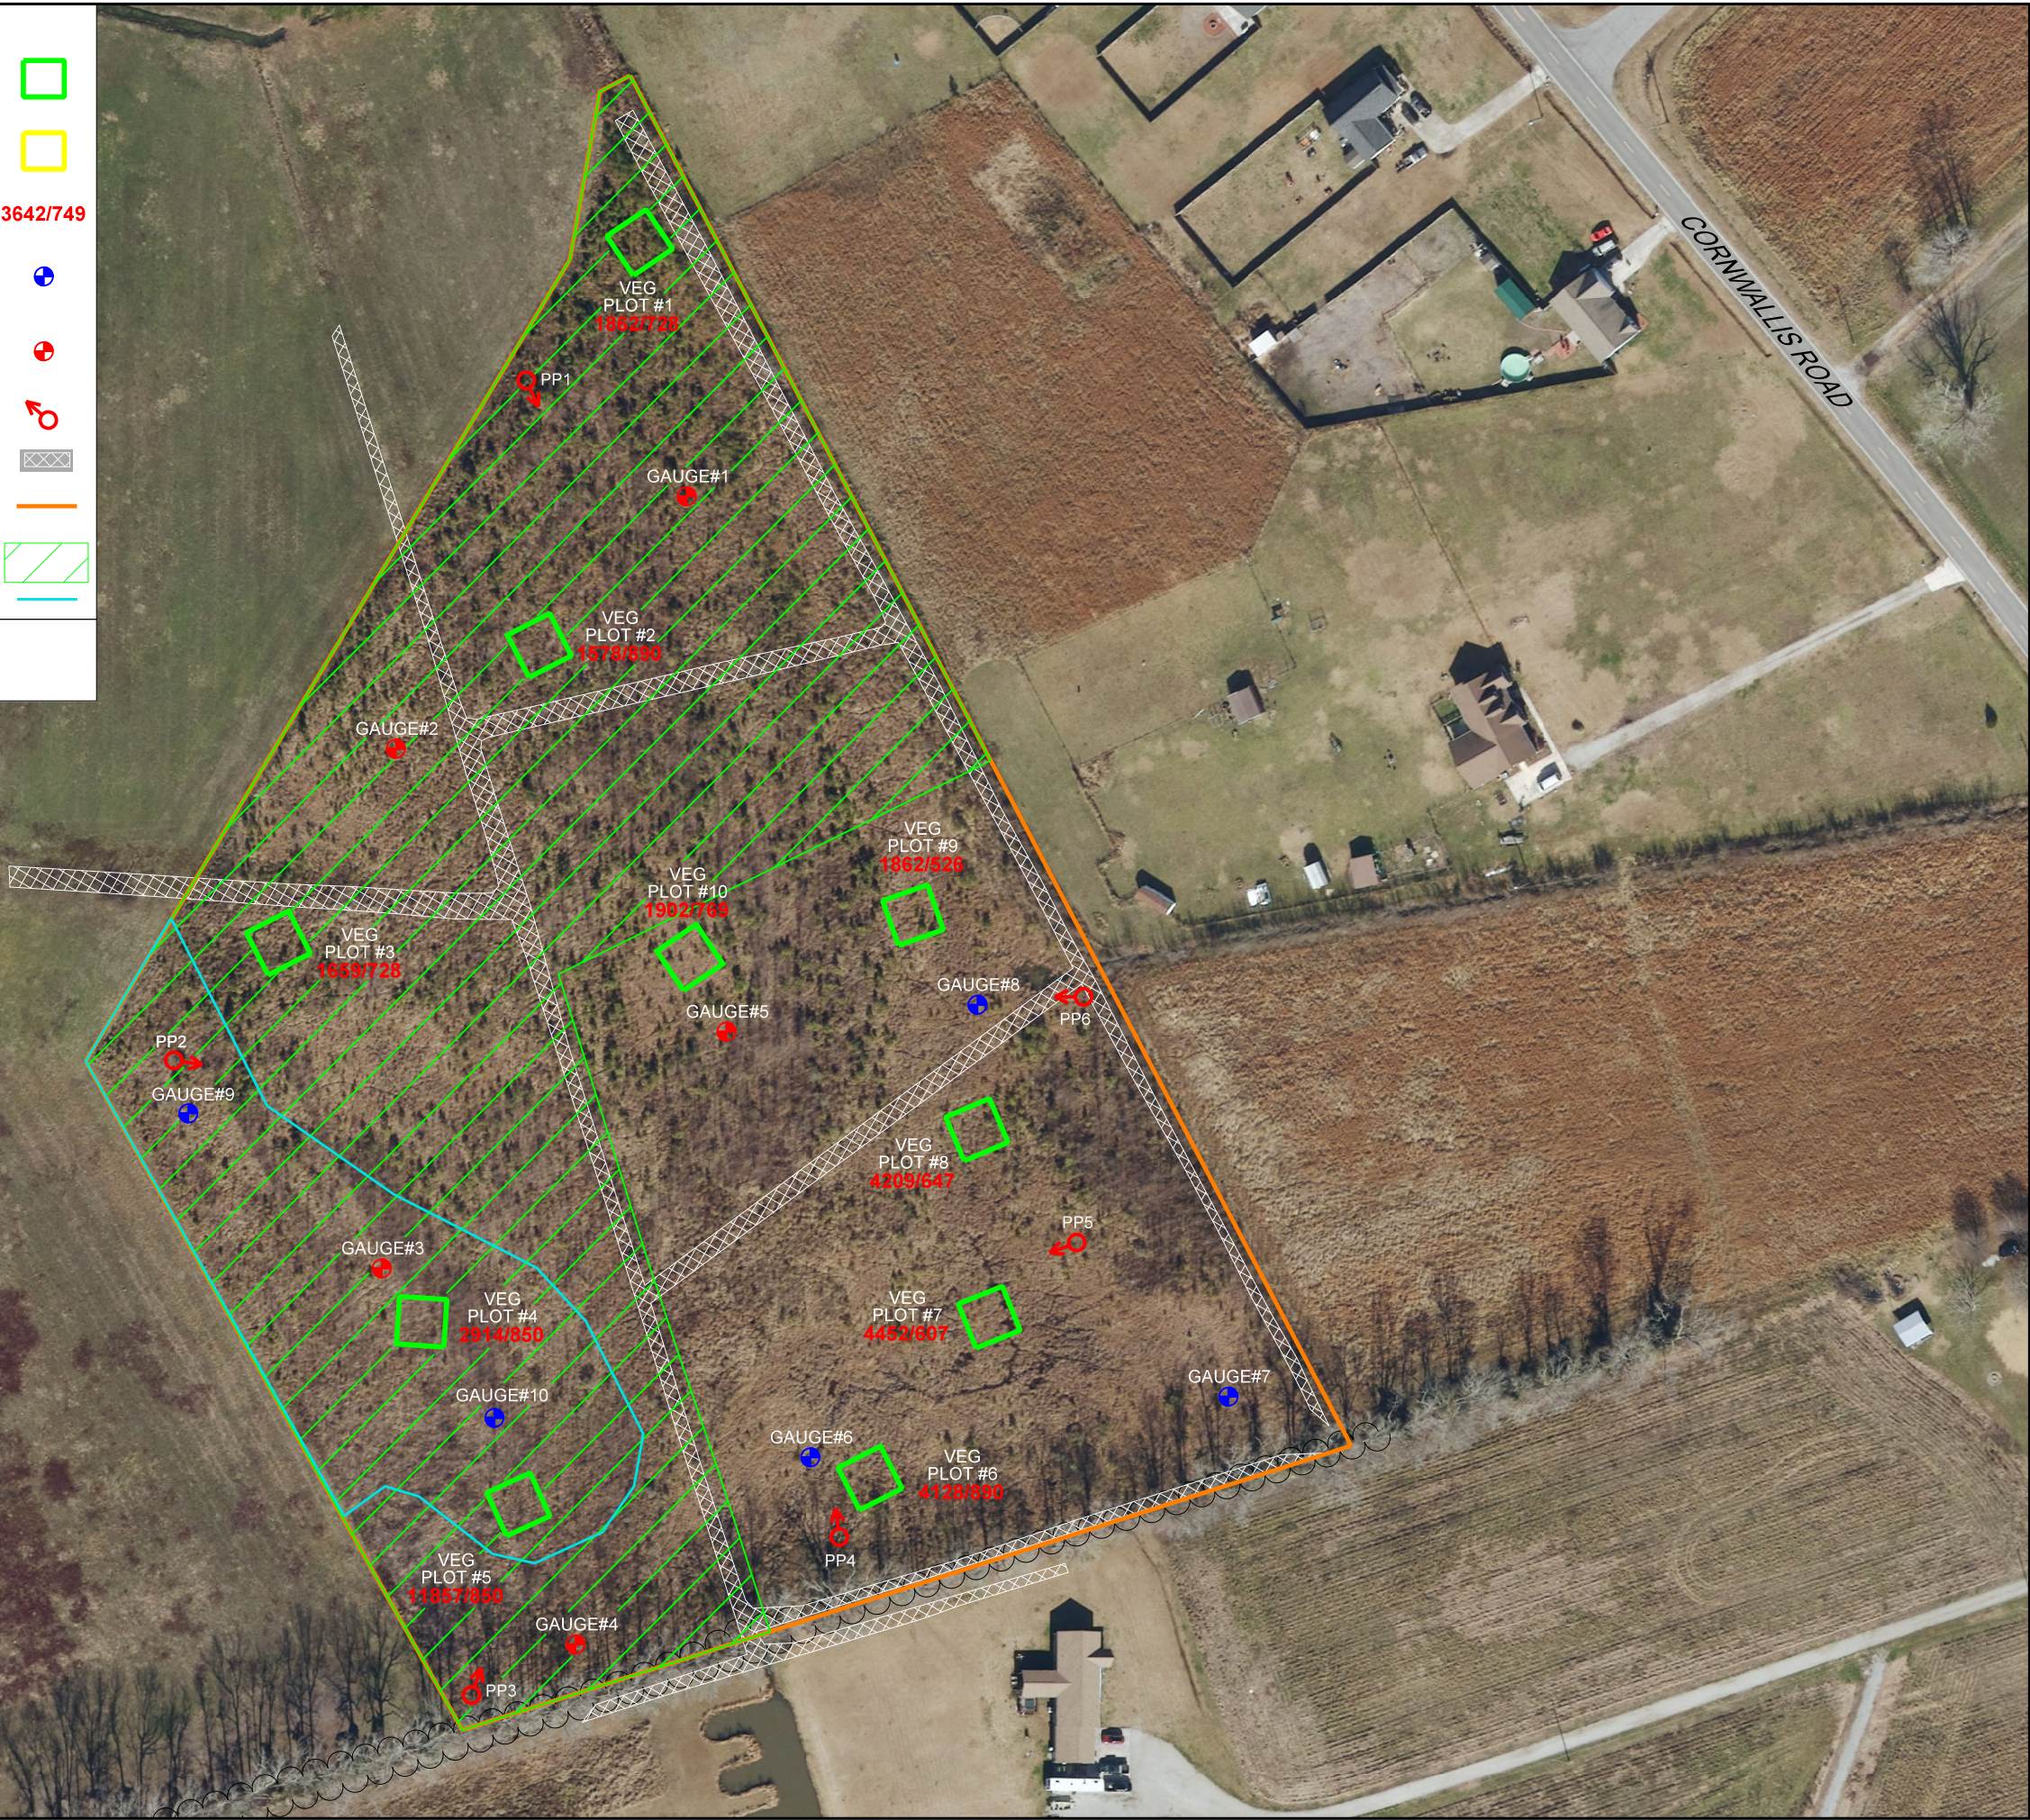
DATE: NOV 2021  
 SCALE: GRAPHIC  
 CURRENT CONDITION PLAN VIEW  
 SHEET 1 OF 1  
 FIGURE 3

There are several areas of the site that have been densely colonized by sweetgum and loblolly pine. These areas were treated in the spring of 2017, spring of 2019, spring of 2020, and the fall of 2021. This treatment consisted of cutting the sweetgum and loblolly pine and then spraying the stumps with an herbicide. There was one area of treatment for just sweetgum that consisted of an area of 1.58 acres and another treatment for both loblolly pine and sweetgum that consisted of an area of 7.34 acres. Because of the large seed source for these species directly adjacent to the site, it is unrealistic to expect them to be completely eradicated from the site. These treatments were intended to give the planted stems a chance to grow to a height where they would not be out-competed by these fast growing, primary successional species. While there are still areas of dense sweetgum and loblolly present on the site, these areas are relatively limited and are interspersed with many large (>10 feet) planted stems. As the site continues to develop, it is expected that these areas of dense primary succession species will naturally thin out as they compete with each other and the much larger planted stems.

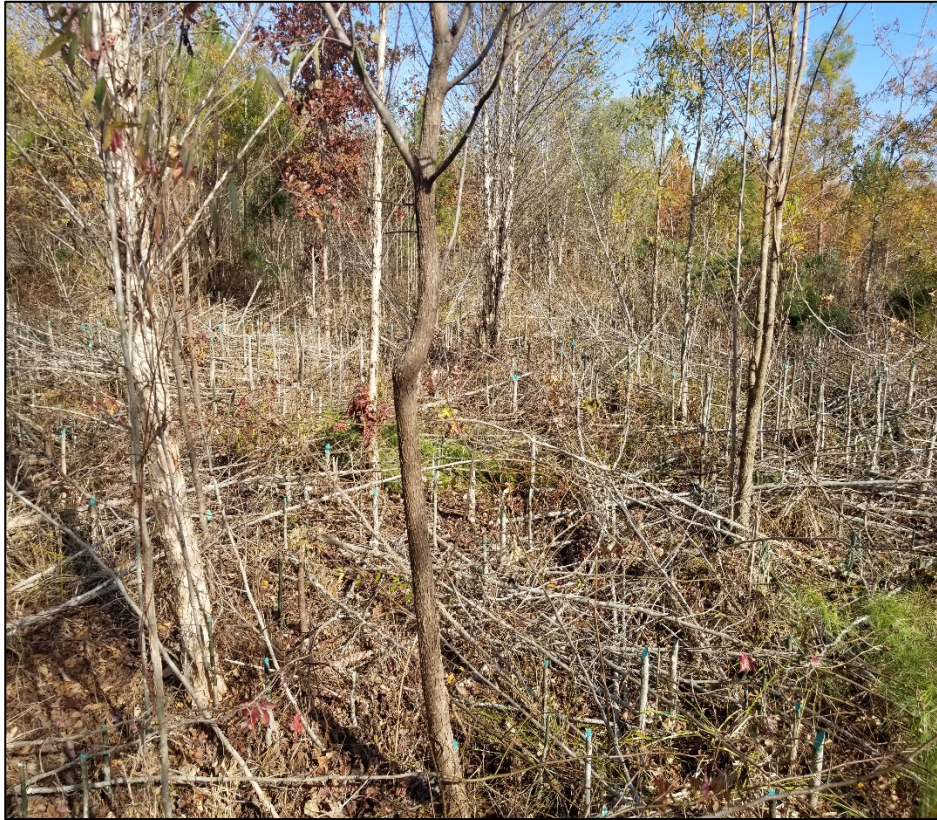
Area of sweetgum and pine treatment – 11/19/21

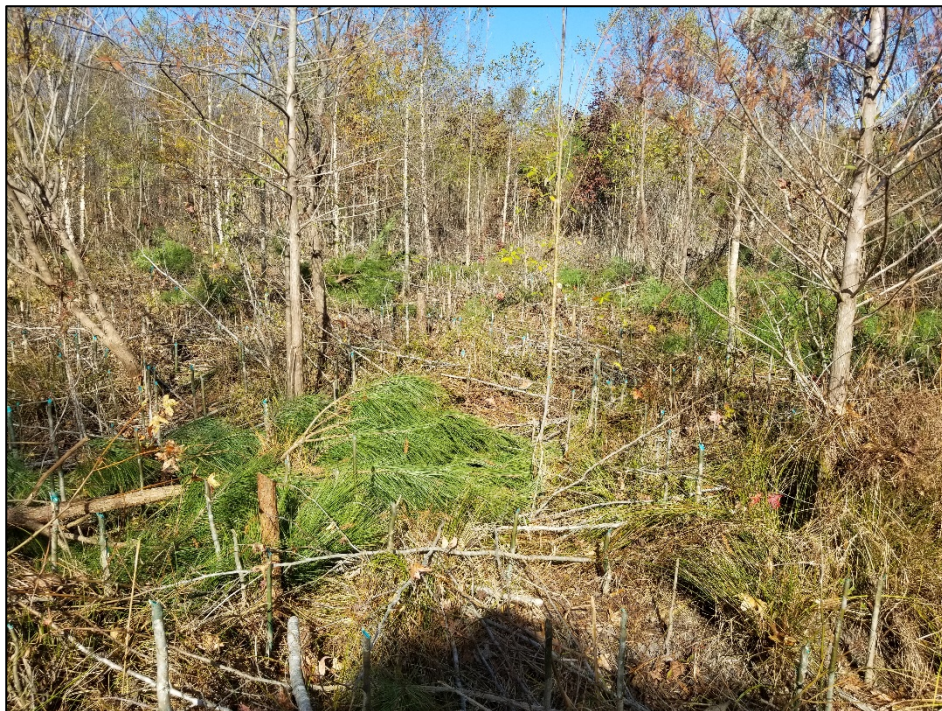
Area of sweetgum and pine treatment – 11/19/21

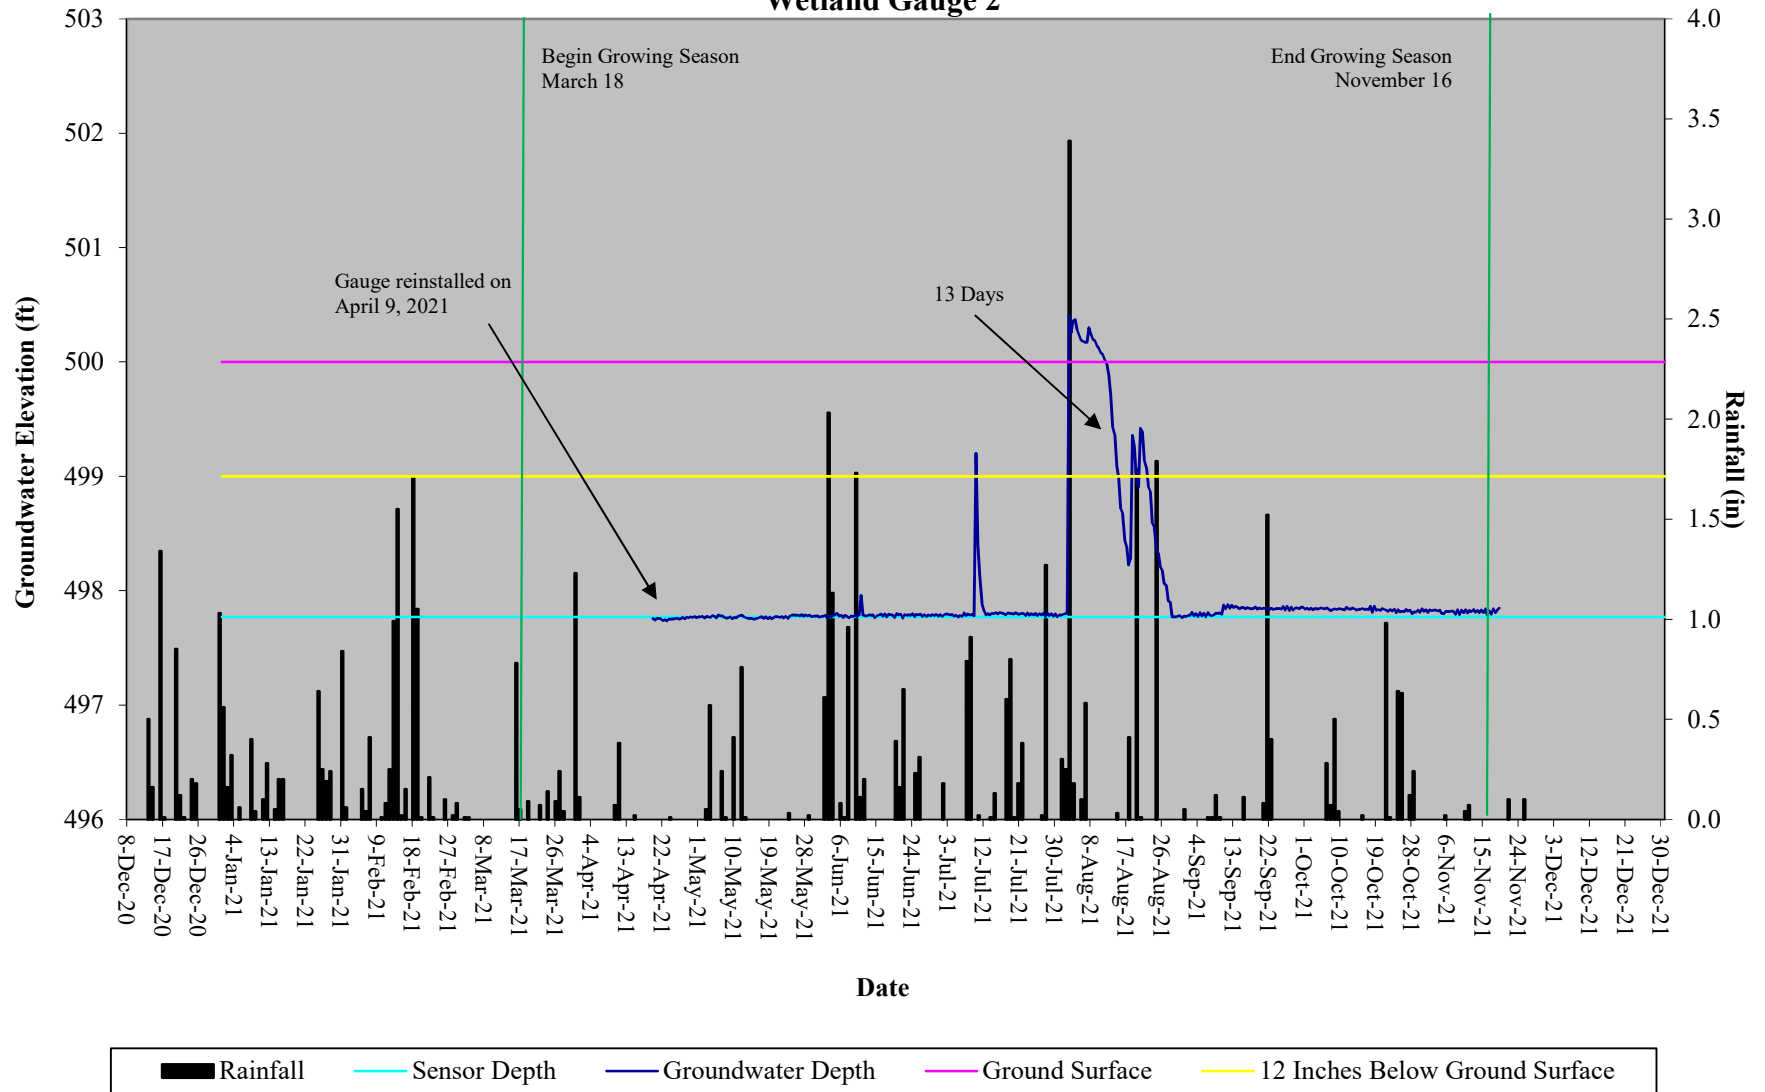
## Bowl Basin Restoration Site Hydrograph Wetland Gauge 2

gauges already installed on site. Gauge 2 was reinstalled on April 19, 2021 due to a gauge malfunction at the beginning of the growing season.

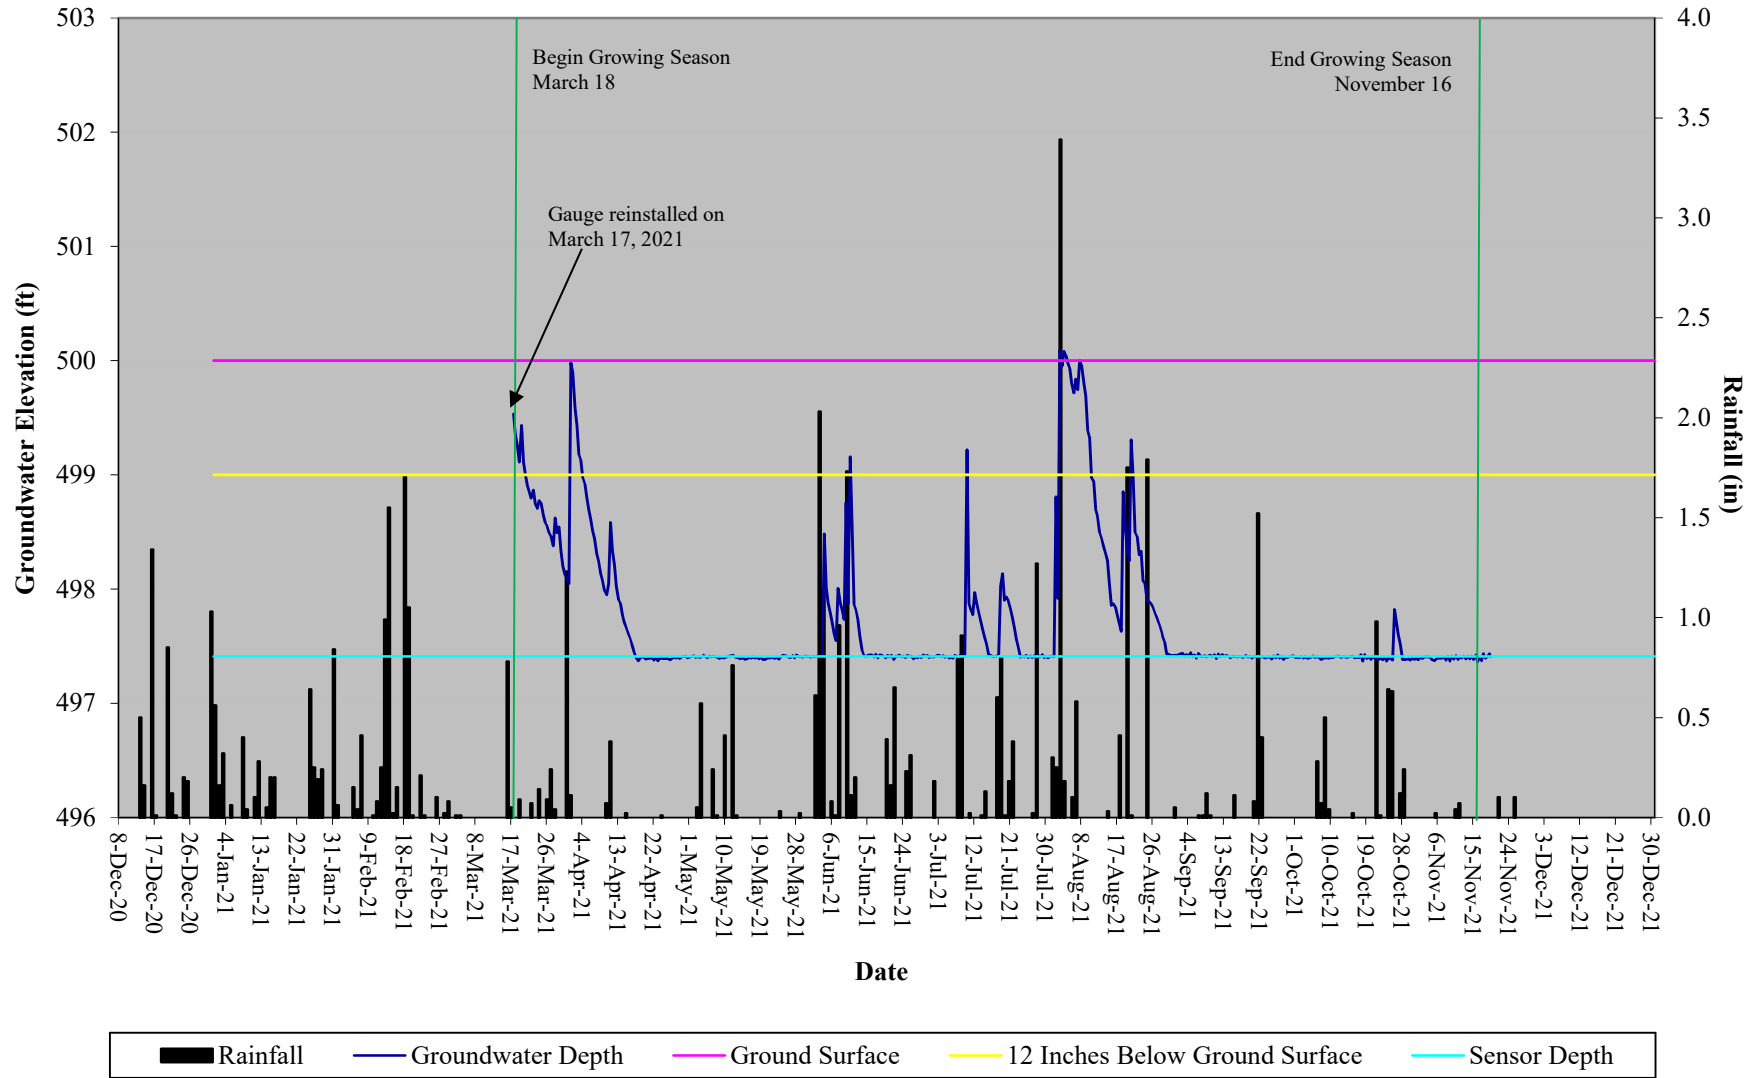
### Bowl Basin Restoration Site Hydrograph Wetland Gauge 5

3. The reason for failing gauges was described by climate and influence of pines, but the area around failing gauge 5 was not treated for pines. Confirm if the area around this gage was treated and update shapefile and area if needed.  
*KCI Response: Due to the abundance of pine on the site and the depth at which their roots extend, the effects that they have on the water table extend beyond the area directly around where they are growing. KCI believes that the removal of the majority of the pines from the site will have a positive impact on the hydrology across the entire site. While there are pines present in the area around this gauge, this area was not as heavily colonized as other parts of the site and so was not included in the treatment area.*

Gauge 5	Yes/24 (9.8%)	Yes/52 (21.3%)	Yes/50 (20.5%)	Yes/36 (14.8%)	No/12 (4.9%)	No/5 (2.1%)	No/8 (3.3%)
Gauge 6	Yes/79 (32.4%)	Yes/60 (24.6%)	Yes/62 (25.4%)	Yes/58 (23.8%)	Yes/40 (16.4%)	Yes/41 (16.9%)	Yes/38 (15.6%)
Gauge 7	Yes/25 (10.2%)	Yes/38 (15.6%)	No/12 (4.9%)	Yes/31 (12.7%)	Yes/22 (9.0%)	Yes/24 (9.9%)	Yes/27 (11.1%)
Gauge 8	Yes/37 (15.2%)	Yes/51 (20.9%)	Yes/49 (20.1%)	Yes/40 (16.4%)	Yes/22 (9.0%)	Yes/61 (25.1%)	Yes/26 (10.7%)
Gauge 9*						Yes/61 (25.1%)	Yes/28 (11.5%)
Gauge 10*						Yes/61 (25.1%)	Yes/28 (11.5%)
