Fletcher Stream and Wetland Mitigation Site

Annual Monitoring Report

Monitoring Year 2 of 7

Henderson County, North Carolina

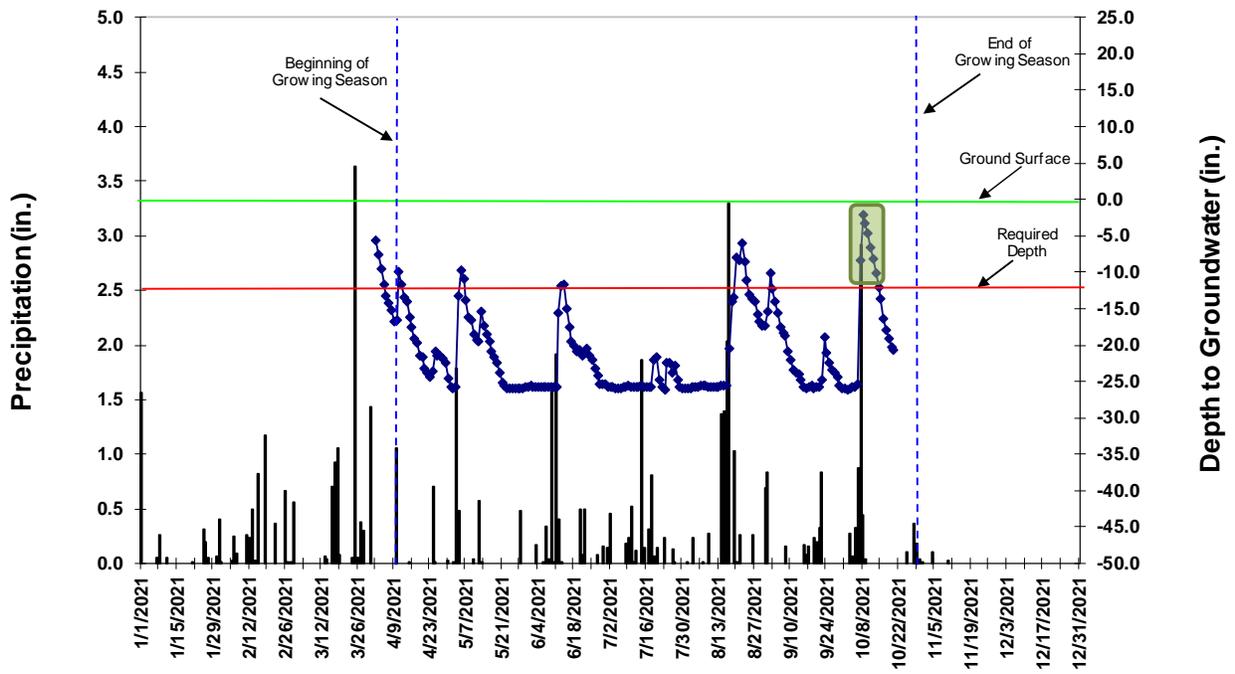
Gauge ID: **MW3**

Total Number of Consecutive Days Water Table within 12 inches of Soil Surface:

Percentage of Growing Season Water Table within 12 inches of Soil Surface:

7%

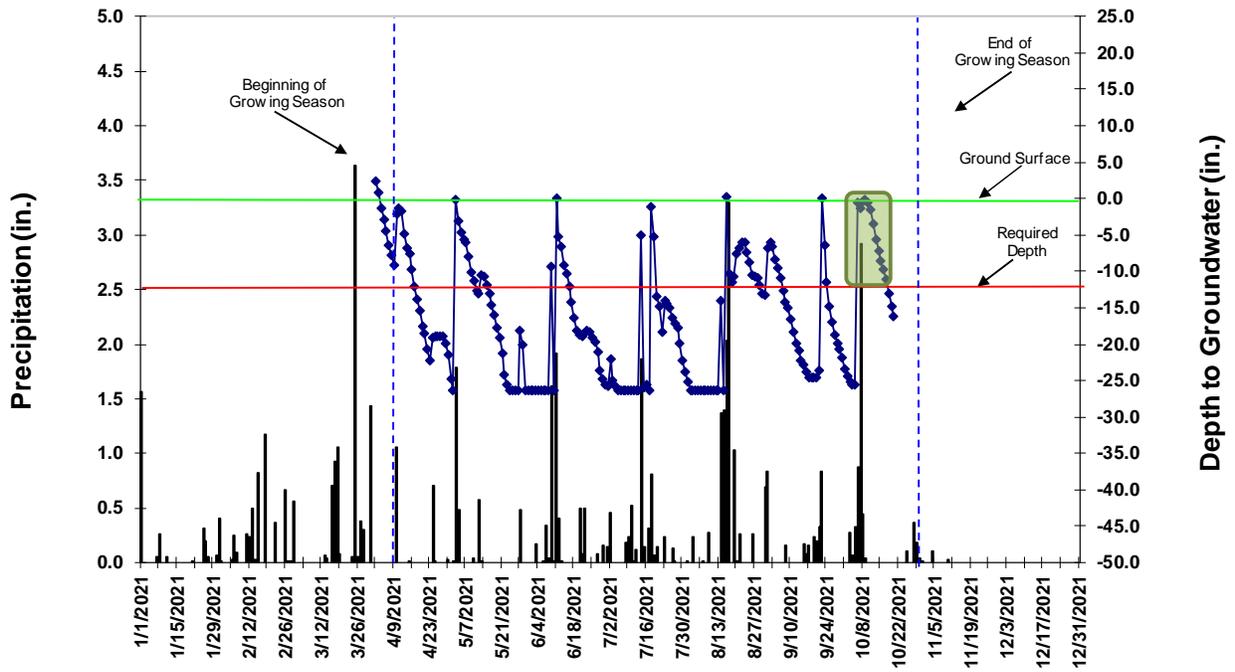
Gauge ID: **MW4**
 Total Number of Consecutive Days Water Table within 12 inches of Soil Surface: **10**
 Percentage of Growing Season Water Table within 12 inches of Soil Surface: **5%**

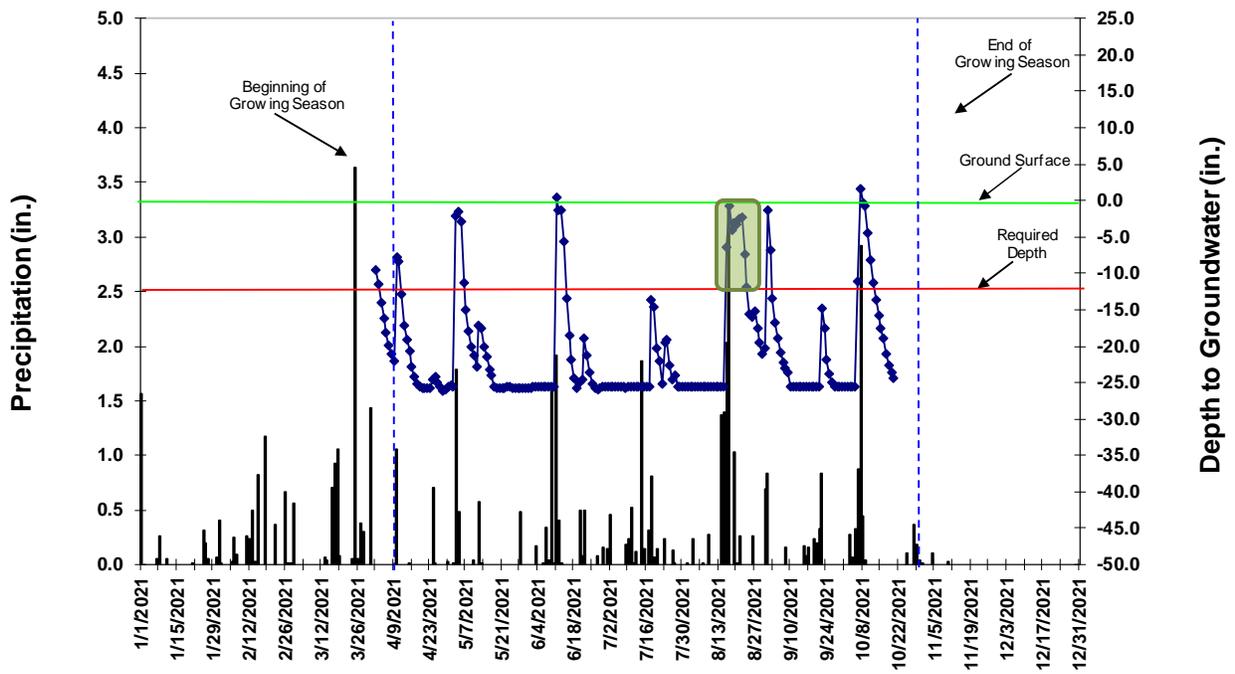
- The figure for MW7 highlights an area where the water level drops below the required depth. **Replaced with corrected highlight.**
- Please submit a feature characterizing the treated invasive areas. **Included in the MY2 database.**
- Please include the crest gauge photos in the report. **Crest Gauges were depicted in the photos associated with cross-sections 1, 11, 15, and 26 in the report. Individual photos of the four Crest Gauges have been added to the Photopoints section of the report and in the support files.**

Gauge ID: **MW7**
 Total Number of Consecutive Days Water Table within 12 inches of Soil Surface: **9**
 Percentage of Growing Season Water Table within 12 inches of Soil Surface: **4%**

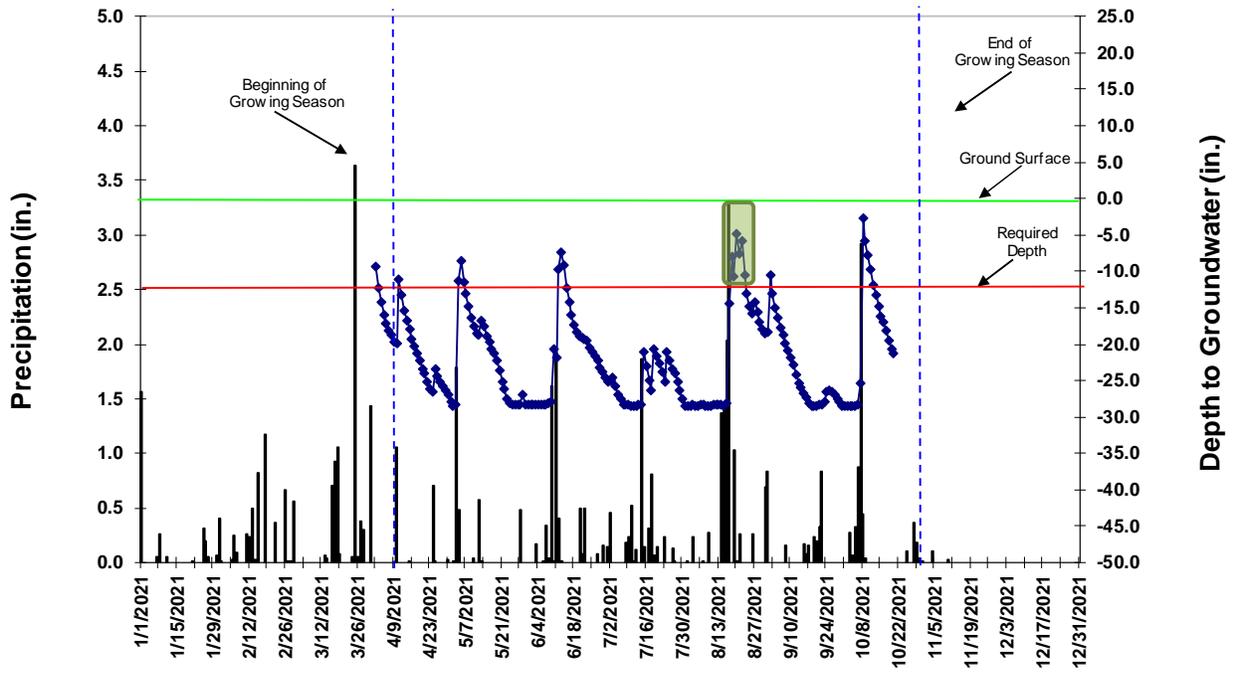
Gauge ID: **MW11**
 Total Number of Consecutive Days Water Table within 12 inches of Soil Surface: **6**
 Percentage of Growing Season Water Table within 12 inches of Soil Surface: **3%**
