**Year One Monitoring Report**

**GROUNDHOG HOLLOW PROJECT**

NCDMS Project #100049 (Contract #7417) | RFP 16-007277 (Issued 6/21/2017)

Alexander County, North Carolina  
Catawba River Basin  
HUC 03050101

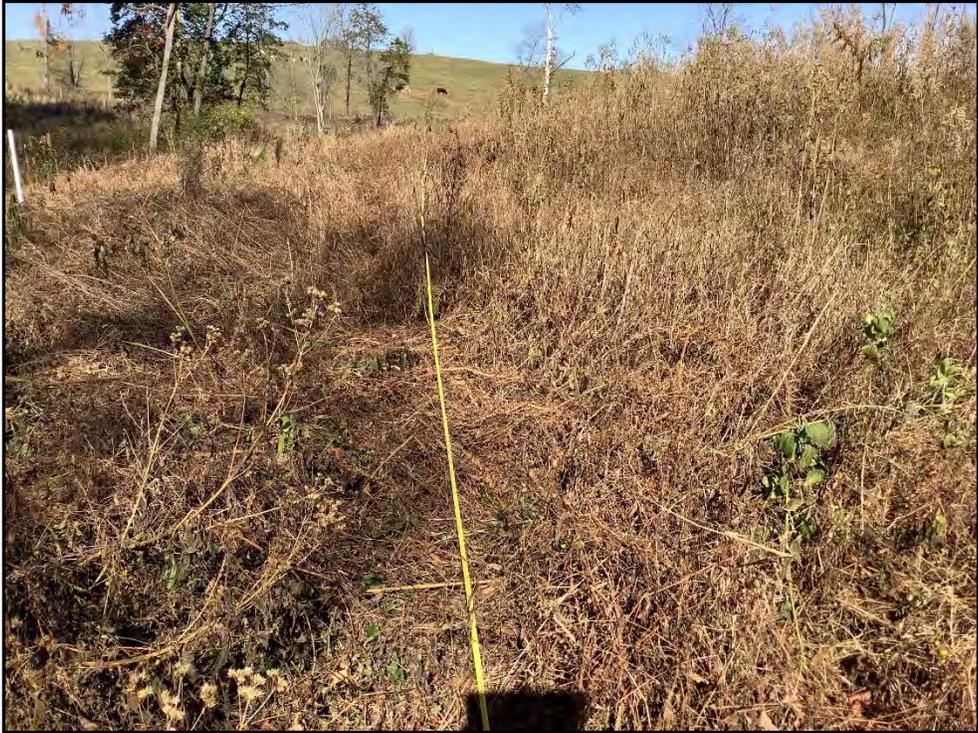
Low Stem Density Area (R1)

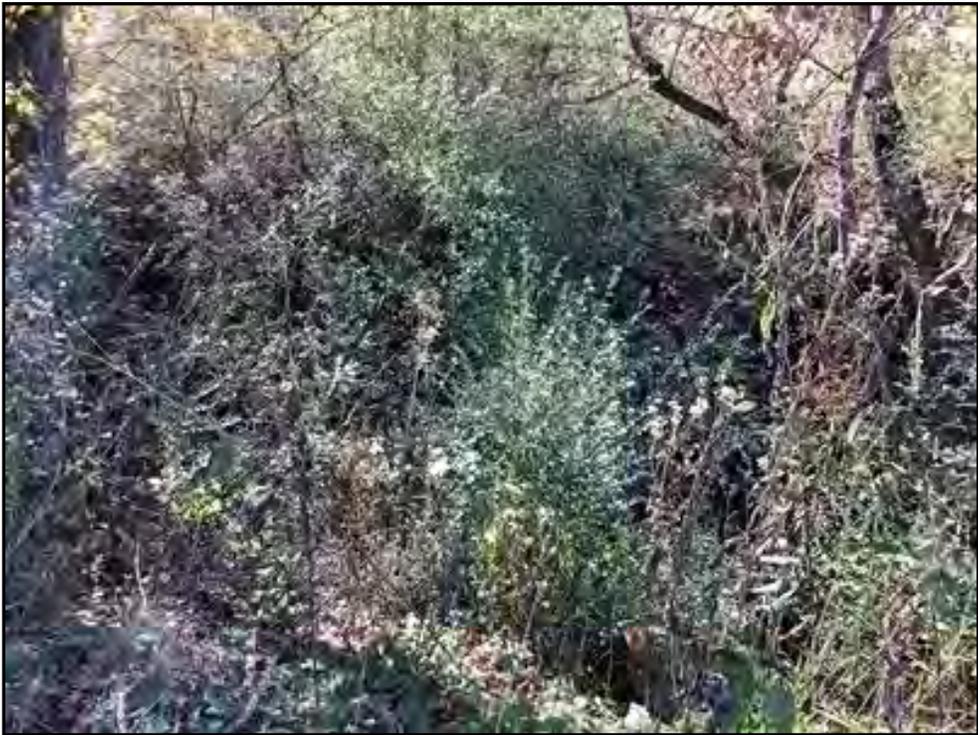
Invasive Species Area – Treated 12/2021 (GF4-B)

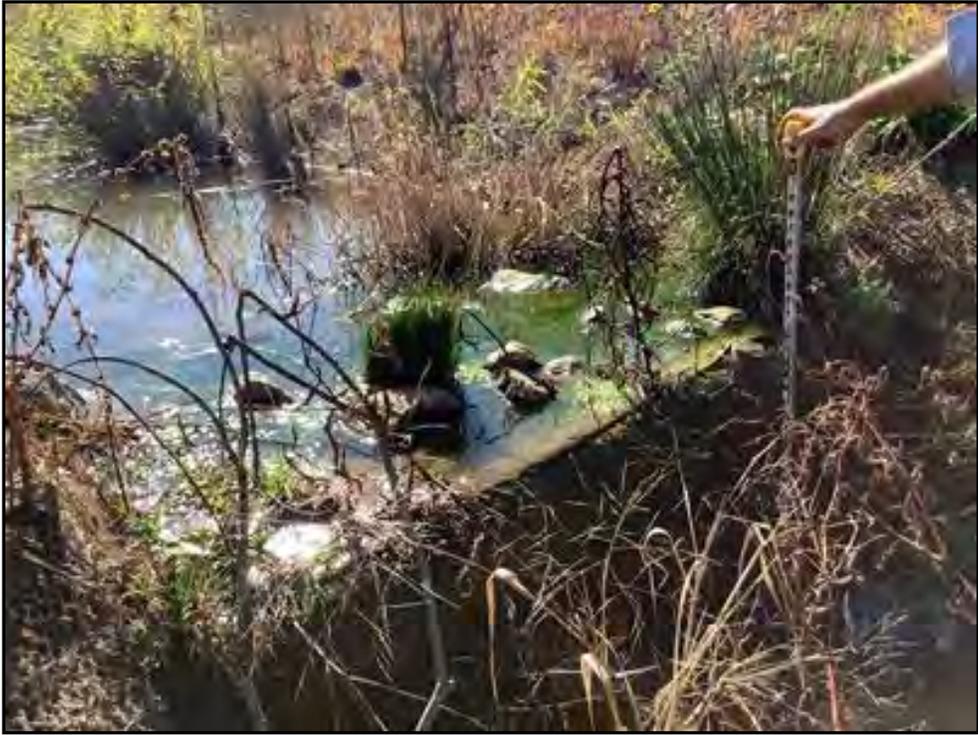
Structure Decline - GF4-A

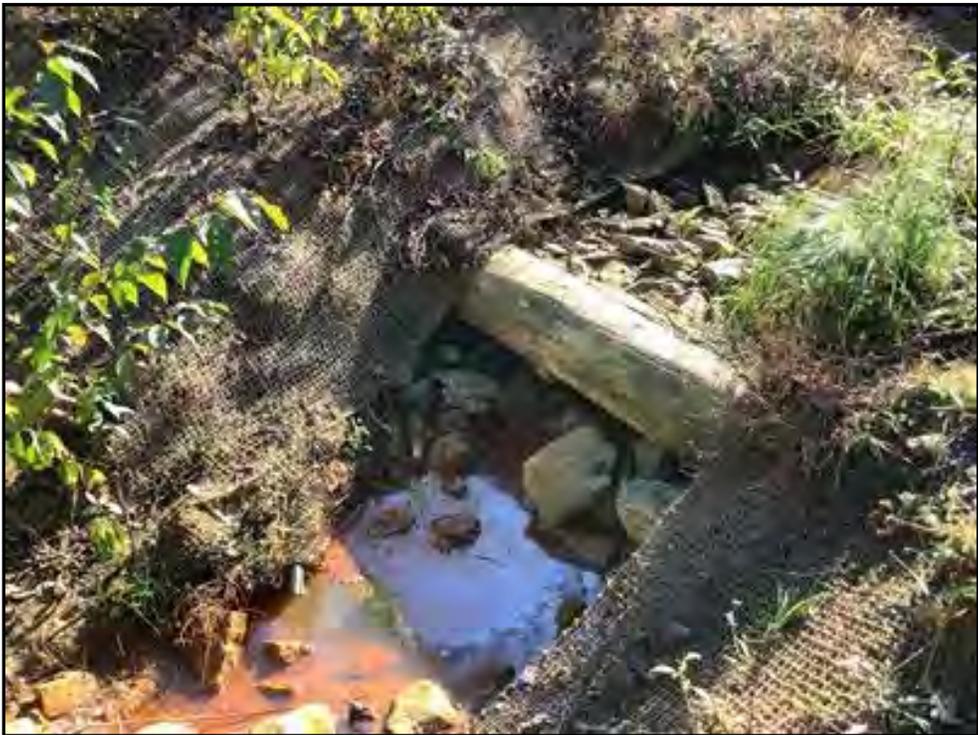
Visual assessment of the stream channel was performed to document signs of instability, such as eroding banks, structural instability, or excessive sedimentation. Two structures are beginning to show wear on GF2-A, where the stream is potentially beginning to add stress to the banks around the log sills. On enhancement reach GF4-A a log sill is beginning to scour out a pool below. These potential problem areas will be monitored and if addressed if they continue to worsen in MY2, but it is anticipated that site vegetation will anchor these structures. Problem areas are cataloged in **Appendix B**. The channel over all is transporting sediment as designed and will continue to be monitored for aggradation and degradation.

Structure Decline - GF2-A

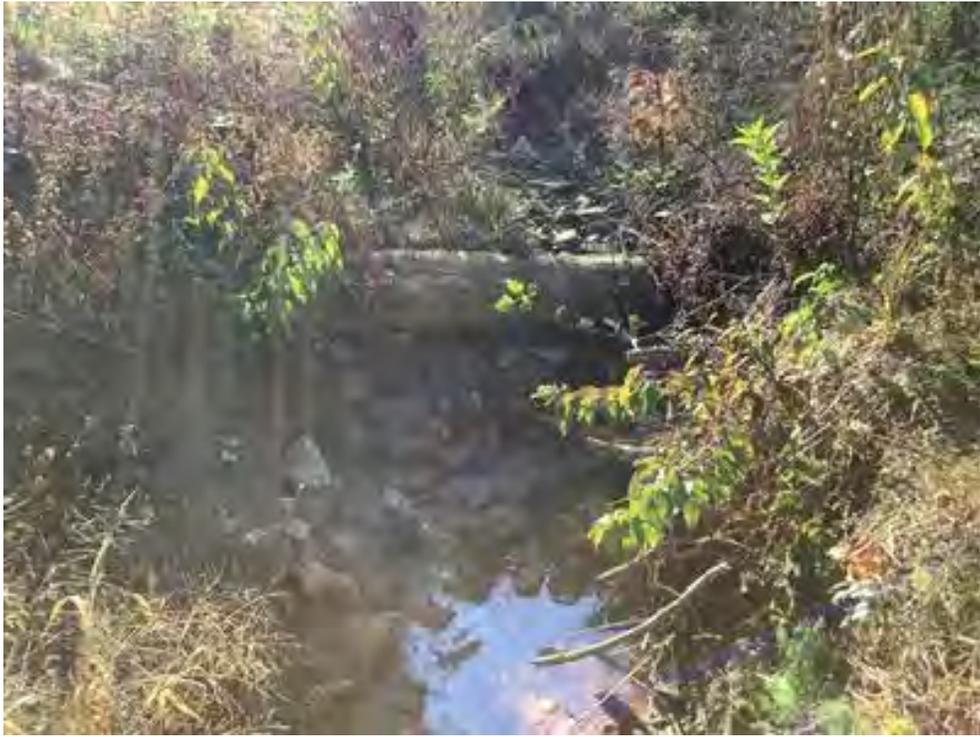
Structure Decline- GF2-A
