Monitoring Report

Harrell Stream and Wetland Mitigation Site

Monitoring Year 2 (2021)

NCDMS Project No. 100005

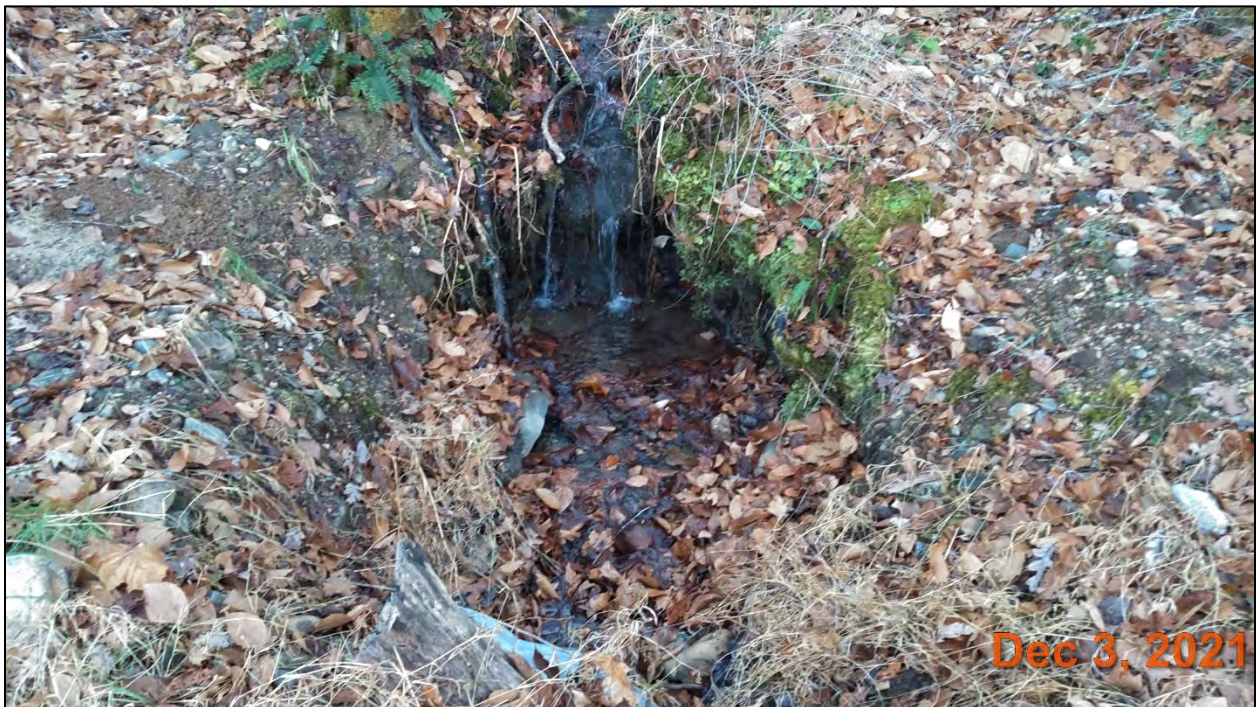
Photo point #1 supplemental: Please review and confirm that the stream feature shown is not a head cut that requires attention/ maintenance. **Reviewed and confirmed. This feature was a pre-existing drop into a culverted crossing and has remained stable. This photo is representative of both the culvert intake at the Reach 1A-B transition and as documentation of the removal of construction debris as discussed during the August 31, 2021 IRT meeting.**

Photo point #1 supplemental, facing stormwater control measure along Reach 1A boundary.

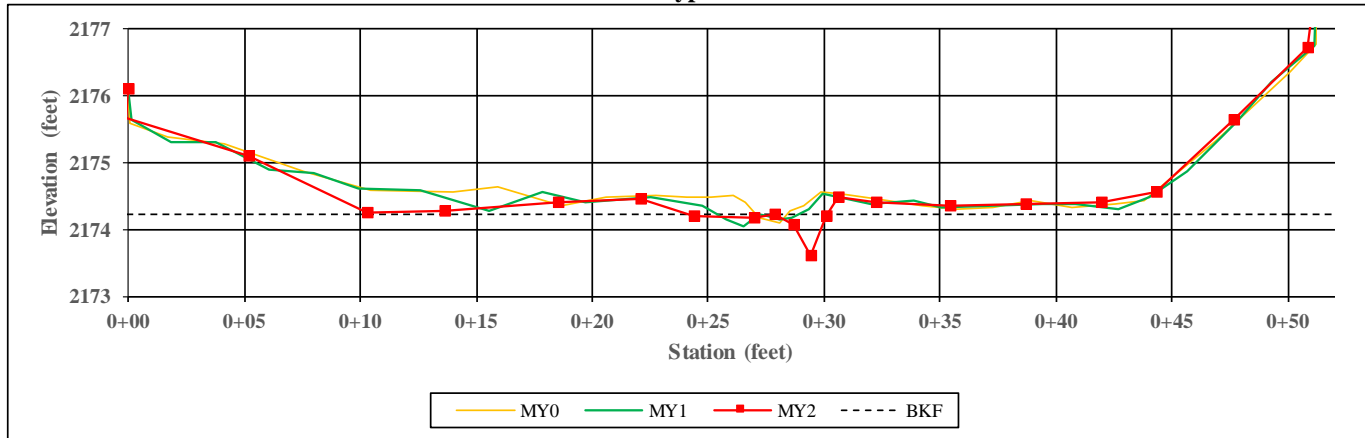
XS Number: 5
XS Type: Riffle

CHANNEL DIMENSIONS SUMMARY	MY0	MY1	MY2	MY3	MY4	MY5	MY6	MY7
Bankfull Width (ft)	2.5	4.4	5.8	-	-	-	-	-
Floodprone Width (ft)	33.4	33.4	33.4	-	-	-	-	-
Bankfull Mean Depth (ft)	0.3	0.2	0.1	-	-	-	-	-
Bankfull Max Depth (ft)	0.4	0.3	0.6	-	-	-	-	-
Bankfull Cross-Sectional Area (ft ²)	0.7	0.7	0.7	-	-	-	-	-
Width/Depth Ratio	8.6	29.6	46.4	-	-	-	-	-
Entrenchment Ratio	13.2	7.5	5.8	-	-	-	-	-
Bank Height Ratio	1.0	1.1	1.4	-	-	-	-	-

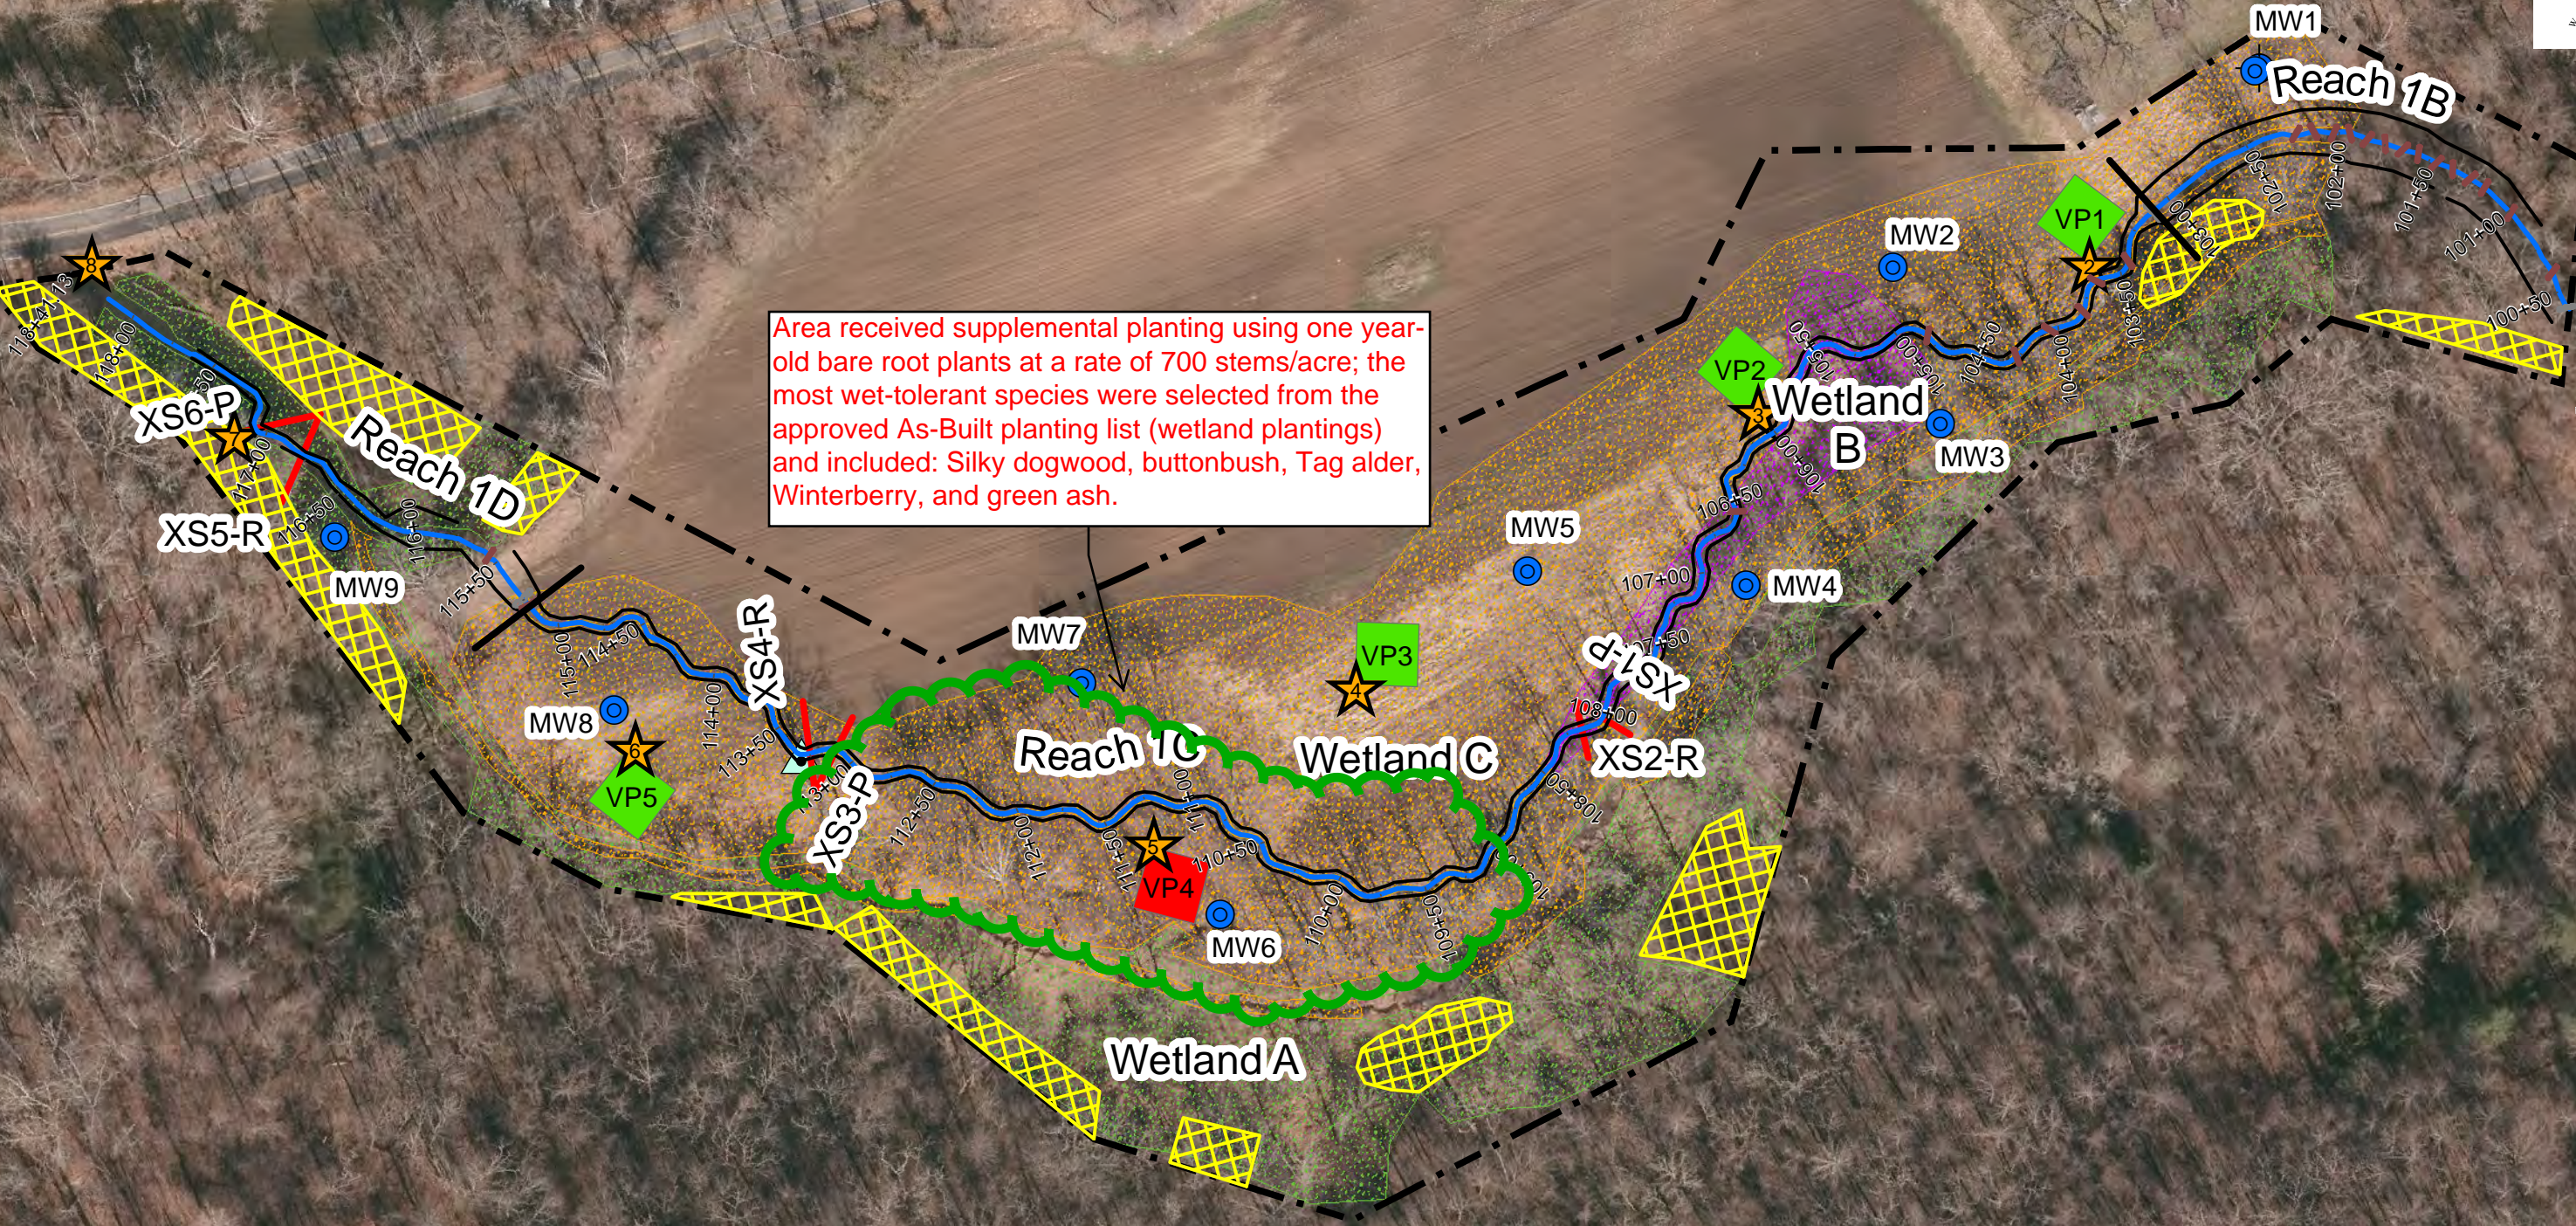
Supplemental Planting
Harrell Mitigation Site
Jackson County, NC
February 2021

Area received supplemental planting using one year-old bare root plants at a rate of 700 stems/acre; the most wet-tolerant species were selected from the approved As-Built planting list (wetland plantings) and included: Silky dogwood, buttonbush, Tag alder, Winterberry, and green ash.
