**Year 1 Monitoring Report**

**LITTLE SEBASTIAN SITE**

NCDMS Project # 100027 (Contract # 7187) | RFP 16-006993 (Issued 9/16/2016)  
USACE Action ID: SAW-2017-01507 | DWR Project # 2017-1041

**February 2022**

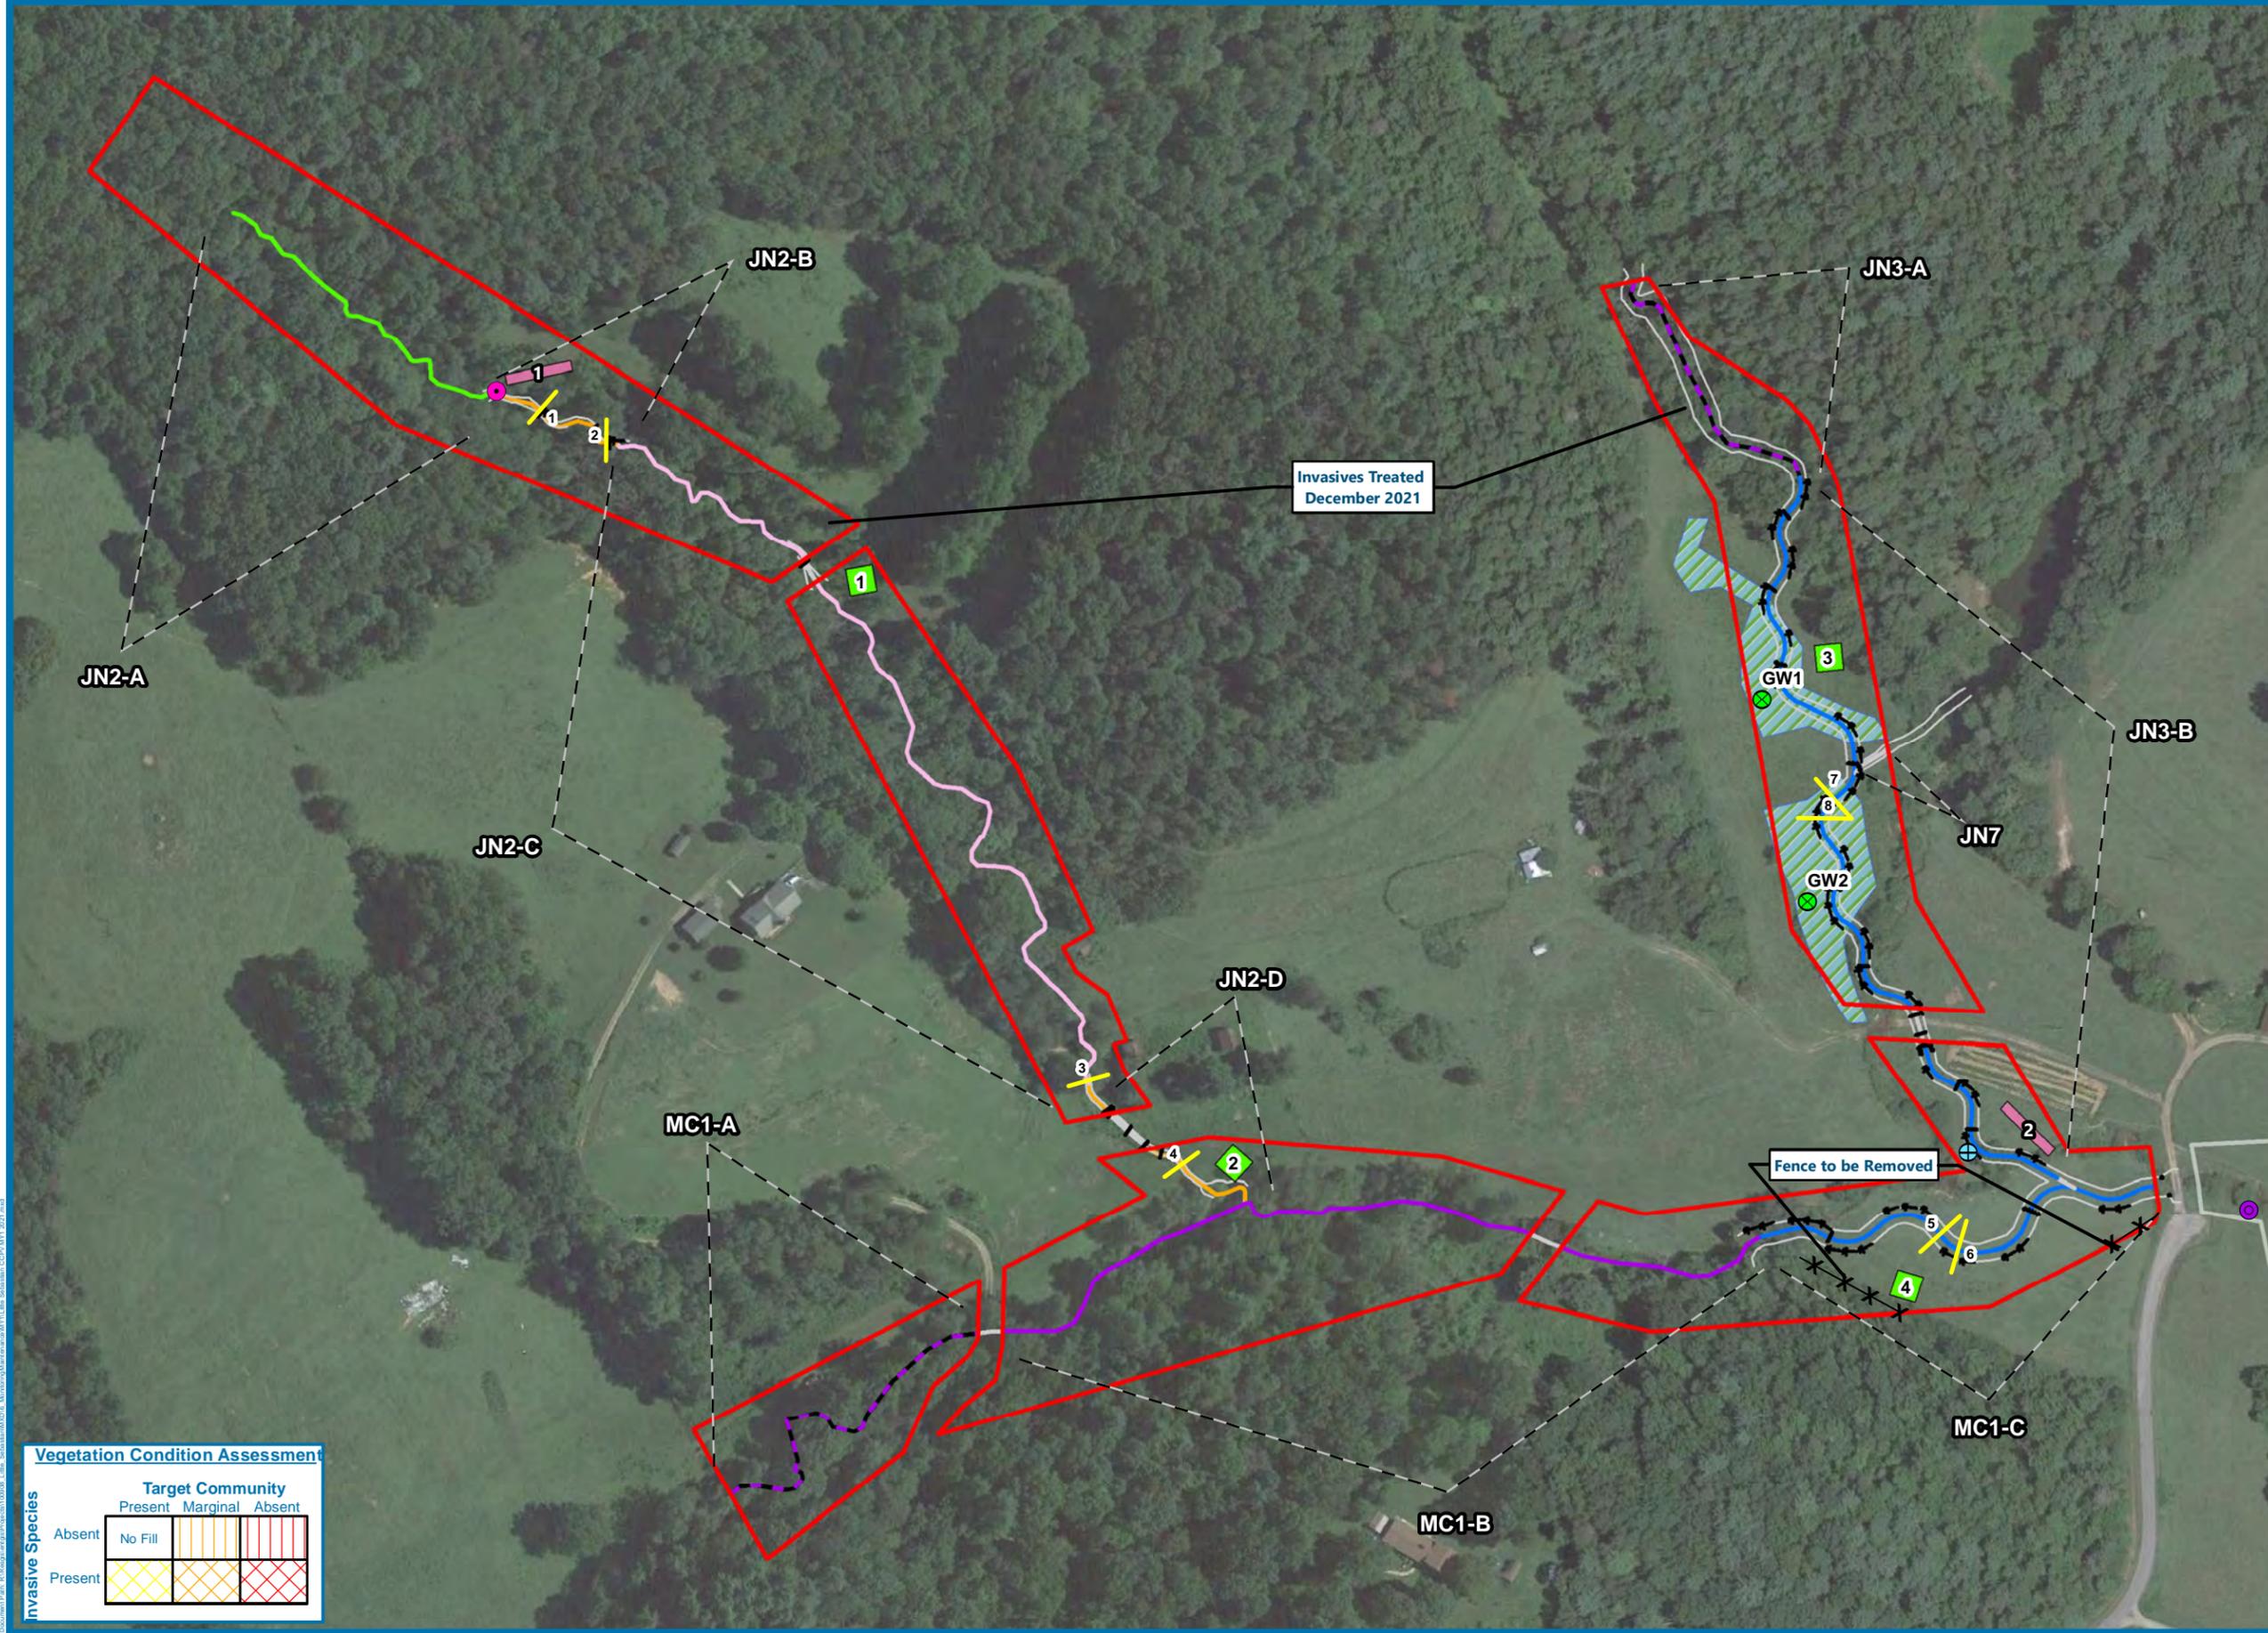
Current Conditions  
Plan View

Two areas of pre-existing fencing, adjacent to reach MC1, will be removed from the conservation easement in early 2022. Approximate fence locations can be found in **Figure 2, Appendix B**.

[These areas of fencing will be relocated in early 2022. Photo documentation and a call-out on the CCPV will be provided with the 2022 MY2 report. A note has been added to Section 1.7: Monitoring Performance in the MY1 report, regarding plans to remove the fencing from within the conservation easement.](#)
