## MY1 Monitoring Report

Owen Farms Mitigation Site  
Transylvania County, NC

NCDMS Project No. 100064  
NCDMS Contract No. 7532  
NCDMS RFP No. 16-007334  
(Issued 9/8/2017)

Data Collected: 2021

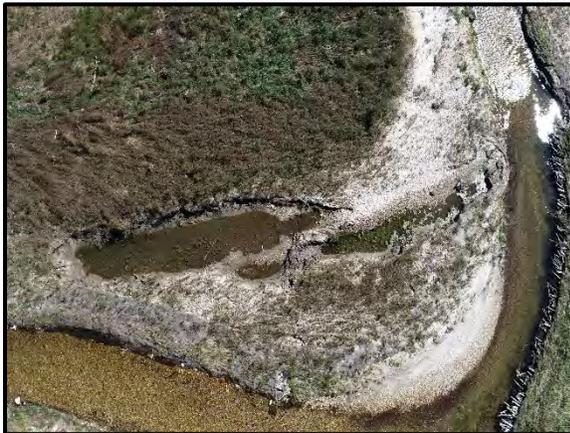
**3.27 Aerial overview of damage along left bank of West Fork French Broad River, 9/28/2021**

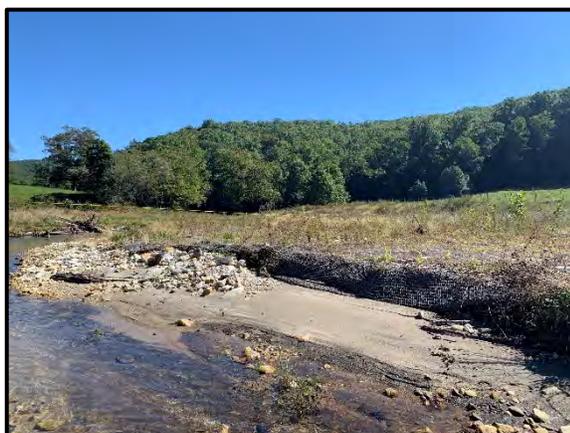
**3.29 Storm damage to right bank of West Fork French Broad River above XS 4, 9/27/2021**

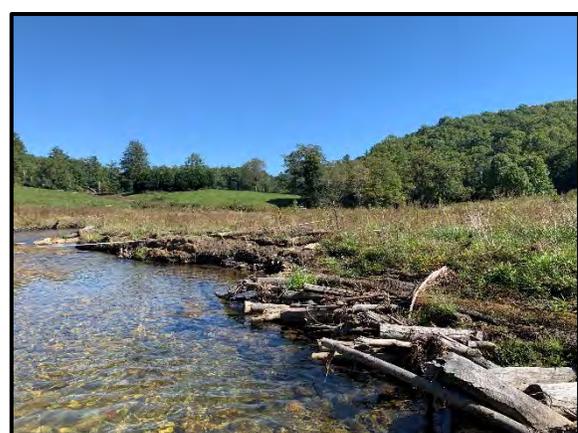
**3.30 Storm damage to right bank of West Fork French Broad River at above XS3, 9/27/2021**

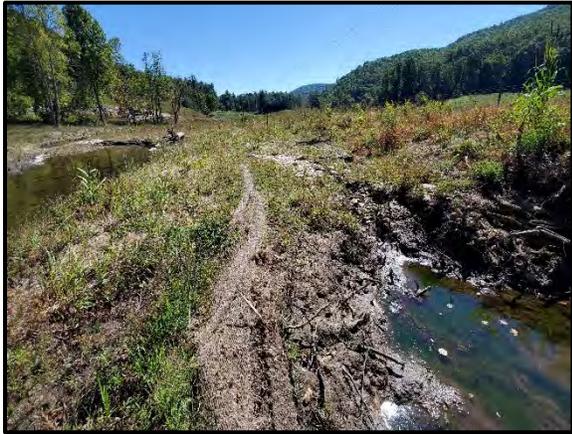
**3.31 Scour hole at Station 10+00,  
9/27/2021**

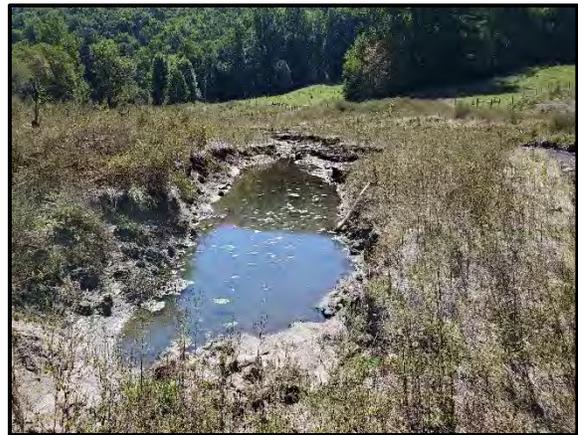
**3.34 Severe floodplain erosion  
between Station 16+25 and 18+10,  
9/27/201**

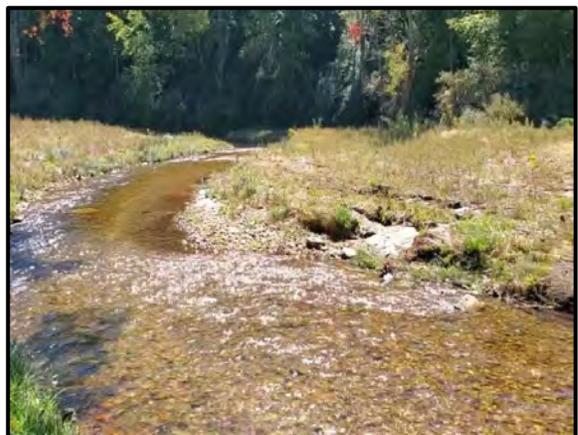
**3.36 Toe scour at station 24+30,  
9/21/2021**

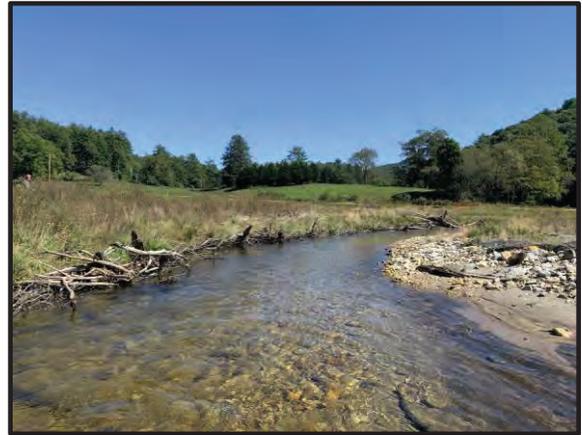
**4.3 West Fork French Broad  
Cross Section 3, 9/27/2021**

The large majority of cross section geometry along WFFBR has remained consistent with the As-Built condition with the exception of Cross Section 3. During the storm event of August 2021, overbank flows eroded a large scour hole in the left floodplain bench of WFFBR starting at STA 16+25 and continued through left bank at STA 18+63. The failed bank at STA 18+63 allowed storm flow to bypass the upstream meander and direct perpendicular flow into the right bank of WFFBR through Cross Section 3. Approximately 35 feet of the right bank experienced bank failure due to the storm event (STA 18+55-18+90). Evidence of this can be seen in Figure 5.3 and Figure 4.3.

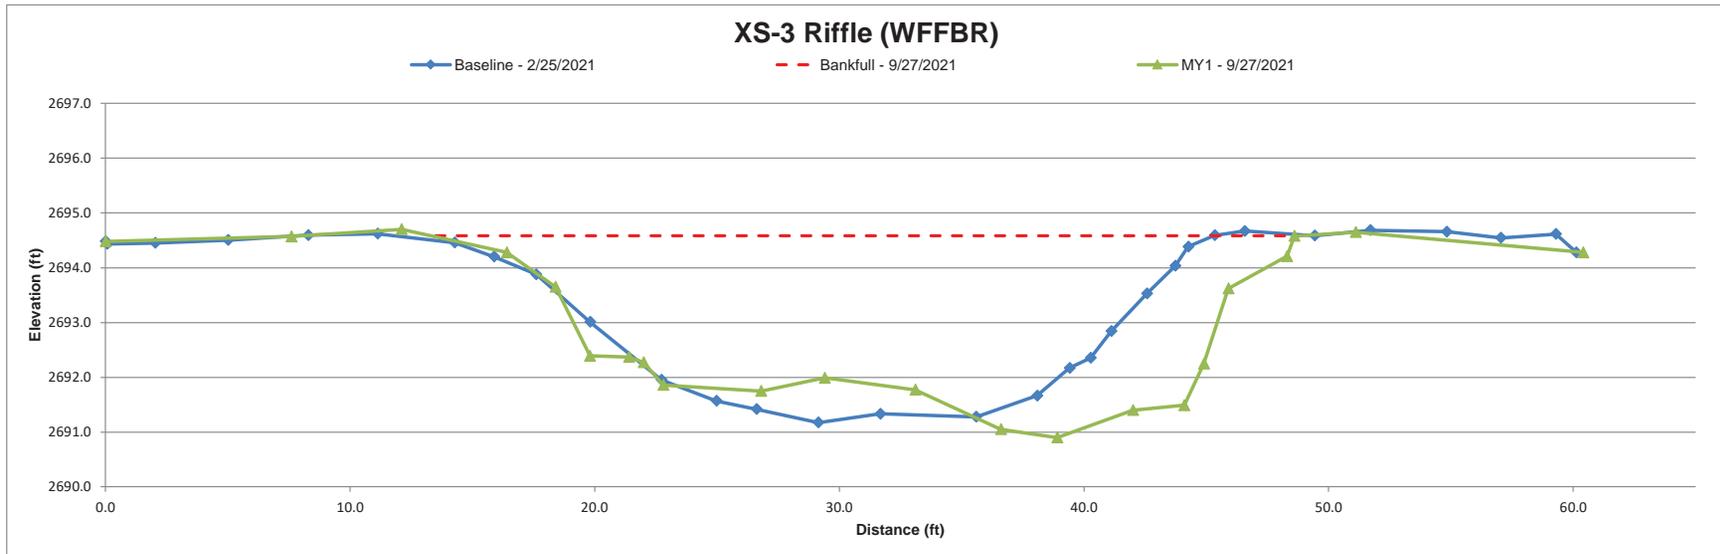
River Basin	French Broad
Watershed	06010105010020
XS ID	XS 3 (WFFBR)
Drainage Area (Acres)	3,795
Date	9/27/2021
Field Crew	CLS, RVS

Dimensions	Cross Section 3 (Riffle)					
	Base	MY1	MY2	MY3	MY4	MY5
Bankfull Elevation (ft) - Based on As Built-Bankfull Area	2694.46	2694.11				
Bank Height Ratio	1.00	1.15				
Thalweg Elevation	2691.17	2690.90				
Low Top Of Bank Elevation	2694.46	2694.58				
Low Top of Bank Max Depth (ft)	3.29	3.68				
Low Top Of Bank Cross Sectional Area (ft <sup>2</sup> )	65.45	80.97

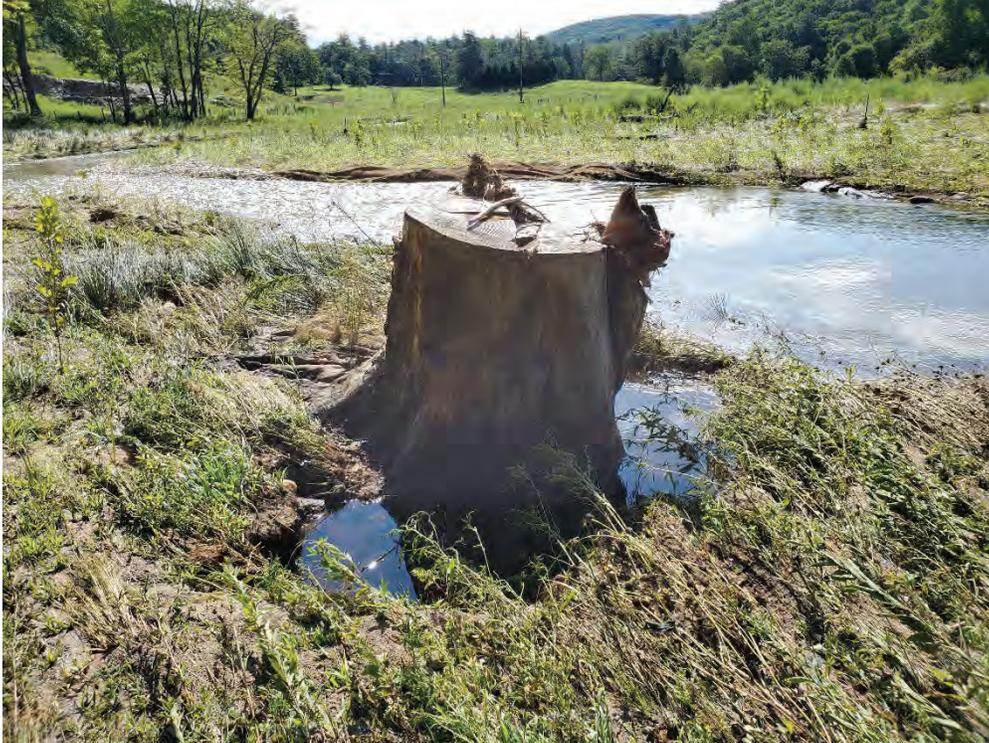
Looking downstream at stump to be removed on left bank near Station 10+75.

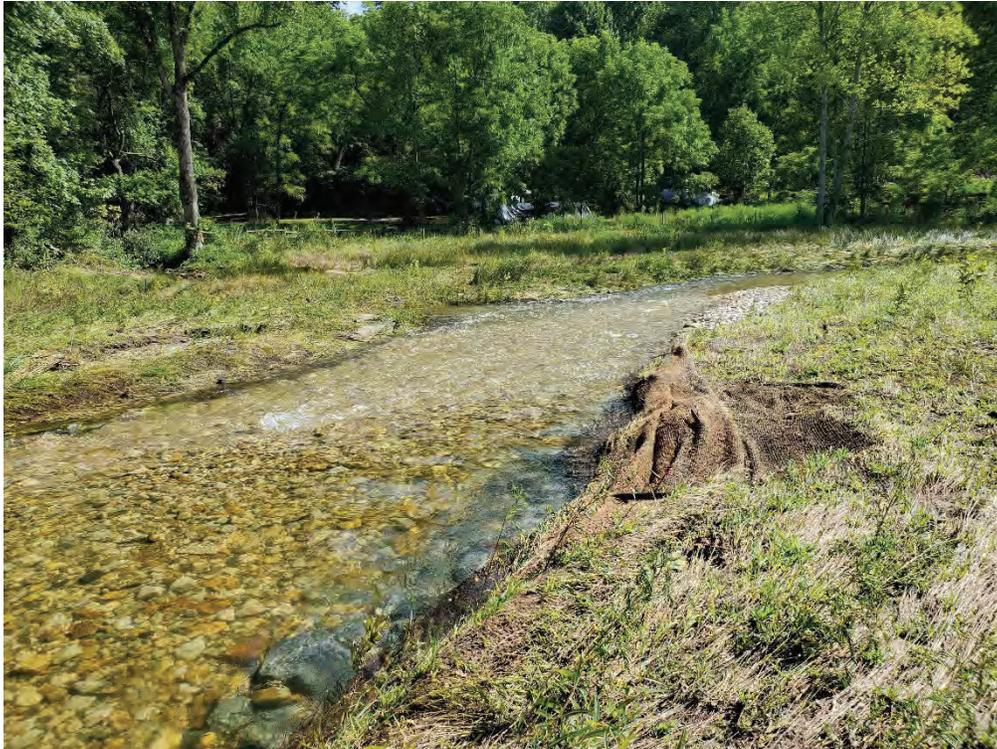
Looking downstream at eroded right bank near station 11+00.

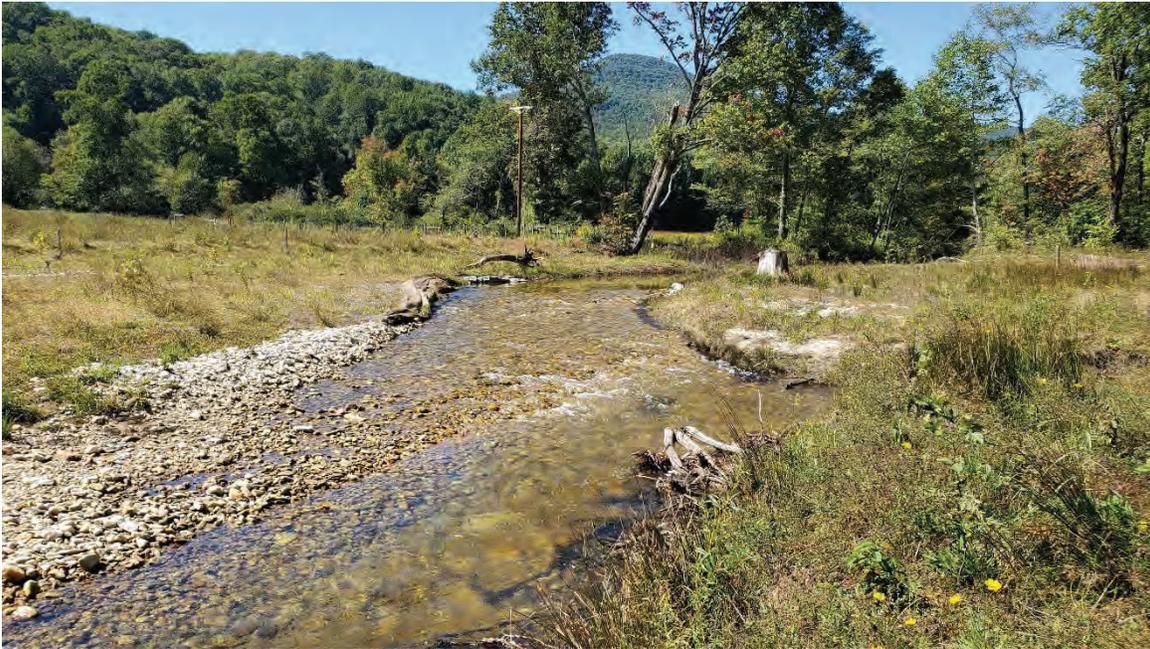
Looking upstream at excess material deposited in channel, creating transverse bar near Station 11+25.

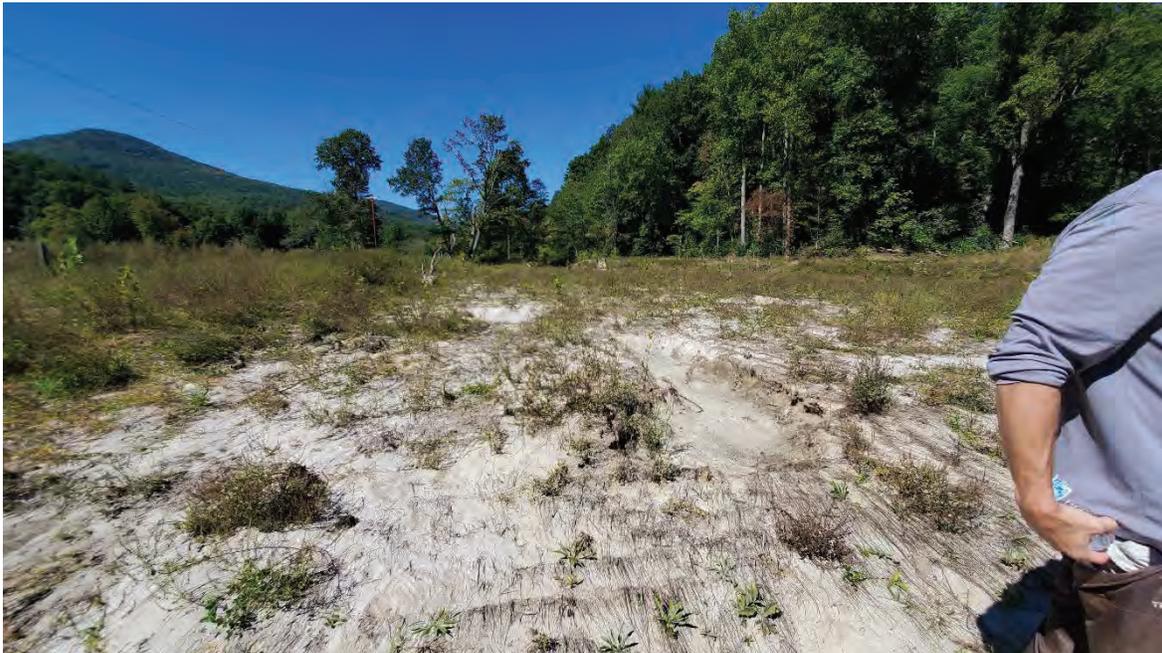
Looking upstream at scour in the right floodplain near Station 13+00.

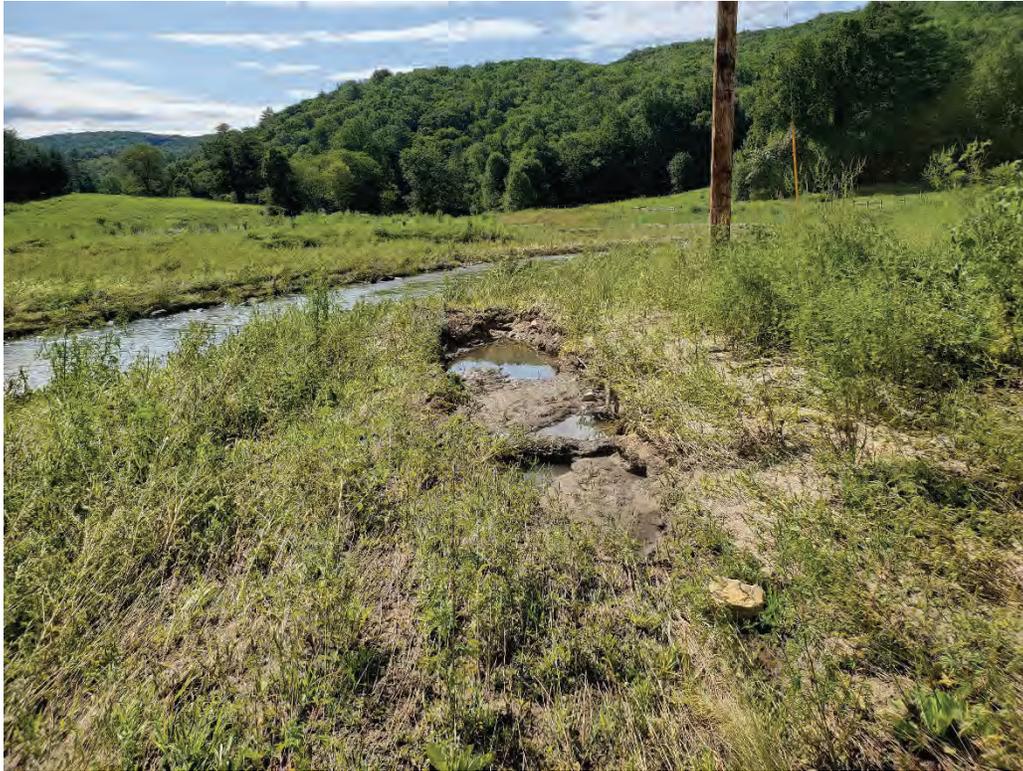
Looking downstream at scour hole in right floodplain near Station 15+50.

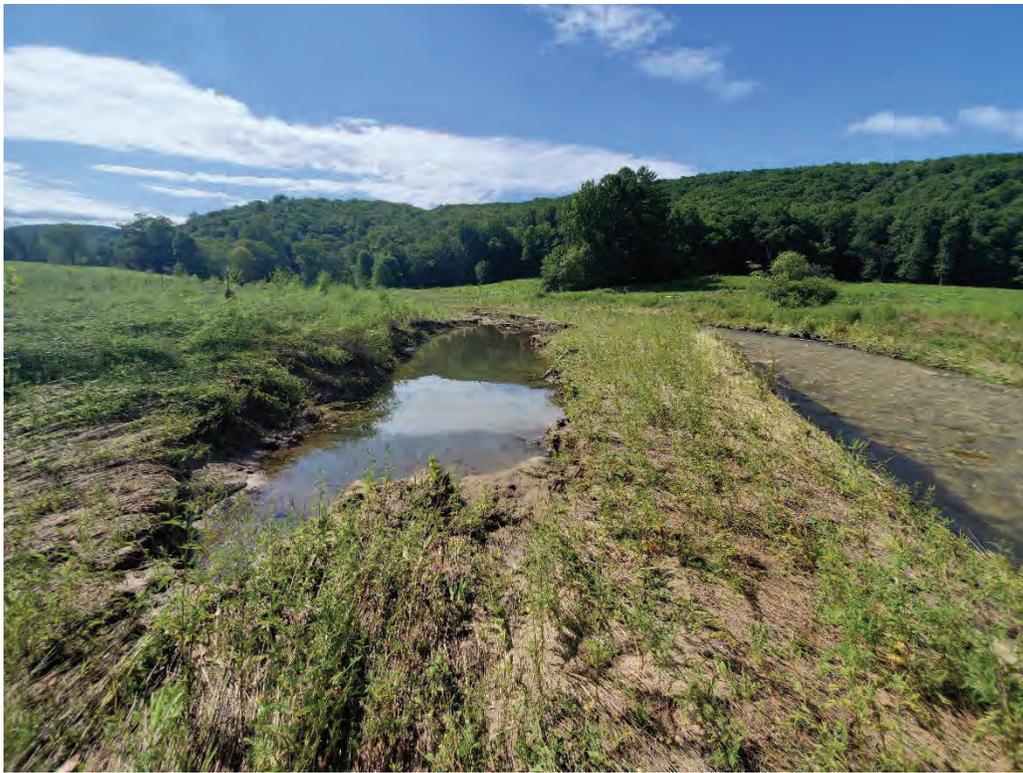
Looking downstream at scour in left floodplain near station 17+50.

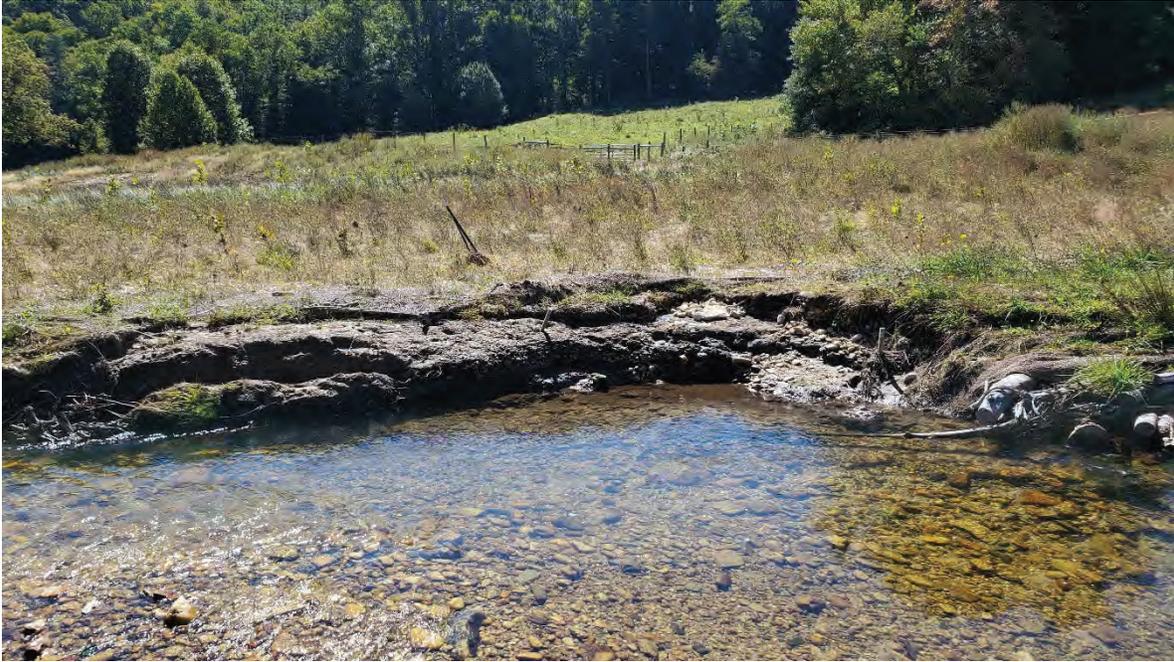
Looking at eroded right bank near station 18+75.

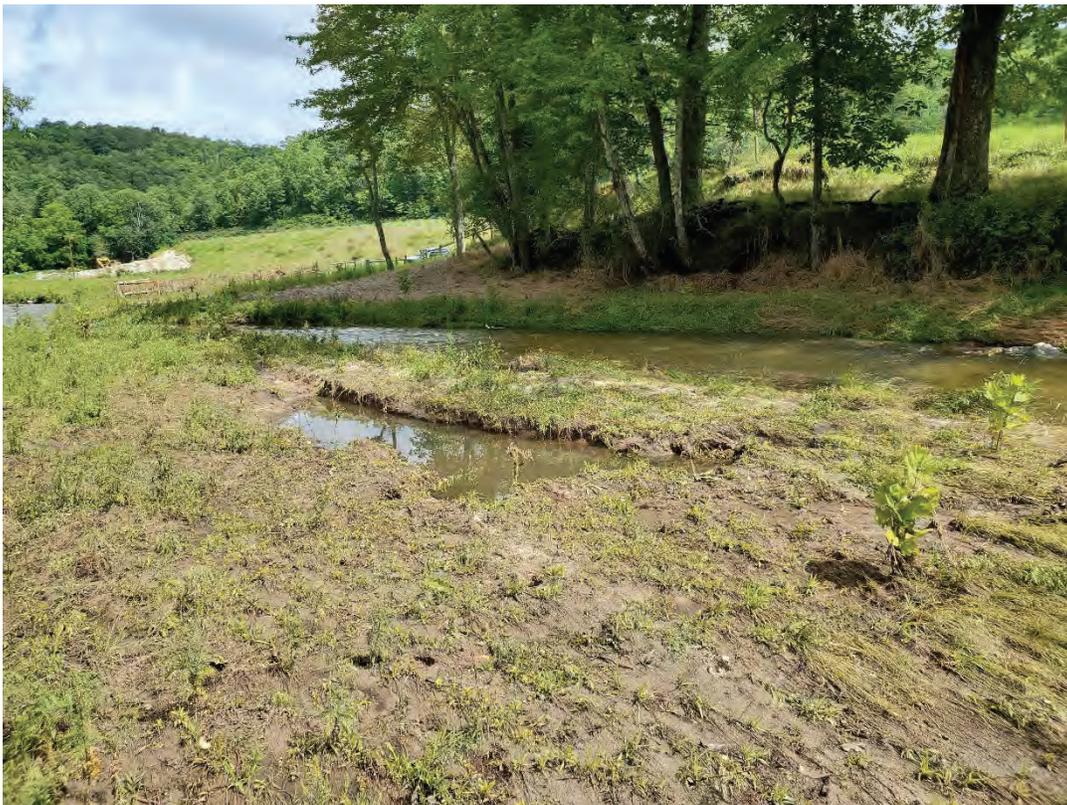
Looking upstream at scour in the right floodplain near station 25+75.

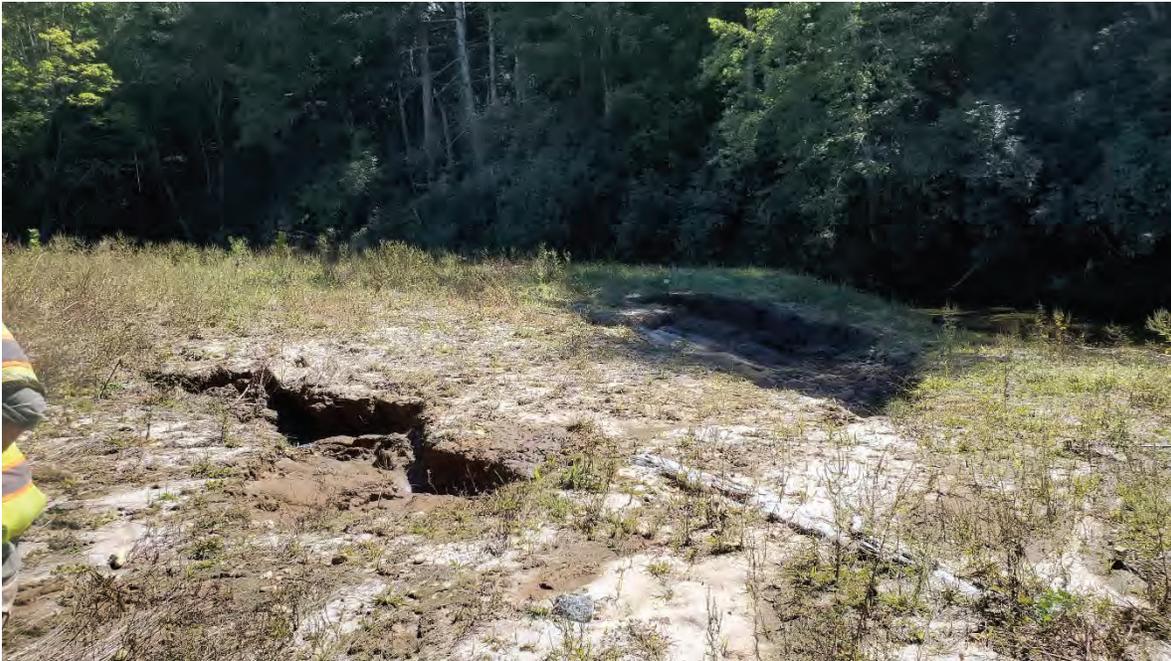
Looking downstream at scour in the left floodplain near station 28+50
