# **FINAL-MY1 Monitoring Report**

## **Seniard Creek Mitigation Site**

**NCDMS Project No. 100017**

Data Collected: April-November 2021

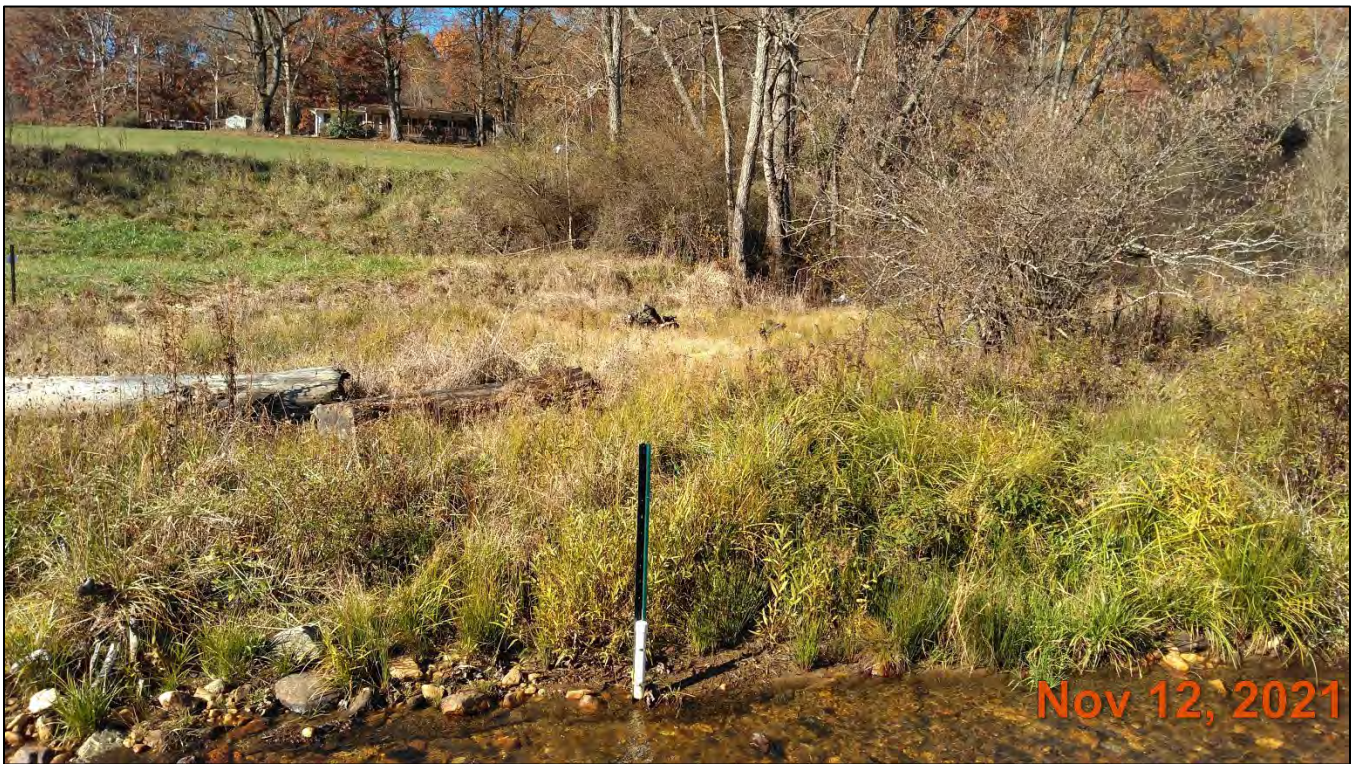
Photo Point 2.1 Seniard Creek Reach 1 Stage Recorder and Pre-existing Wetland.

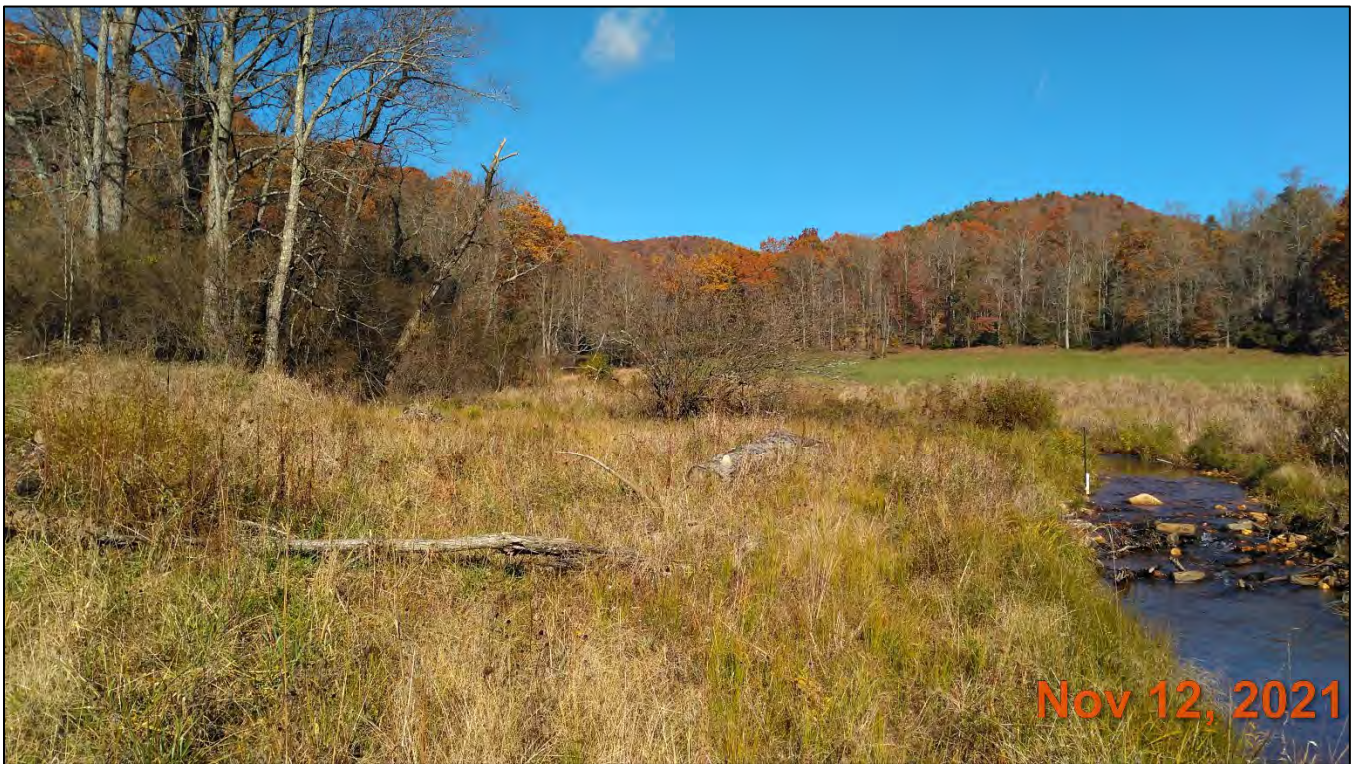
Photo Point 3. Facing upstream showing Stream Gage #1.

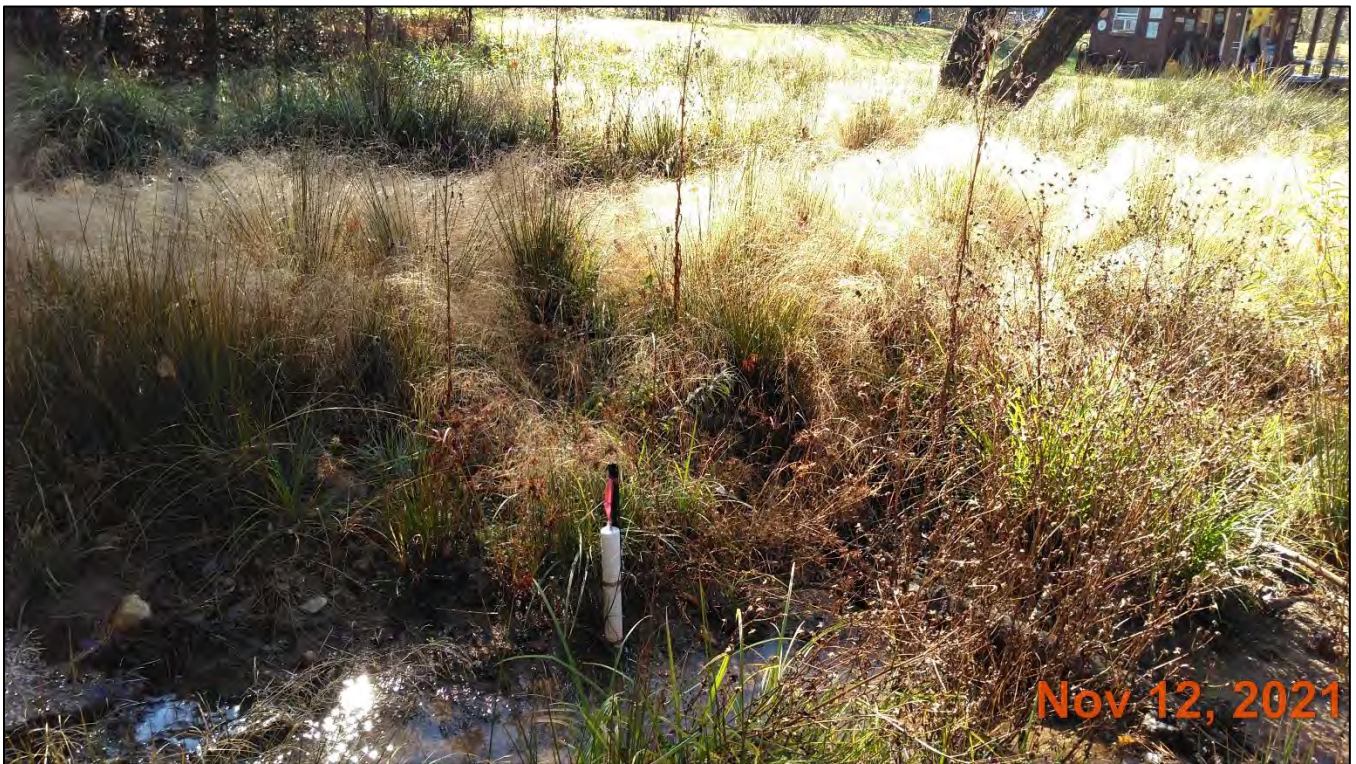
Photo Point 7.2 Stage Recorder Lee Branch.

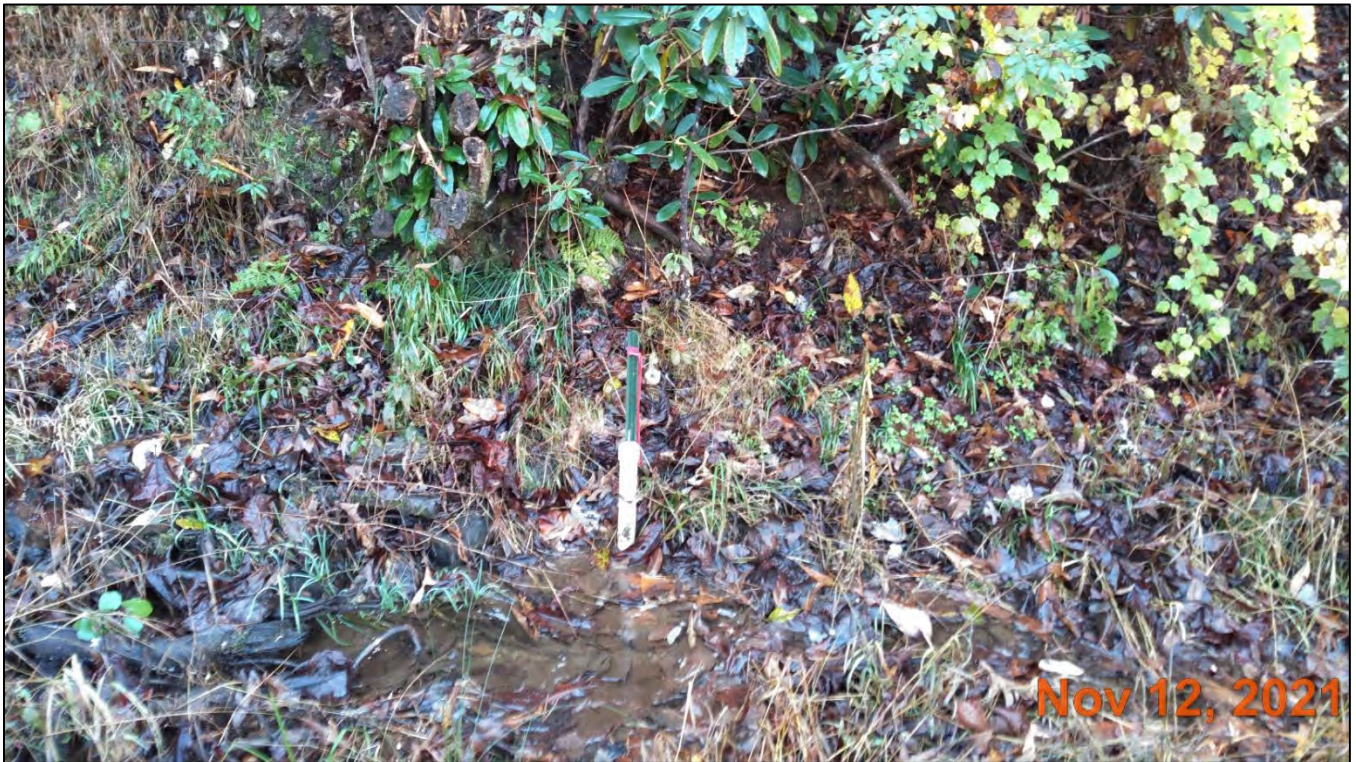
Photo Point 9.1 David Branch 1B Stage Recorder.

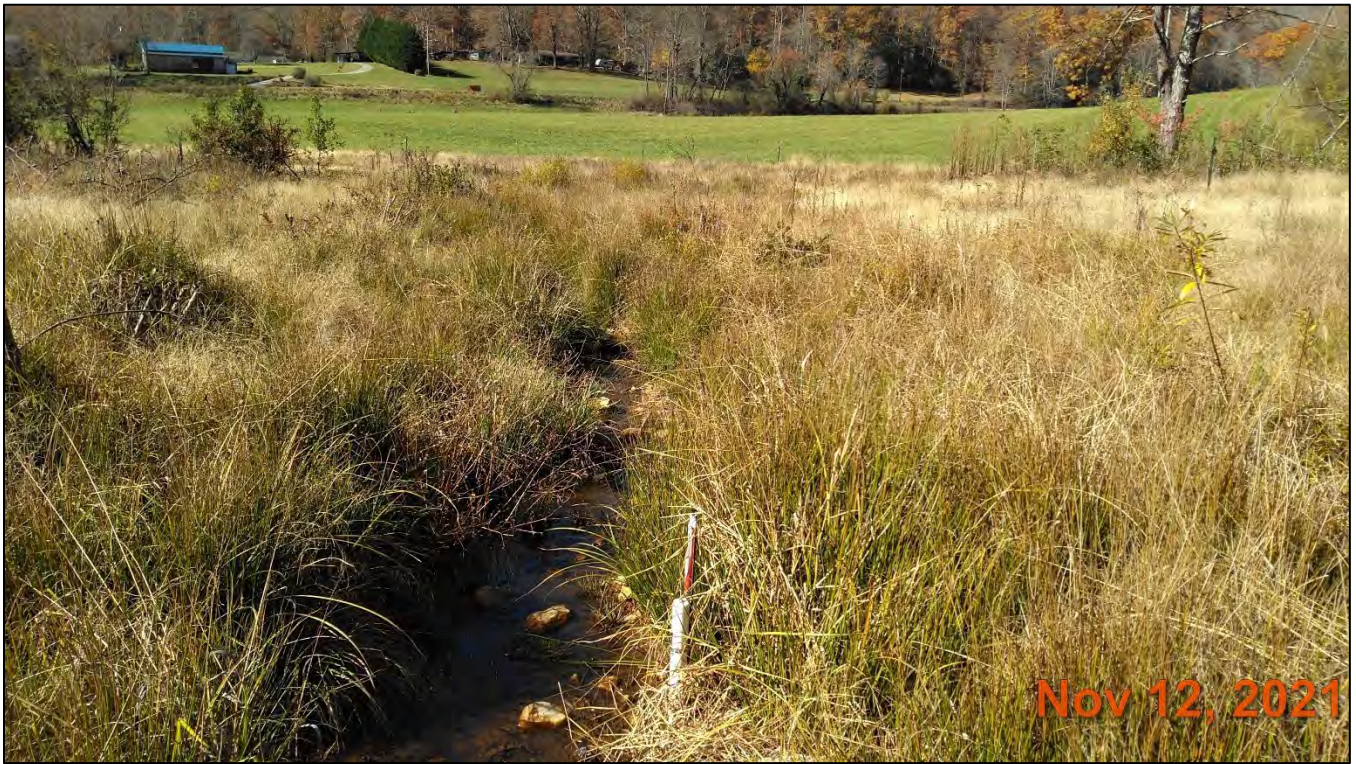
Photo Point 9.4 Facing downstream, David Branch 1C Stage Recorder.
