Monitoring Report MY03

**Stony Fork Restoration Site
Upper Neuse River Basin - 03020201
Monitoring Year 03
DMS Contract 6830**

**DMS Project Number 97085
DWR #: 2016-0372
USACE Action ID: 2016-00875
Johnston County, North Carolina**

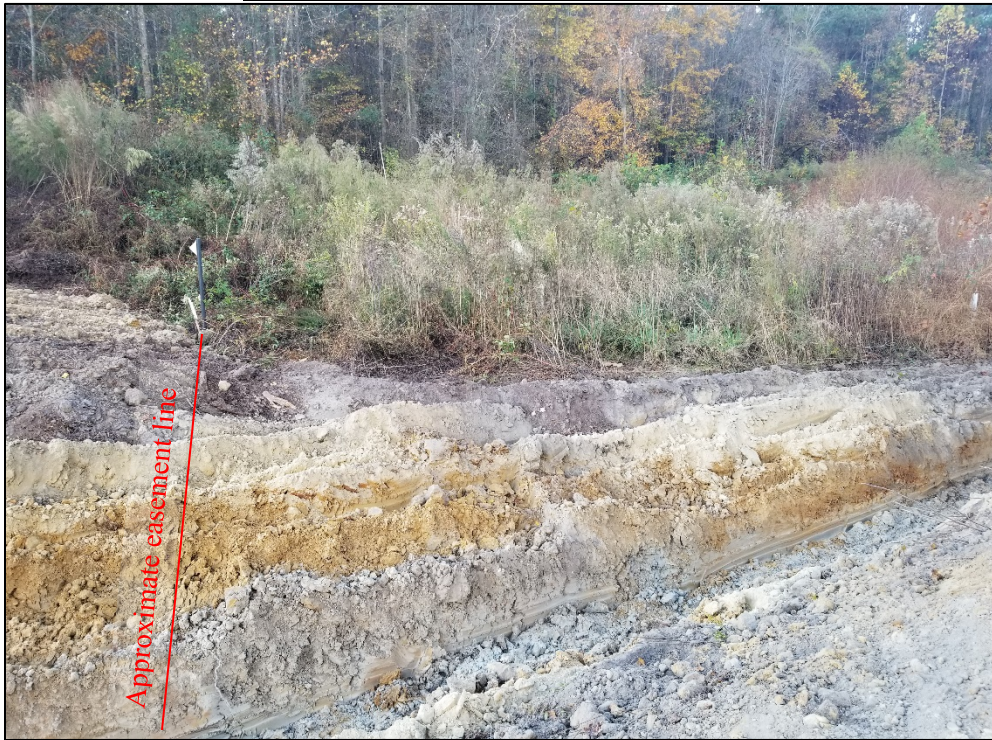
During MY02, ATV tracks were discovered traveling through a small portion of the easement. These tracks appeared to originate from the neighborhood adjacent to the project. A formal notice of violation was issued and the issue was discussed with the landowner of the site. Fresh tracks were noted in the first half of 2021 but since June 10, 2021, no new tracks have been seen and the area has revegetated to the point that no evidence of this encroachment remains.

Photo 1 – View of encroachment looking along the easement line

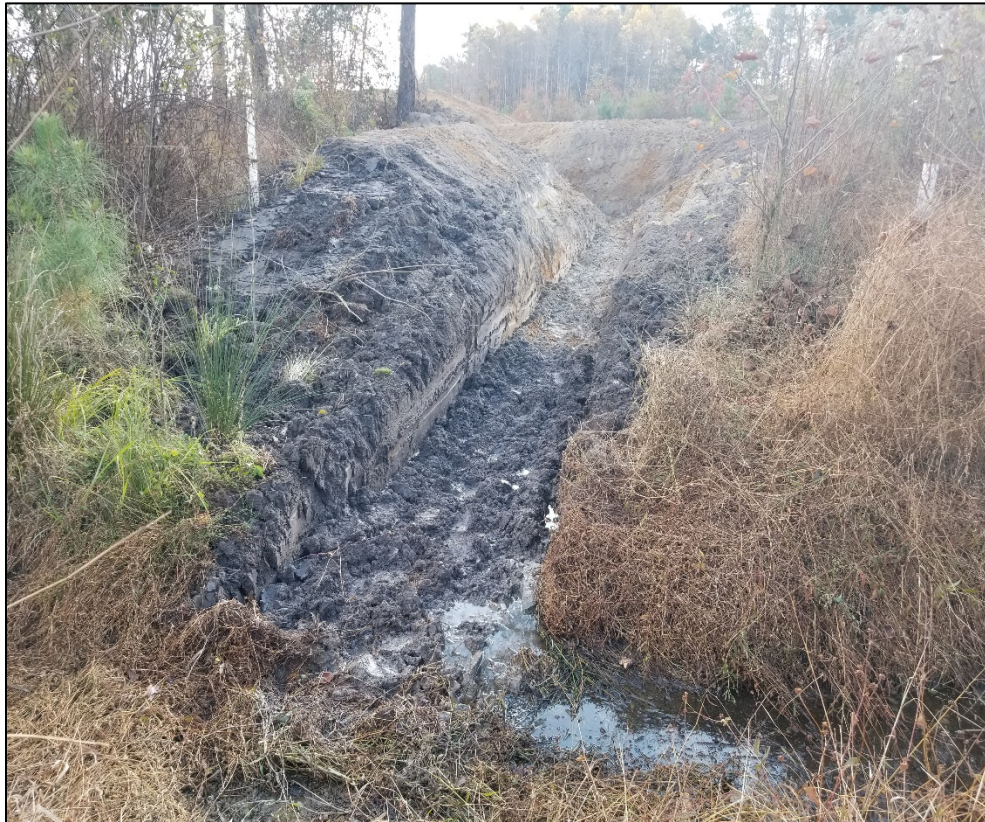
Photo 2 – View of encroachment from left bank of project stream

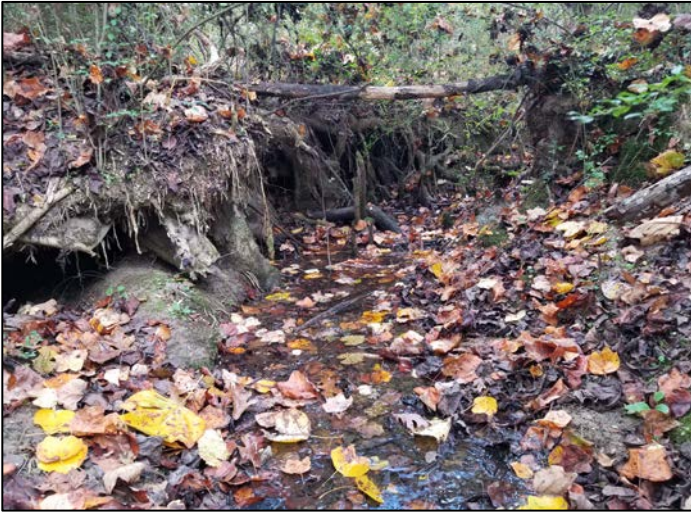
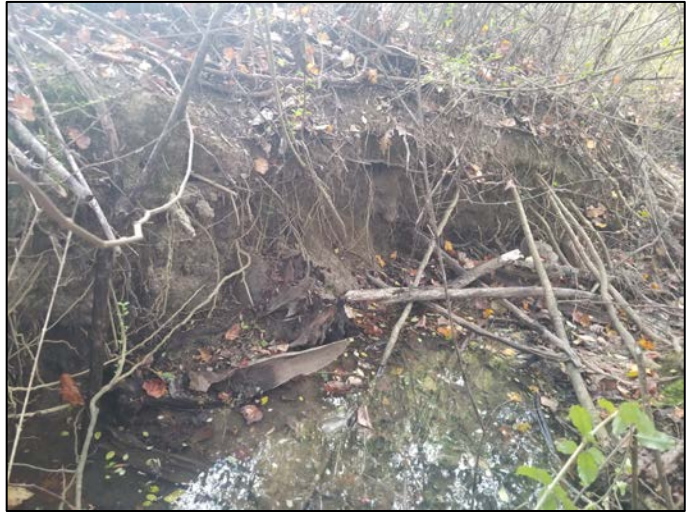
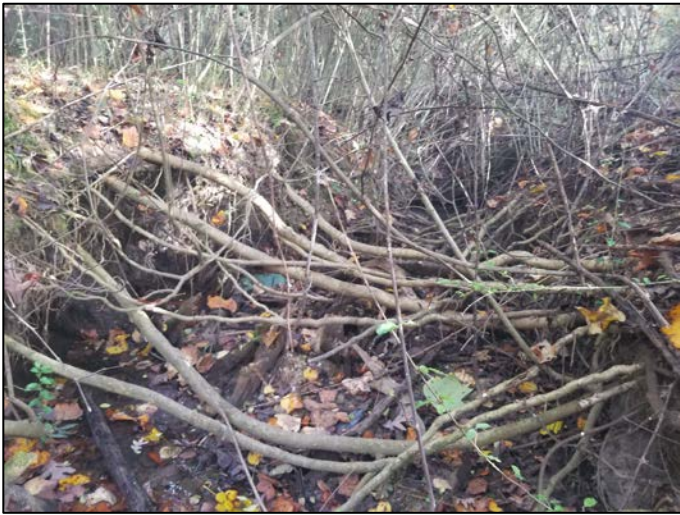
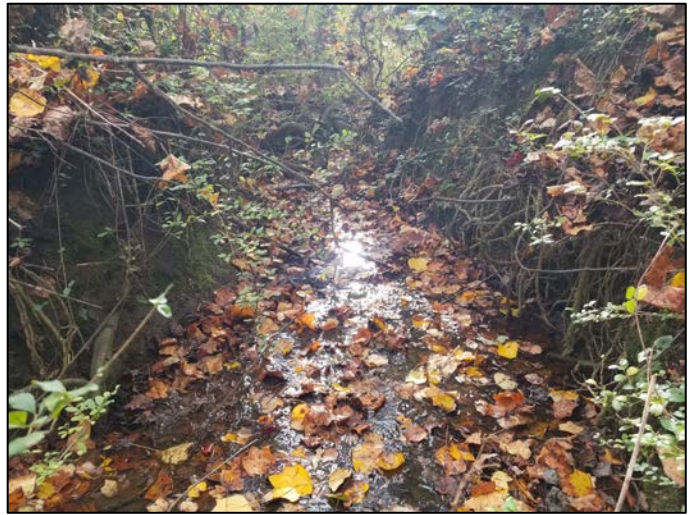
Upstream Reach of T3 Photos

3. T3 has shown aggradation in other years as well. Please identify the suspected source of this sediment upstream for clarity.
KCI Response: The banks of the upstream reach of T3, which is located outside of the bounds of the project, are the primary source of sediment that is causing aggradation. These banks are very unstable and actively eroding. Several pictures of these banks have been added to Appendix B – Visual Assessment Data.

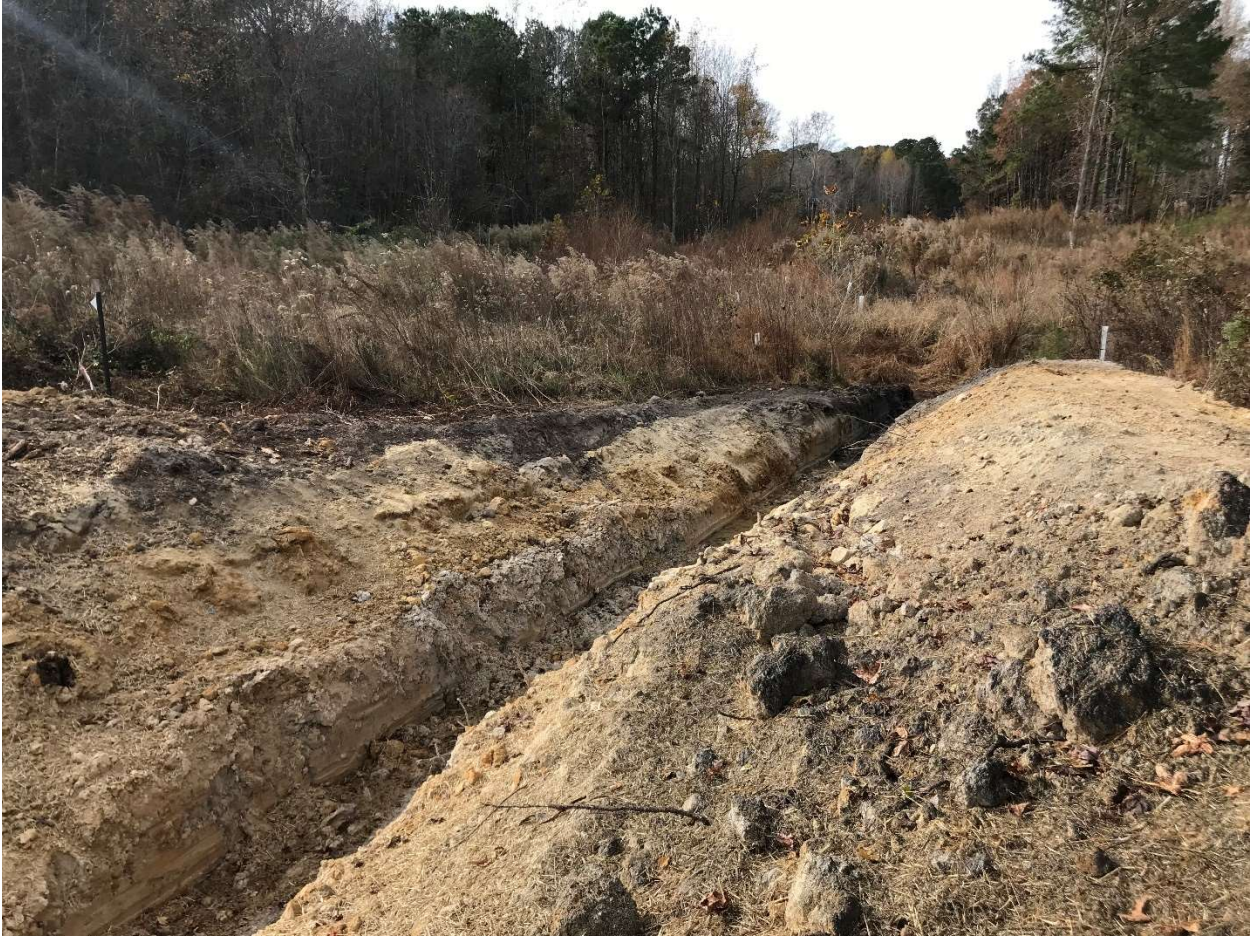
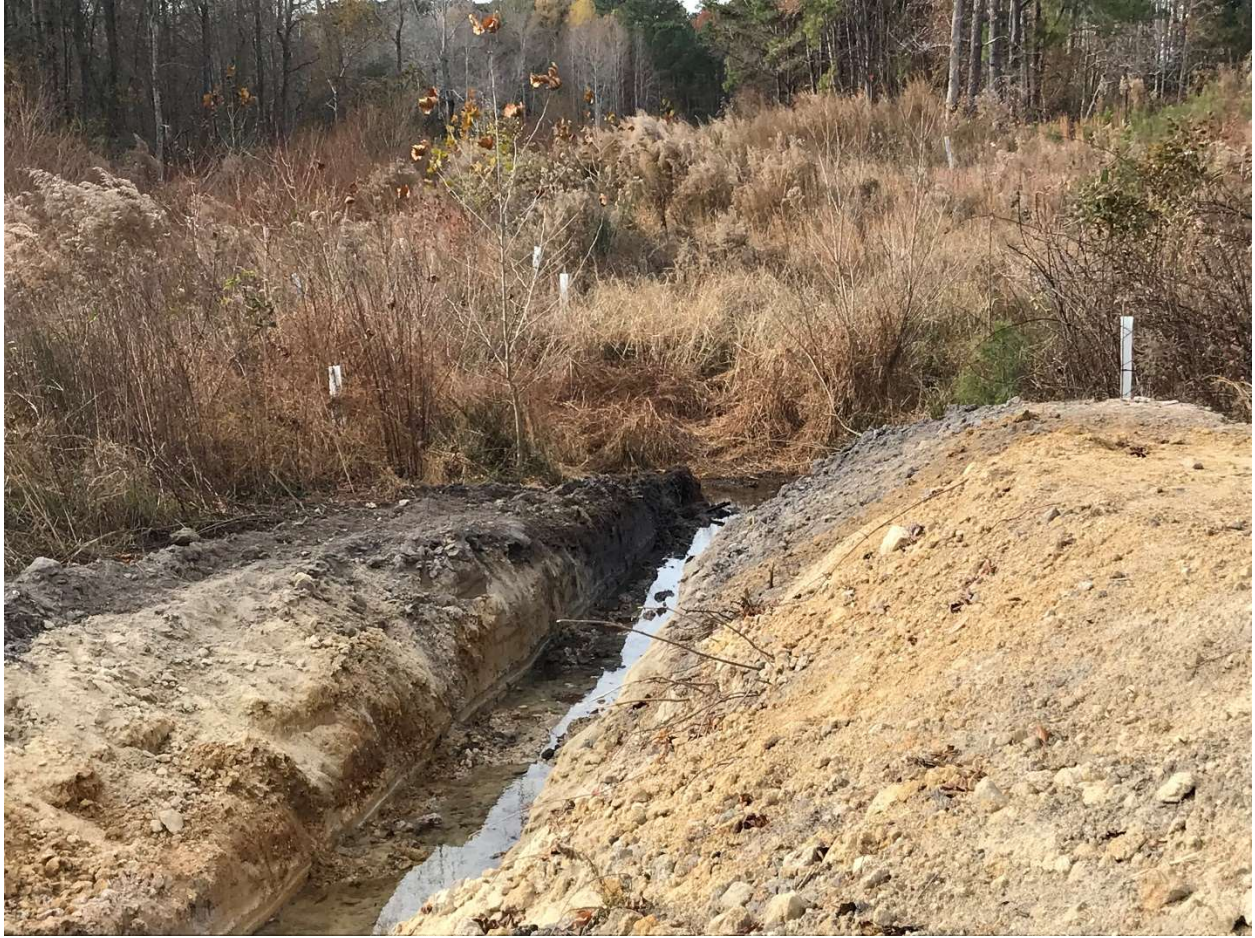
In response to a complaint, on November 24, 2021, personnel of this office conducted a site inspection of the stream located in the above referenced project area. Accordingly, the following observations were noted during the site inspection of the above mentioned property:

- The perennial stream with the violation on the site, Stony Fork (also currently in a State Conservation Area) classified as *Class C; NSW* and located within the Neuse River Basin.
- Stony Fork is depicted on the most recent published Johnston County NRCS Soil Survey (1994) as well as the most recent USGS Topographic map at a 1:24 scale and therefore, the features are subject to Section 14-393 of the Johnston County Code of Ordinances, Riparian buffer protection (for lands within the Neuse River Basin).
- The riparian buffer has been excavated through both zones 1 and 2. No diffused flow present from the sediment basin above the buffer.
