**Year 1 Monitoring Report**

**UT WEST BRANCH ROCKY RIVER  
RESTORATION SITE**

NCDMS Project #92684 (Contract # WBRR010521)  
USACE Action ID: SAW-2017-00342 | NCDWR Project #18-1696

Mecklenburg County, North Carolina  
Yadkin River Basin | HUC 03040105

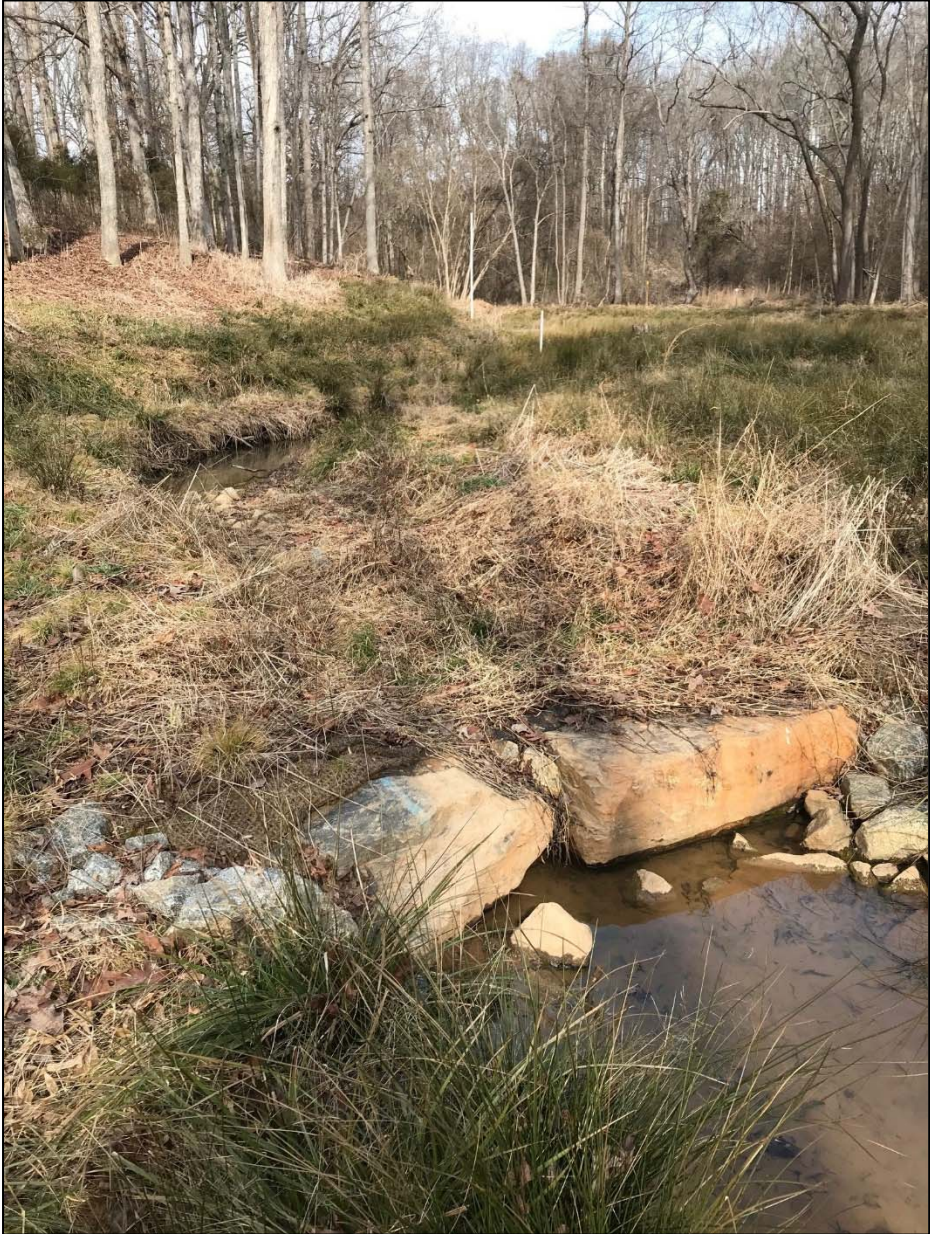
- RES states that *"The rock sill on UTWB-1 that was piping at as-built appears to be stabilizing and the aggradation on UT2 has not aggraded further."* Can you please describe the aggradation seen on UT2, how/when it started and what the likely source is. This will need to be at least visually evaluated over time and compared year to year to determine any improvement or worsening trend. Also what is meant by 'stabilizing' on the rock sill? Are you saying that piping is no longer occurring?  
*The aggradation on UT2 was observed throughout the whole reach by DMS and RES at as-built. RES believes the source is an area of denuded soil in the powerline to the east of the reach within its drainage area. Cross sections 13 and 14, on this reach, show very minor changes to dimension, indicating that the aggradation is not worsening. RES believes the annual cross section monitoring is the best way to track what is happening year to year as well as cross section and flow gauge photos. When RES observed the rock sill on UTWB-1 (12+40) in December 2021, RES believed the piping had stopped; however, when DMS observed the rock sill in February 2022 the rock sill was still piping. RES will continue to closely monitor both of these areas.*

Visual assessment of the stream channel was performed to document signs of instability, such as eroding banks, structural instability, or excessive sedimentation. Overall, the channel is transporting sediment as designed and will continue to be monitored for aggradation and degradation. The rock sill on UTWB-1 (12+40) that was piping at as-built appears was still piping in February 2022 (**Appendix B**). Additionally, visual observations of aggradation were noted on throughout UT2, however, Cross Sections 13 and 14 appear stable between as-built and MY1. Both areas will continue to be monitored closely.

UTWB-1 Station 12+40 piping rock sill (2/3/2022)

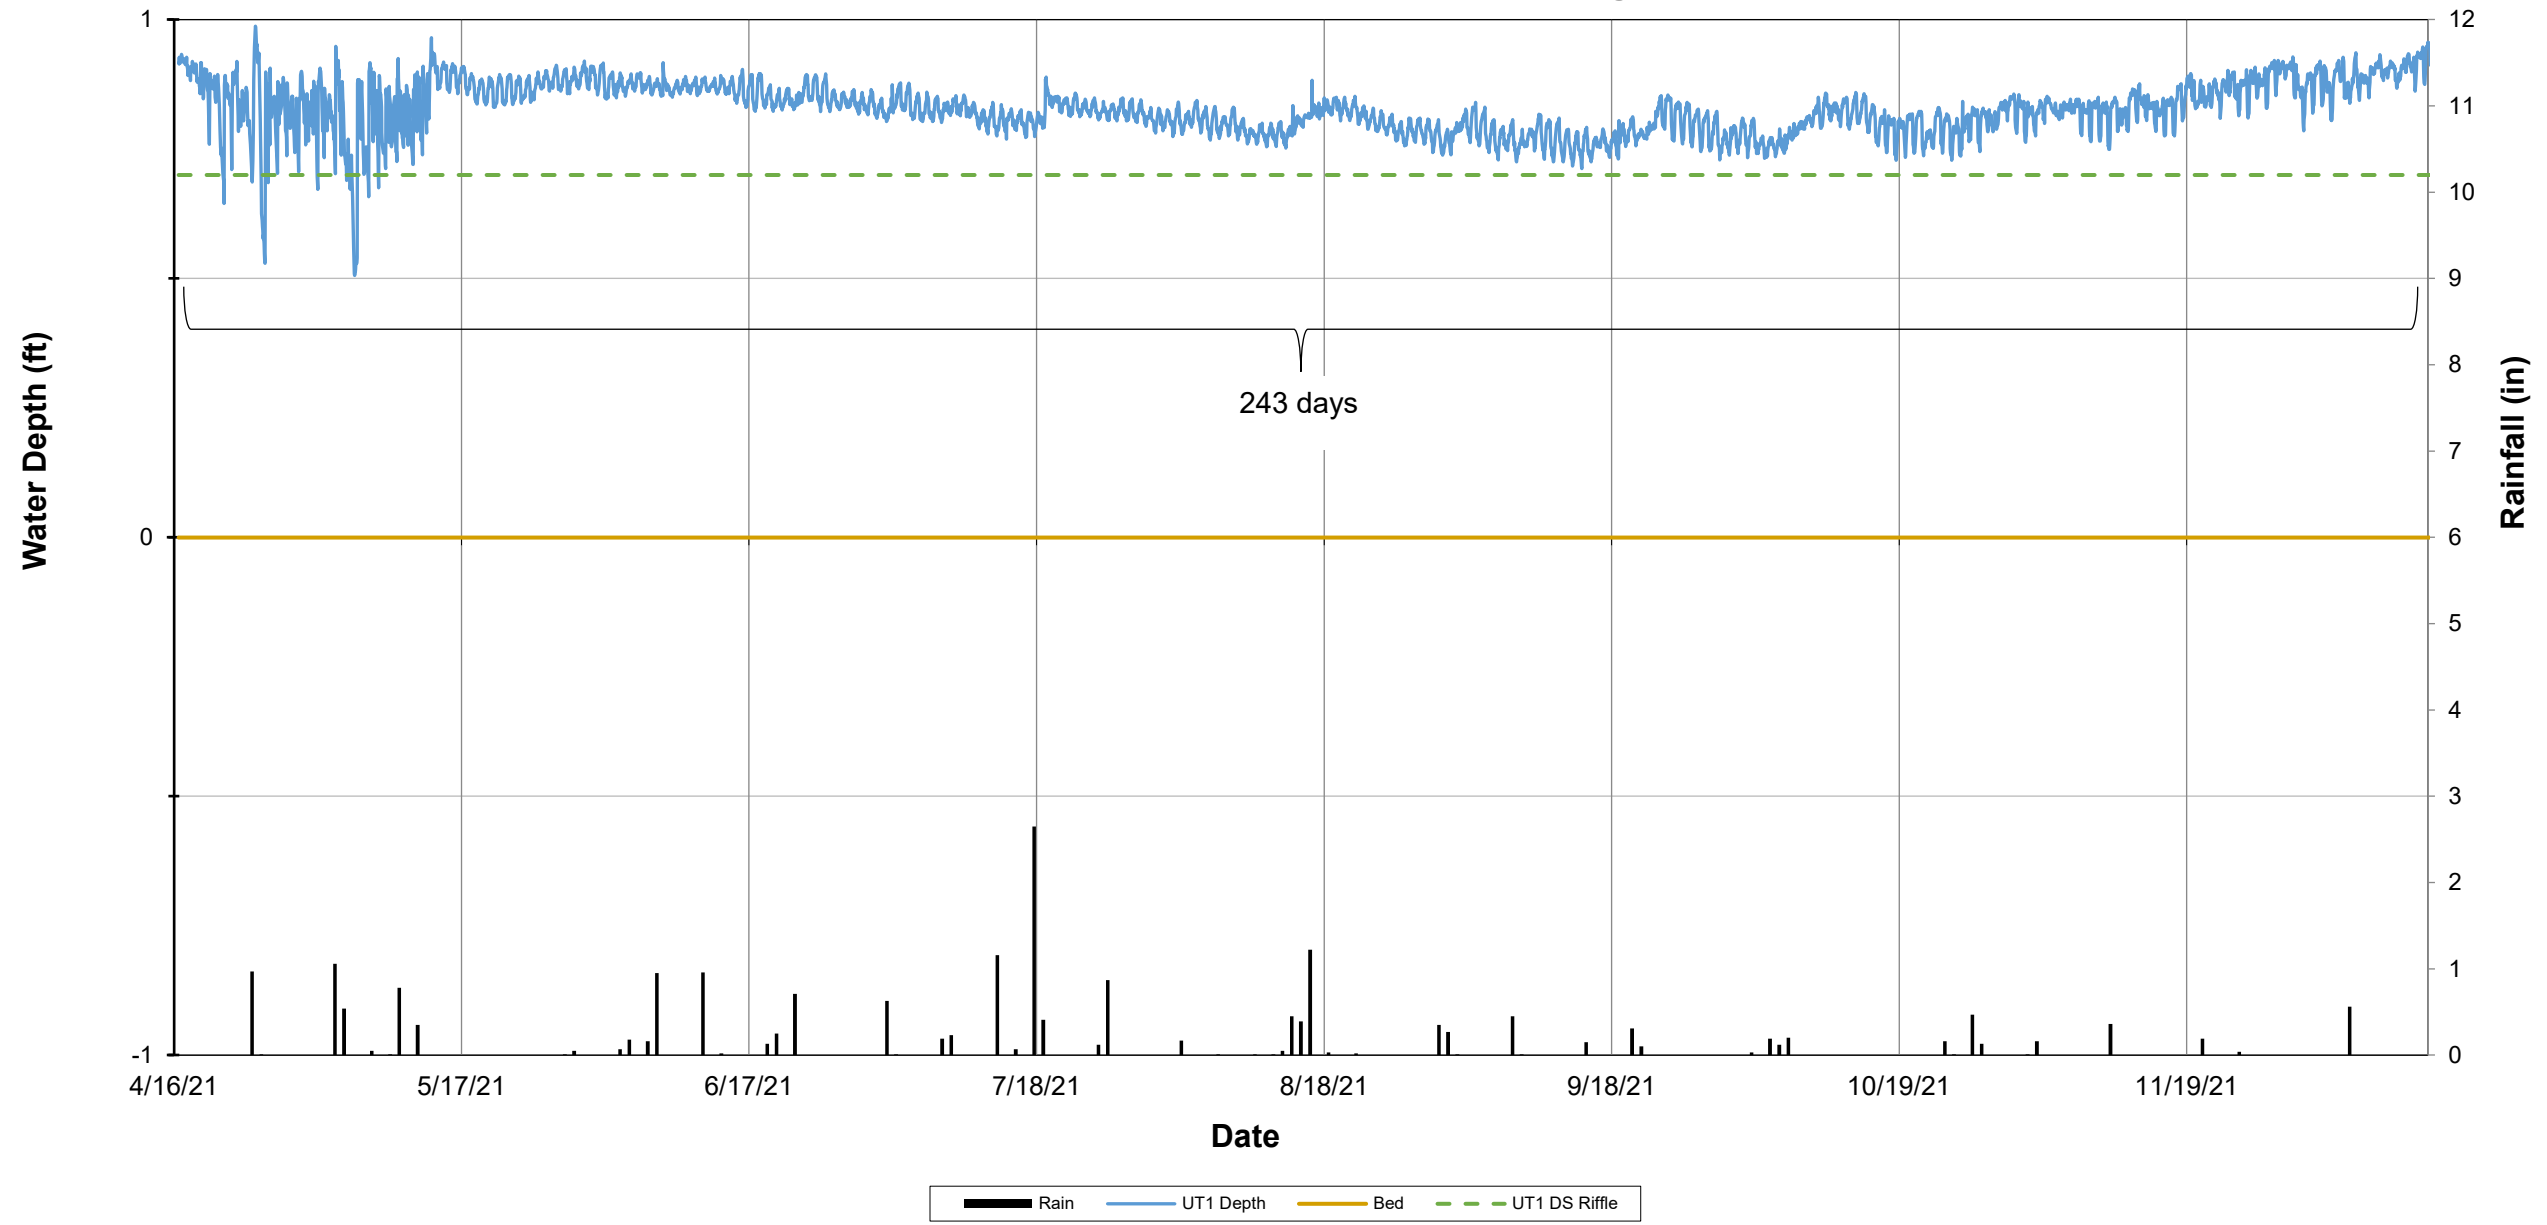
# MY1 2021 UTWBRR UT1 Flow Gauge

Year	Number of Bankfull Events	Maximum Bankfull Height (ft)	Date of Maximum Bankfull Event	
Stage Recorder UTWB-3				
MY1 2021	0	N/A	N/A	
Year	Number of Flow Events	Maximum Consecutive Flow Days	Maximum Cummlative Flow Days	Maximum Consecutive Flow Date Range
Flow Gauge UT1				
MY1 2021	1	186	186	4/16/2021 - 10/19/2021
Flow Gauge UT2				
MY1 2021	1	186	186	4/16/2021 - 10/19/2021

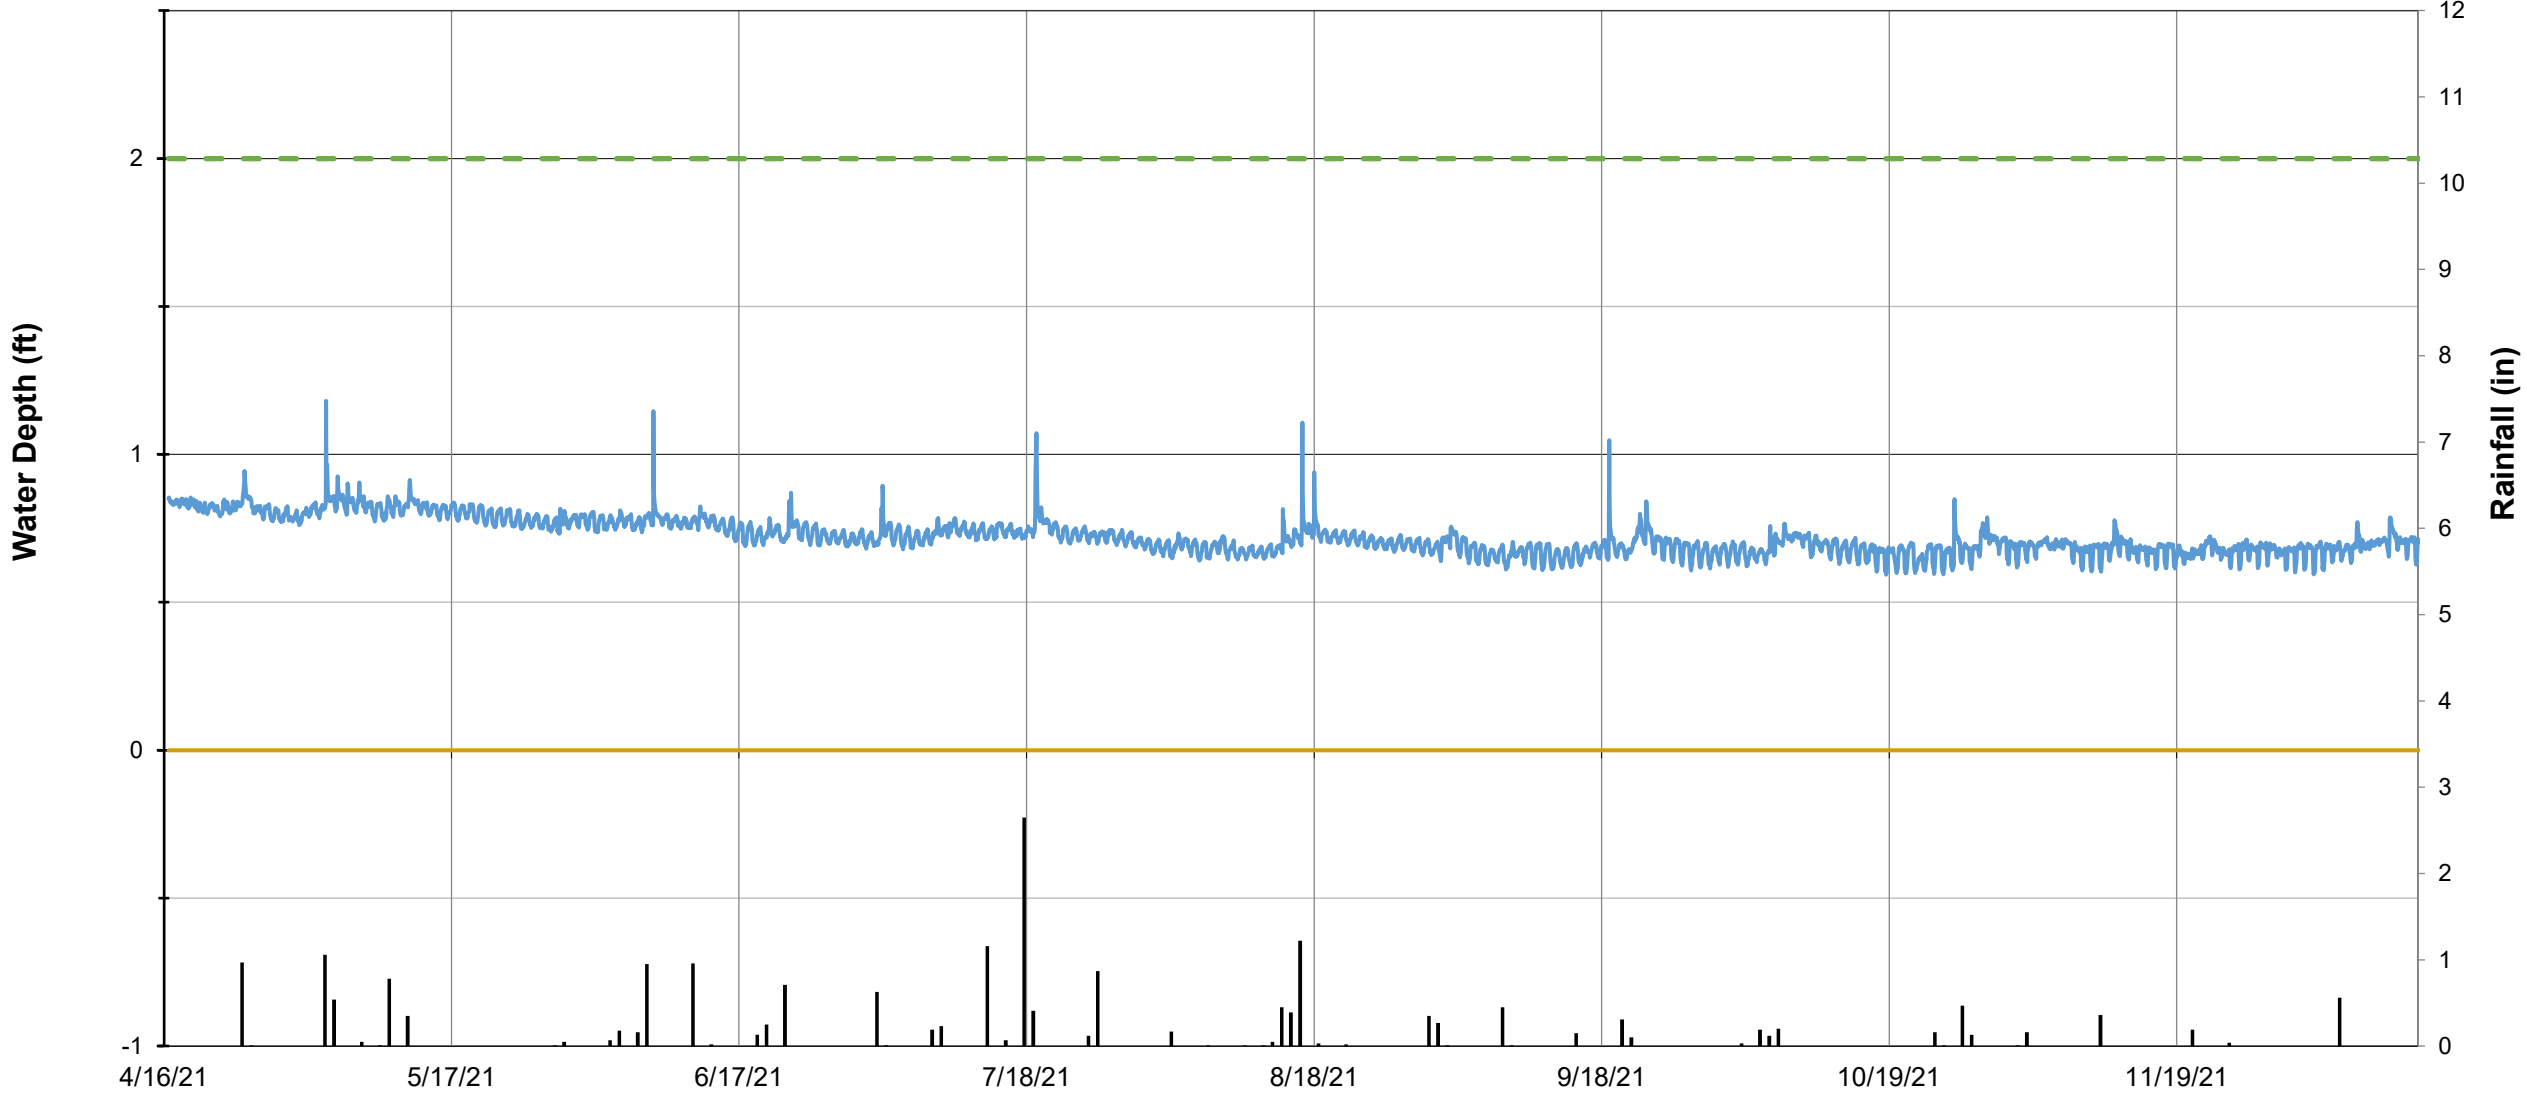
### MY1 2021 UTWBRR UTWB-3 Stage Recorder

One stage recorder and two flow gauges were installed on April 15, 2021 and will document bankfull events and flow days, respectively. The stage recorder was installed on UTWB-2 and the flow gauges were installed on UT1-2 and UT2-2. In MY1, the stage recorder did not record any bankfull events. Additionally, no visual evidence of bankfull events were observed. There were no rainfall events greater than 2.65 inches recorded in MY1, so RES expects bankfull events to occur in subsequent years when larger rainfall events take place. If any bankfull events are recorded in late 2021, they will be included in the MY2 report. Both flow gauges recorded 243 consecutive flow days. The gauge locations can be found on **Figure 2**, photos are in **Appendix B**, and associated data is in **Appendix E**.
