**BASELINE MONITORING
DOCUMENT AND AS-BUILT
BASELINE REPORT
FINAL**

BUCKWATER MITIGATION SITE

Orange County, NC

DMS Project Number 97084

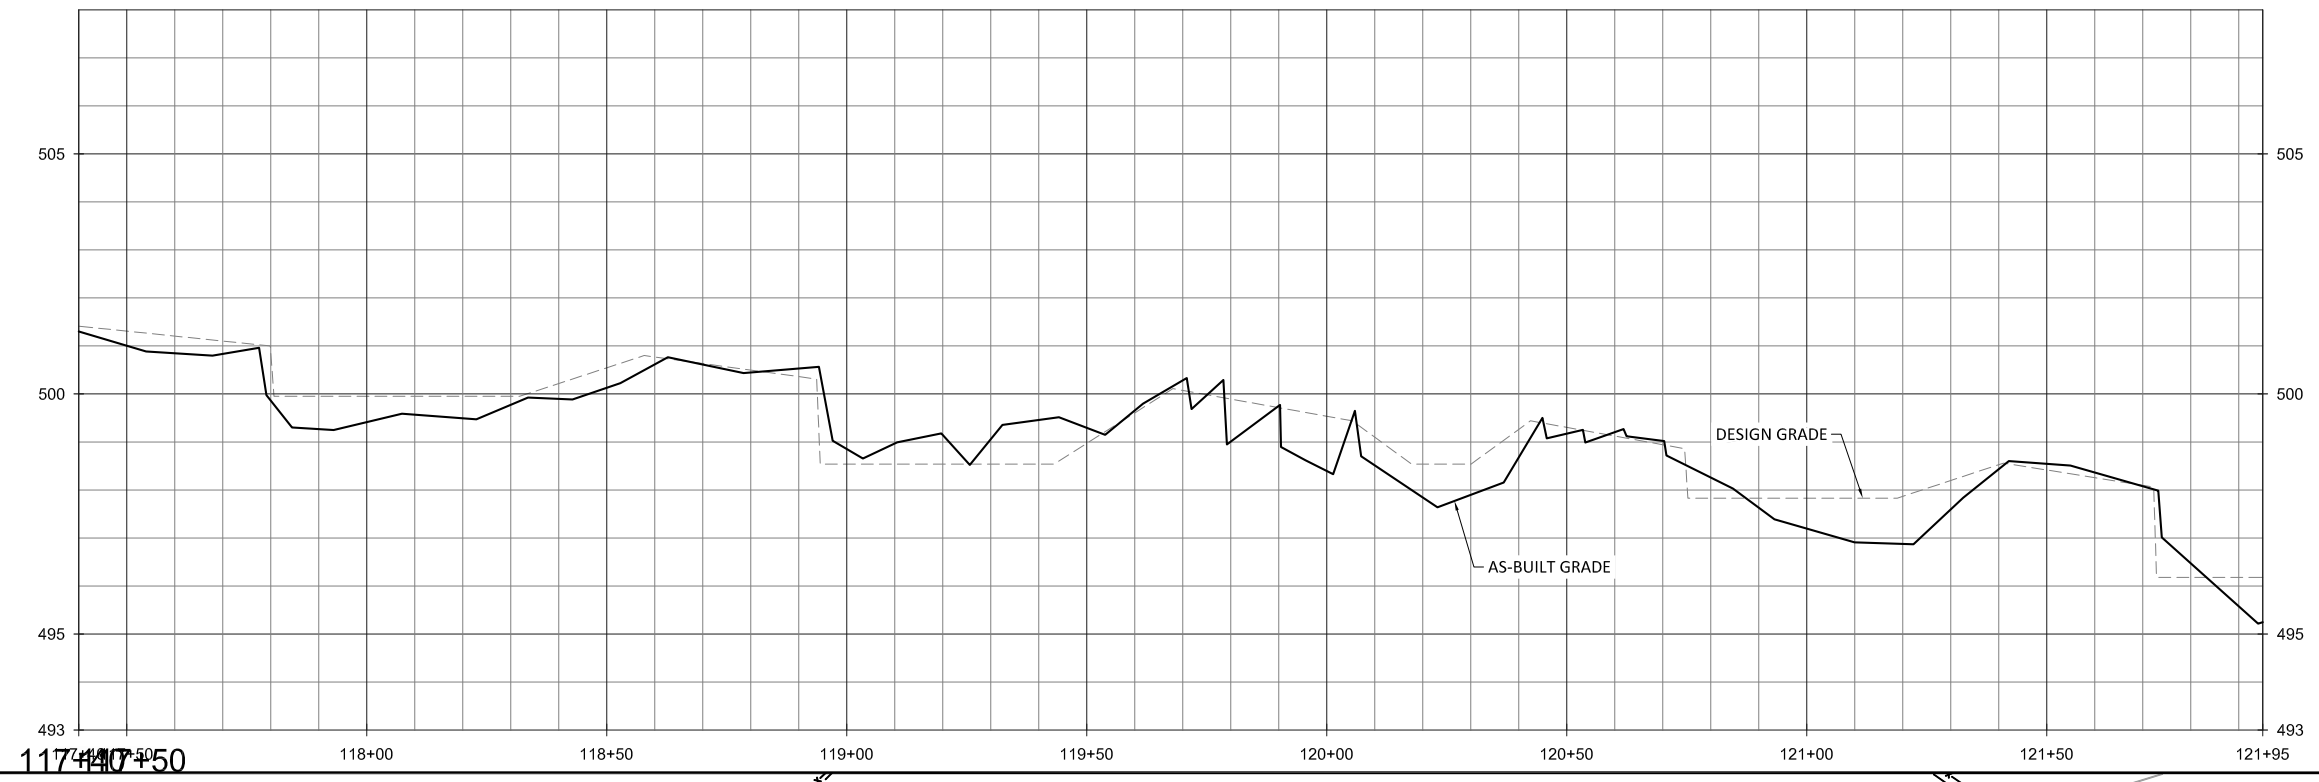
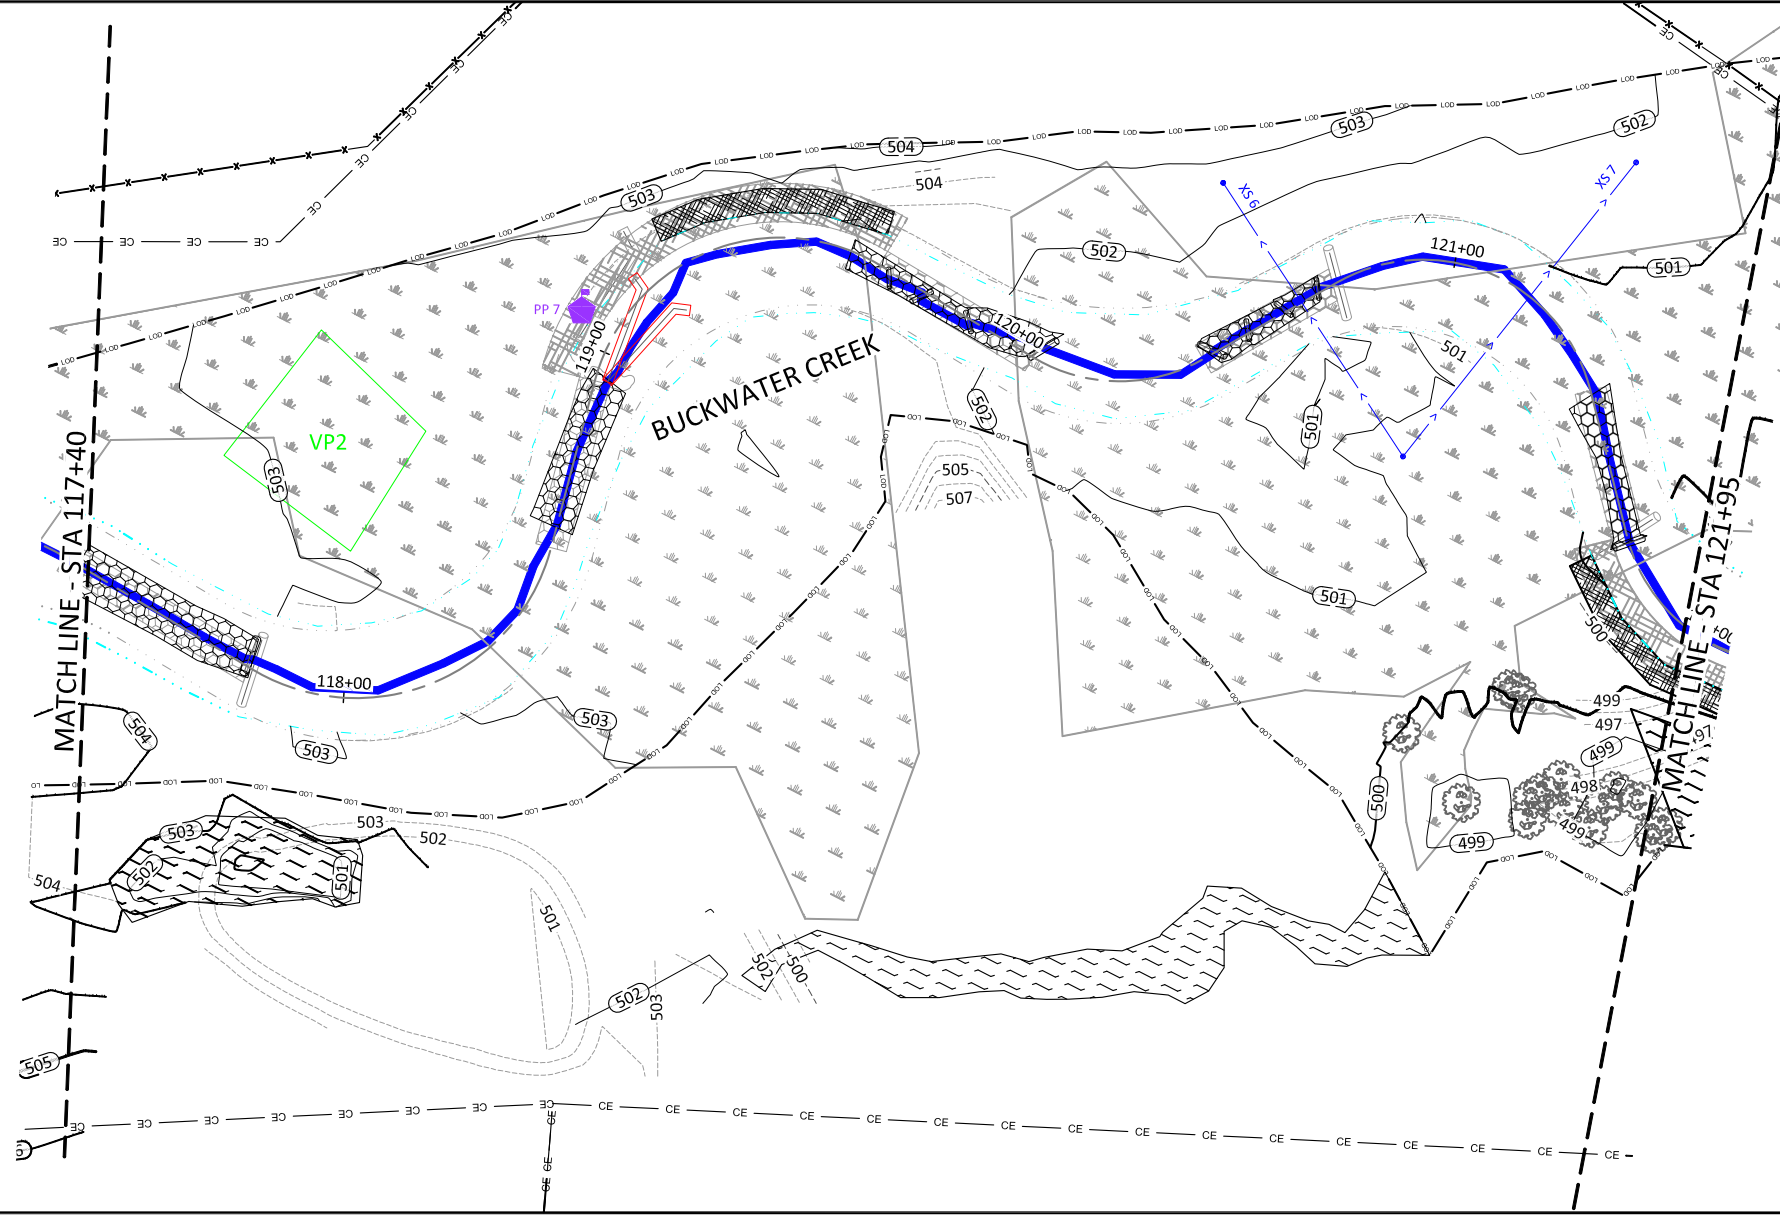
- NOTE:**
1. STA 118+86: A LOG CROSS VANE WAS INSTALLED INSTEAD OF A LOG J HOOK.
 2. STA 119+44: POOL SHALLOW NOT INSTALLED DUE TO FIELD CONDITIONS.

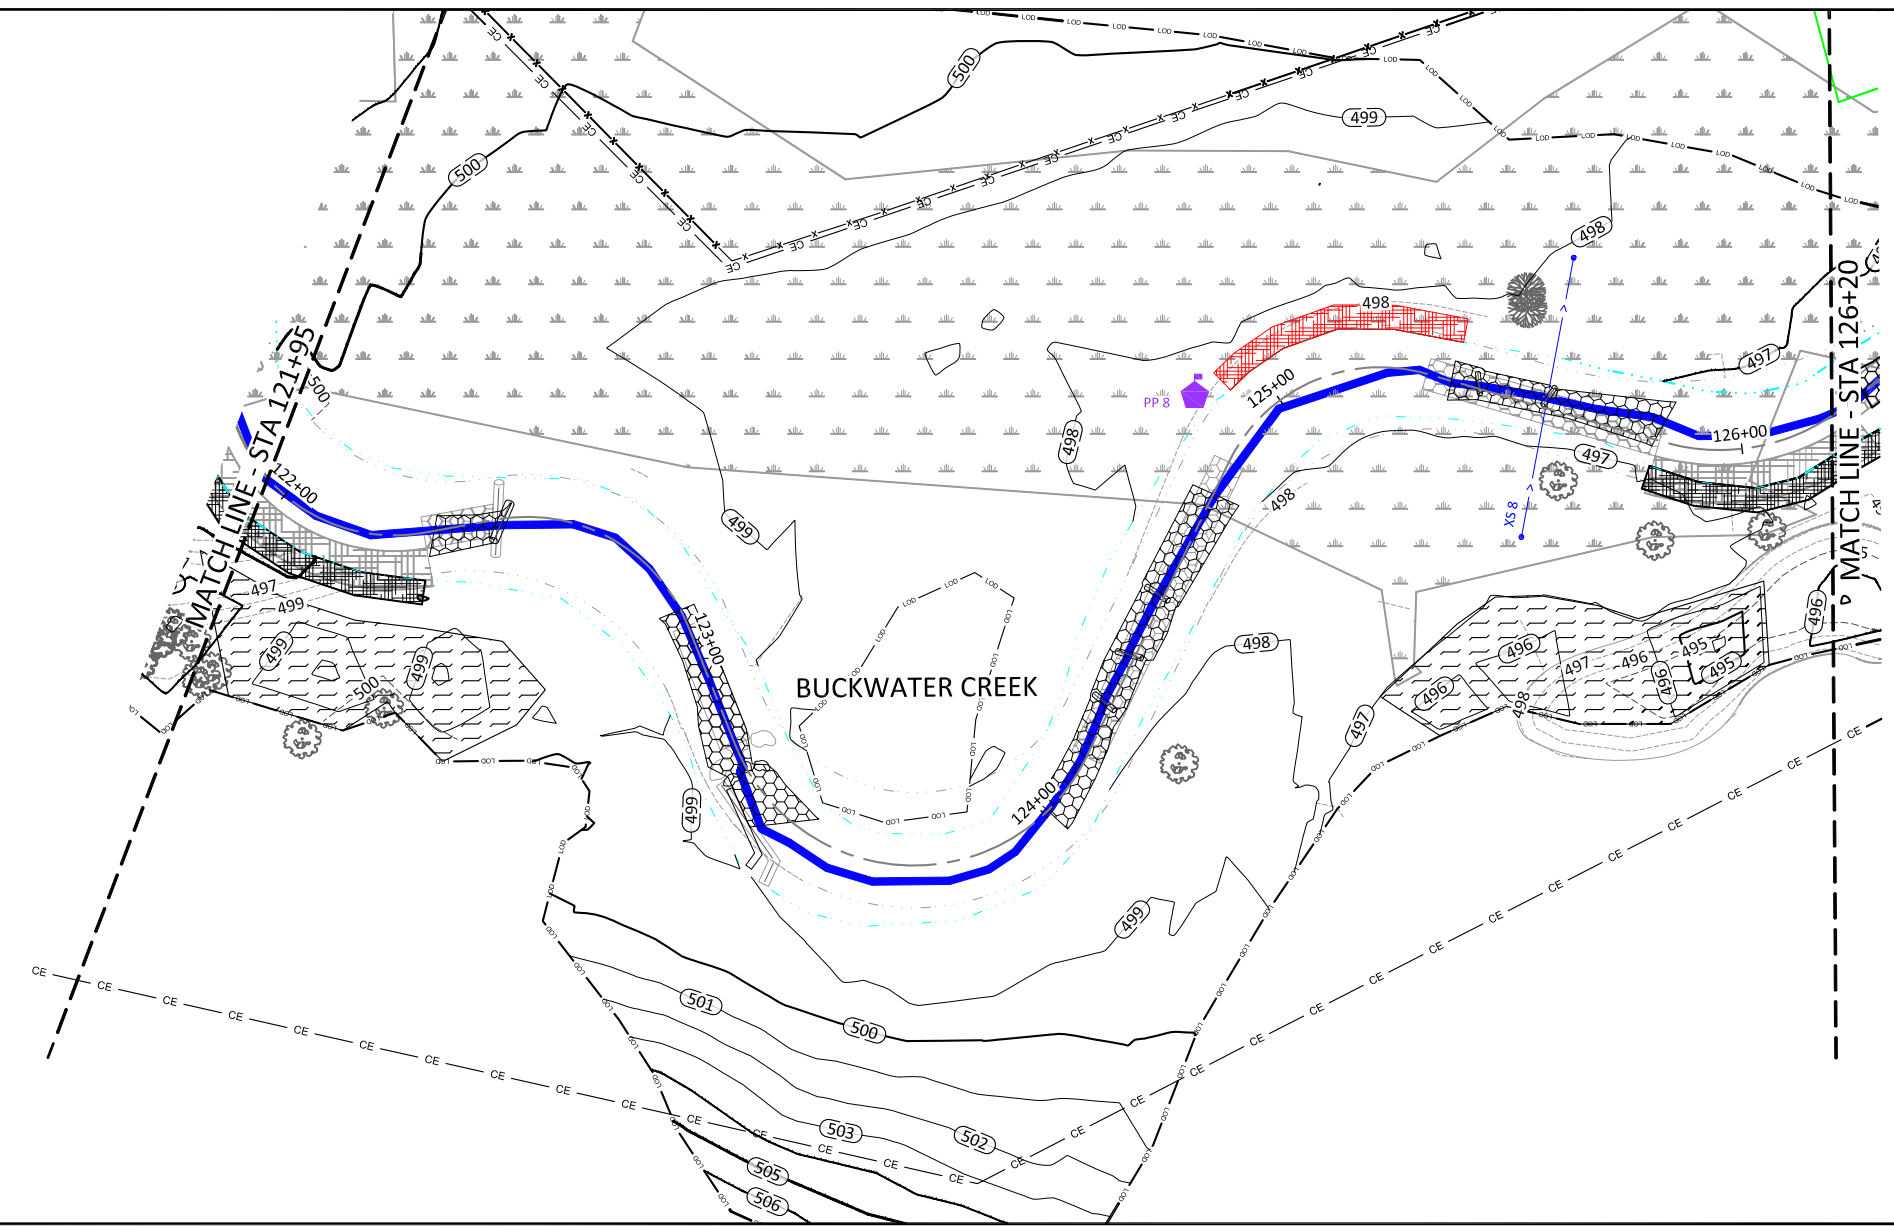
NOTE:
 1. STA 125+14: BRUSH TOE WAS INSTALLED.

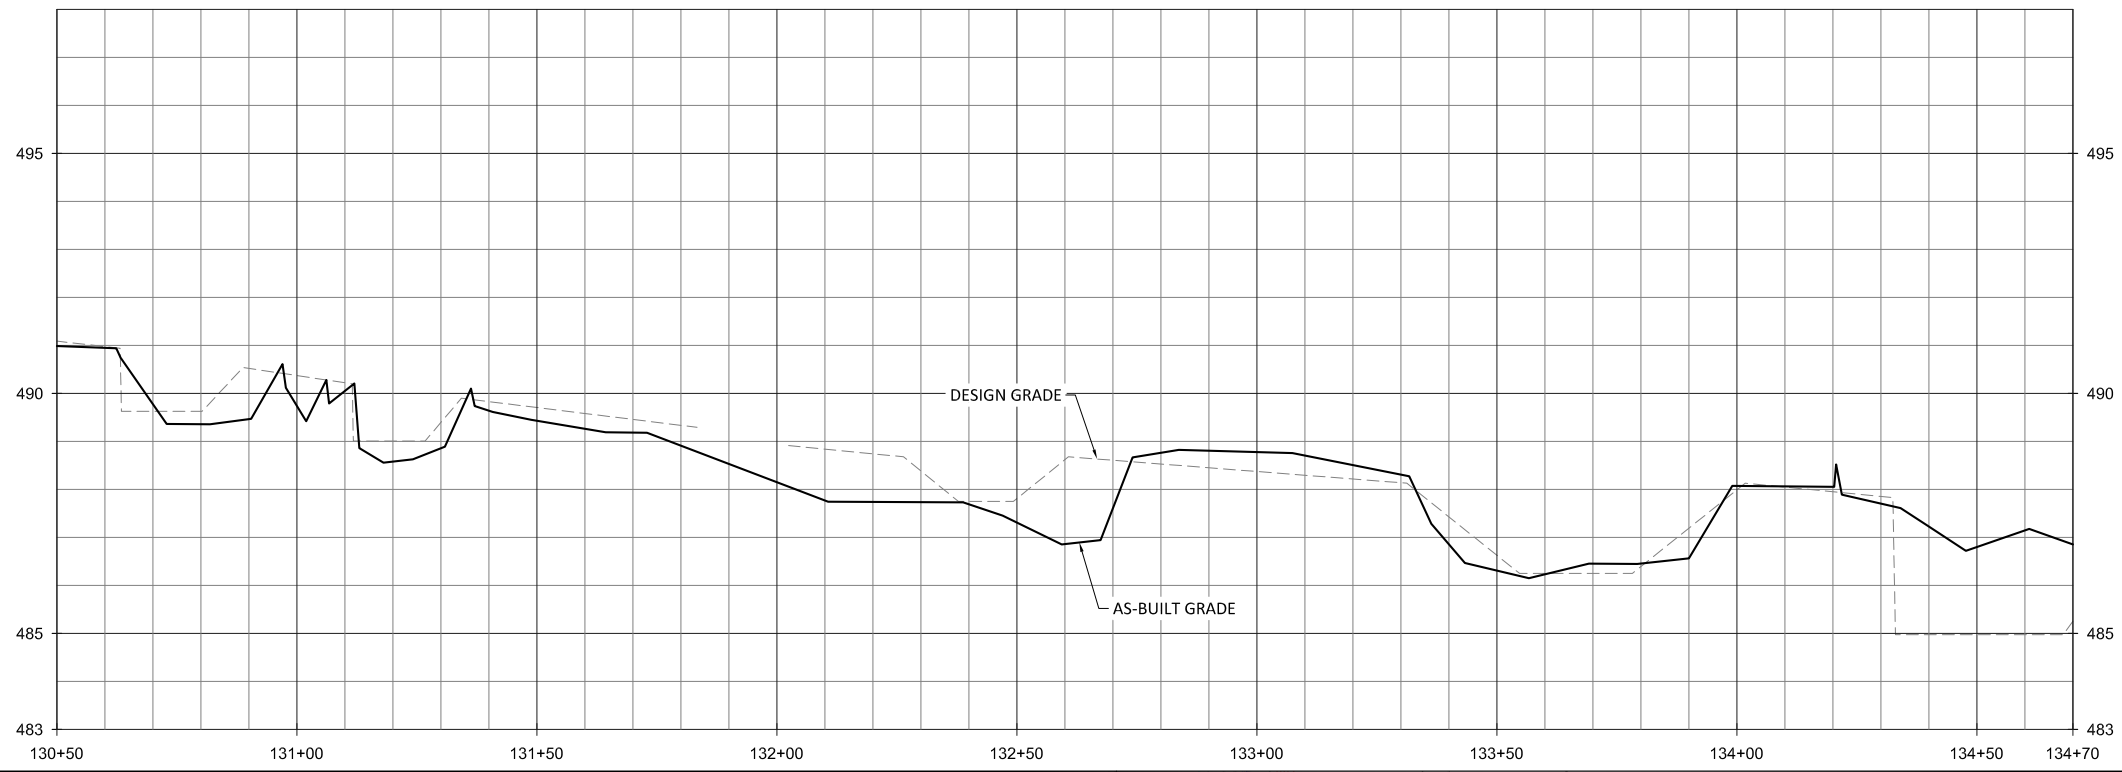
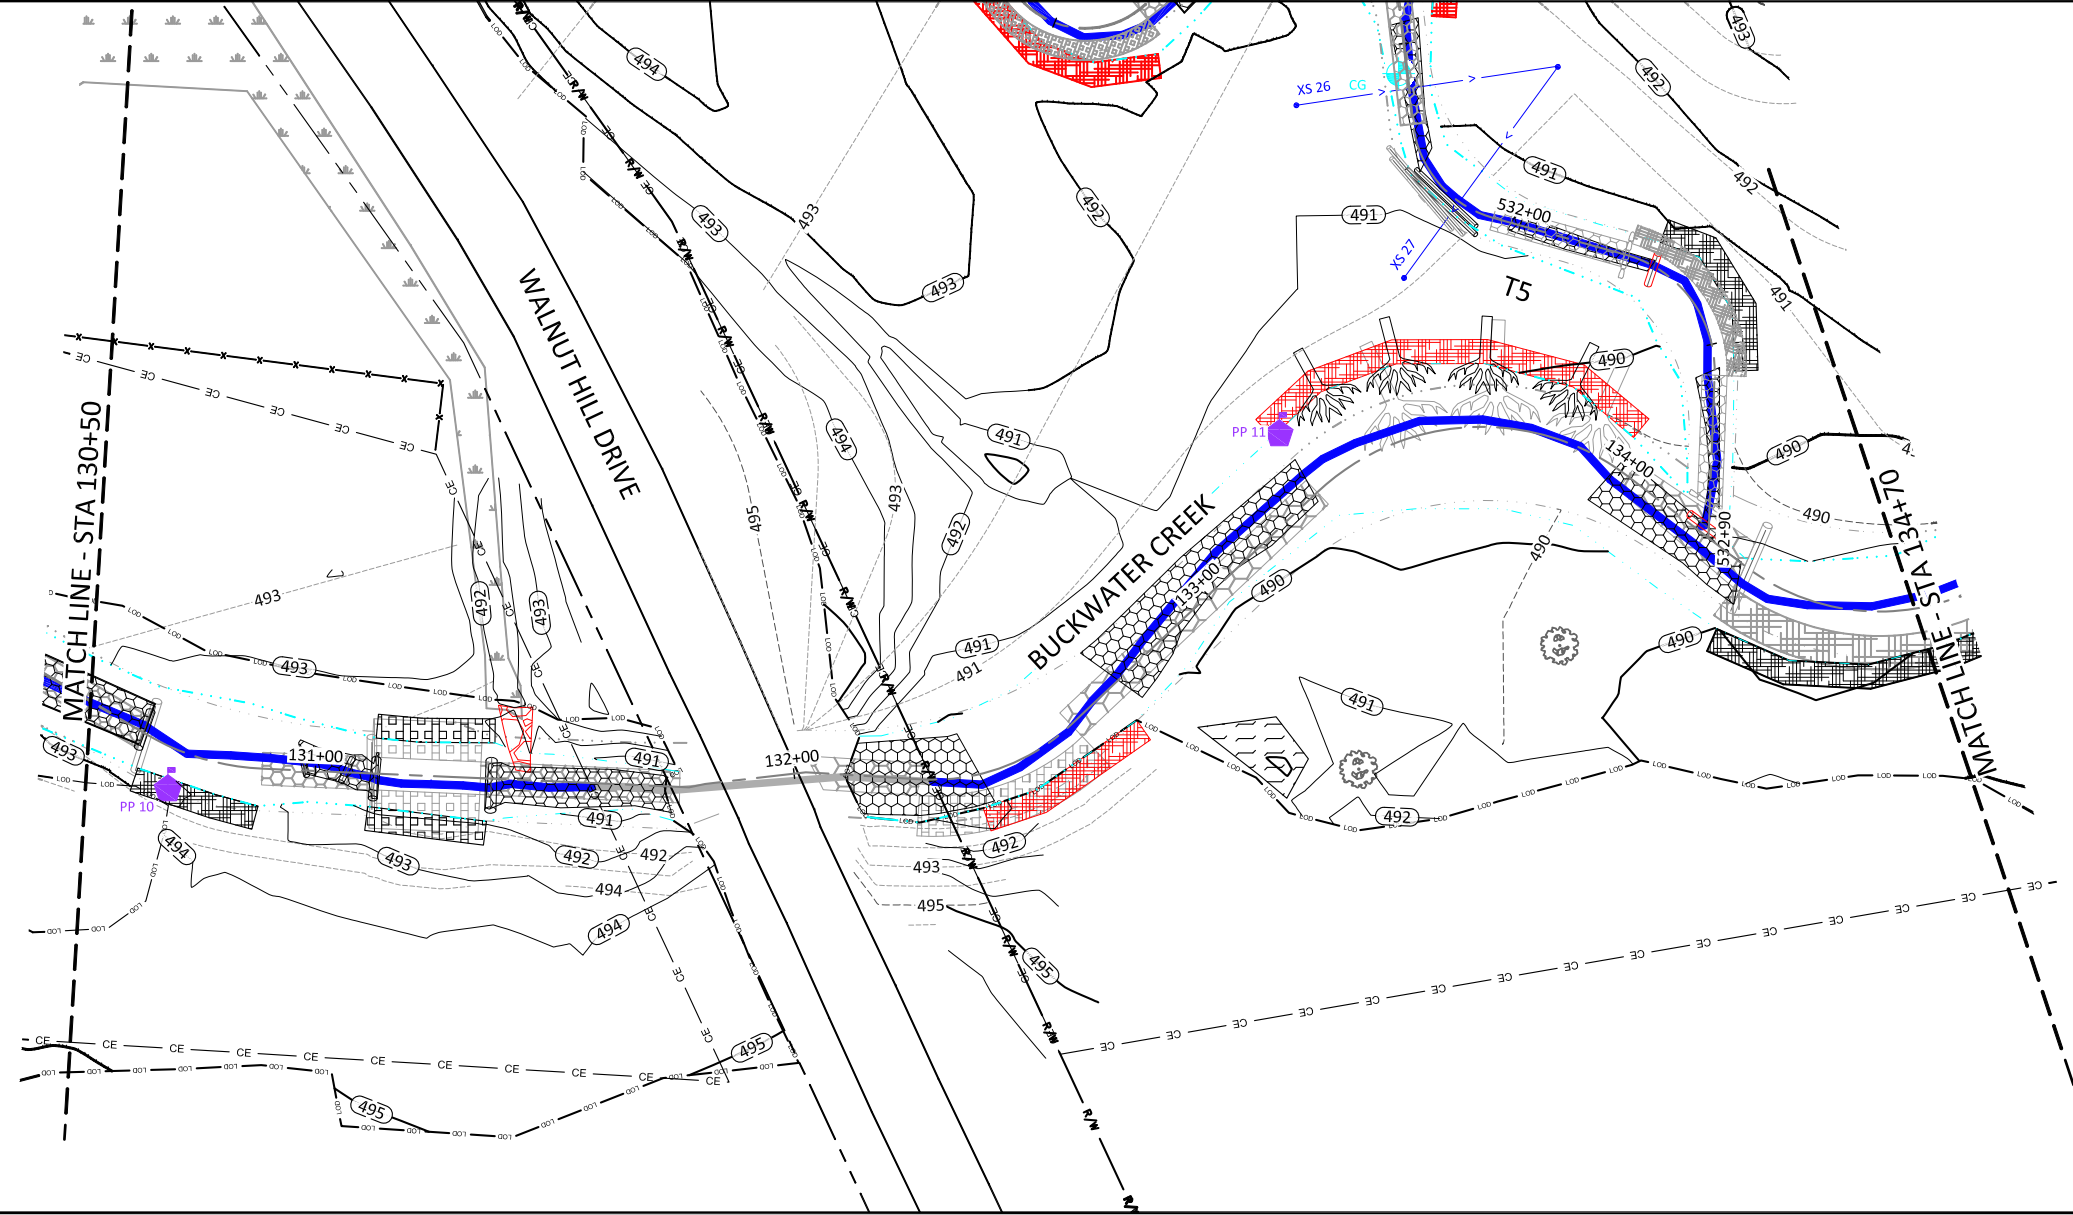
- NOTE:**
1. STA 131+36: A RIPRAP OUTLET WAS INSTALLED.
 2. STA 132+50: BRUSH TOE WAS INSTALLED INSTEAD OF SOD MAT.
 3. STA 133+62: BRUSH TOE WAS ADDED WITH THE ROOT WADS.
 4. STA 134+34: LOG SILL WAS NOT INSTALLED DUE TO FIELD CONDITIONS.

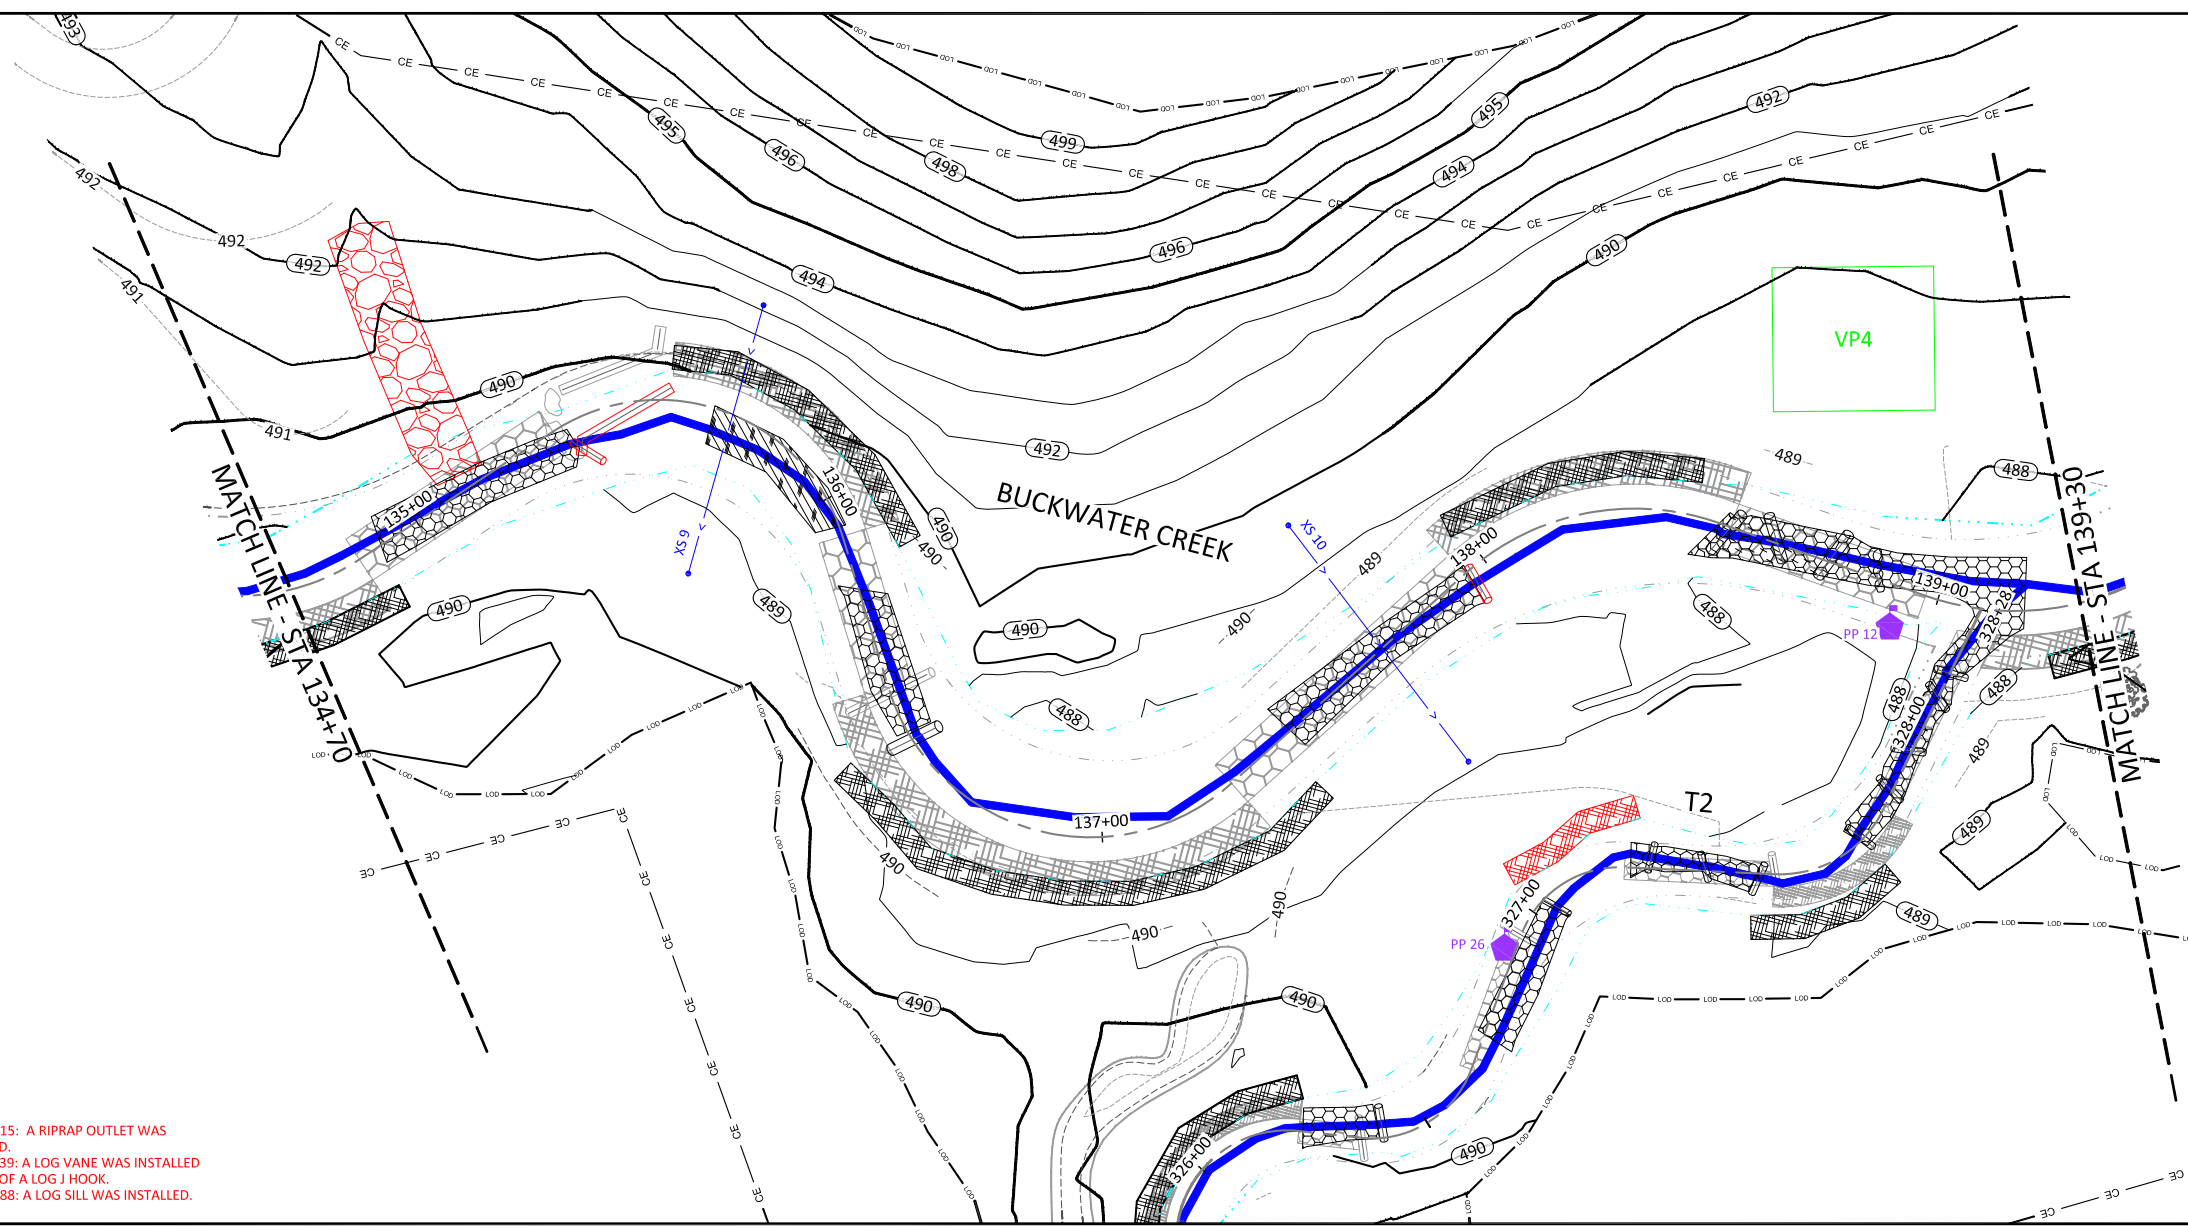
- NOTE:**
1. STA 135+15: A RIPRAP OUTLET WAS INSTALLED.
 2. STA 135+39: A LOG VANE WAS INSTALLED INSTEAD OF A LOG J HOOK.
 3. STA 137+88: A LOG SILL WAS INSTALLED.

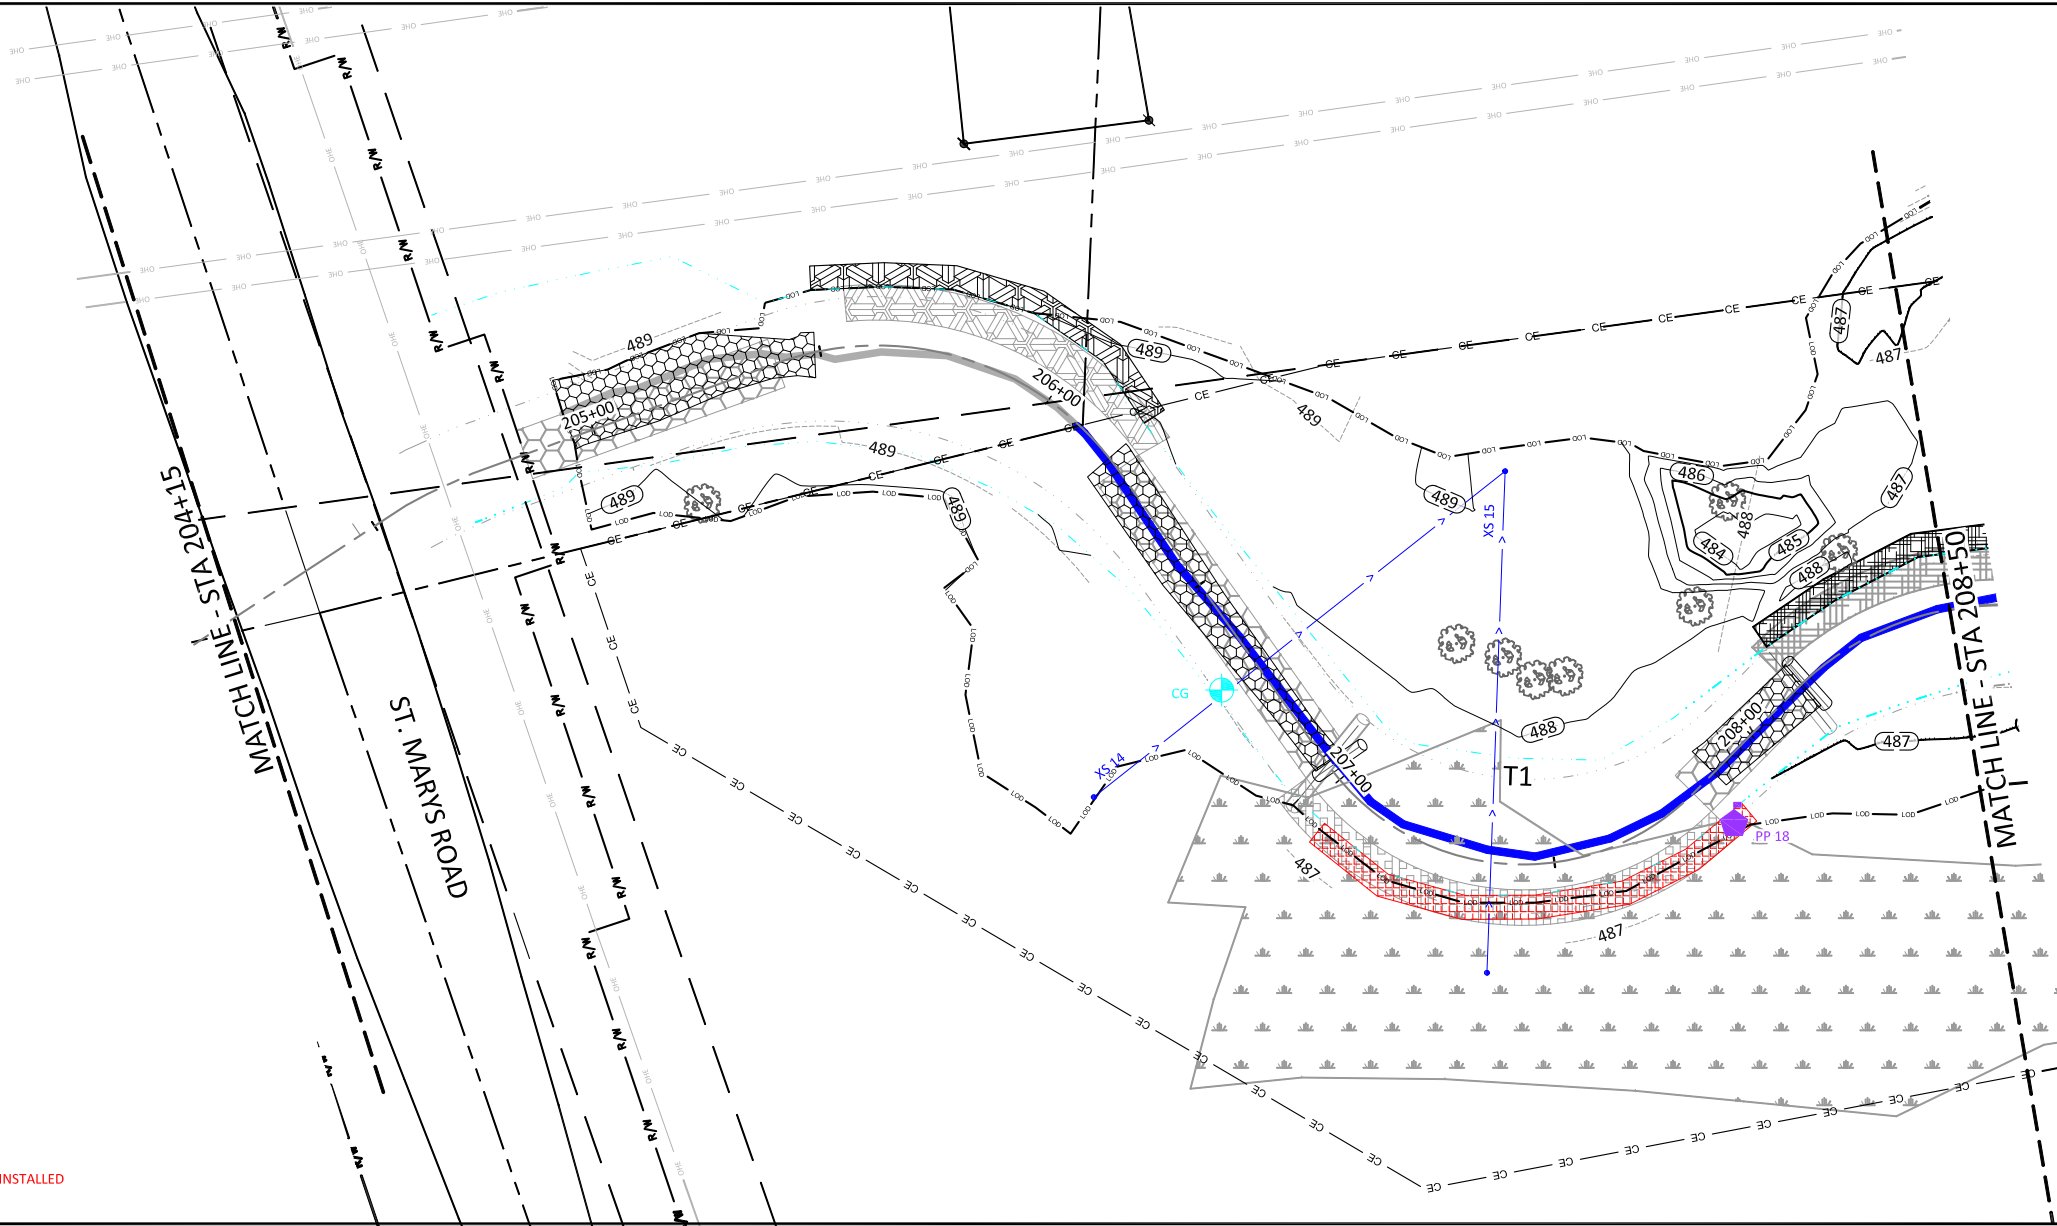
NOTE:
 1. STA 207+54: BOULDER TOE WAS INSTALLED INSTEAD OF SOD MATS.

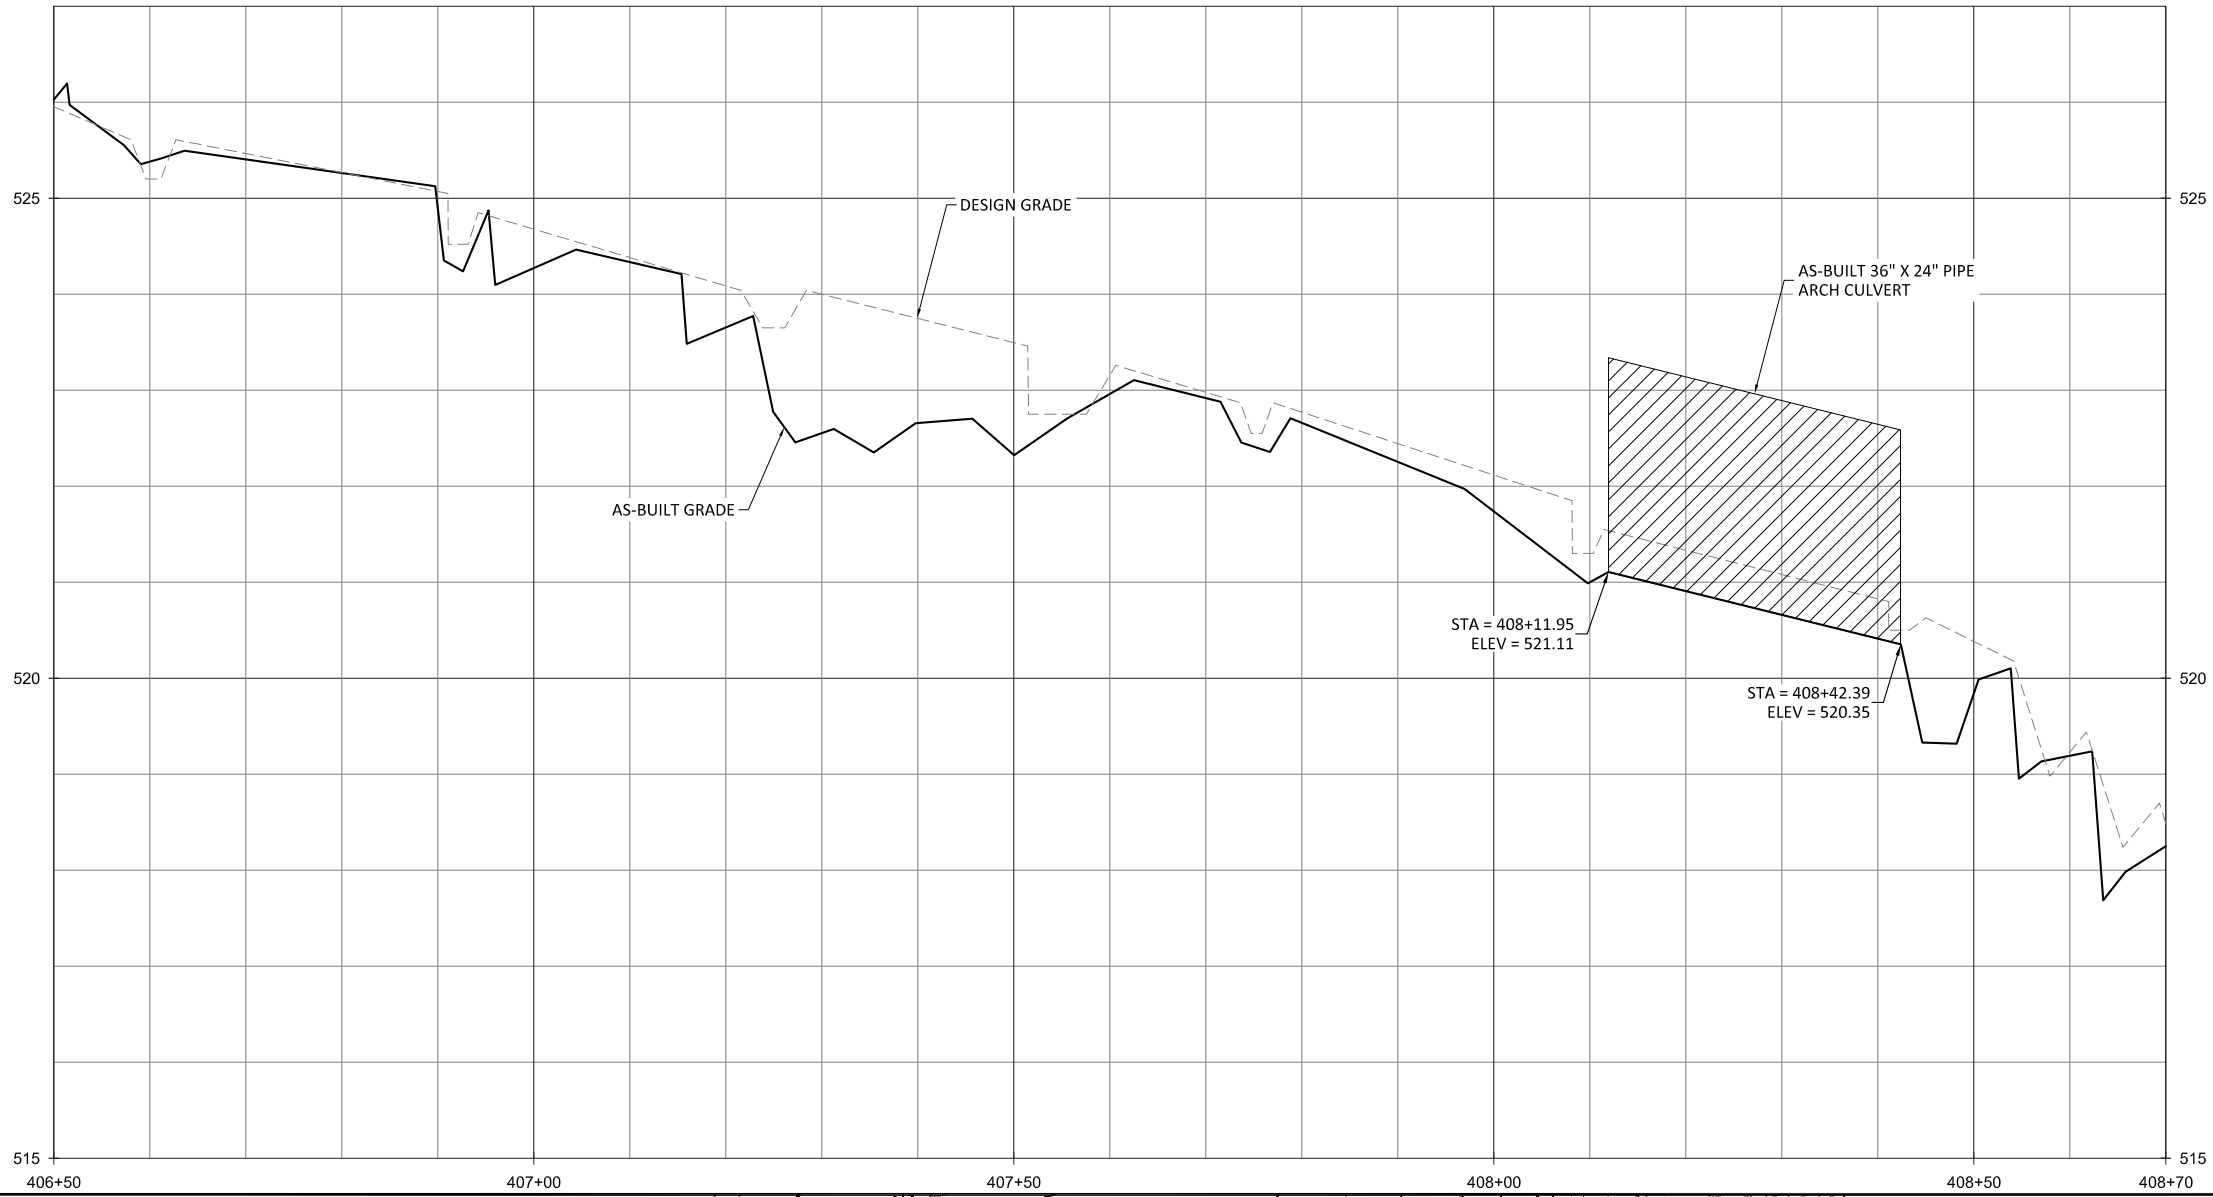
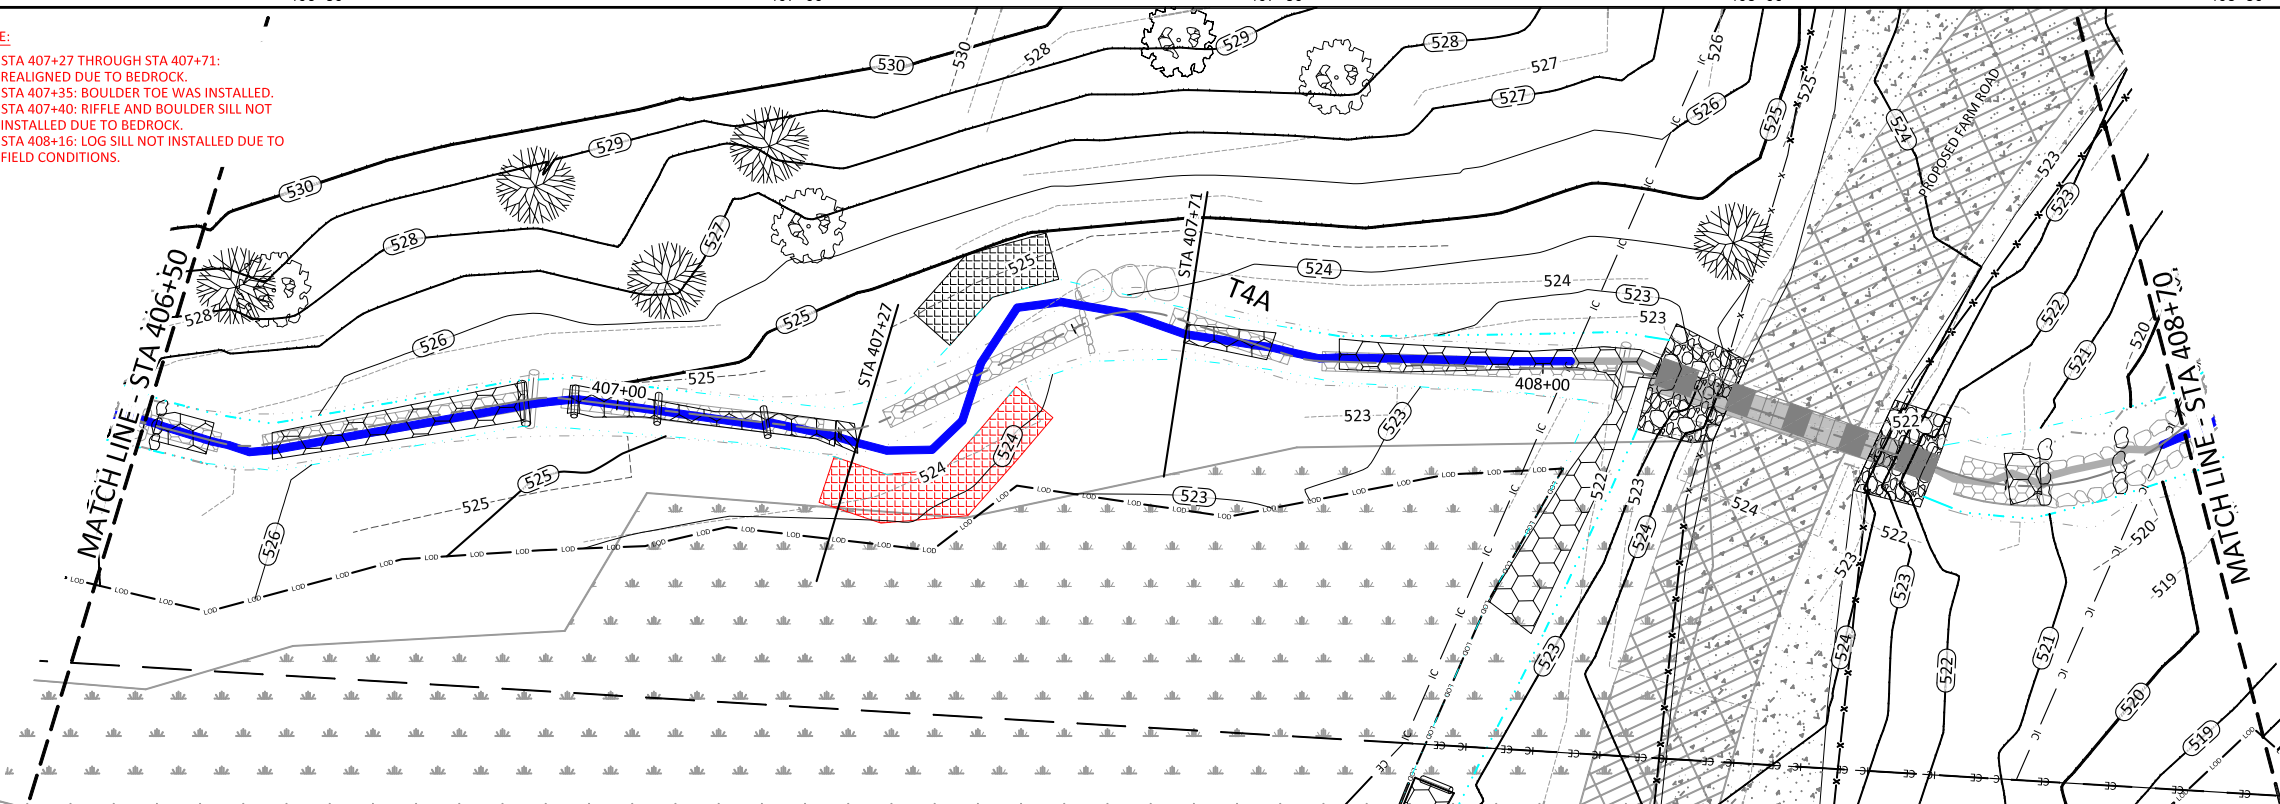
Buckwater Mitigation Site
Orange County, North Carolina
T4A Reach 3 & T4
Stream Plan and Profile

- Station 407+27 through Station 407+71 realigned due to bedrock;
- Station 404+35 boulder toe was installed;
- Station 407+40 riffle and boulder sill not installed due to bedrock;
- Station 408+16 log sill not installed due to field conditions.

- 1. STA 407+27 THROUGH STA 407+71: REALIGNED DUE TO BEDROCK.
- 2. STA 407+35: BOULDER TOE WAS INSTALLED.
- 3. STA 407+40: RIFFLE AND BOULDER SILL NOT INSTALLED DUE TO BEDROCK.
- 4. STA 408+16: LOG SILL NOT INSTALLED DUE TO FIELD CONDITIONS.

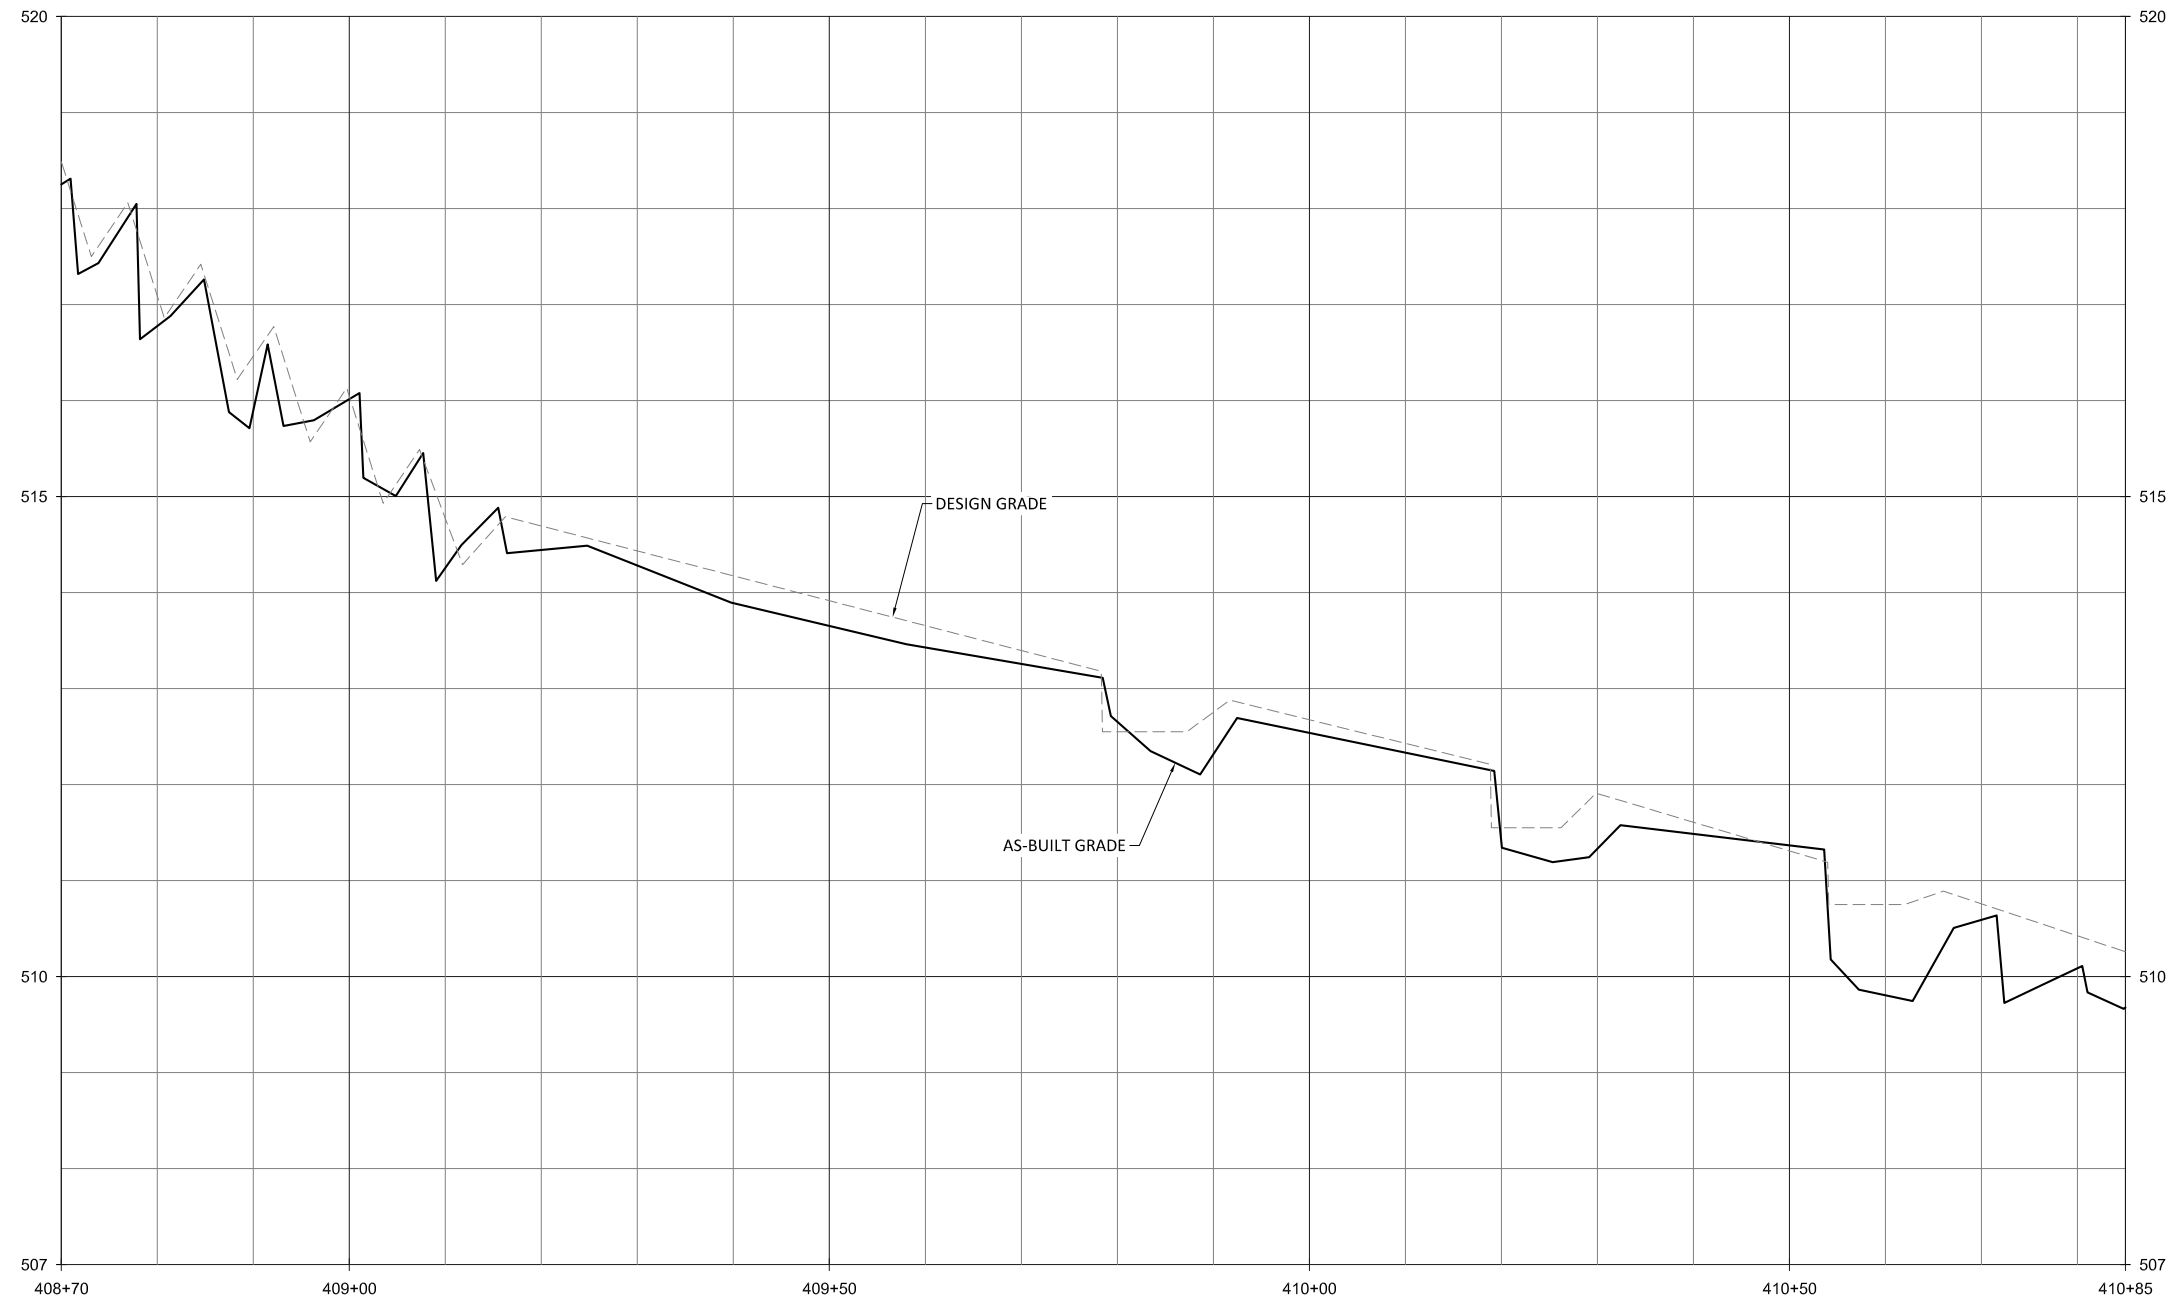
NOTE:
 1. STA 409+98: BRUSH TOE WAS INSTALLED.
 2. STA 410+37: BRUSH TOE WAS INSTALLED.
