**BASELINE MONITORING
DOCUMENT AND AS-BUILT
BASELINE REPORT
FINAL**

BUCKWATER MITIGATION SITE

Orange County, NC

DMS Project Number 97084

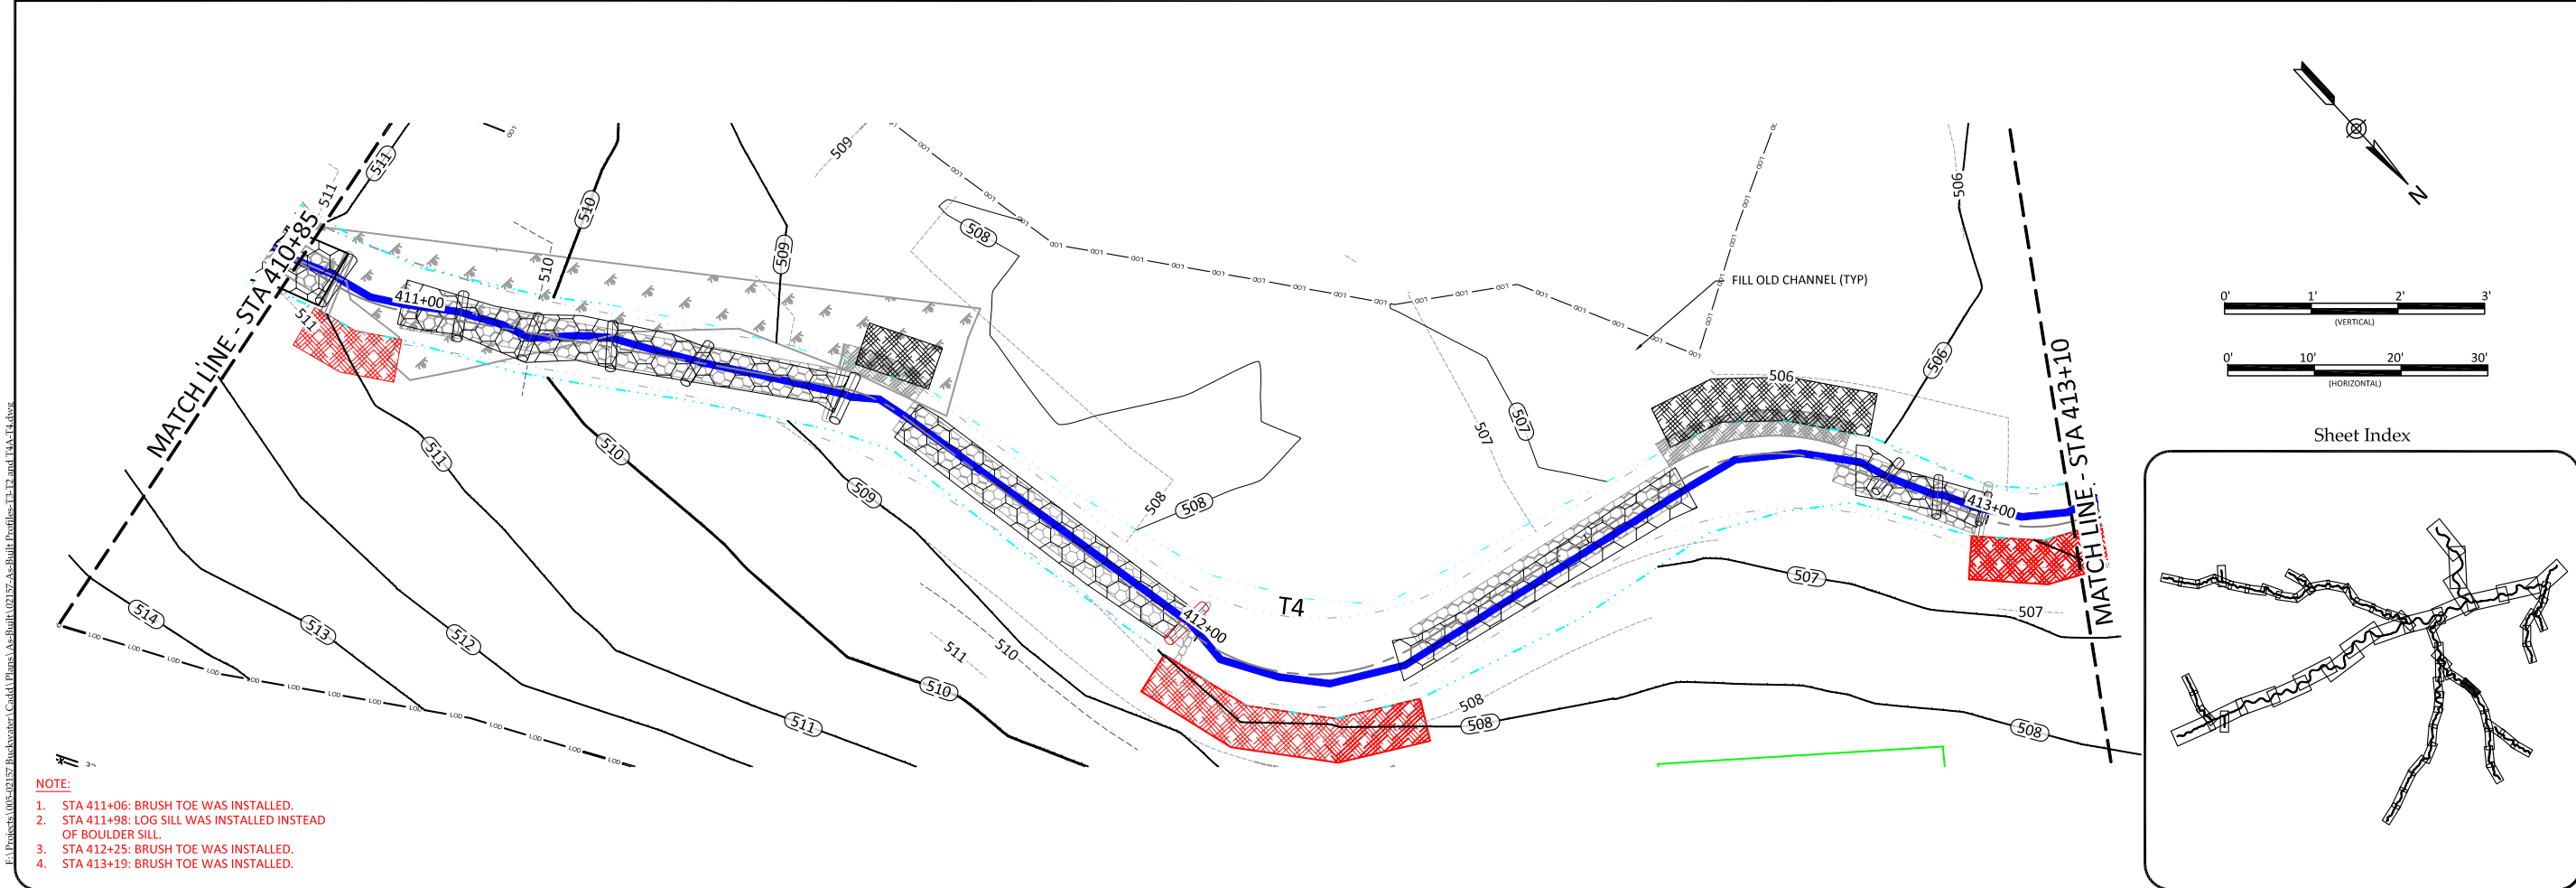
- NOTE:
1. STA 411+06: BRUSH TOE WAS INSTALLED.
 2. STA 411+98: LOG SILL WAS INSTALLED INSTEAD OF BOULDER SILL.
 3. STA 412+25: BRUSH TOE WAS INSTALLED.
 4. STA 413+19: BRUSH TOE WAS INSTALLED.

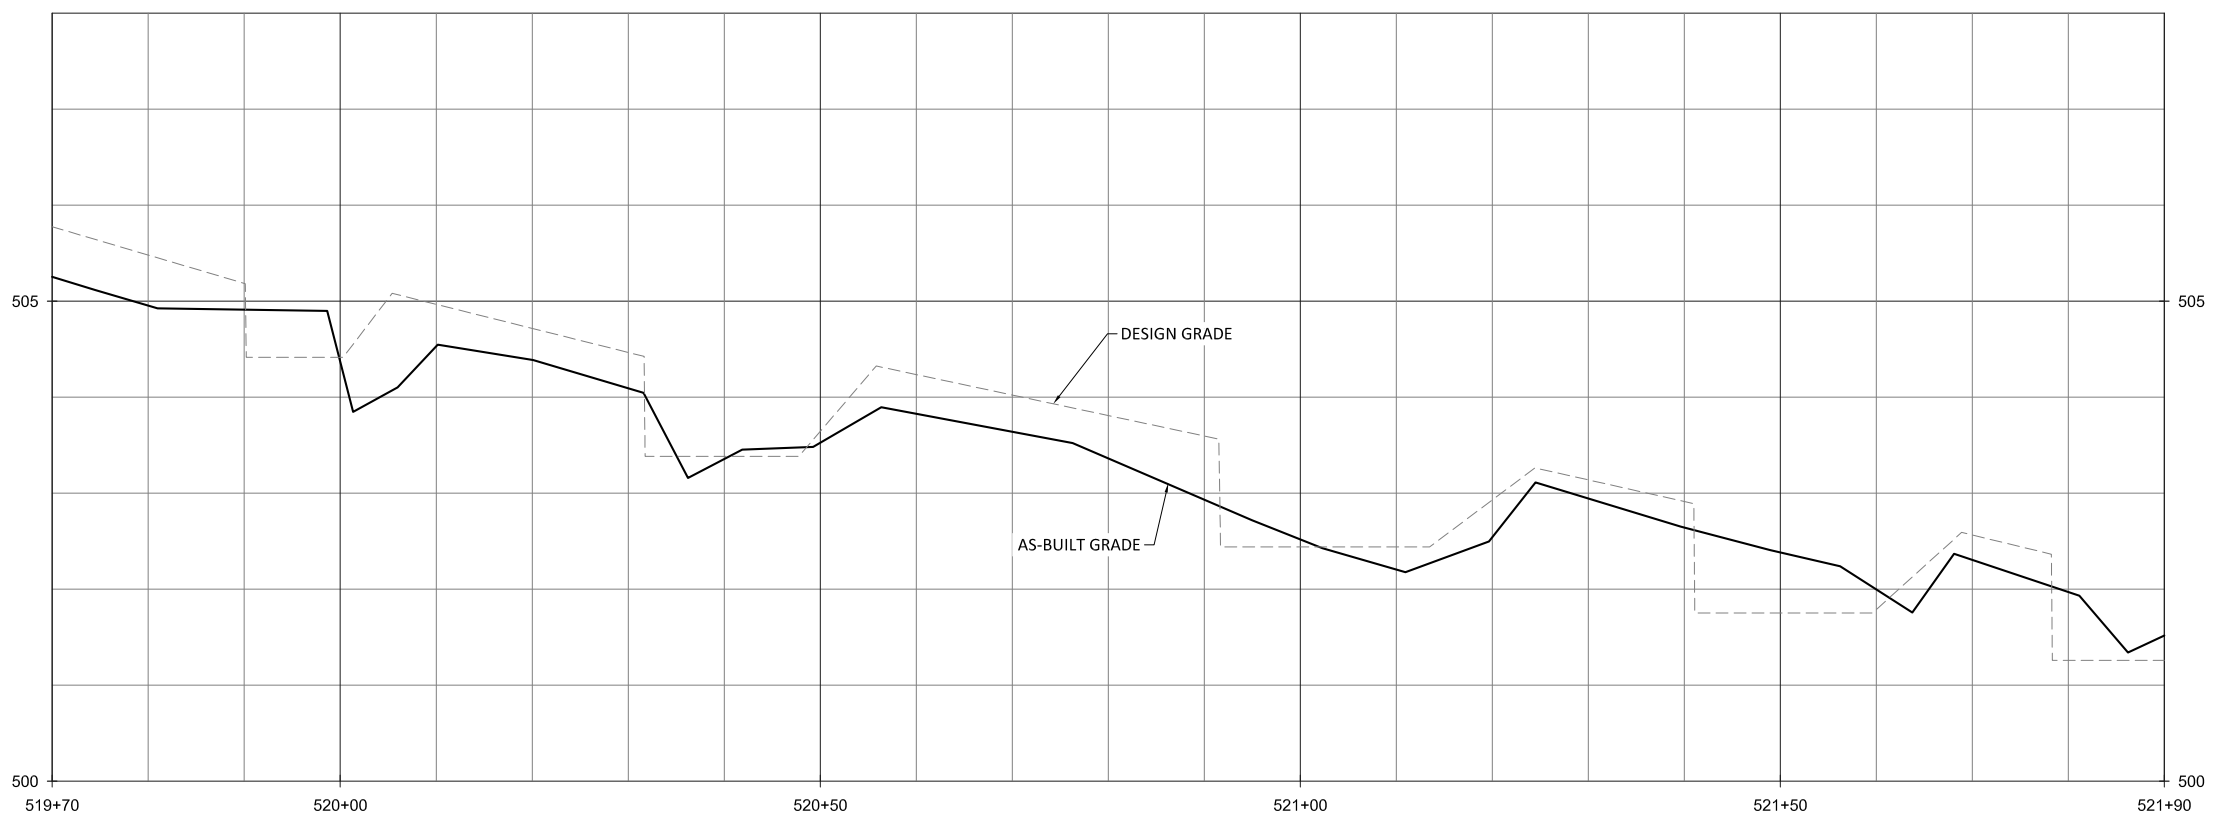
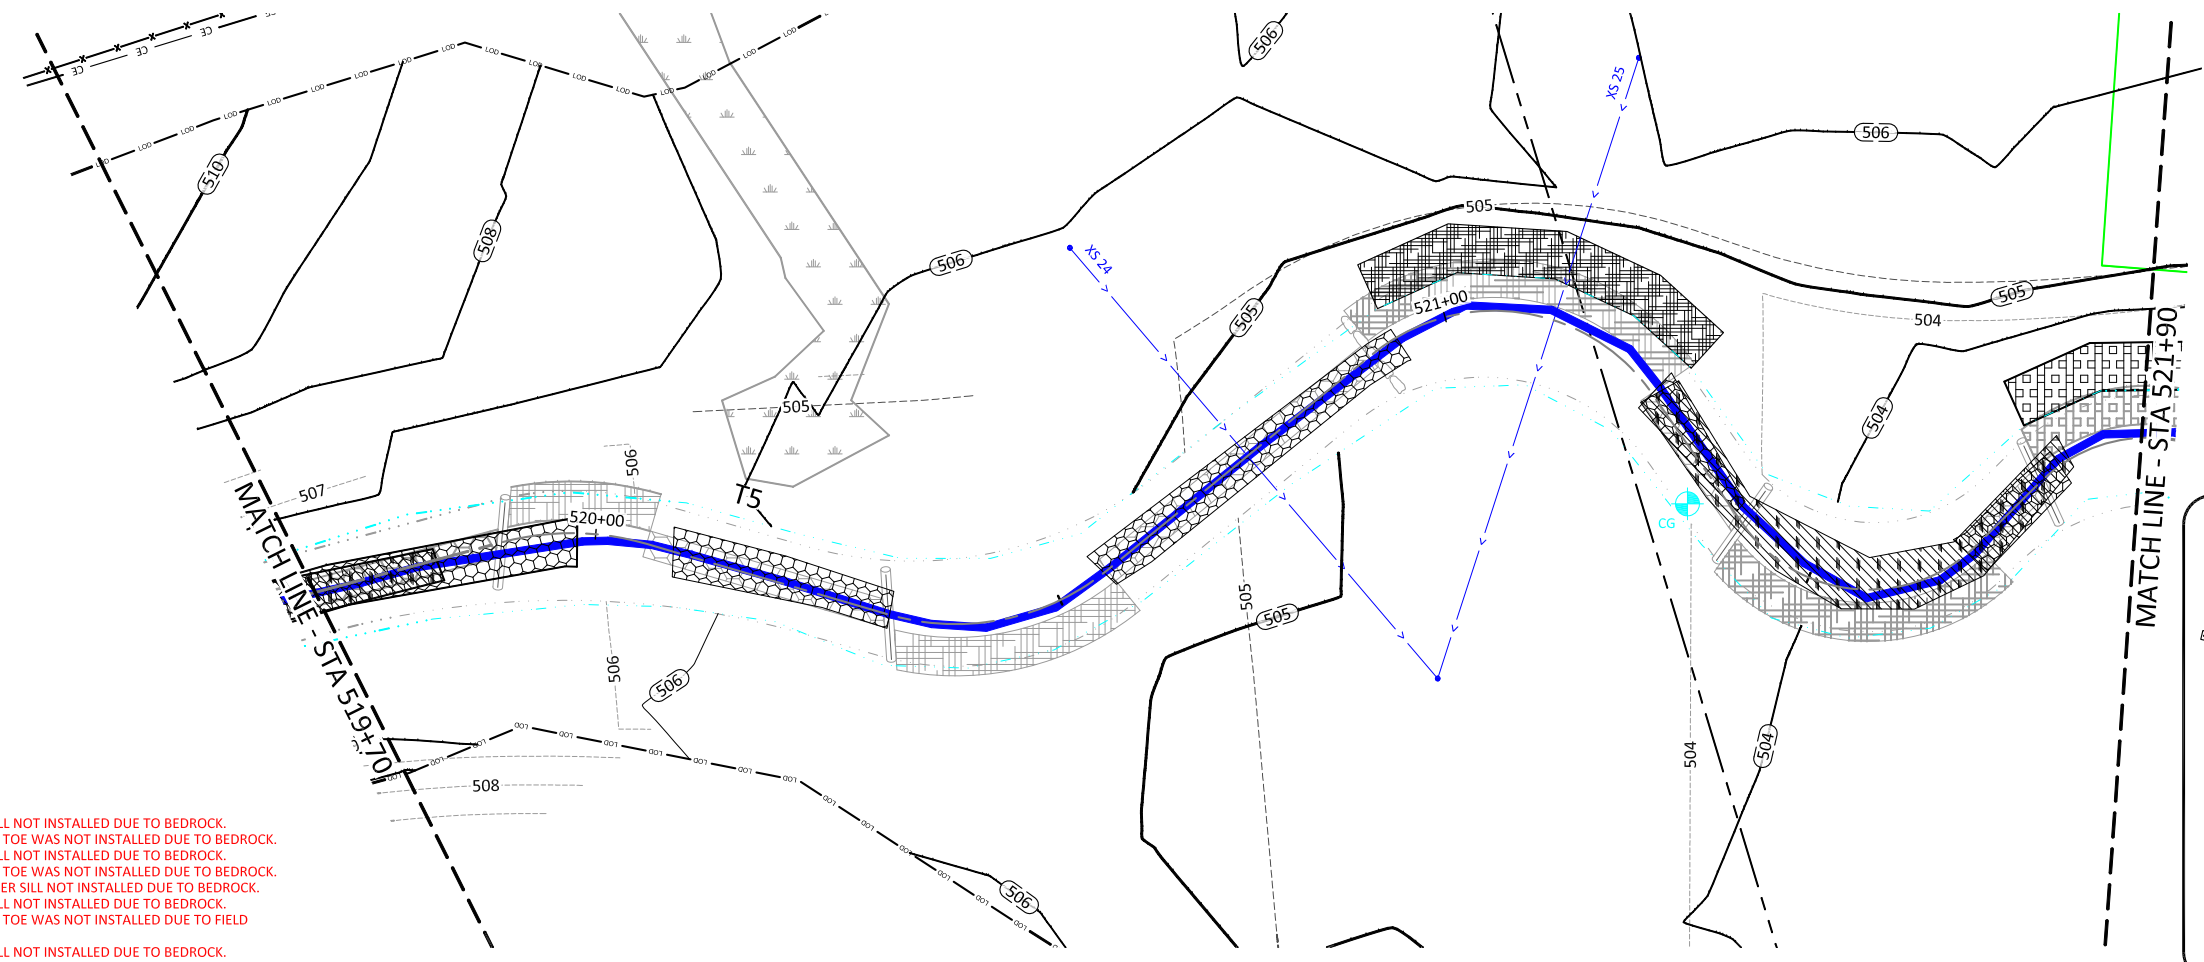
- Station 521+41 log sill not installed due to bedrock;
- Station 521+56 brush toe not installed due to field conditions;
- Station 521+78 log sill not installed due to bedrock;

- NOTE:**
1. STA 519+90: LOG SILL NOT INSTALLED DUE TO BEDROCK.
 2. STA 519+99: BRUSH TOE WAS NOT INSTALLED DUE TO BEDROCK.
 3. STA 520+32: LOG SILL NOT INSTALLED DUE TO BEDROCK.
 4. STA 520+44: BRUSH TOE WAS NOT INSTALLED DUE TO BEDROCK.
 5. STA 520+92: BOULDER SILL NOT INSTALLED DUE TO BEDROCK.
 6. STA 521+41: LOG SILL NOT INSTALLED DUE TO BEDROCK.
 7. STA 521+56: BRUSH TOE WAS NOT INSTALLED DUE TO FIELD CONDITIONS.
 8. STA 521+78: LOG SILL NOT INSTALLED DUE TO BEDROCK.

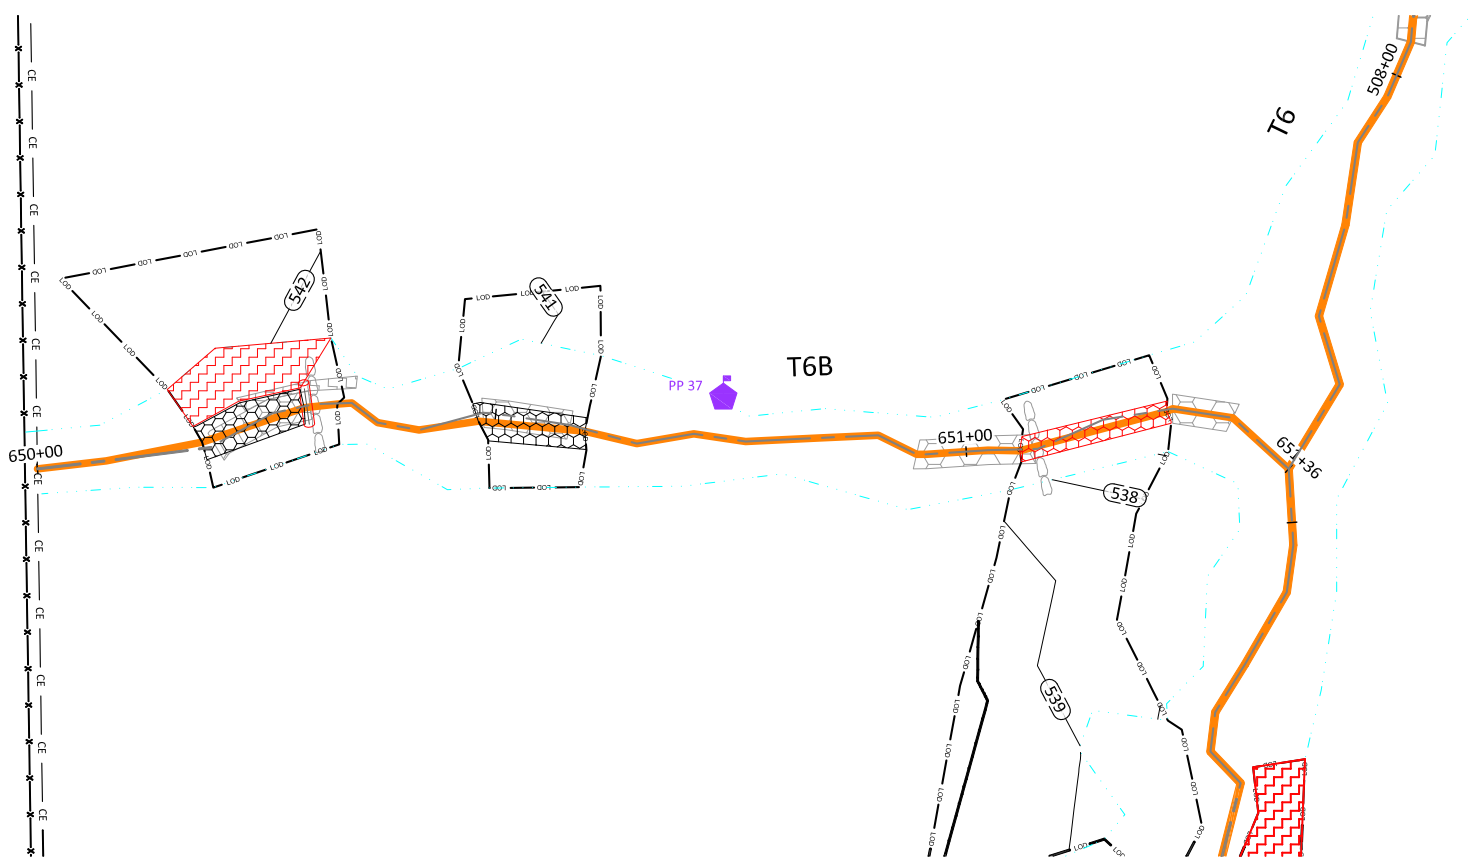
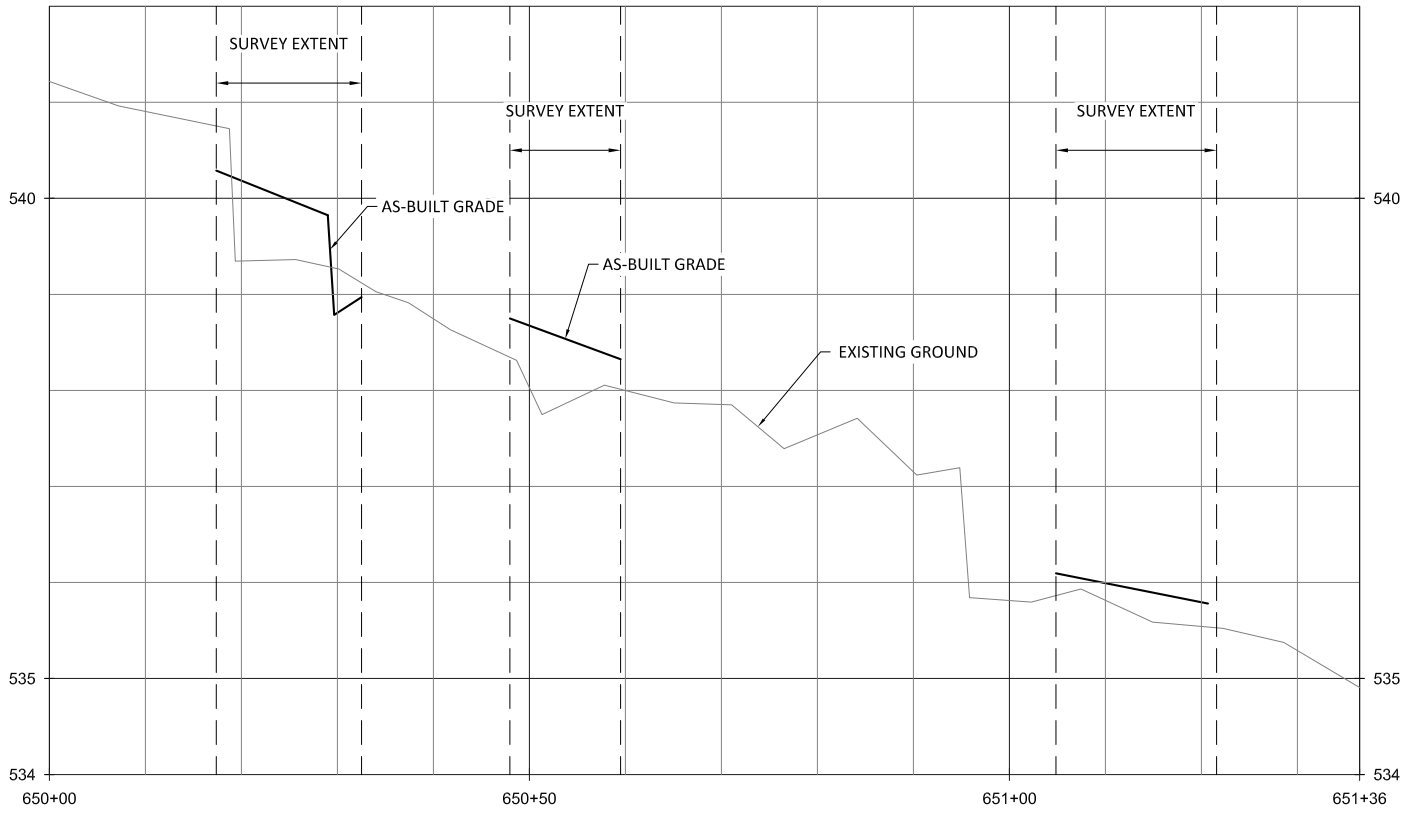
- Station 650+29 log sill was installed instead of boulder sill;
- Station 651+05 boulder sill was not installed due to field conditions;
- Station 651+13 due to field conditions, one riffle was installed instead of two.

- NOTE:**
1. STA 650+29: LOG SILL WAS INSTALLED INSTEAD OF BOULDER SILL.
 2. STA 651+05: BOULDER SILL WAS NOT INSTALLED DUE TO FIELD CONDITIONS.
 3. STA 651+13: DUE TO FIELD CONDITIONS, ONE RIFFLE WAS INSTALLED INSTEAD OF TWO.

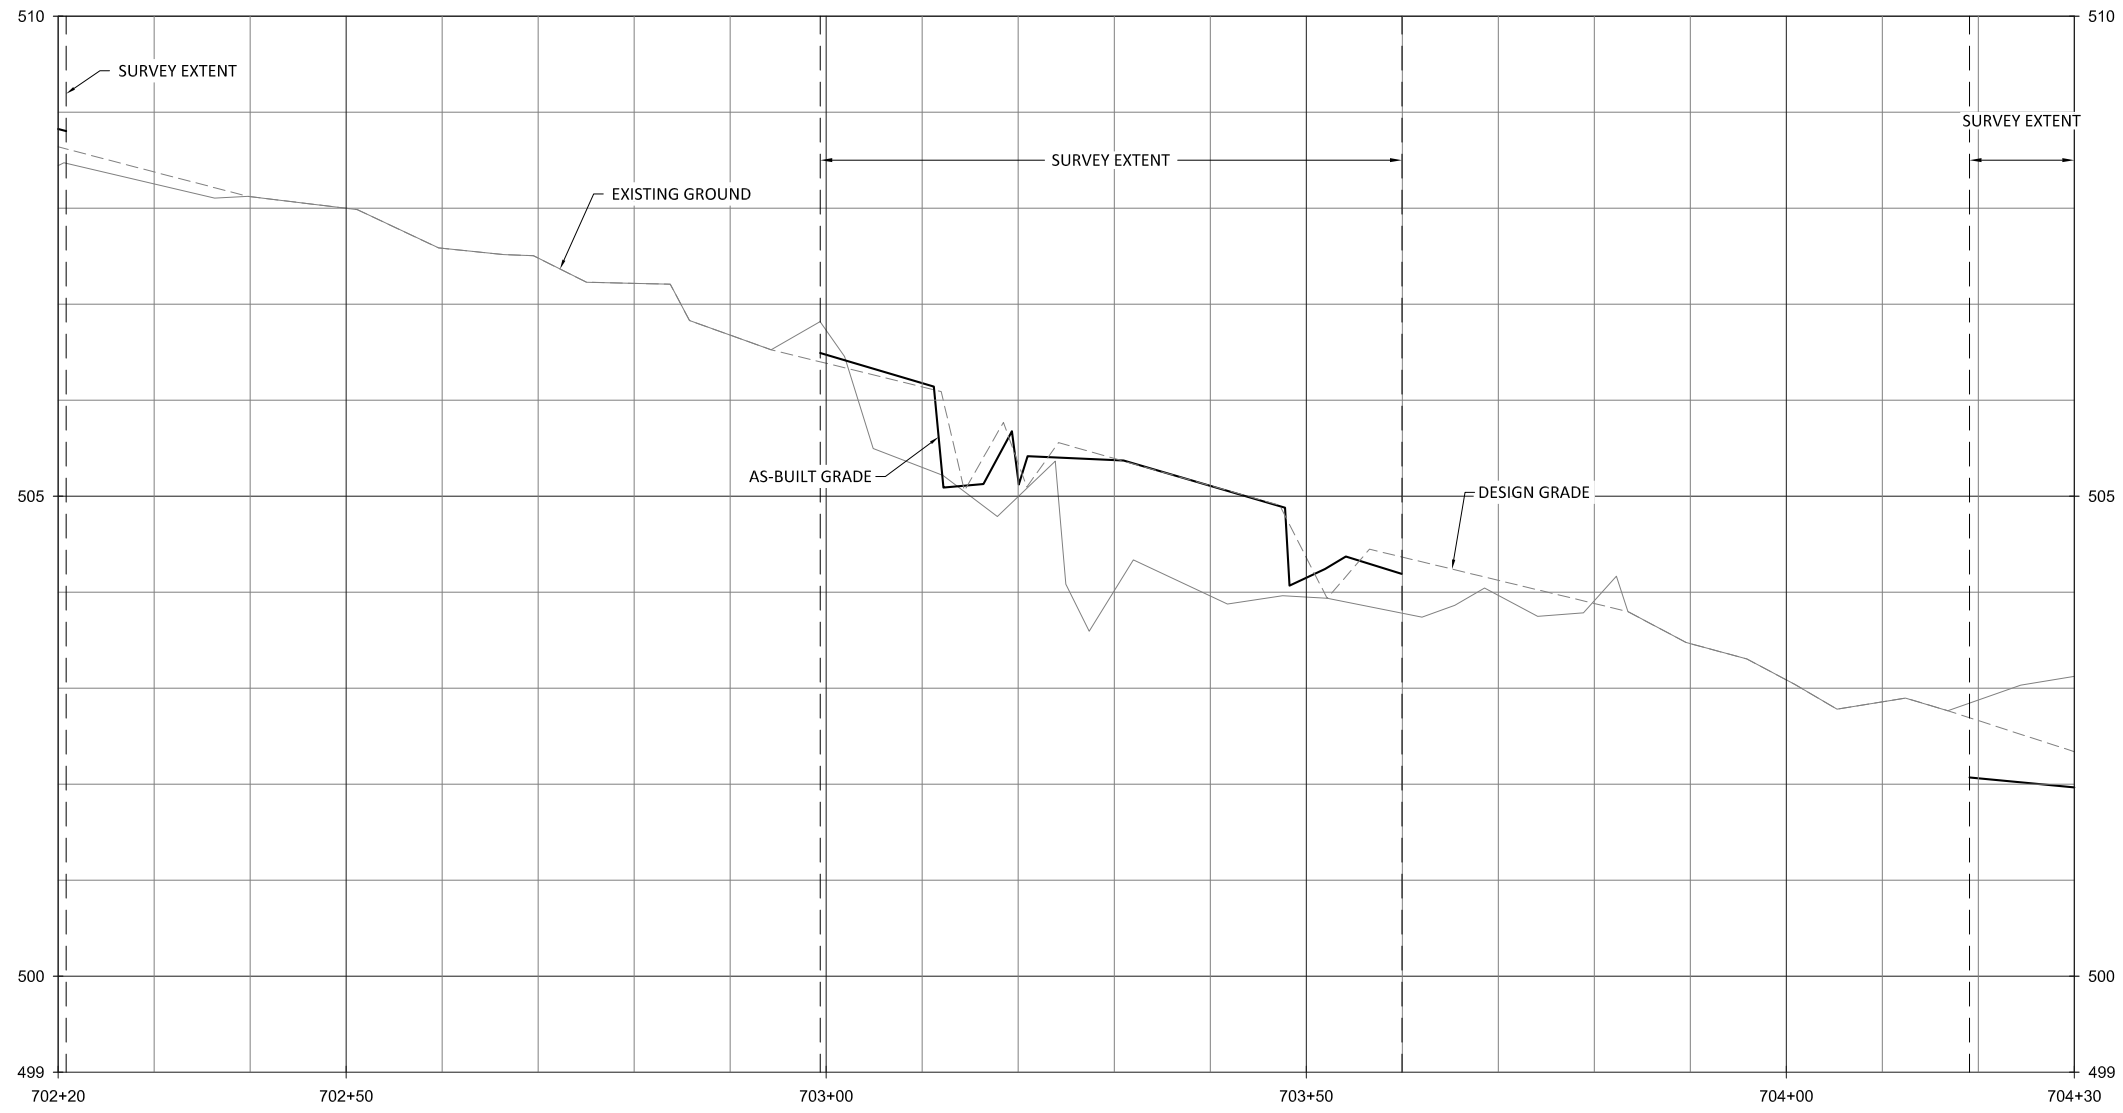
- NOTE:**
1. STA 703+04: RIFFLE ADDED.
 2. STA 703+38: RIFFLE ADDED.

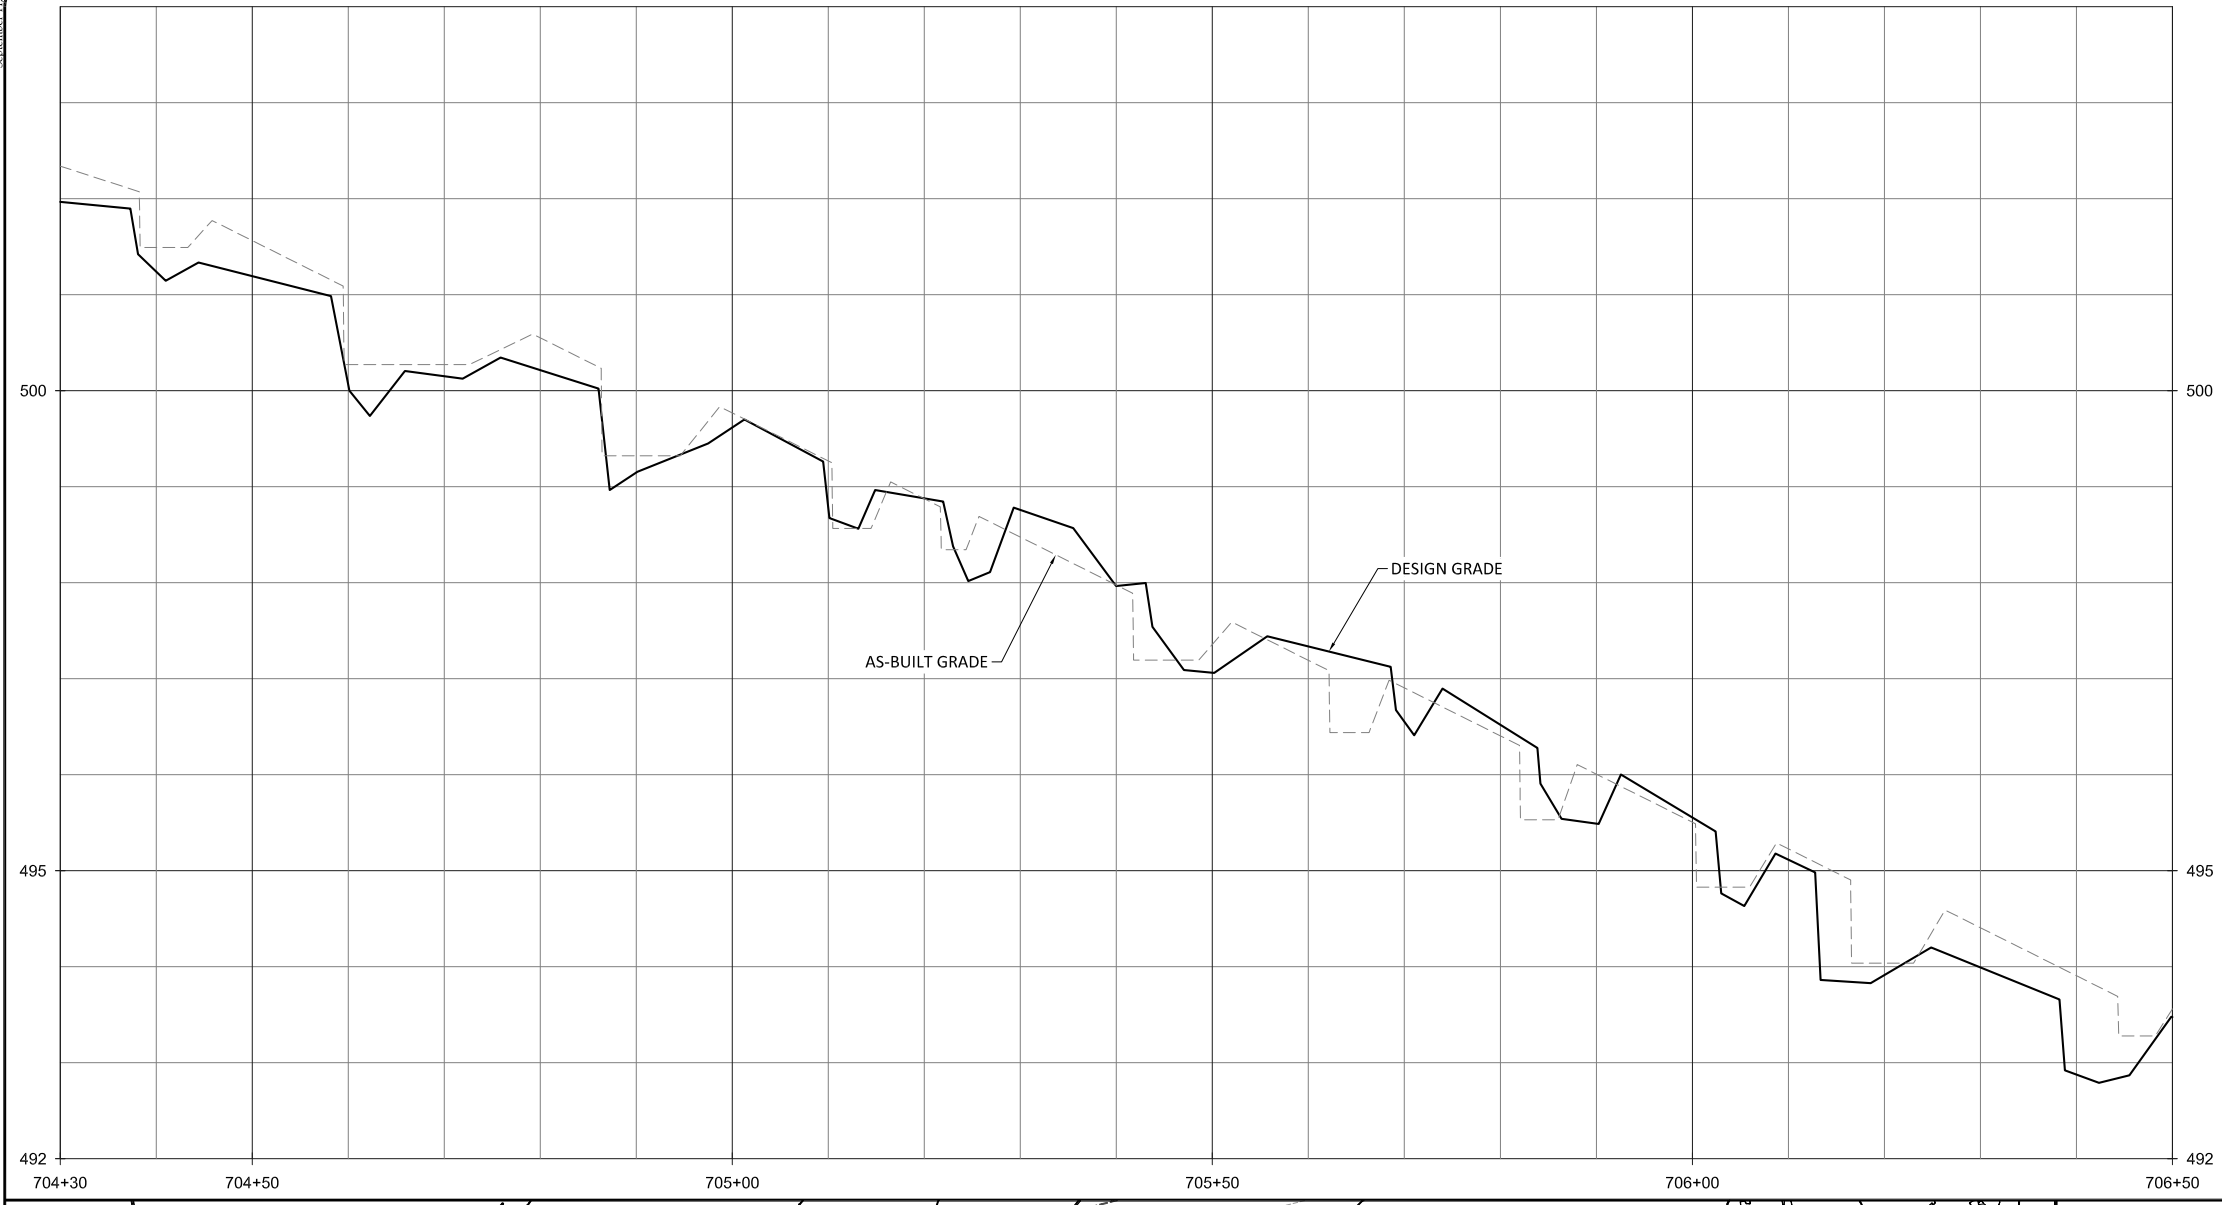
- NOTE:**
1. STA 705+42: LOG SILL INSTALLED INSTEAD OF BOULDER SILL.
 2. STA 705+70: LOG SILL INSTALLED INSTEAD OF BOULDER SILL.
 3. STA 706+40: LOG SILL INSTALLED INSTEAD OF BOULDER SILL.

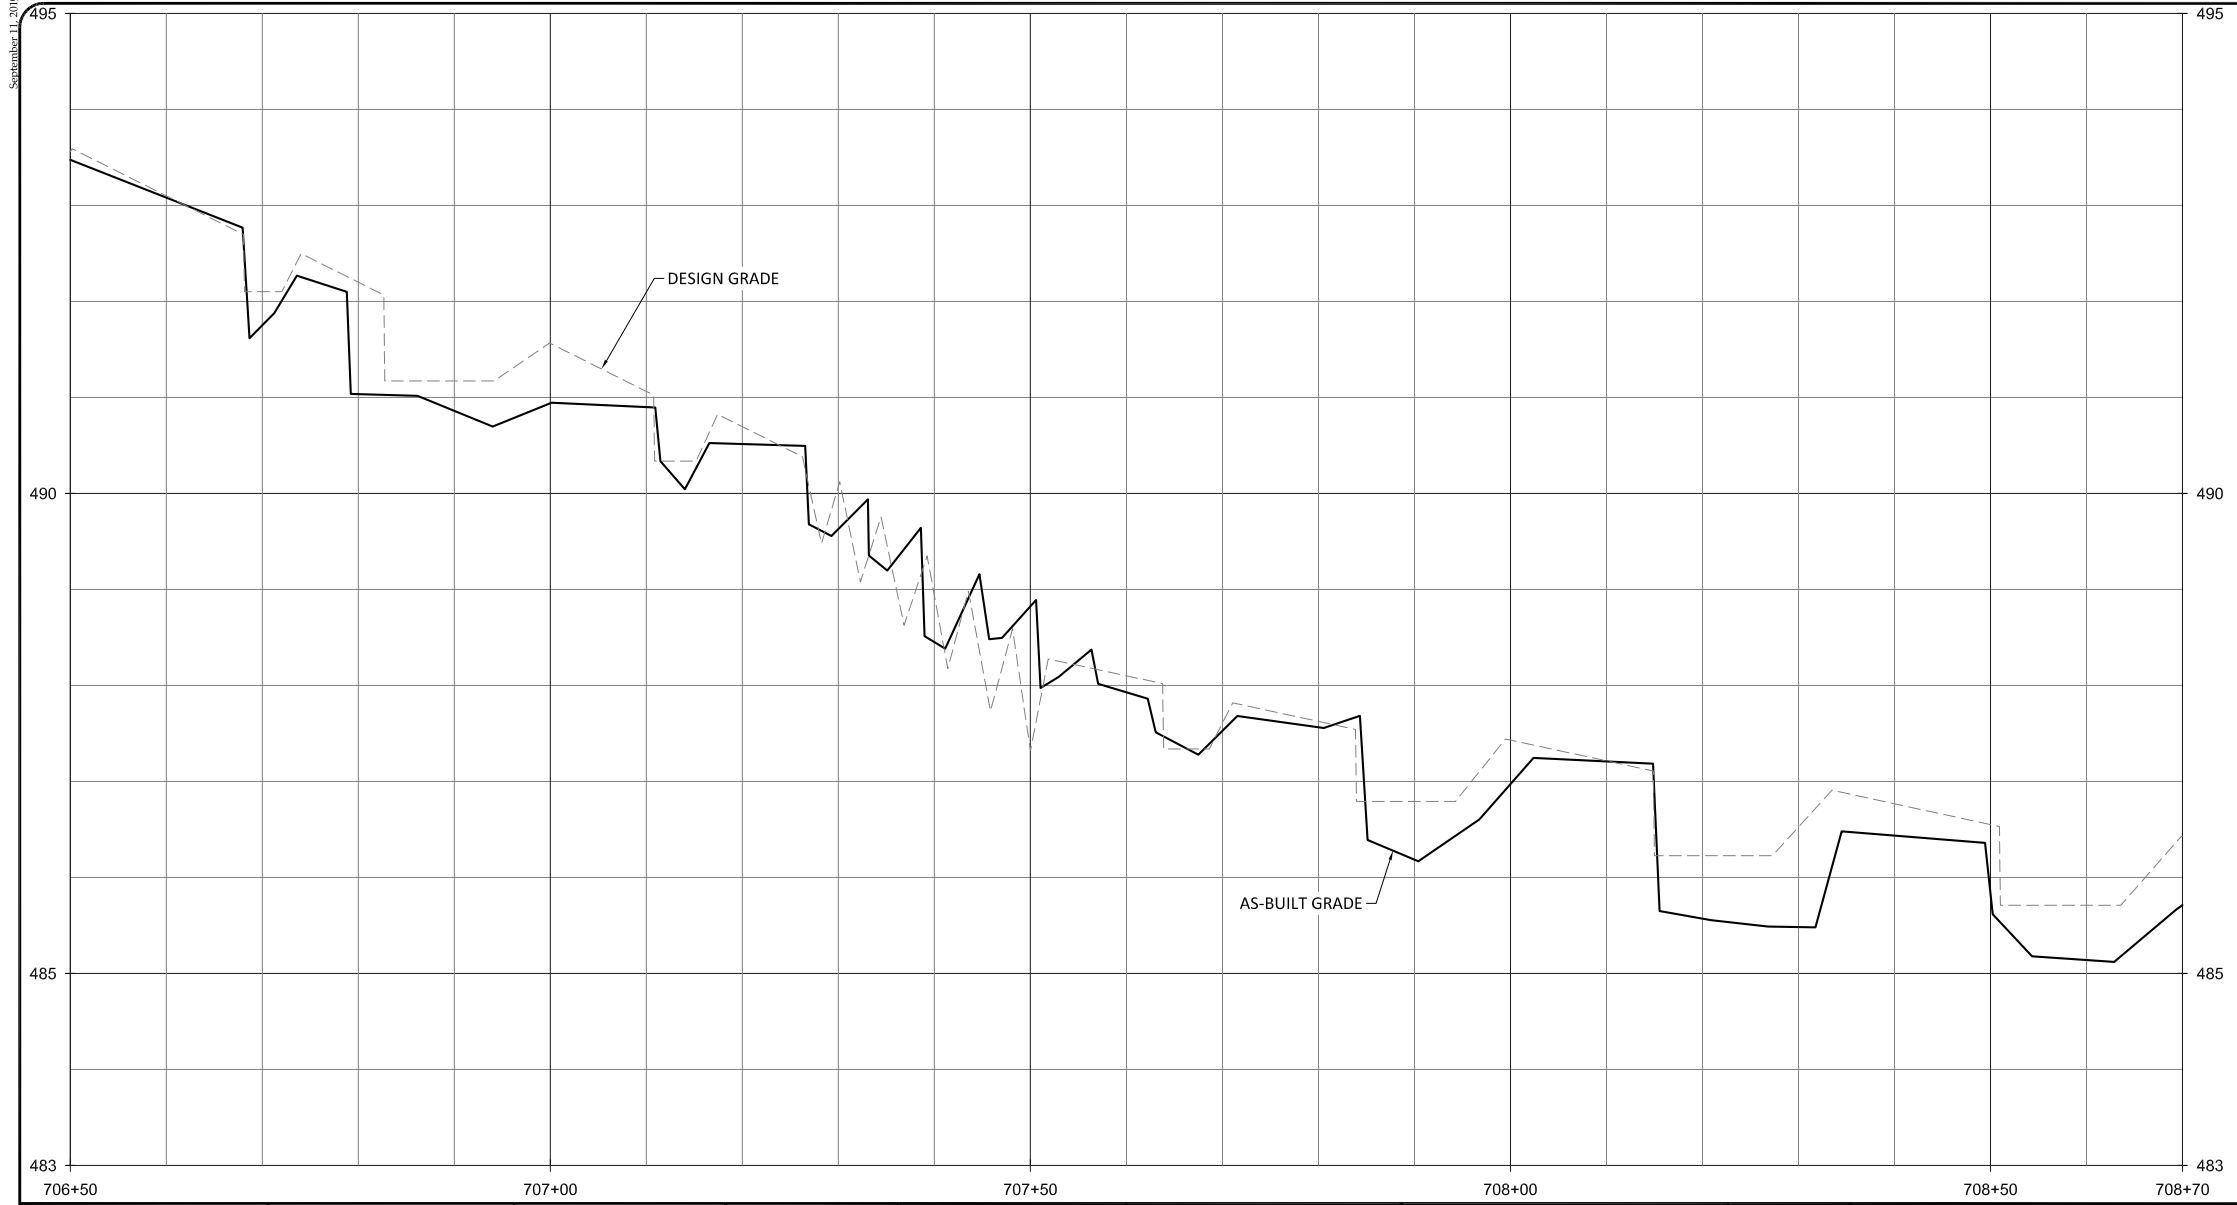
Buckwater Mitigation Site
Orange County, North Carolina
T7 Reach 2
Stream Plan and Profile

- NOTE:**
1. STA 706+69: LOG SILL INSTALLED INSTEAD OF BOULDER SILL
 2. STA 706+80: LOG SILL INSTALLED INSTEAD OF BOULDER SILL
 3. STA 707+64: LOG SILL INSTALLED INSTEAD OF BOULDER SILL
 4. STA 708+18: LOG SILL INSTALLED INSTEAD OF BOULDER SILL
 5. STA 708+53: LOG SILL INSTALLED INSTEAD OF BOULDER SILL

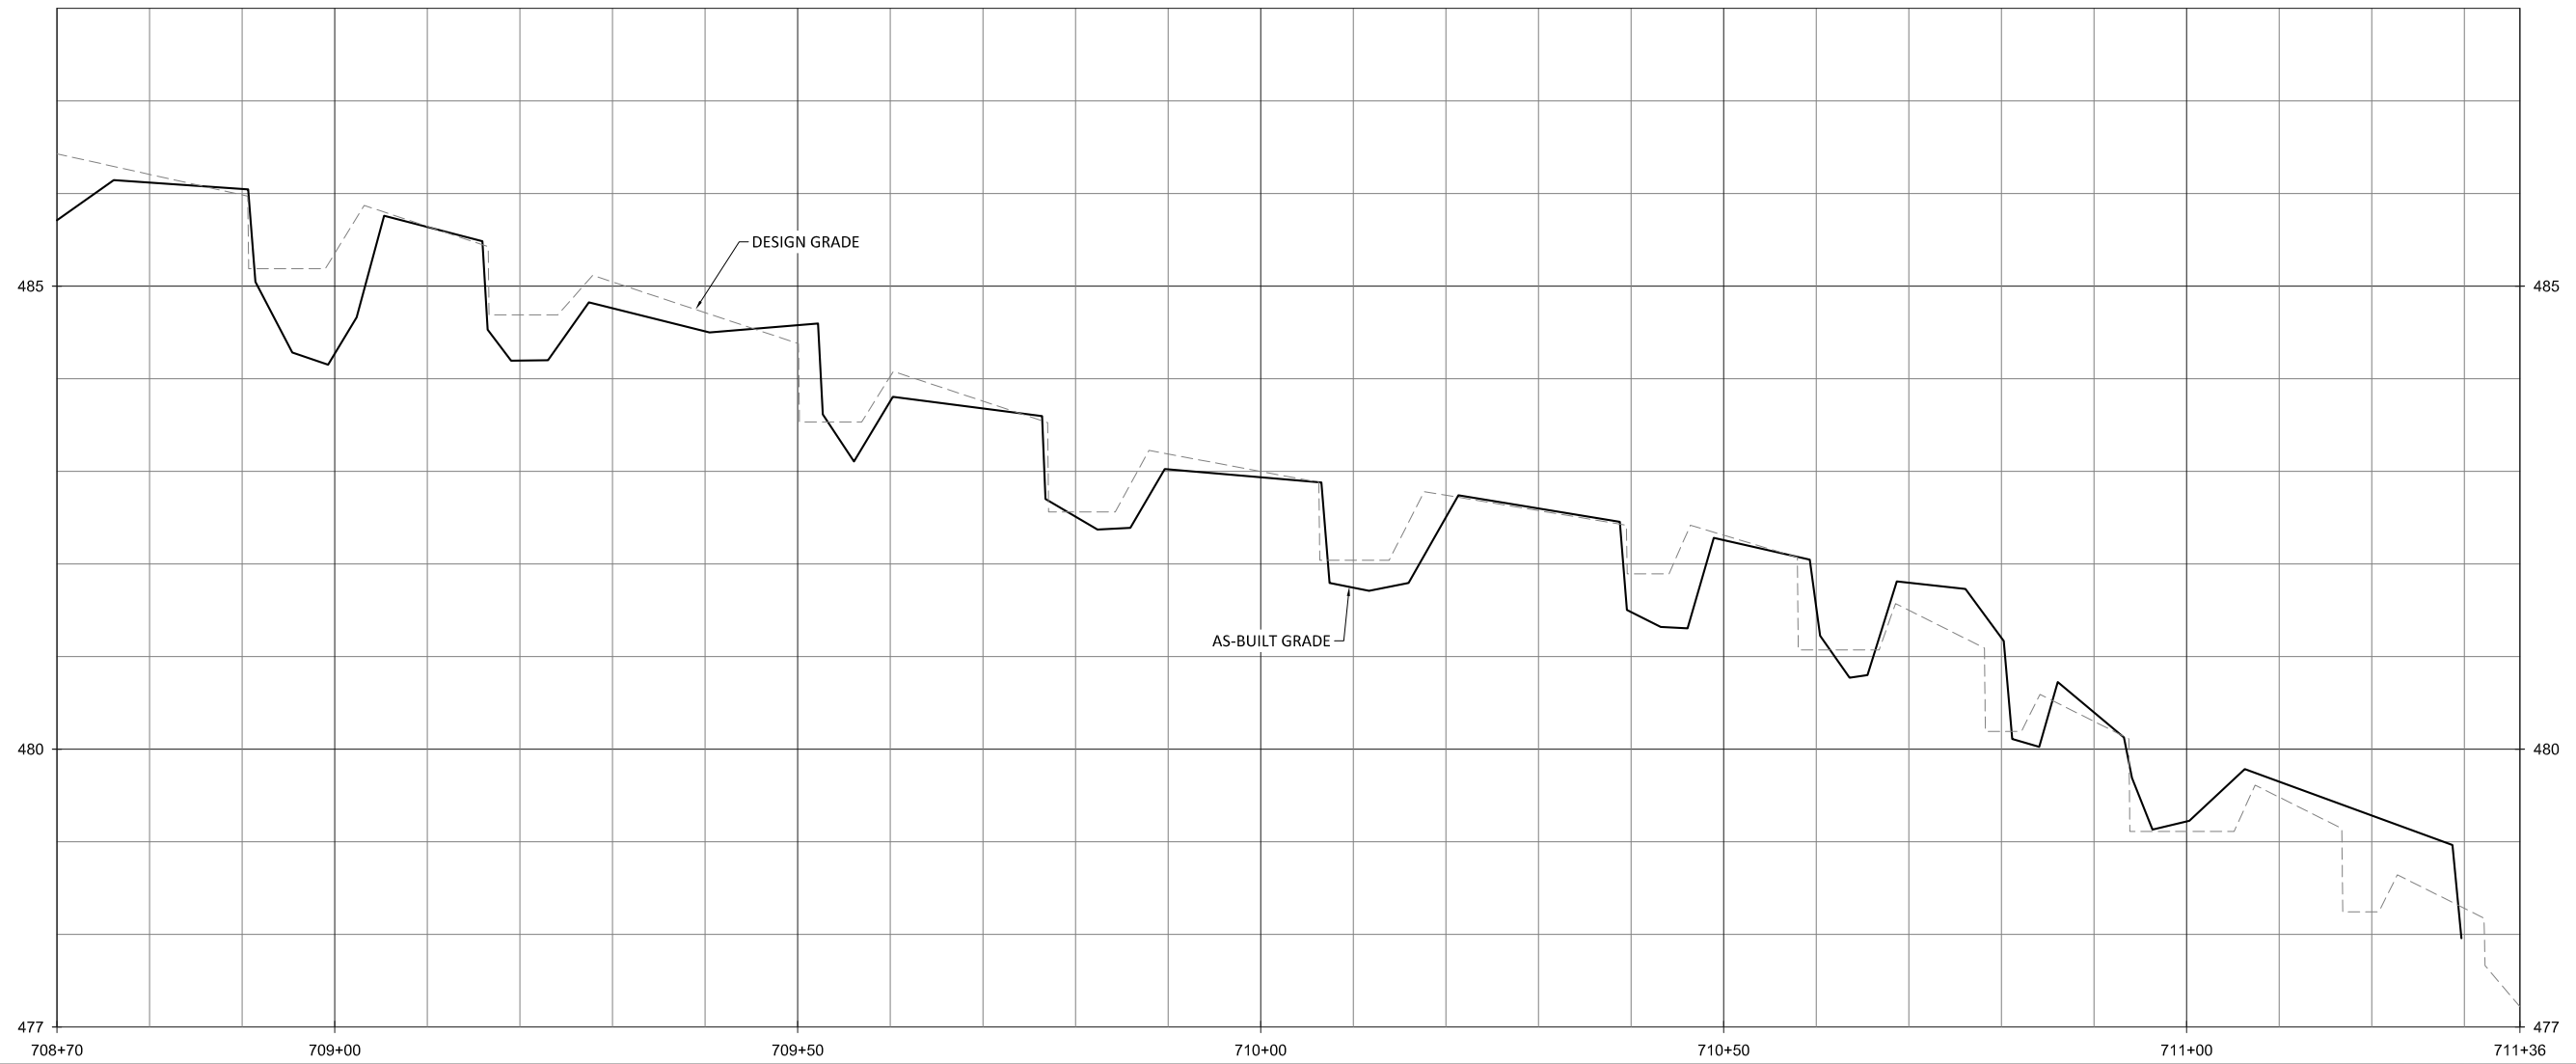
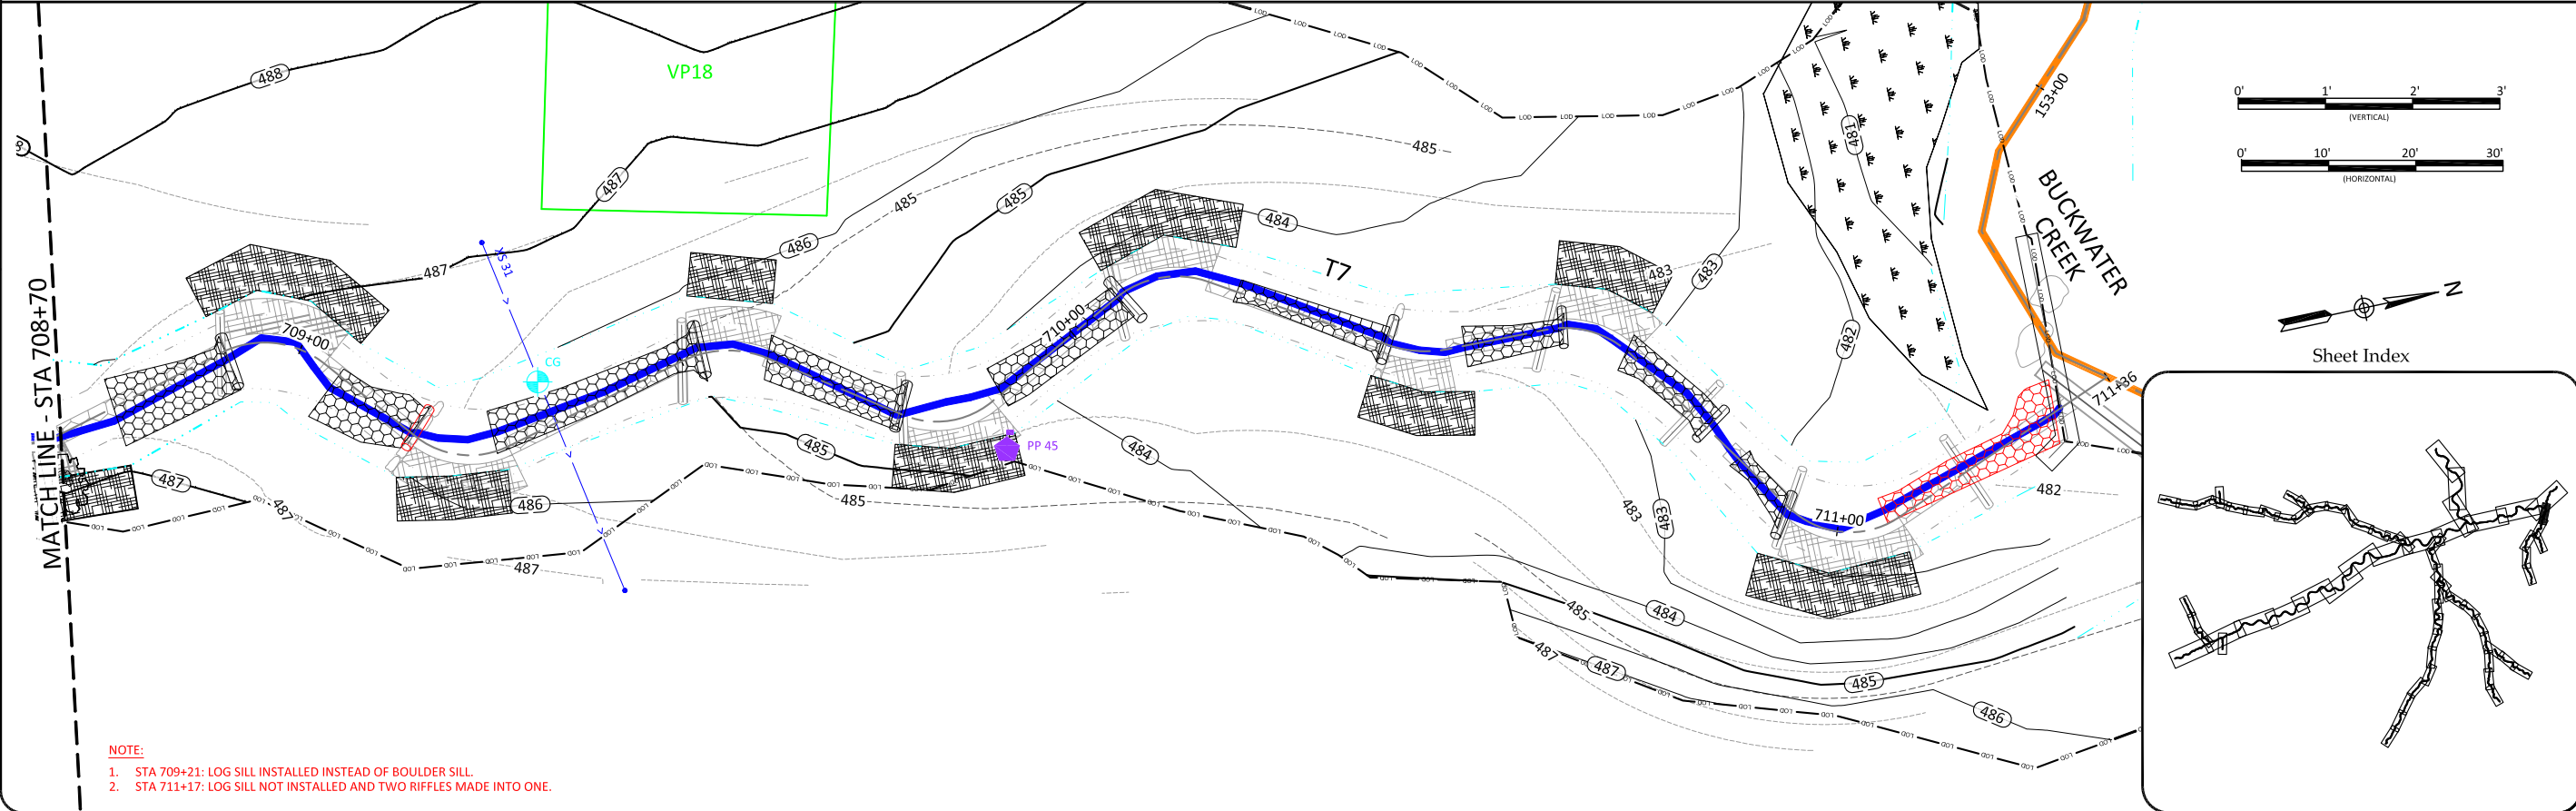
- NOTE:**
1. STA 709+21: LOG SILL INSTALLED INSTEAD OF BOULDER SILL.
 2. STA 711+17: LOG SILL NOT INSTALLED AND TWO RIFFLES MADE INTO ONE.
