**BASELINE MONITORING
DOCUMENT AND AS-BUILT
BASELINE REPORT
FINAL**

BUCKWATER MITIGATION SITE

Orange County, NC

DMS Project Number 97084

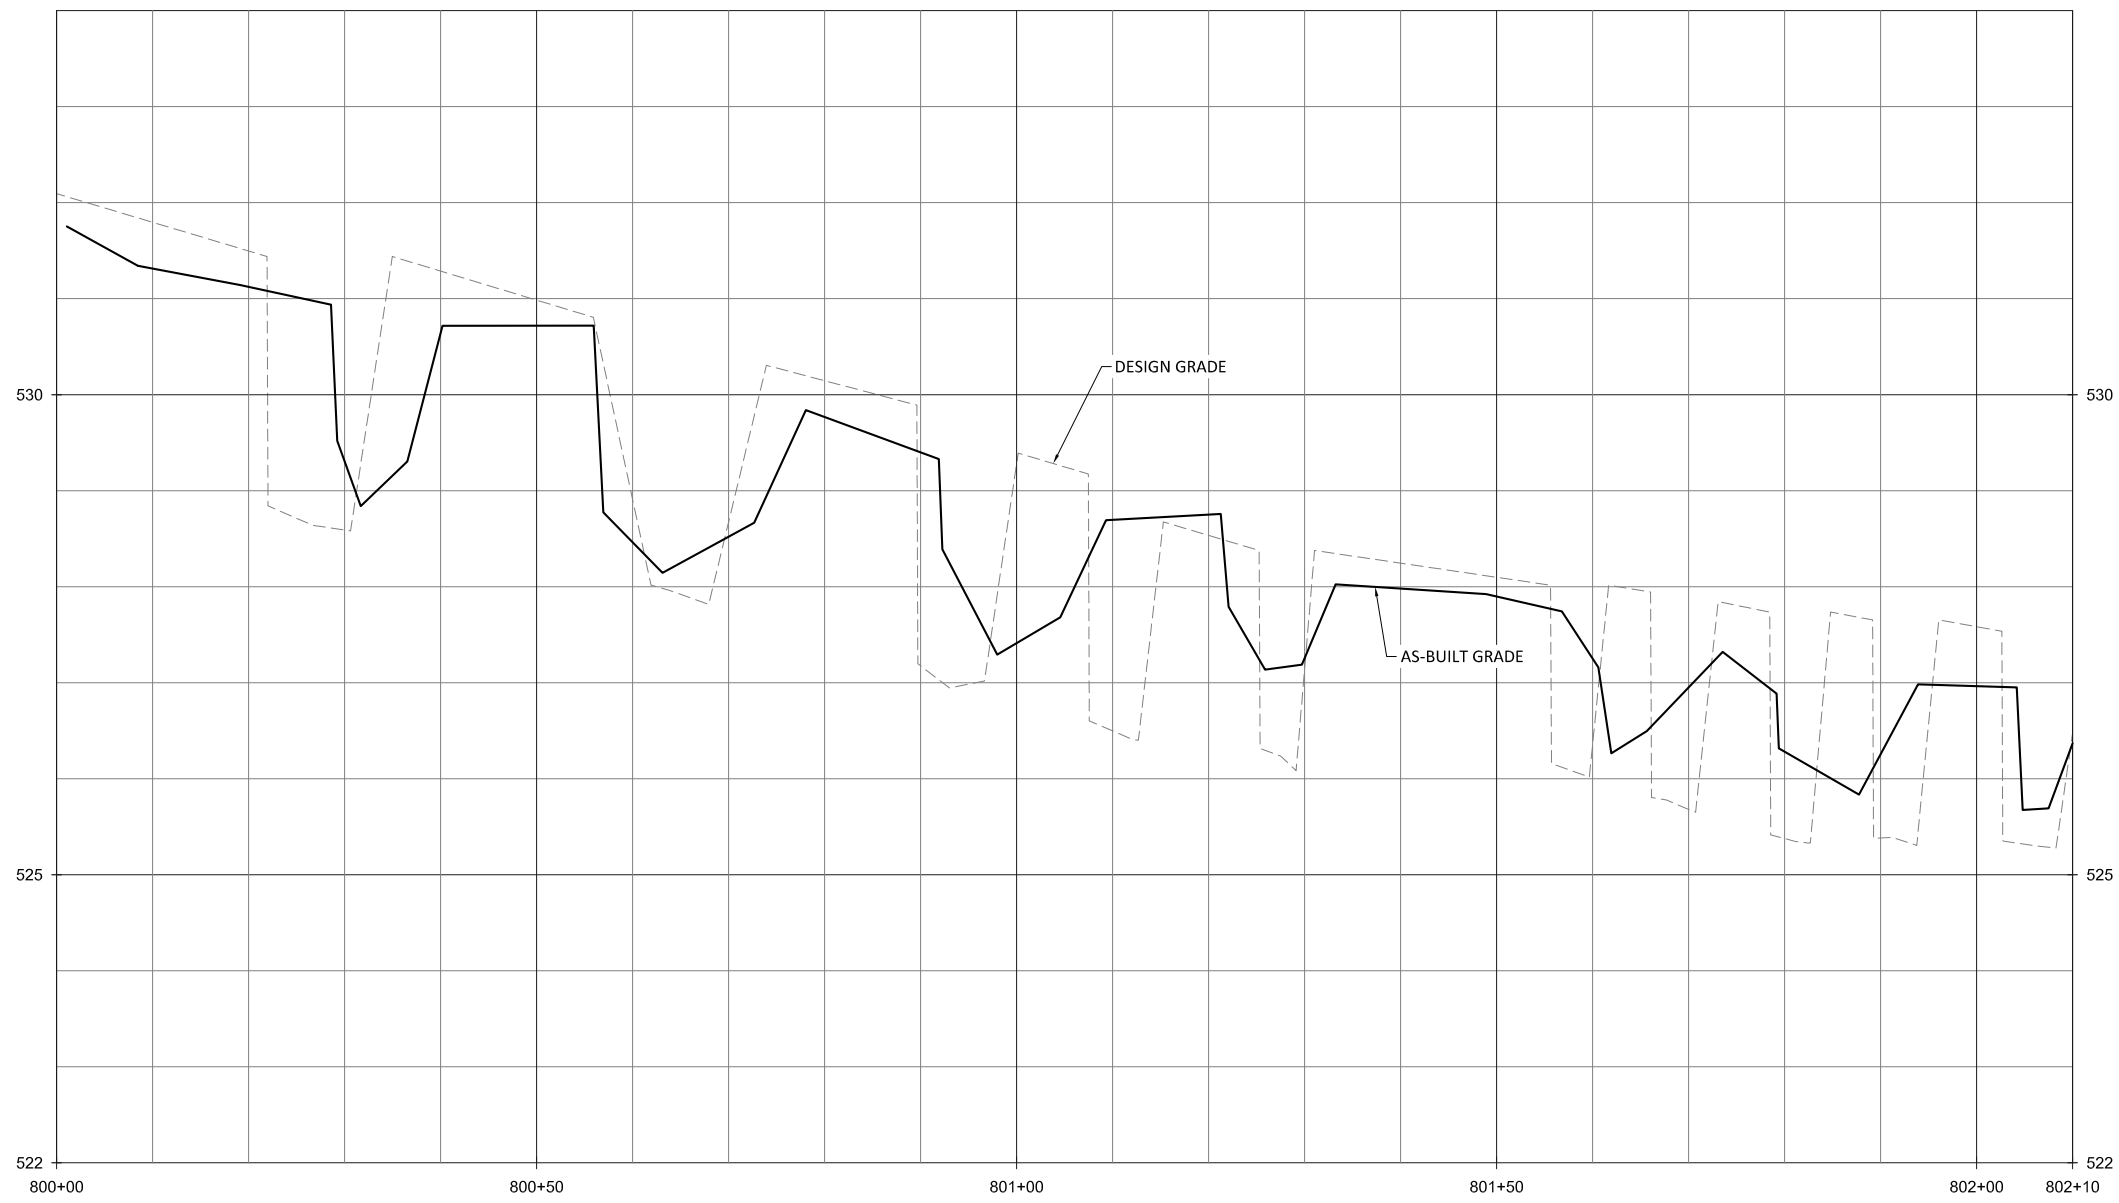
- Station 801+04 due to site conditions no riffle installed;
- Station 801+07 due to site conditions no boulder sill installed;
- Station 801+75 due to site conditions no brush toe installed;
- Station 801+63 due to site conditions no riffle installed;
- Station 801+66 due to site conditions no boulder sill installed;
- Station 801+70 due to site conditions no brush toe installed;
- Station 801+82 due to site conditions no brush toe installed;
- Station 801+87 due to site conditions no riffle installed;
- Station 801+89 due to site conditions no boulder sill installed;
- Station 804+93 due to site conditions no boulder sill installed;
- Station 805+62 brush toe was not installed to avoid impacting existing vegetation;
- Station 805+81 brush toe was not installed to avoid impacting existing vegetation.

1. STA 801+04: DUE TO SITE CONDITIONS NO RIFFLE INSTALLED.
2. STA 801+07: DUE TO SITE CONDITIONS NO BOULDER SILL INSTALLED.
3. STA 801+75: DUE TO SITE CONDITIONS NO BRUSH TOE INSTALLED.
4. STA 801+63: DUE TO SITE CONDITIONS NO RIFFLE INSTALLED.
5. STA 801+66: DUE TO SITE CONDITIONS NO BOULDER SILL INSTALLED.
6. STA 801+70: DUE TO SITE CONDITIONS NO BRUSH TOE INSTALLED.
7. STA 801+82: DUE TO SITE CONDITIONS NO BRUSH TOE INSTALLED.
8. STA 801+87: DUE TO SITE CONDITIONS NO RIFFLE INSTALLED.
9. STA 801+89: DUE TO SITE CONDITIONS NO BOULDER SILL INSTALLED.
