Annual Monitoring Report

**Mill Dam Creek Restoration Site
Yadkin River Basin - 03040101
Monitoring Year 01
DEQ Contract 6898
DMS Project Number 97136**

**DWR #: 18-1349
USACE Action ID: 2016-01335
Yadkin County, North Carolina**

**Data Collected: 2020
Date Submitted: January 2021**

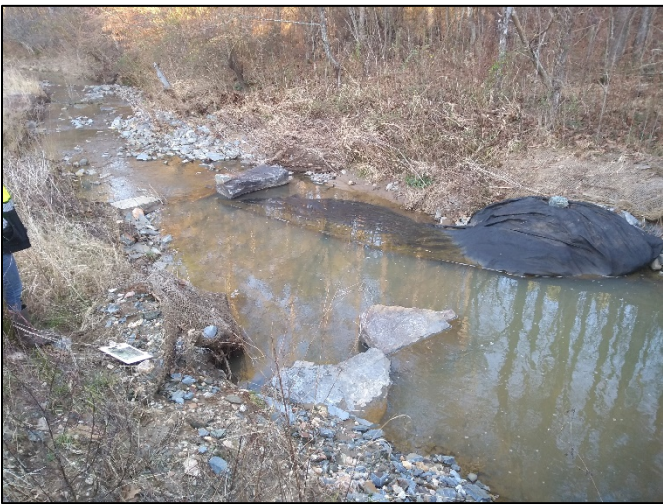
- Monitoring Results: Please add short discussion in second paragraph concerning erosion areas noted on CCPV and the damaged boulder sill on UTHC4-1 in regards to heavy rainfall events in 2020.
KCI Response: This discussion has been added to the report.

Damaged boulder sill, Sta 55+60, 12/18/20

Overall the site is functioning as designed with no major problem areas or threats to project success identified during MY01. The few areas that were damaged by the heavy rains in 2020 are of limited extent and are being evaluated to determine if future repairs are necessary.

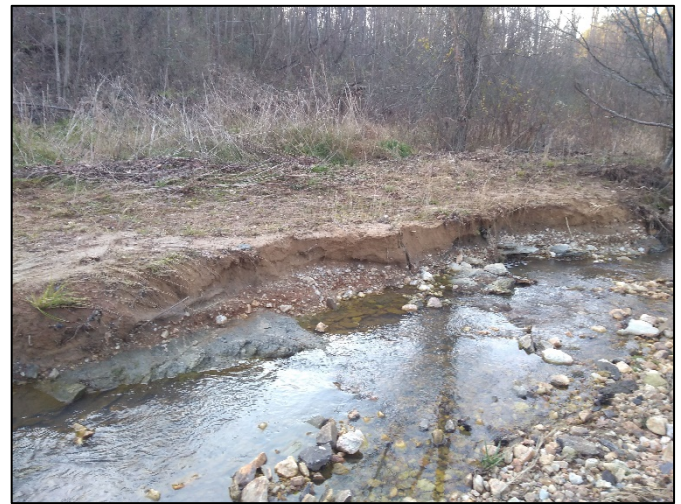
Outer bend erosion, Sta 61+00, 12/18/20
