Thomas Creek Restoration Project

Year 1 Monitoring Report

Wake County, North Carolina

DMS Project ID Number – 96074, DEQ Contract No. 5549

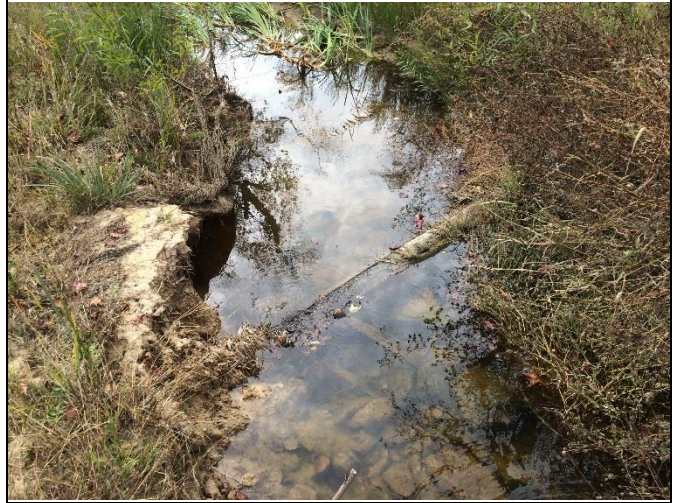
lateral/vertical stability and in-stream structure performance categories. The only exception is a 10-foot section along the left bank of a log step-pool structure on Reach 2 that has recently shown scour damage from Hurricane Matthew. It is not believed this small area will stabilize on its own without future repair, which will be conducted in 2017. The location and photographs of this lone problem area can be found in Appendix B.

Stream Problem Area (upstream), Oct. 2016, Station 40+60

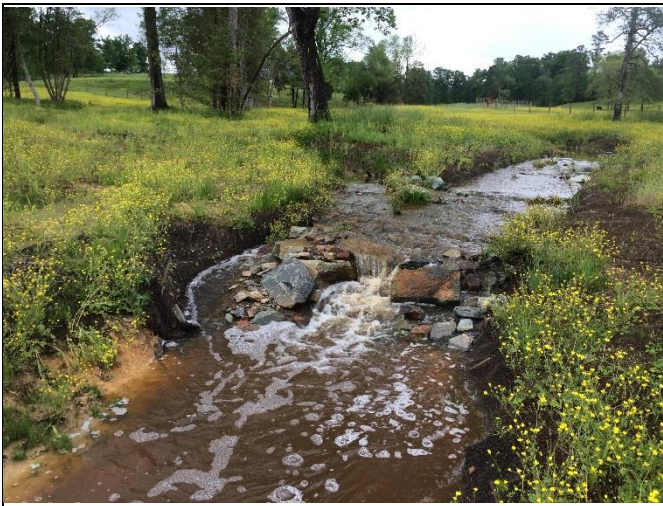
Stream Problem Area (downstream), Oct. 2016, Station 40+60

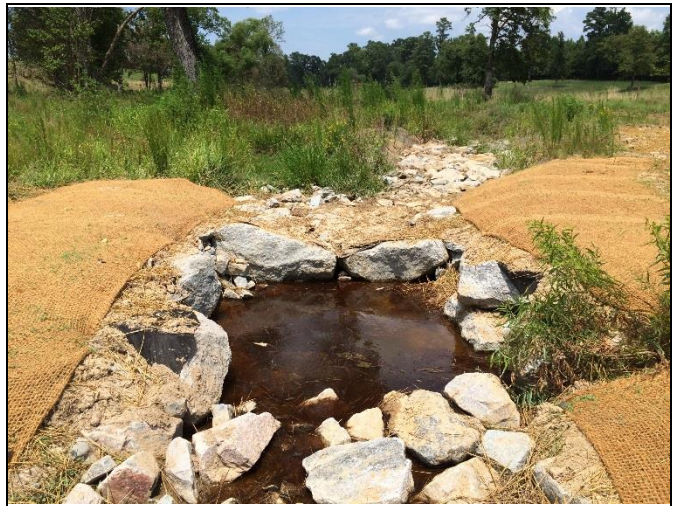
Additionally, damage from Hurricane Joaquin in October 2015 caused damage to the rock step pool located at the confluence of Reach 2 and Reach 5, and also to two riffles and their adjacent banks along Reach 1 immediately downstream. The high flows scoured around the rock step pool, scoured out pools, pushed riffle rock to one side, and began undermining channel banks. Once started, the damage slowly got worse over the winter with each storm event. In July 2016, a River Works crew mobilized on site and replaced the rock step pool with a larger boulder cross vane at the confluence, and repaired the channel banks and two rock riffles downstream with slightly larger cobble. This section has been stable since construction and remained stable after Hurricane Matthew in October 2016, a larger storm event than Hurricane Joaquin in 2015. The location and photographs of this repaired stream section can be found in Appendix B.

Repaired Stream Area (before), May 2016, Station 42+00

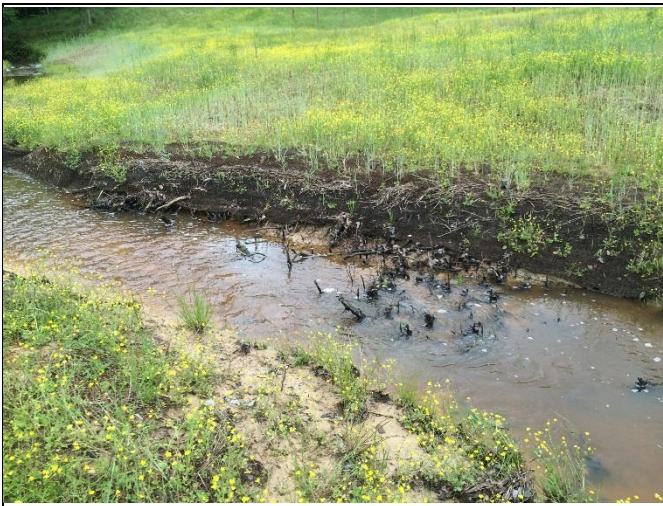
Repaired Stream Area (after), Oct. 2016, Station 42+00

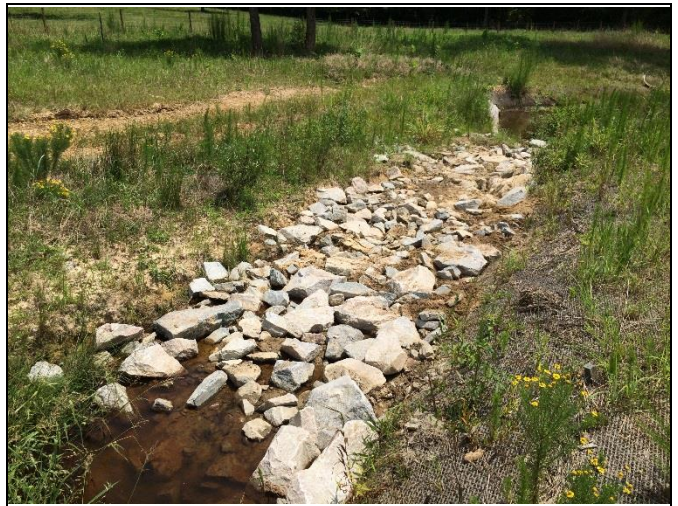
Repaired Stream Area (before), May 2016, Station 42+50
